Your Ref: 27716466QMX
Our Ref : CS/MSG18008026/Z

11th May 2018

**TECHNICAL INVESTIGATION REPORT OF FIRE INCIDENT INVOLVING THE
INSURED VEHICLE SJU 7407K ON 27th April 2018**

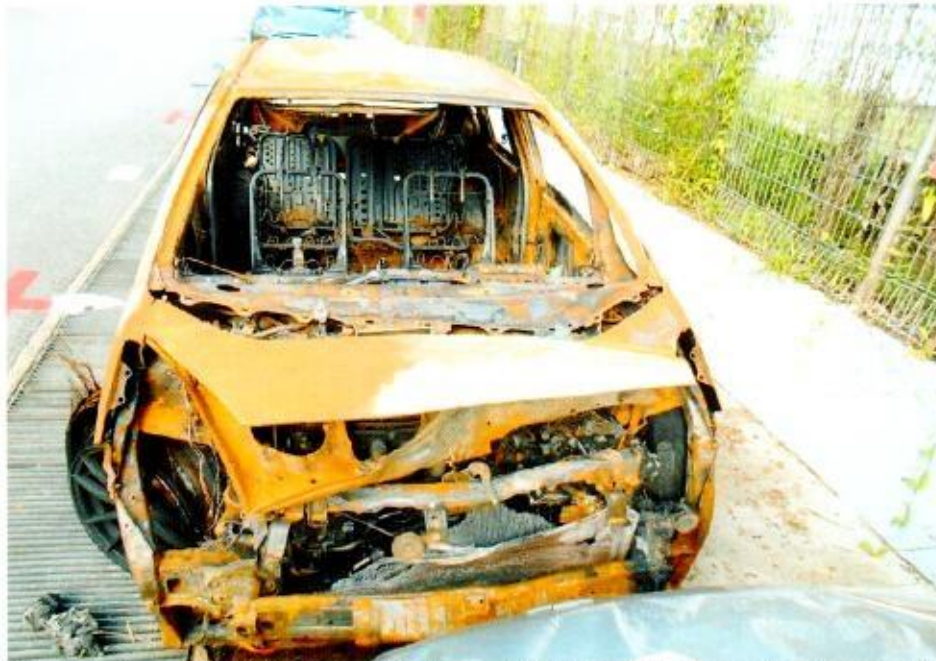
Photo 1 shows the front view of the Insured Vehicle at the time of our inspection. The Insured Vehicle was noted to have sustained fire damages that severely effected on the entire parts of the Insured Vehicle.

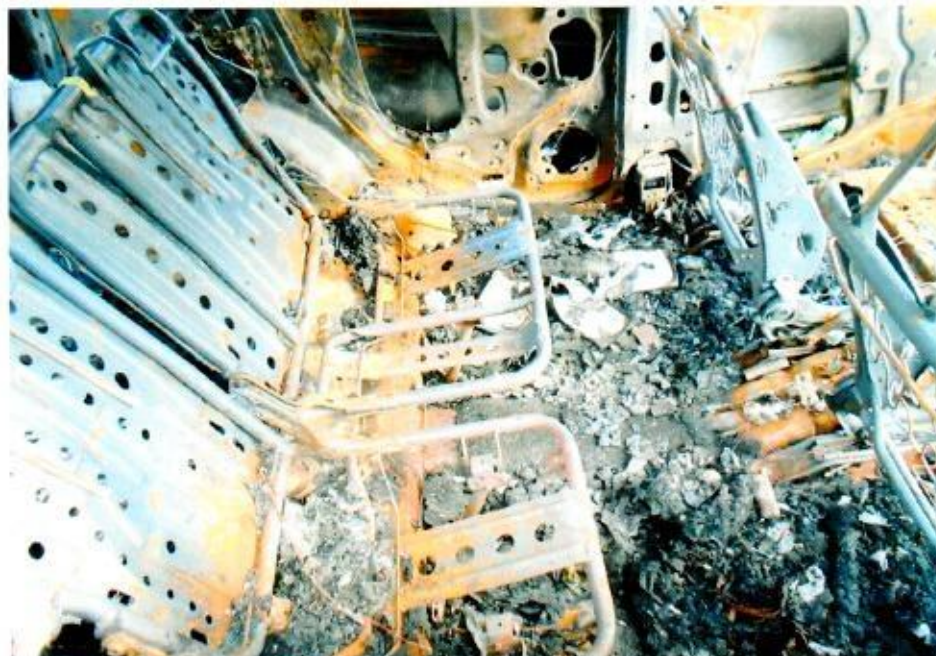
Photo 2 shows the interior view of the Insured vehicle, it was observed to have sustained with severe burnt damages due to the fire.

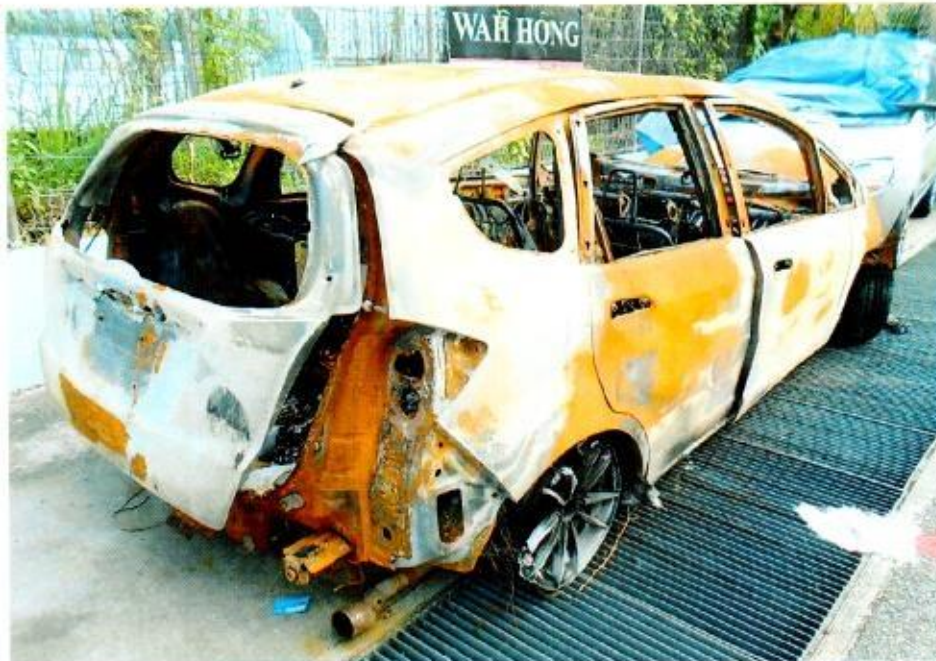
Photo 3 shows the rear right side of the Insured Vehicle at the time of our inspection. The Insured Vehicle was noted to have sustained fire damages that severely effected on the entire parts of the Insured Vehicle.

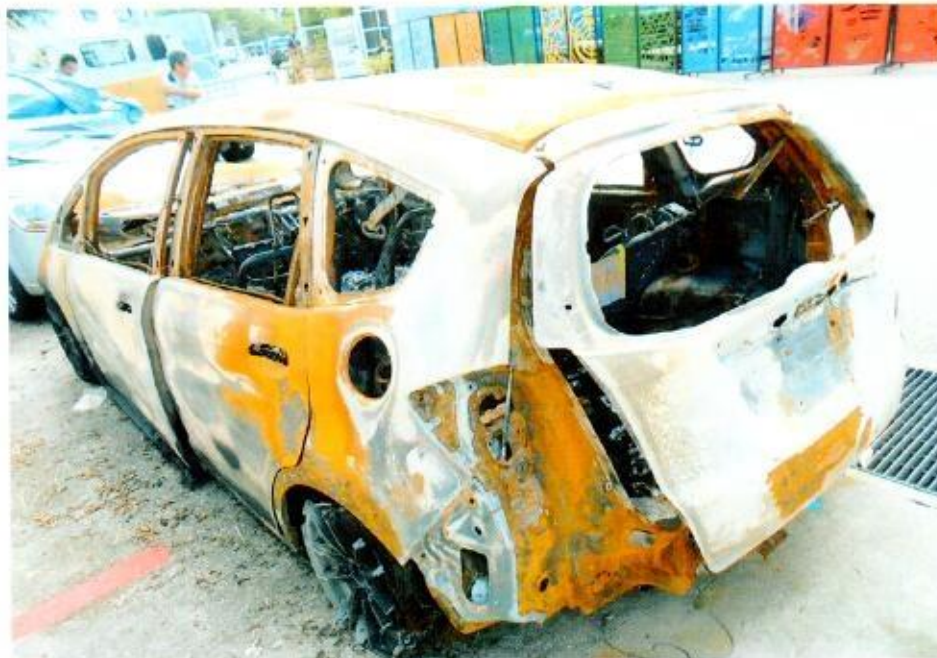
Photo 4 shows the rear left side of the Insured Vehicle at the time of our inspection. The Insured Vehicle was noted to have sustained fire damages that severely effected on the entire parts of the Insured Vehicle.

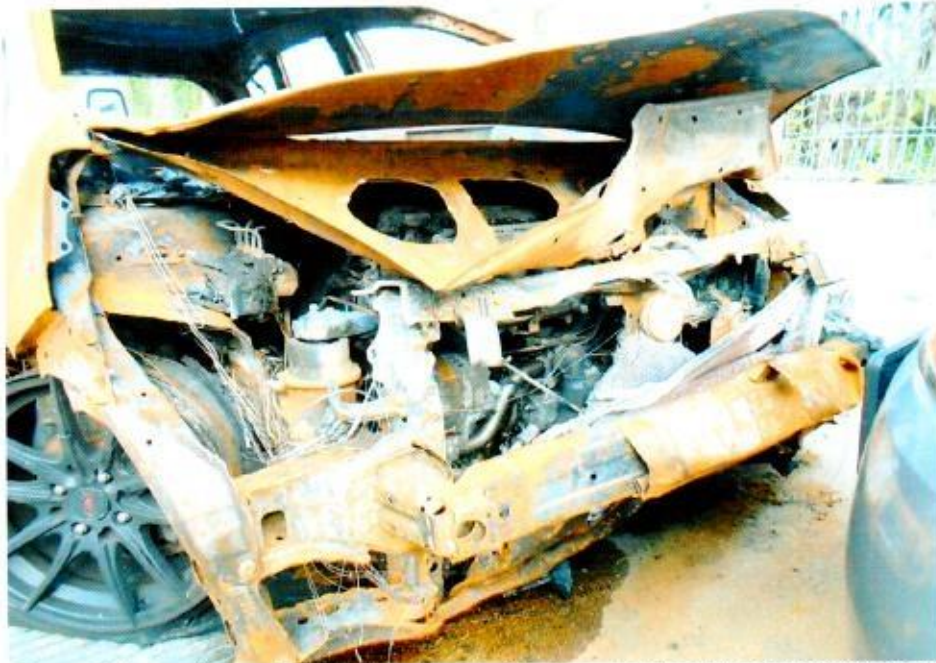
Photo 5 shows the engine compartment of the Insured Vehicle at the time of our inspection. The fire damages the entire engine compartment.

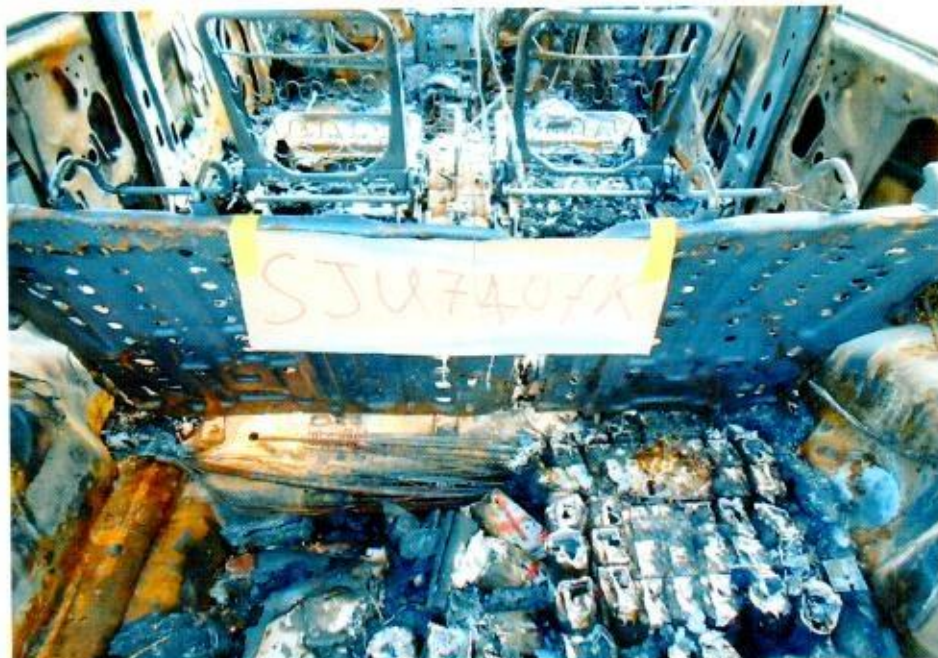
Photo 6 shows the rear internal portion of the Insured Vehicle at the time of inspection.

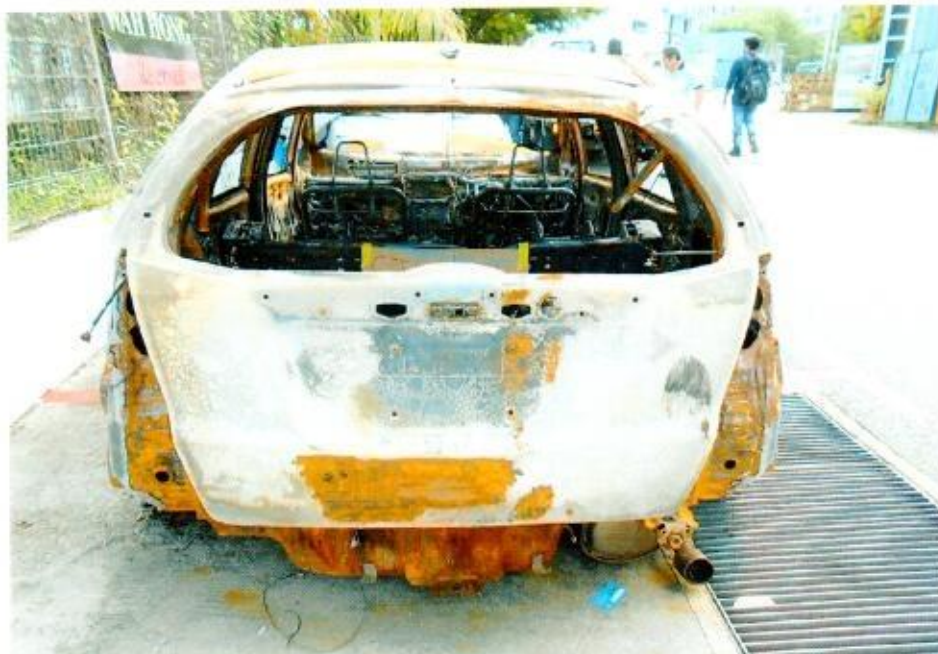
6. The whitish burn marks are a result of exposure to prolonged heat intensity. Rust would normally start to develop around these areas soon after a fire as prolonged exposure to high heat intensity usually causes steel/metal material body parts to be exposed to natural environmental condition. The rust that had developed on the Insured Vehicle is an indication that it had sustained exposure to prolonged high heat intensity. See photo 7 below.

Photo 7 shows the whitish burn marks are a result of exposure to prolonged heat intensity. Rust would normally start to develop around these areas soon after a fire as prolonged exposure to high heat intensity usually causes steel/metal material body parts to be exposed to natural environmental condition. The rust that had developed on the Insured Vehicle is an indication that it had sustained exposure to prolonged high heat intensity.

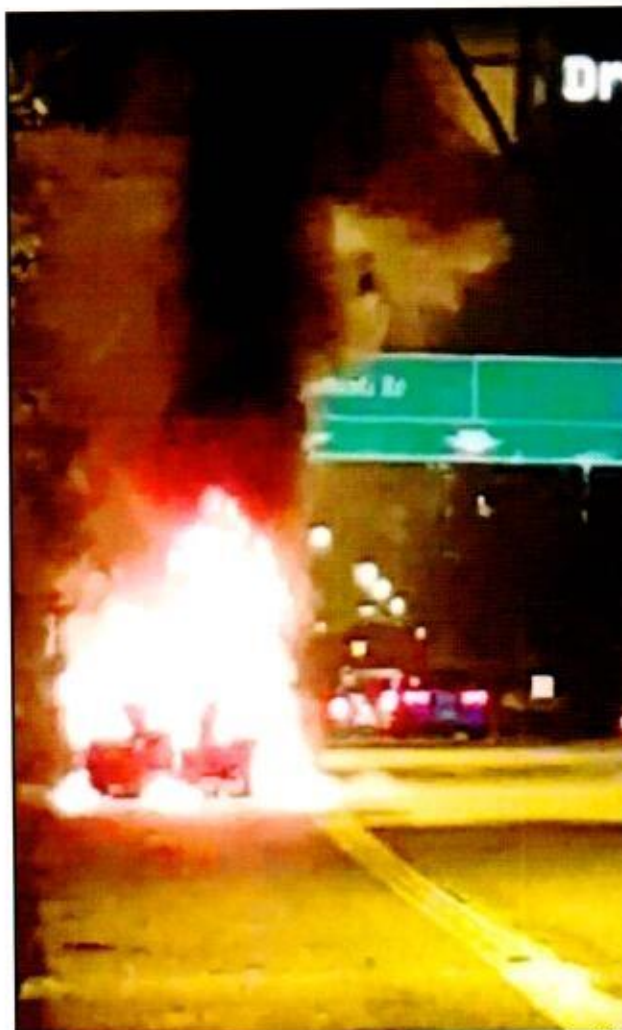
Photo 14 shows the fire incident entrance of AYE from South Buona Vista Road.
