Your Ref: 27716466QMX  
Our Ref : CS/MSG18008026/Z

11<sup>th</sup> May 2018

### **TECHNICAL INVESTIGATION REPORT OF FIRE INCIDENT INVOLVING THE INSURED VEHICLE SJU 7407K ON 27<sup>th</sup> April 2018**

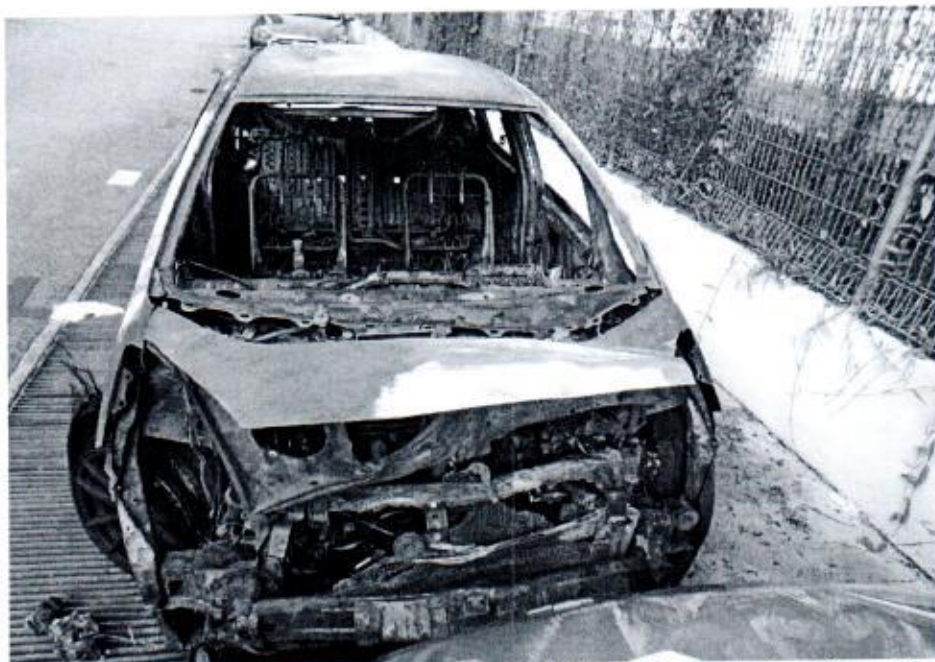
5. The Insured Vehicle was noted to have sustained fire damages that severely effected on the entire parts of the Insured Vehicle. The fire damages was observed on its interior compartment, engine compartment, front portion, left portion, right portion & rear portion. Rust had accumulated all over the Insured Vehicle as a result of exposure to environmental condition for a period of time. See photos 1 – 6 below.

**Photo 1** shows the front view of the Insured Vehicle at the time of our inspection. The Insured Vehicle was noted to have sustained fire damages that severely effected on the entire parts of the Insured Vehicle.

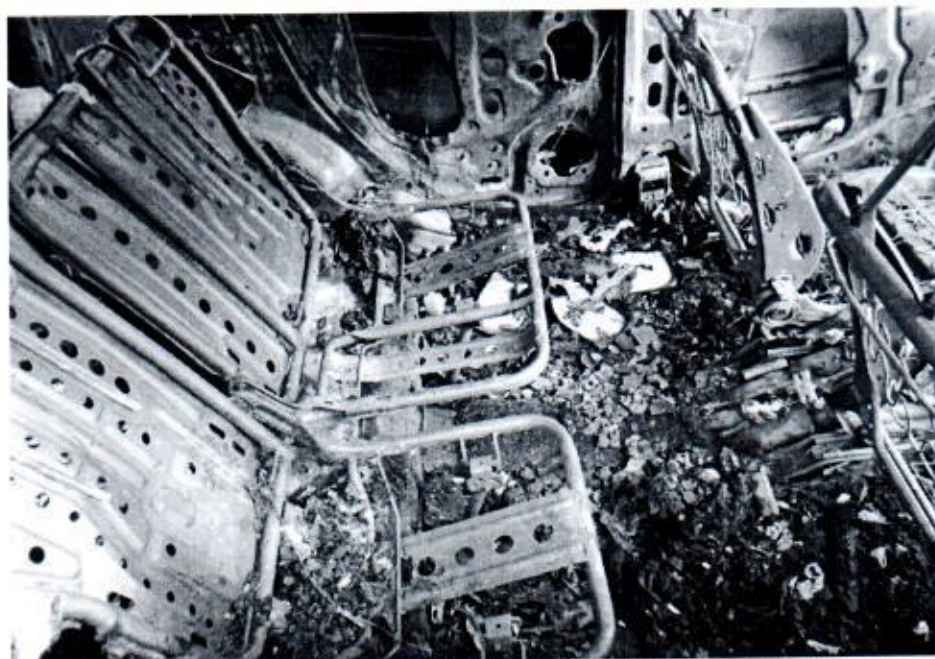
**Photo 2** shows the interior view of the Insured vehicle, it was observed to have sustained with severe burnt damages due to the fire.

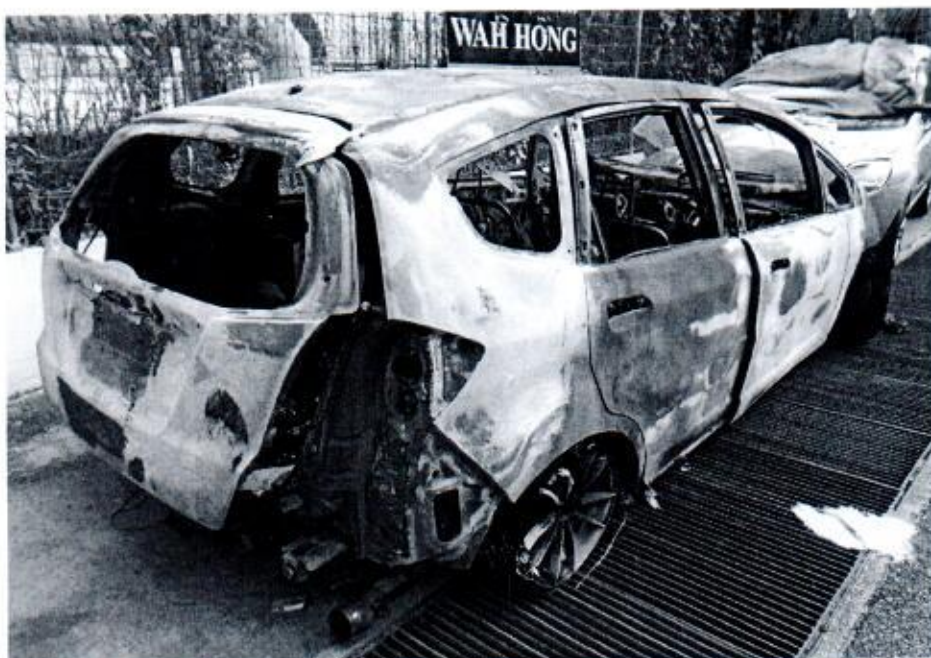
**Photo 3** shows the rear right side of the Insured Vehicle at the time of our inspection. The Insured Vehicle was noted to have sustained fire damages that severely effected on the entire parts of the Insured Vehicle.

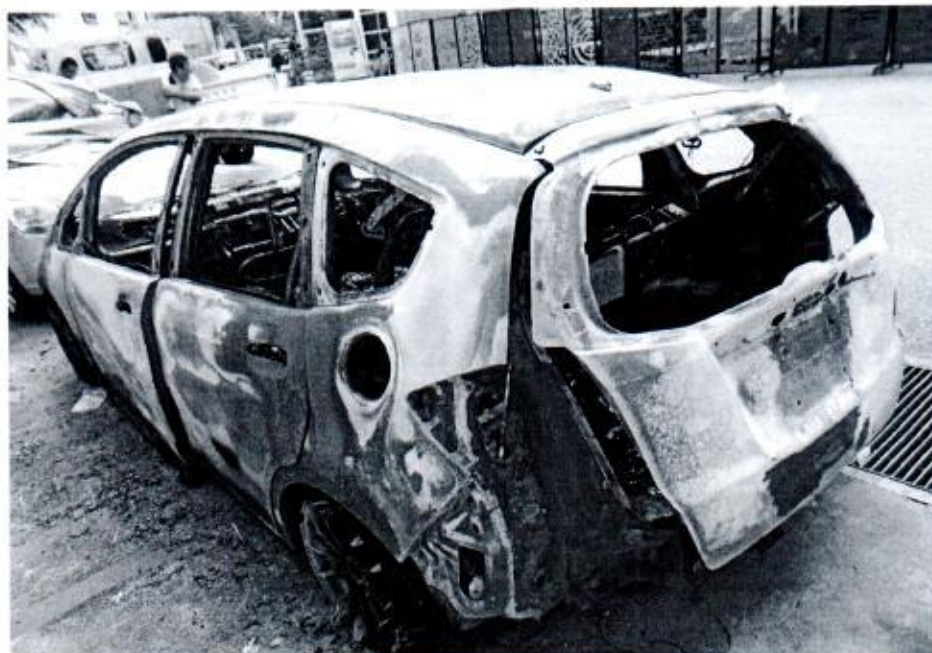
**Photo 4** shows the rear left side of the Insured Vehicle at the time of our inspection. The Insured Vehicle was noted to have sustained fire damages that severely effected on the entire parts of the Insured Vehicle.

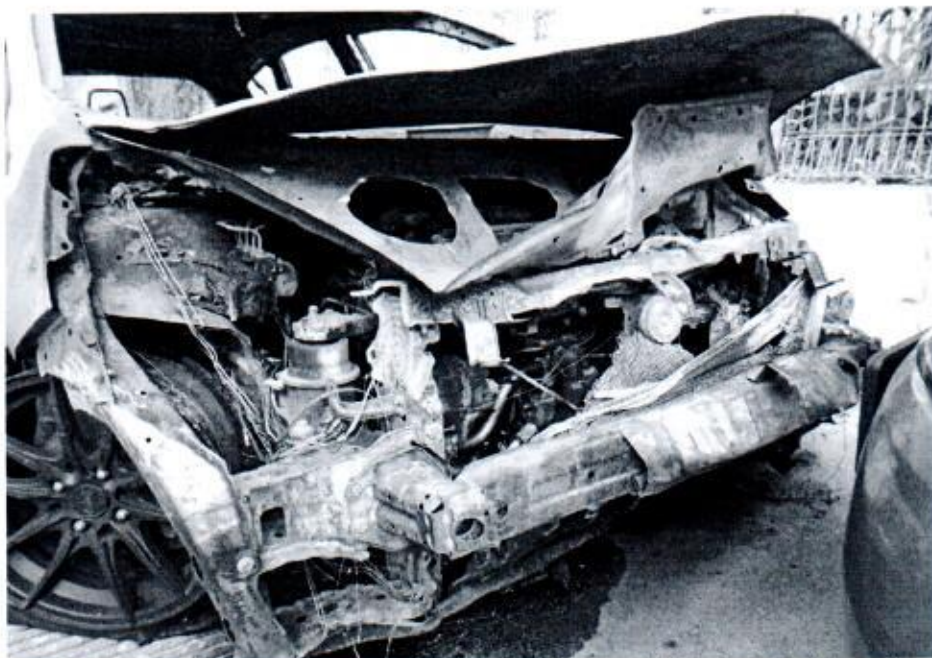
**Photo 5** shows the engine compartment of the Insured Vehicle at the time of our inspection. The fire damages the entire engine compartment.

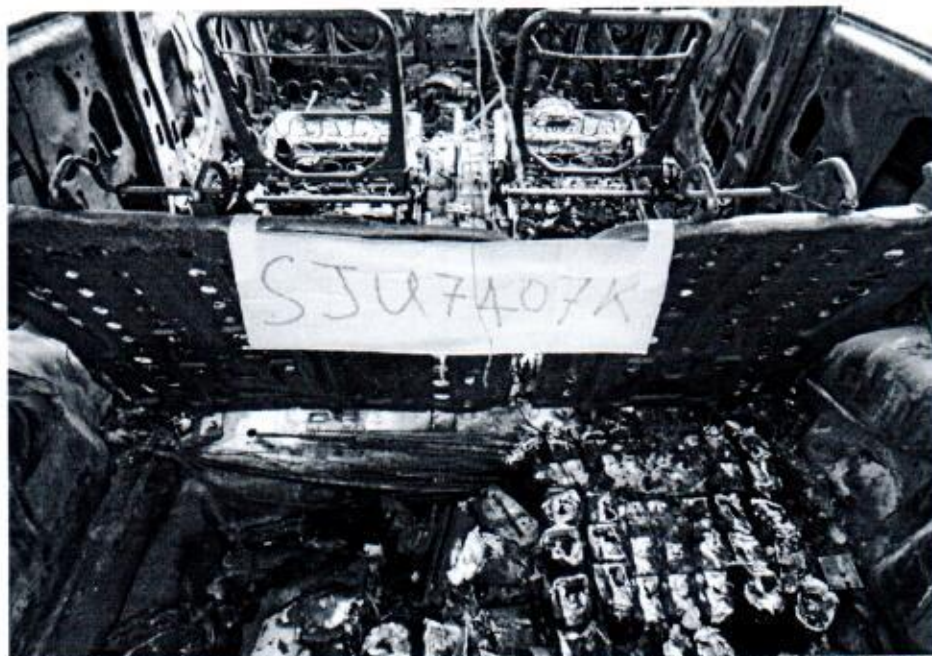
**Photo 6** shows the rear internal portion of the Insured Vehicle at the time of inspection.

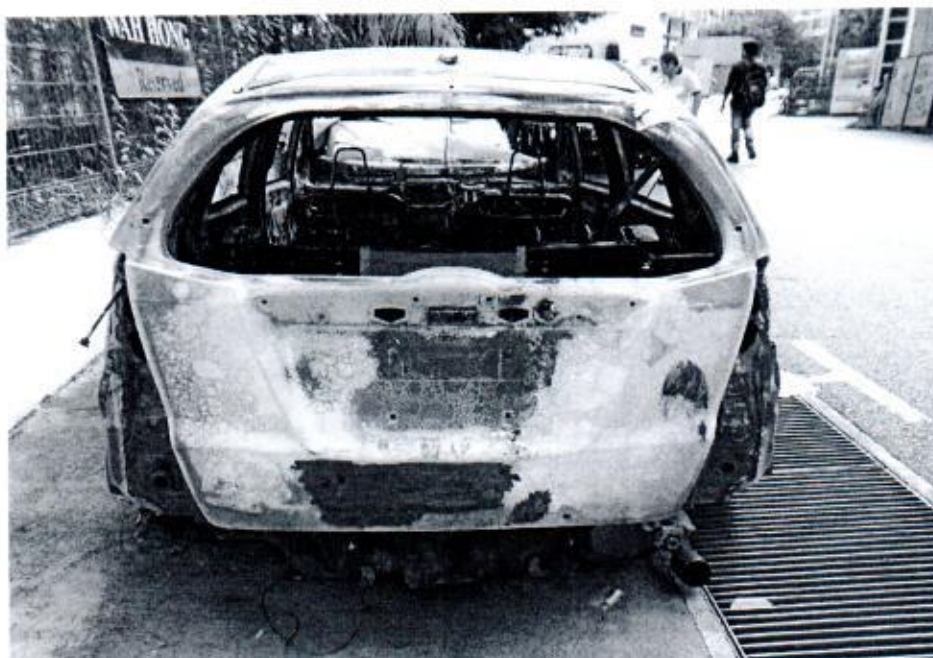
6. The whitish burn marks are a result of exposure to prolonged heat intensity. Rust would normally start to develop around these areas soon after a fire as prolonged exposure to high heat intensity usually causes steel/metal material body parts to be exposed to natural environmental condition. The rust that had developed on the Insured Vehicle is an indication that it had sustained exposure to prolonged high heat intensity. See photo 7 below.

**Photo 7** shows the whitish burn marks are a result of exposure to prolonged heat intensity. Rust would normally start to develop around these areas soon after a fire as prolonged exposure to high heat intensity usually causes steel/metal material body parts to be exposed to natural environmental condition. The rust that had developed on the Insured Vehicle is an indication that it had sustained exposure to prolonged high heat intensity.

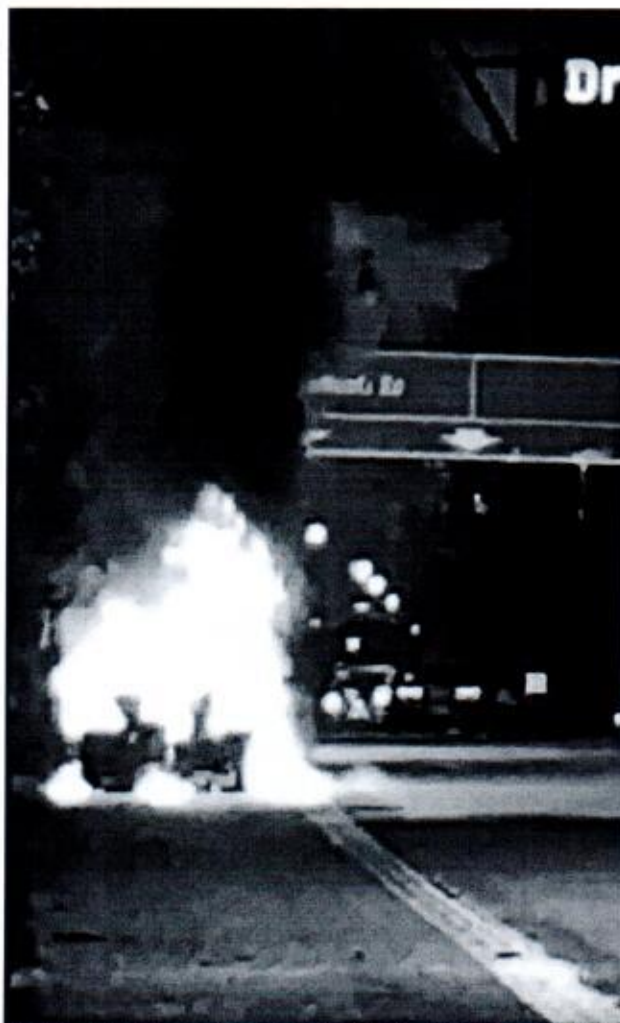
**Photo 14** shows the fire incident entrance of AYE from South Buona Vista Road.
