Your Ref: TP/IP/09205/2018
Our Ref :CI/TPD18008067/Z

15th March 2018

MECHANICAL INSPECTION REPORT OF MOTORCYCLE JLE 2293

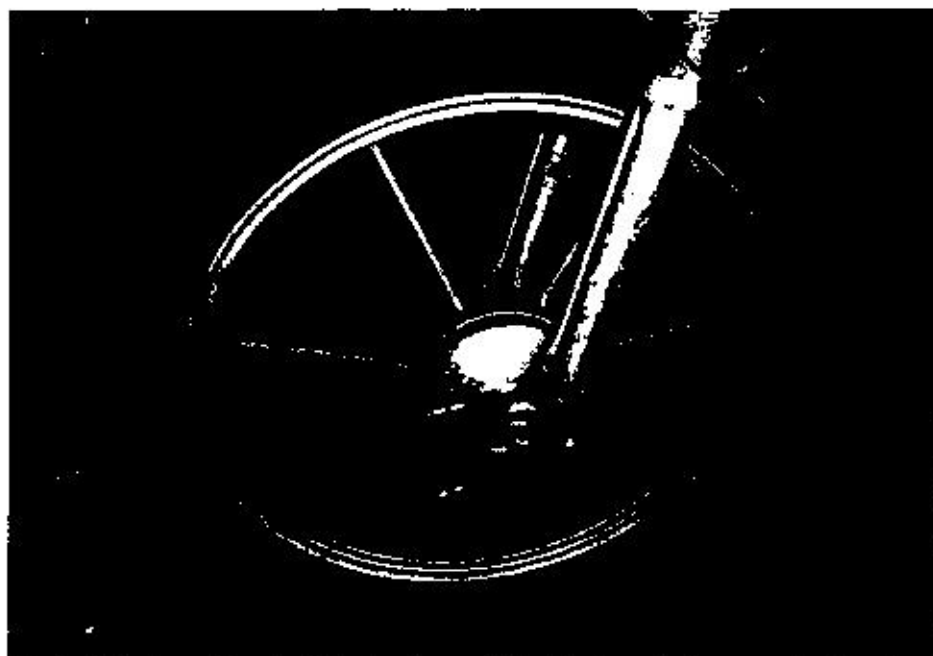
13. A static brake test was conducted only on the Motorcycle's front brake. The test was conducted by lifting the front tyre above ground & applies a little spinning action to it. The right hand brake lever was then gripped in order to stop the spinning front tyre. The result was satisfactory. It stopped after gripping the right hand brake to the fullest. It shows that the front brake drum was responding to the gripping action. This had appeared to indicate that the front brake was in a serviceable condition.

Photo 12 shows the front brake drum of the Motorcycle (arrowed). Our visual checks of these various components had revealed all to be intact with no visible damage was observed.
