VEHICLE DAMAGE INSPECTION REPORT

Our File No: CC3/MSG18008163/SSBE2

Claimant Vehicle No : SMB143G

Make & Model: MERCEDES-BENZ CITARO O530, 6.4 D (A)

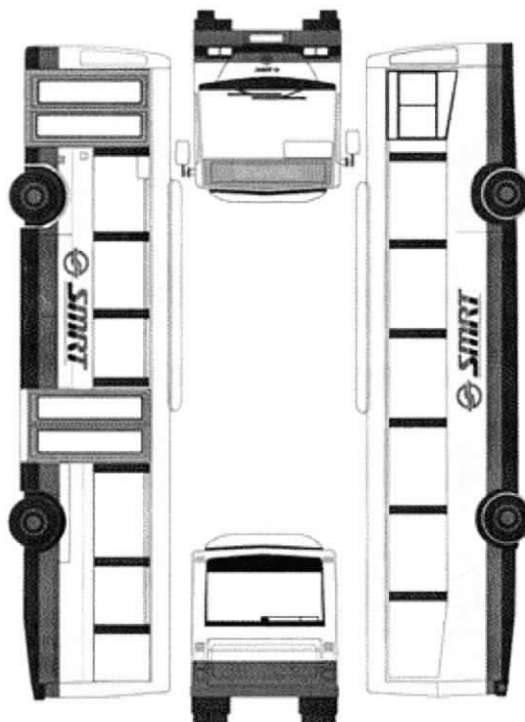
The vehicle sustained impact / damages n/s front portion and parts claimed are consistent to the accident.

SMB143G - LEFT FRONT PORTION
 SKM9831K (TP) - INSURED WITH MSIG

Job Scope	Quotation from ARC	Adjusted by Surveyor, if applicable
TO REPAIR FRONT LH PORTION	795.00	0.00 530
Total Labour	795.00	0.00

Job Scope	Quotation from ARC	Adjusted by Surveyor, if applicable
PROVIDE LABOUR AND MATERIAL TO PUTTY AND RESPRAY ABOVE REPAIR ITEMS	446.00	0.00 300
Total Spray Painting & Panel Beating	446.00	0.00

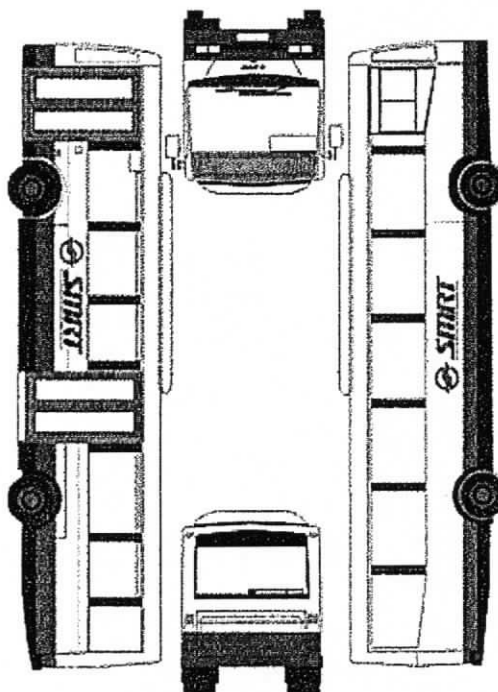
Reg. No : SMB143G
Ref. No : BUS/04/18/1033
Reg. Date : 18/03/2011
Vehicle Type : BUS -12M
Make : MB CITARO MERCEDES
Model : MB CITARO O530
Name of Driver : Syakirin Bin Mahat
Type of Accident : SIDE SWIPE
Date / Time of Accident : 19/04/2018 06:20:00 PM
Accident Reported Date / Time : 26/04/2018 12:00:00 AM
Surveyor is Required? : Yes
Survey by : MSIG
Vehicle is Towed Back? : No
Towed Back Date/Time : 01/01/2000
Replacement Vehicle issued? : No
Accident Repair Job Card No : 000024095878
Special Instruction to ARC, if any :
SMB143G - LEFT FRONT PORTION
SKM9831K (TP) - INSURED WITH MSIG
Prepared Date : 26/04/2018 04:29:56 PM

Job Scope	Quotation from ARC	Adjusted by Surveyor, if applicable
TO REPAIR FRONT LH PORTION	795.00	530.00
Total Labour	795.00	530.00

Job Scope	Quotation from ARC	Adjusted by Surveyor, if applicable
PROVIDE LABOUR AND MATERIAL TO PUTTY AND RESPRAY ABOVE REPAIR ITEMS	446.00	300.00
Total Spray Painting & Panel Beating	446.00	300.00
