## VEHICLE DAMAGE INSPECTION REPORT

Our File No: CC3/MSG18008165/SRBN2

Handling Insurer:	MSIG Insurance (Singapore) Pte. Ltd.	Policy No:	28986218QMY
Claimant Vehicle No :	SG1187B	Insured Vehicle No :	SKT8796Z
Date of Loss:	10/08/2017	Nature of Claim:	TP
		Claim No:	557773

Reg No:	SG1187B	Engine No:	902926C1101347
Make & Model:	MERCEDES-BENZ CITARO O530, 6.4 D AT TURBO ABS (A)	Chassis No:	WEB62808323130022
Reg. Date:	07/07/2016 (Man. Year: 2015)	Odometer:	0 km
Colour:	Multi-colour		
Engine Capacity:	6374 cc		
Market Value/New Car Price:	N/A		
Sum Insured (\$\$):	Market Value/New Car Price

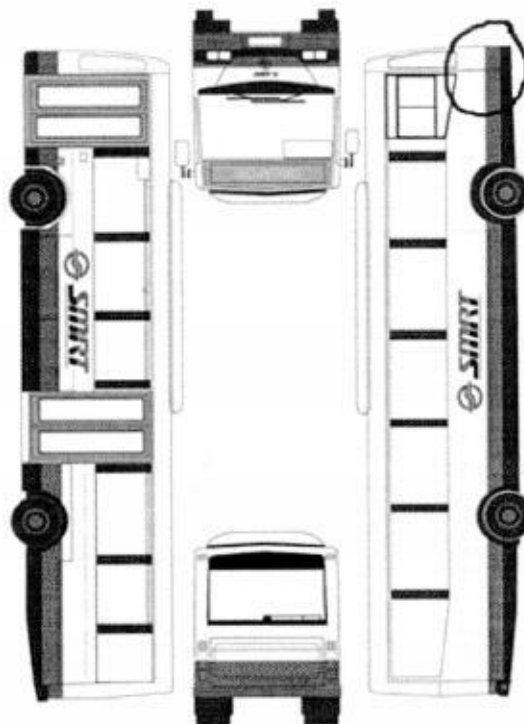
SG1187B - FRONT RIGHT PORTION  
 SGT8796Z (TP) - INSURED WITH MSIG. LEFT REAR PORTION  
 Prepared Date : 11/08/2017 03:50:53 PM

- Part by part repair  
 - Photo After Paint

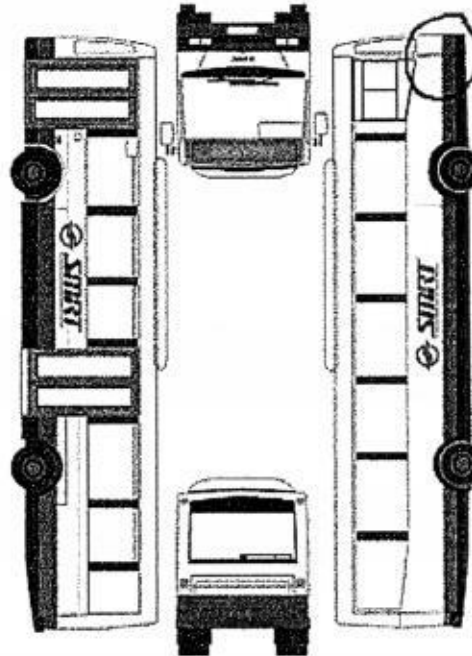
Reg. No : SG1187B  
Ref. No : BUS/08/17/1011  
Reg. Date : 07/07/2016  
Vehicle Type : BUS -12M  
Make : MB CITARO MERCEDES  
Model : MB CITARO O530  
Name of Driver : Lee Sing Yang  
Type of Accident : SIDE SWIPE  
Date / Time of Accident : 10/08/2017 11:08:00 AM  
Accident Reported Date / Time : 10/08/2017 12:00:00 AM  
Surveyor is Required? : Yes  
Survey by : MSIG  
Vehicle is Towed Back? : No  
Towed Back Date/Time : 01/01/2000  
Replacement Vehicle issued? : No  
Accident Repair Job Card No : 000024096067  
Special Instruction to ARC, if any :  
SG1187B - FRONT RIGHT PORTION  
SKT8796Z (TP) - INSURED WITH MSIG. LEFT REAR PORTION  
Prepared Date : 11/08/2017 03:50:53 PM

Job Scope	Quotation from ARC	Adjusted by Surveyor, if applicable
TO REPAIR RH FRONT PORTION	795.00	530.00
<b>Total Labour</b>	<b>795.00</b>	<b>530.00</b>

Job Scope	Quotation from ARC	Adjusted by Surveyor, if applicable
PROVIDE LABOUR AND MATERIAL TO PUTTY AND RESPRAY ABOVE REPAIR ITEMS	354.00	300.00
<b>Total Spray Painting &amp; Panel Beating</b>	<b>354.00</b>	<b>300.00</b>
