INVESTIGATION REPORT:

Our Ref : CI/AIG18008258/N
Policy No : 2100485668-01
Insured : SLG 565H
Date of Incident : 13 April 2018
Location : Jalan Rusa Century Garden (Johor Bahru)

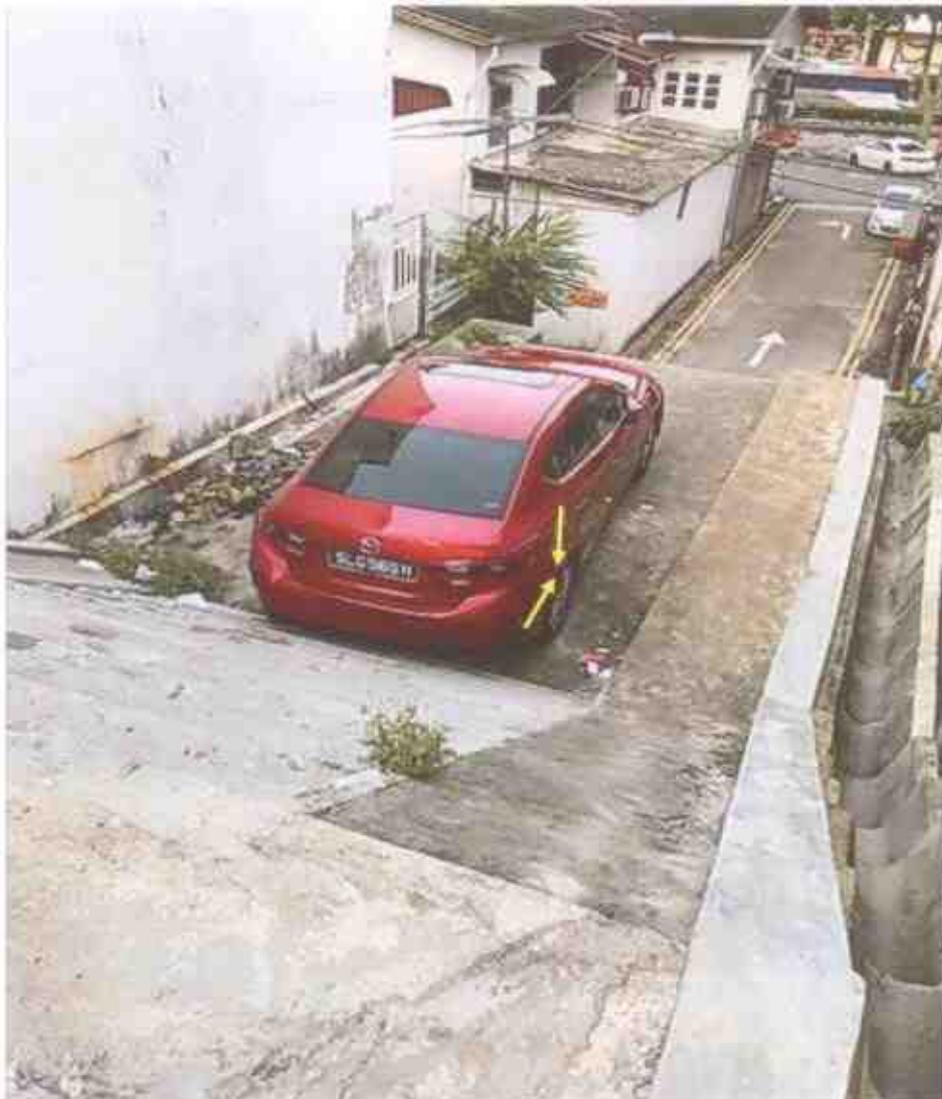
Photo 1 shows a right rear view of the Insured Vehicle at its respective final rest position in between 2 flights of stairs when Mr Haw arrived at the incident location. It seems to correlate with Mr Haw's account of the incident which had occurred along a staircase located at Jalan Rusa, near the vicinity of KSL Shopping Centre. The rear bumper was dislodged at the corner edges (arrowed).

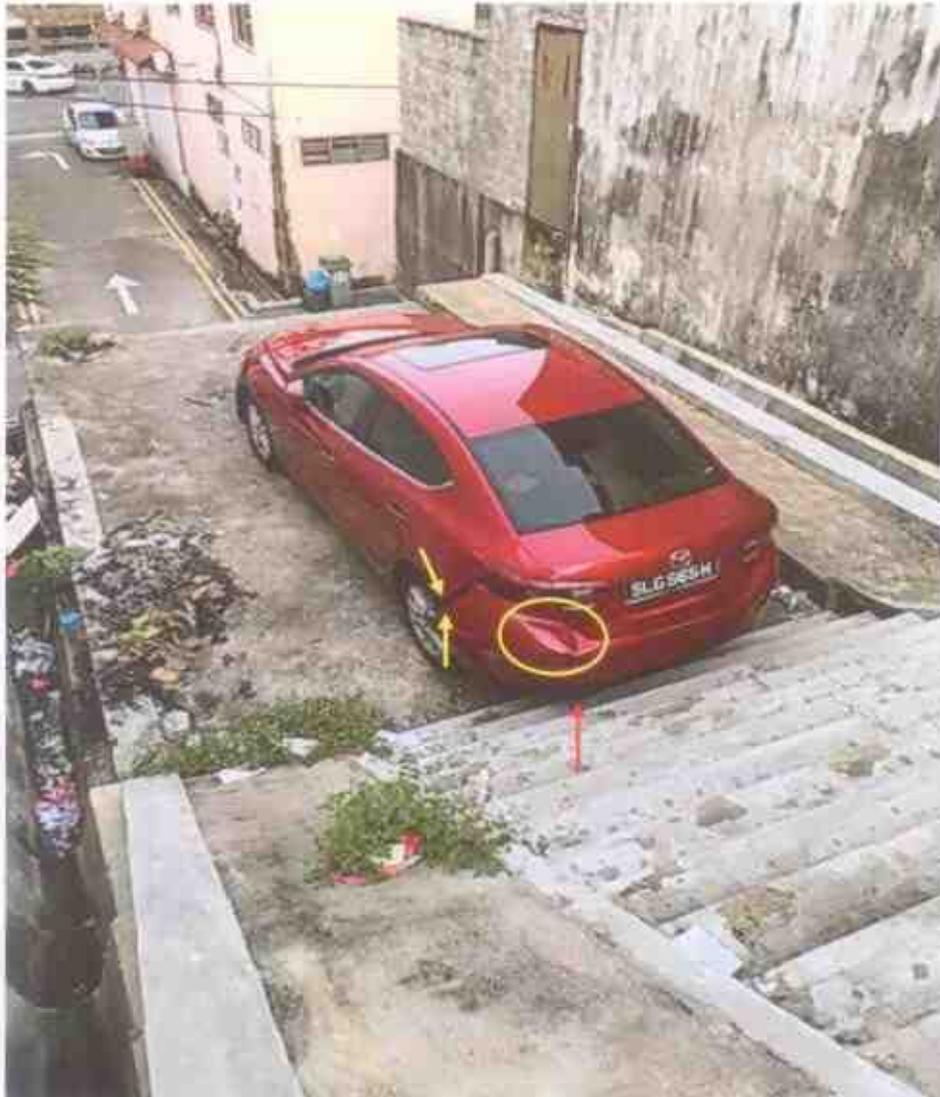
13. Upon closer examination of these photographs, we observed that the underside of the Insured Vehicle's rear bumper, in particular the lower left portion was in contact with the last step of the 1st flight of stairs. There was a dent on the left portion of the rear bumper. The rear bumper was also dislodged at the corner edges. See photos 1 - 6 below.

Photo 2 shows a left rear view of the Insured Vehicle at its respective final rest position in between 2 flights of stairs when Mr Haw arrived at the incident location. Upon closer examination of this photograph, we observed that the underside of the Insured Vehicle's rear bumper, in particular the lower left portion was in contact with the last step of the 1st flight of stairs (red arrow). We also noticed a dent on the left portion of the rear bumper (circled). The rear bumper was also dislodged at the corner edges (yellow arrows).

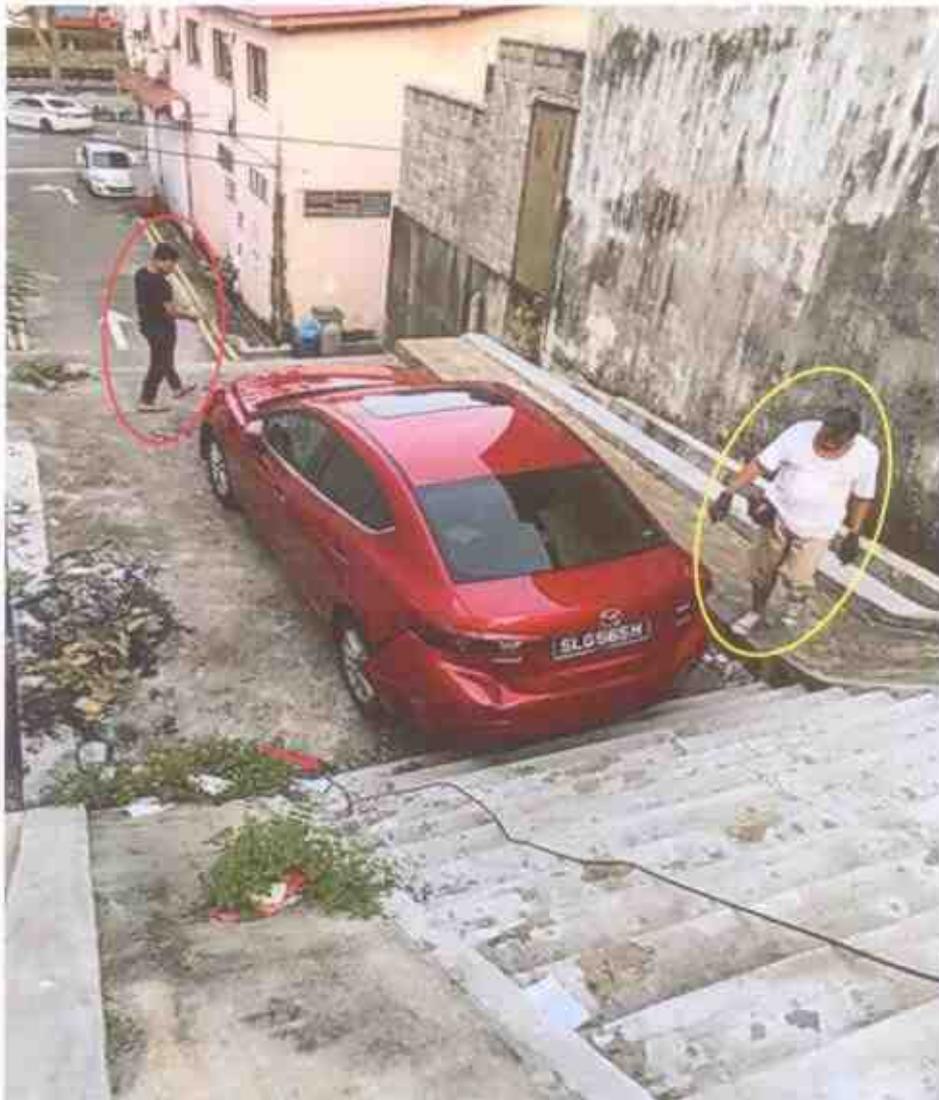
Photo 3 shows the Insured Vehicle getting prepped to be towed up the 1st flight of stairs via a winch (arrowed) by the towing personnel (yellow circle). It seems to correlate with Mr Haw's statement that there was a Malay guy at the incident location (red circle) who assisted Mr Haw by calling for a tow truck.

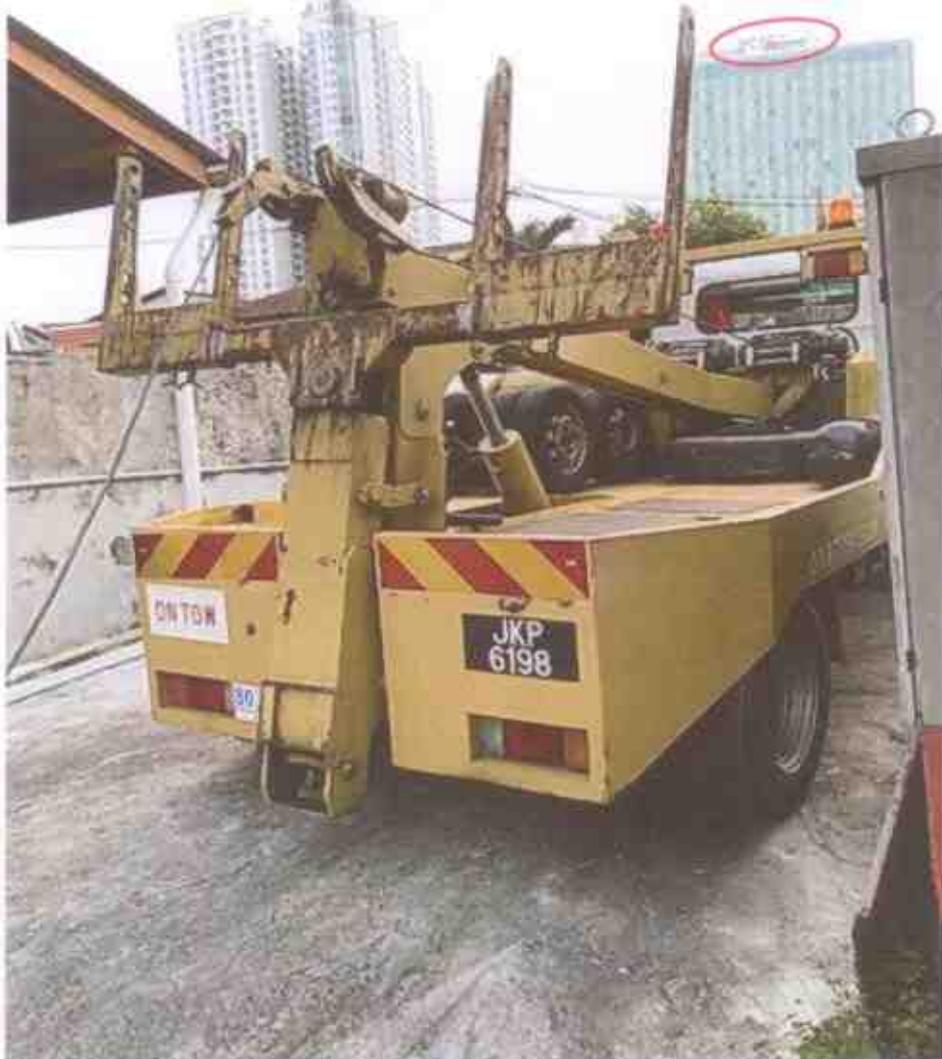
Photo 4 shows the towing personnel using the winch from the tow truck to tow the Insured Vehicle up the 1st flight of stairs. It seems to correlate with Mr Haw's statement that the Insured Vehicle was parked at Jalan Rusa which is near to KSL (circled).

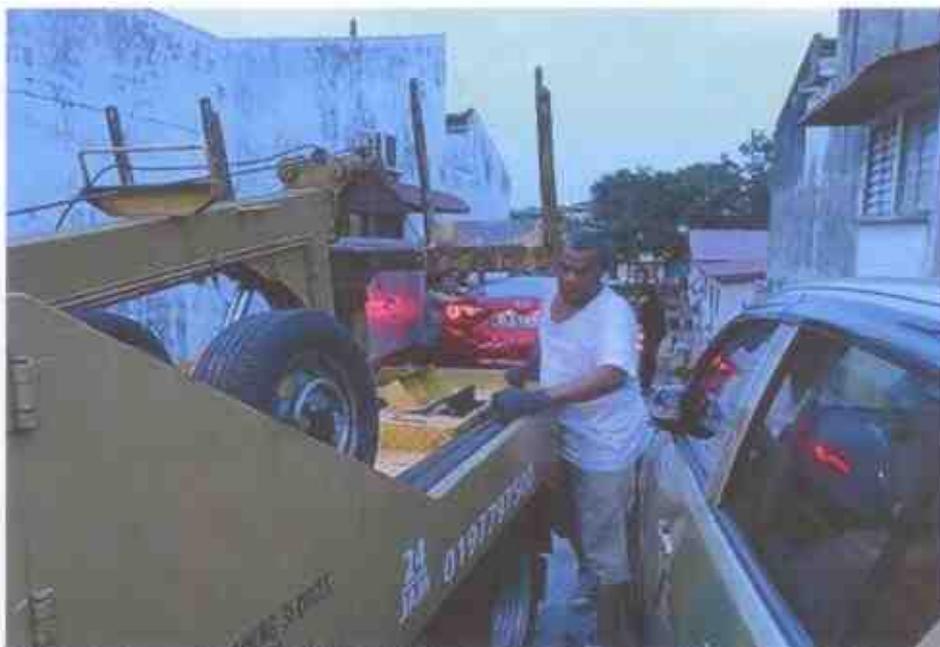
Photo 5 shows the Insured Vehicle being towed up the 1st flight of stairs via a winch by the towing personnel.

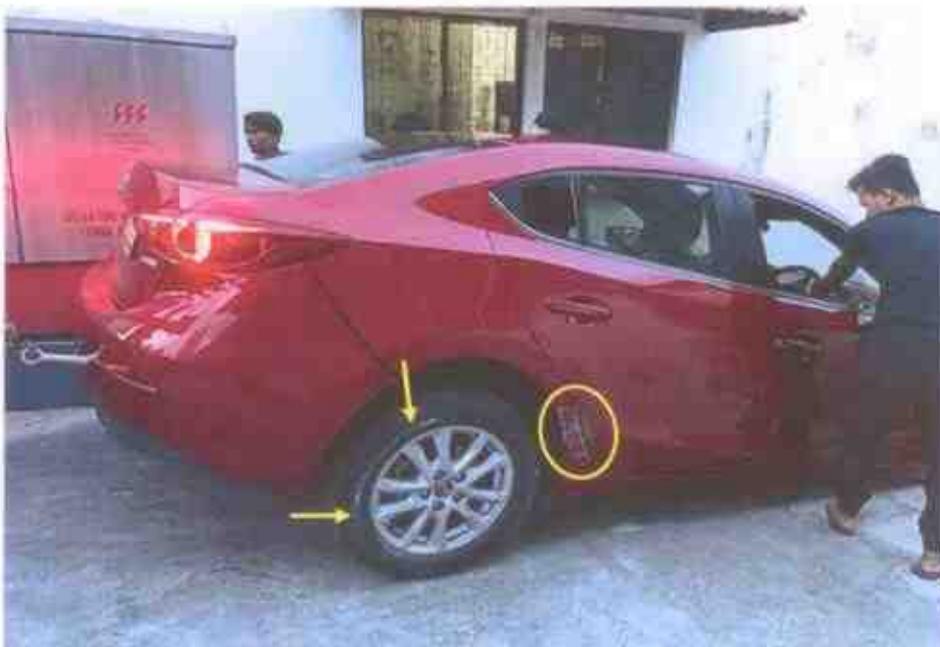
Photo 6 shows the Insured Vehicle after being towed up the 1st flight of stairs via a winch by the towing personnel. Upon closer examination, we observed whitish graze marks on the lower portion of the right rear passenger door (circled) and on the sidewall of the right rear tyre (arrowed). According to Mr Haw, when he inspected the 1st flight of stairs, he noticed a white slab. He mentioned that the right rear portion of the Insured Vehicle might have grazed against the white slab as it rolled down the 1st flight of stairs.

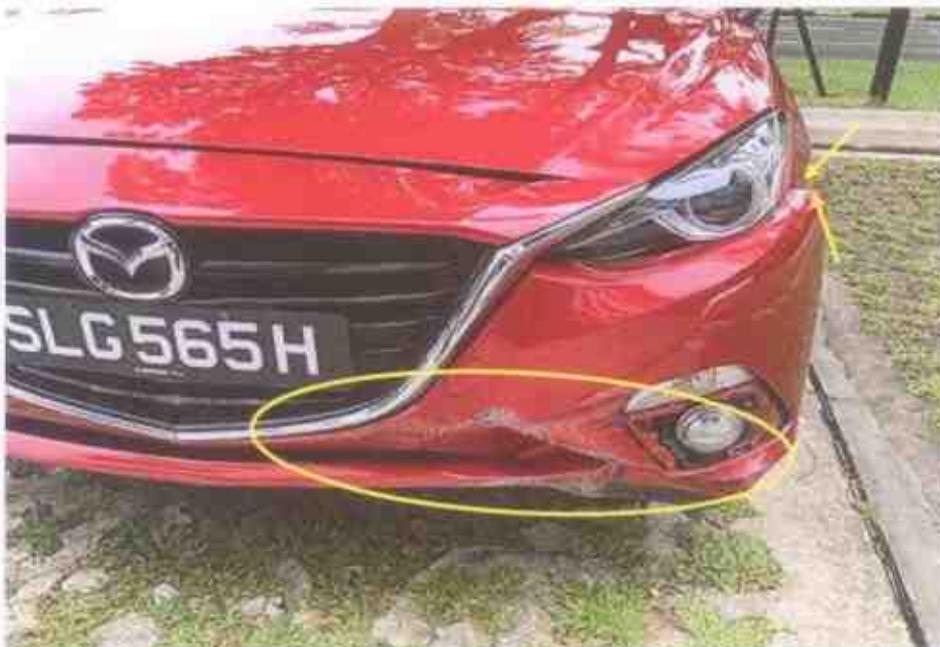
Photo 7 shows a view of the front left portion of the Insured Vehicle taken by Mr Haw the following day at the carpark of his home. The dislodgement of the front bumper at the left corner edge (arrowed) as well as the paint scratch and paint graze marks found on the lower left portion of the front bumper (circled) appear to correspond to the Insured Vehicle rolling down a flight of stairs as per Mr Haw's statement.

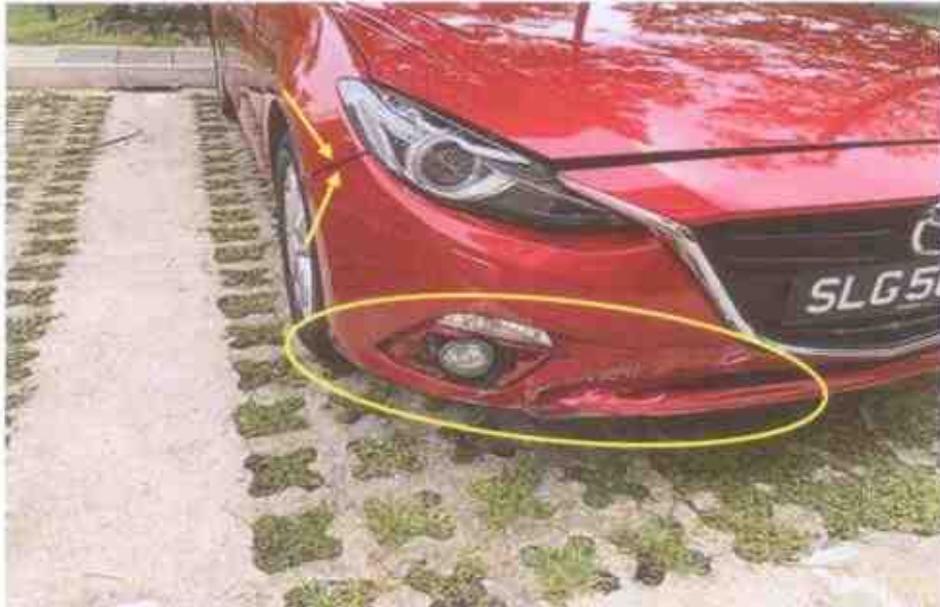
Photo 8 shows a view of the front right portion of the Insured Vehicle taken by Mr Haw the following day at the carpark of his home. The misalignment of the front bumper at the right corner edge (arrowed) as well as the paint scratch and paint graze marks found on the lower right portion of the front bumper (circled) appear to correspond to the Insured Vehicle rolling down a flight of stairs as per Mr Haw's statement.

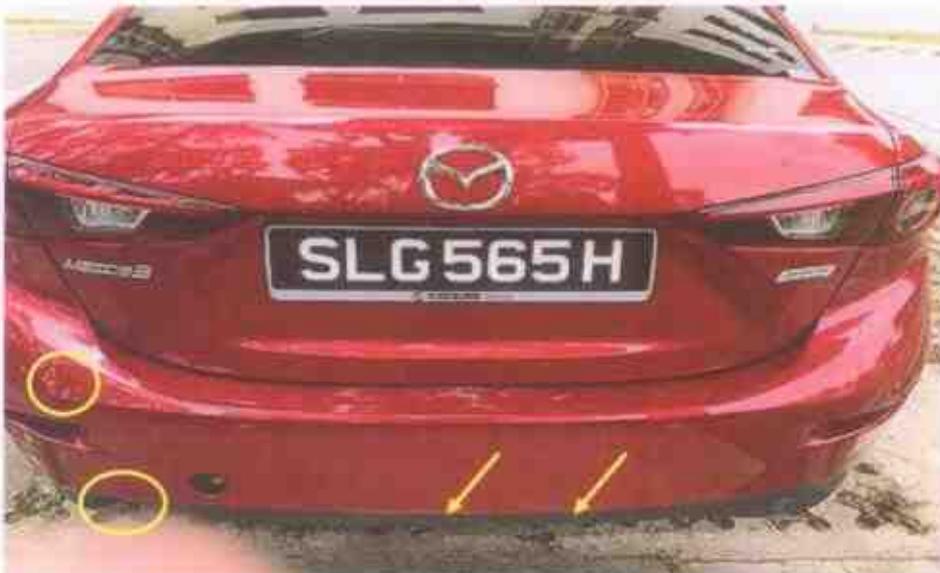
15. The graze marks found on the lower portion of the front and rear bumper would most likely have been caused by the steps as the Insured Vehicle rolled down the 1st flight of stairs. The direct impact force of the Insured Vehicle rolling down the steps (of uneven heights) may have pushed the rear bumper inwards, causing the dent on the left portion of the rear bumper as well as the dislodgement of the rear bumper at the corner edges. See photos 7 – 13 below.

Photo 9 shows a view of the rear portion of the Insured Vehicle taken by Mr Haw the following day at the carpark of his home. The graze marks found on the lower portion of the rear bumper (arrowed) seem to correspond to the Insured Vehicle rolling down a flight of stairs as per Mr Haw's statement. The direct impact force of the Insured Vehicle rolling down the steps (of uneven heights) may have pushed the rear bumper inwards, causing the dents on the left portion of the rear bumper (circled).

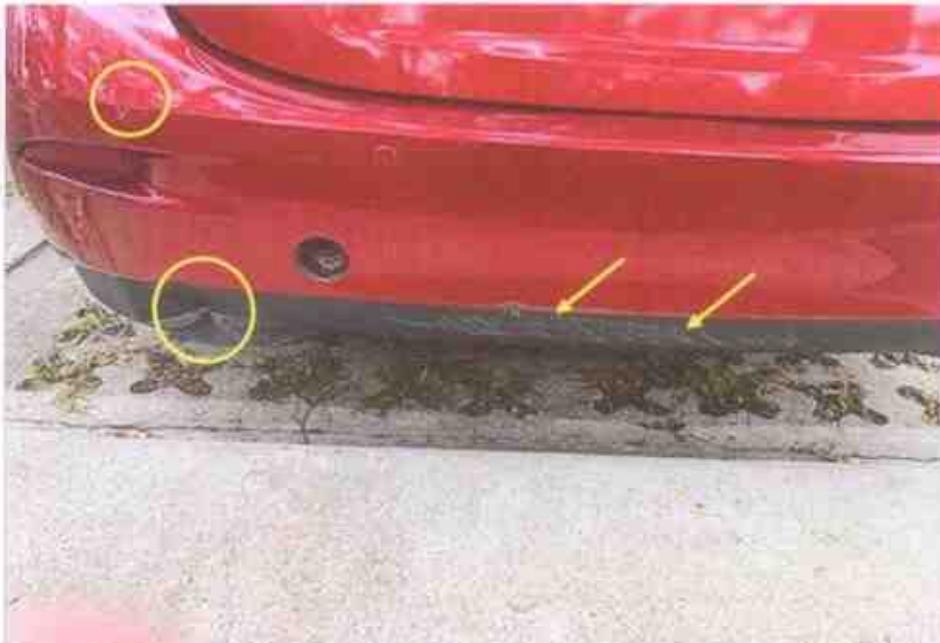
Photo 10 shows a closer view of the graze marks (arrowed) on the lower portion of the rear bumper and dents (circled) found on the left portion of the rear bumper of the Insured Vehicle.

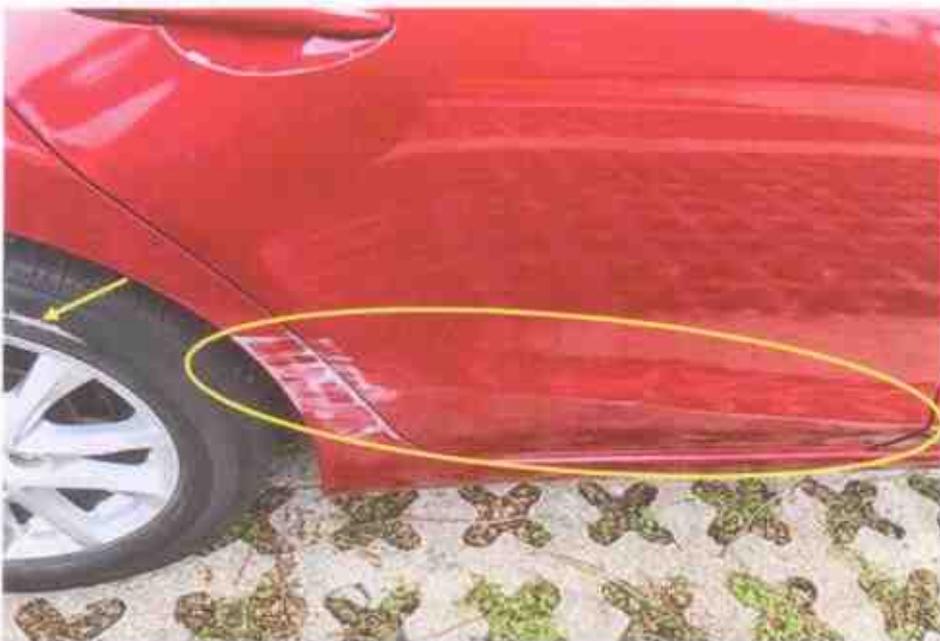
Photo 11 shows a closer view of the whitish graze marks found on the lower portion of the right rear passenger door (circled) and on the sidewall of the right rear tyre (arrowed). These damages seem to correlate with Mr Haw's account of the incident in which when he inspected the 1st flight of stairs, he noticed a white slab. He mentioned that the right rear portion of the Insured Vehicle might have grazed against the white slab as it rolled down the 1st flight of stairs.

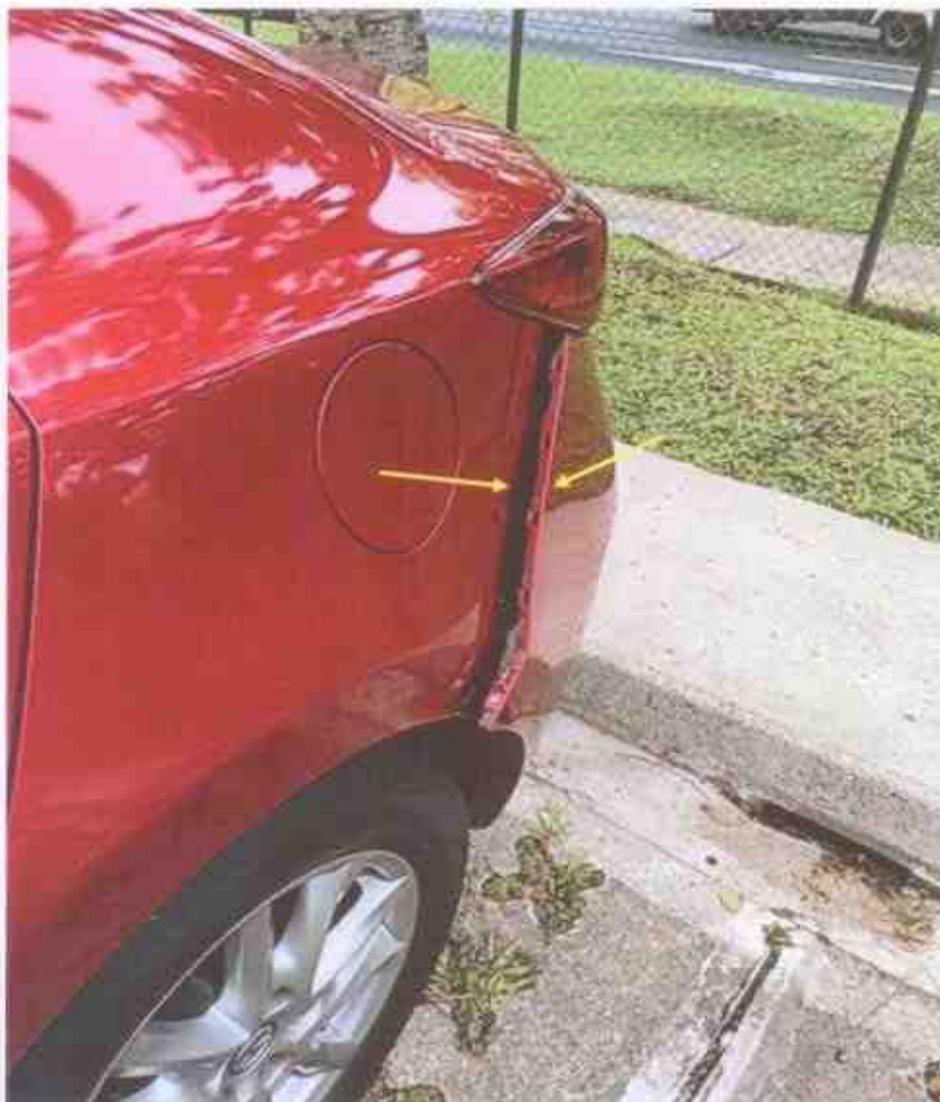
Photo 12 shows a view of the left rear portion of the Insured Vehicle taken by Mr Haw the following day at the carpark of his home. The direct impact force of the Insured Vehicle rolling down the steps (of uneven heights) may have pushed the rear bumper inwards, causing the dislodgement of the rear bumper at the left corner edge (arrowed).

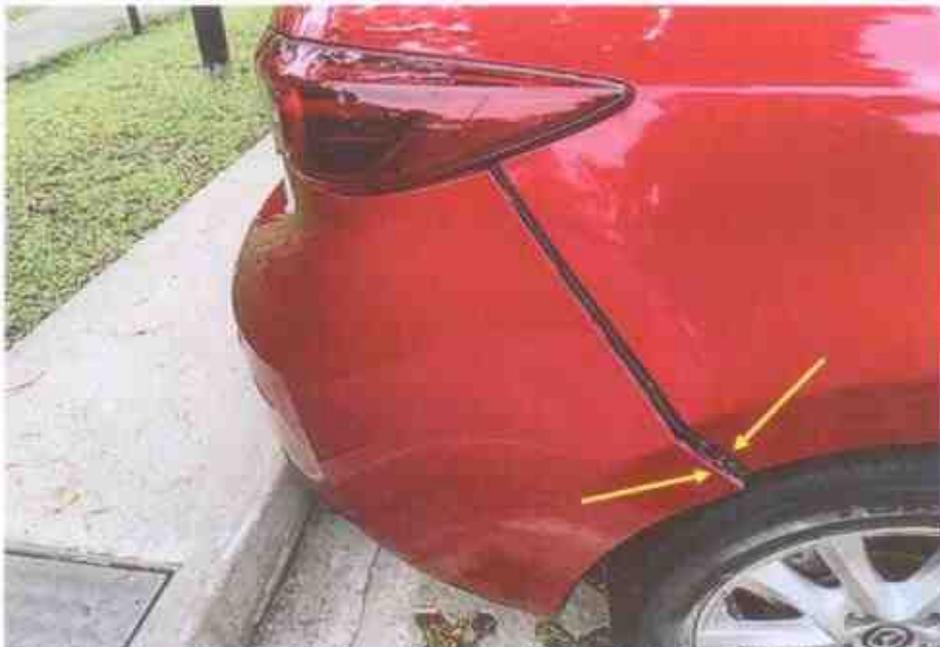
Photo 13 shows a view of the right rear portion of the Insured Vehicle taken by Mr Haw the following day at the carpark of his home. The direct impact force of the Insured Vehicle rolling down the steps (of uneven heights) may have pushed the rear bumper inwards, causing the dislodgement of the rear bumper at the right corner edge (arrowed).
