Your Ref: SSM00F05  
Our Ref :CS/ASM18008297/Z

25<sup>th</sup> May 2018

**TECHNICAL INVESTIGATION REPORT OF FIRE INCIDENT INVOLVING THE  
INSURED VEHICLE SLX 452K ON 28<sup>th</sup> April 2018**

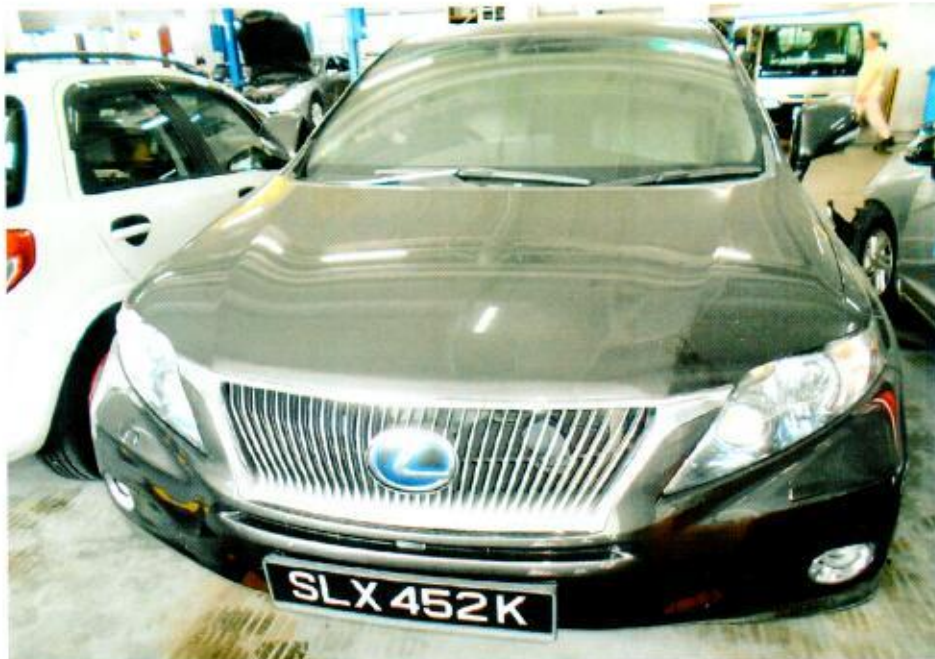
**Photo 1** shows the front view of the Insured Vehicle at the time of our inspection. It was observed to be in good condition not affected by the fire.

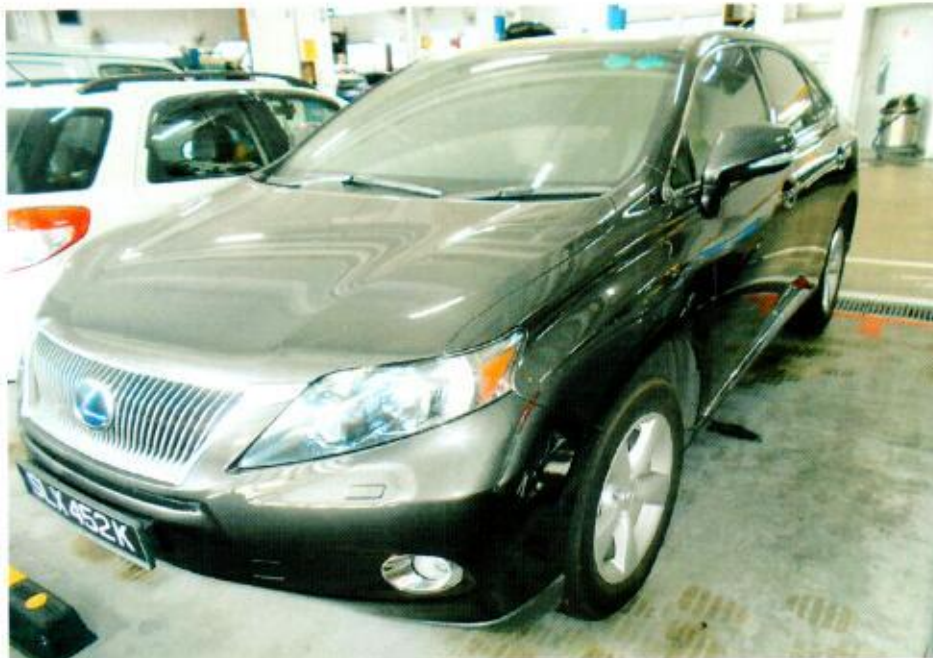
**Photo 2** shows the left side of the Insured Vehicle at the time of our inspection. It was observed to be in good condition not affected by the fire.

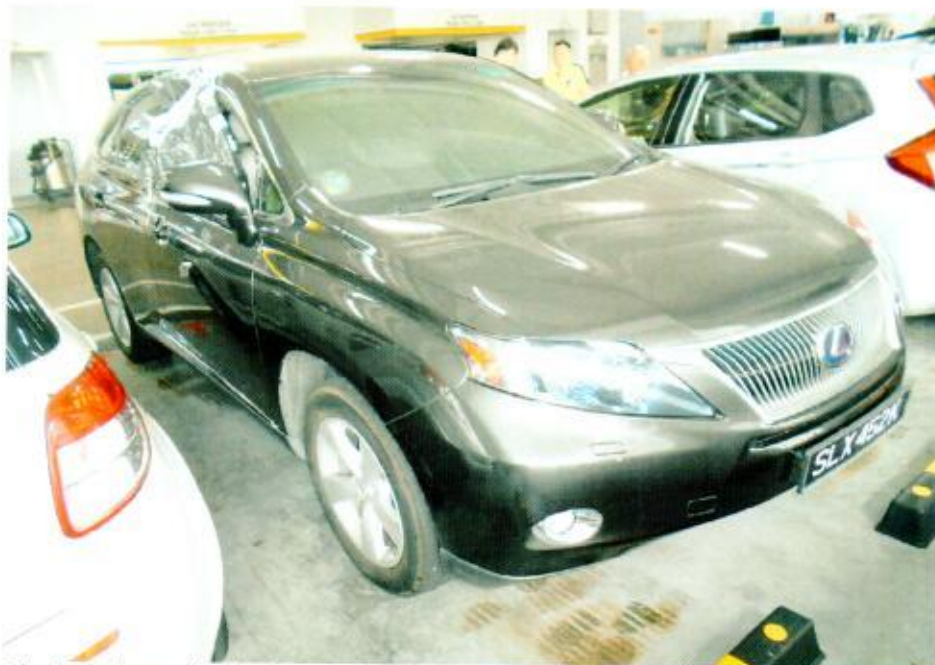
**Photo 3** shows the right side of the Insured Vehicle at the time of our inspection. Its driver's side window was observed to be shattered due to the fire incident.

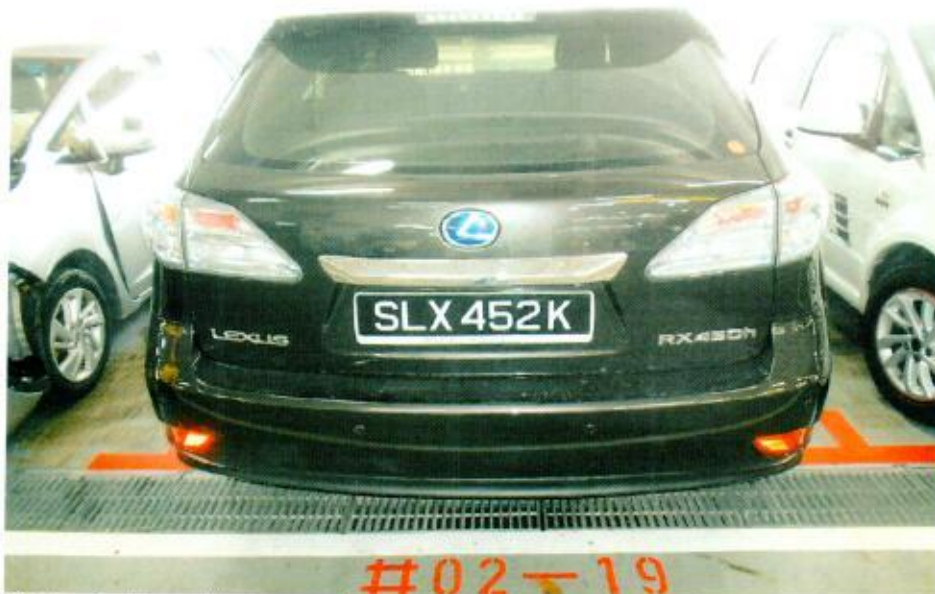
**Photo 4** shows the general view of the rear of the Insured Vehicle. It was observed to be in good condition not affected by the fire.

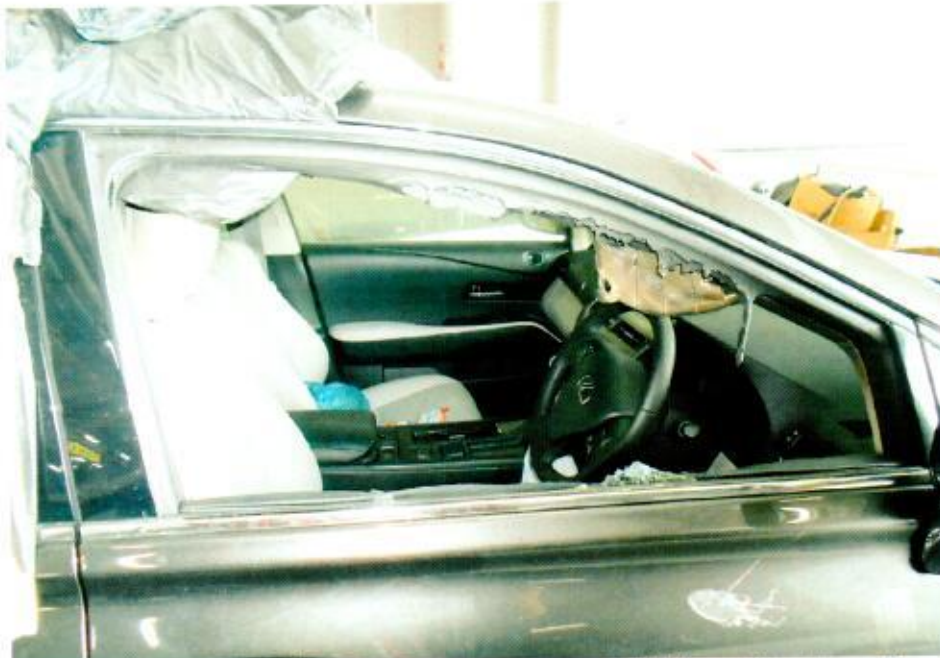
**Photo 5** shows the driver's side of the Insured Vehicle at the time of our inspection. Its driver's side window was observed to be shattered due to the fire incident.

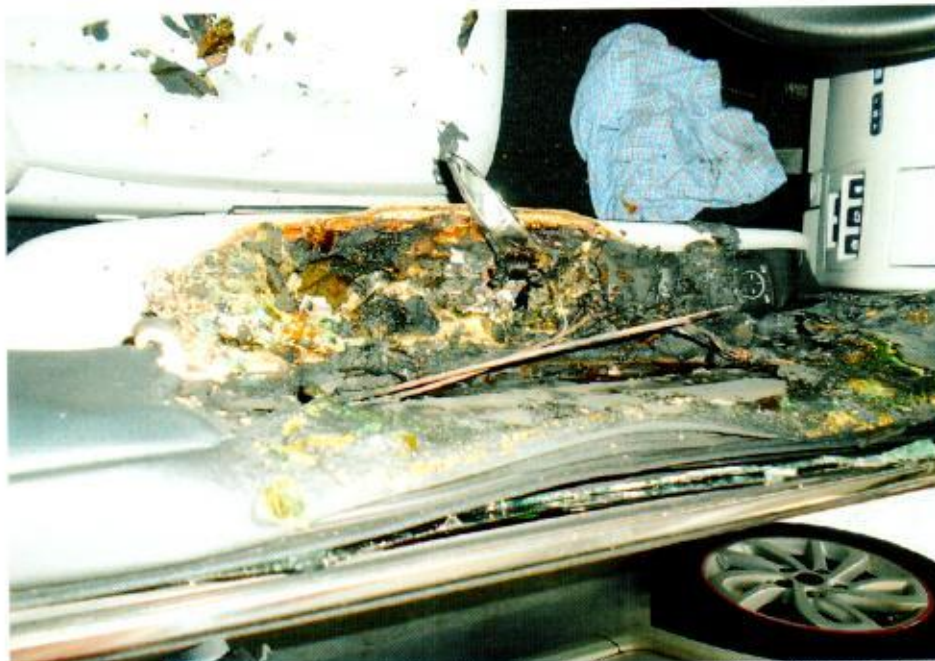
**Photo 6** shows a closer view of the driver's interior door portion of the Insured Vehicle at the time of our inspection (top view). It was observed to be significantly burnt and/or melted as a result of the fire.

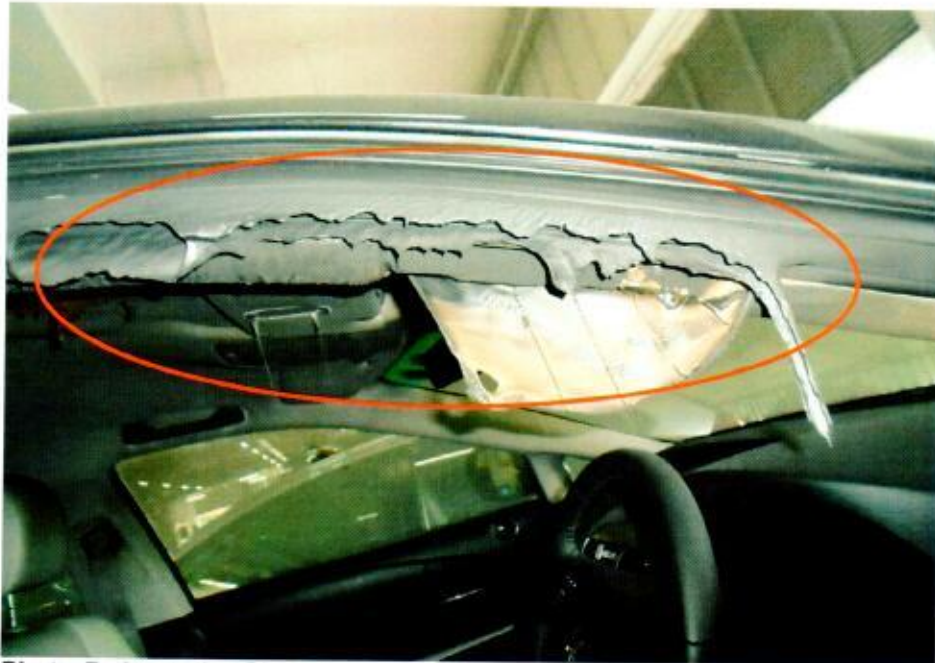
**Photo 7** shows the Glass door outer & inner mounting. The components were observed to be slightly burnt and/or melted as a result of the fire (circled).

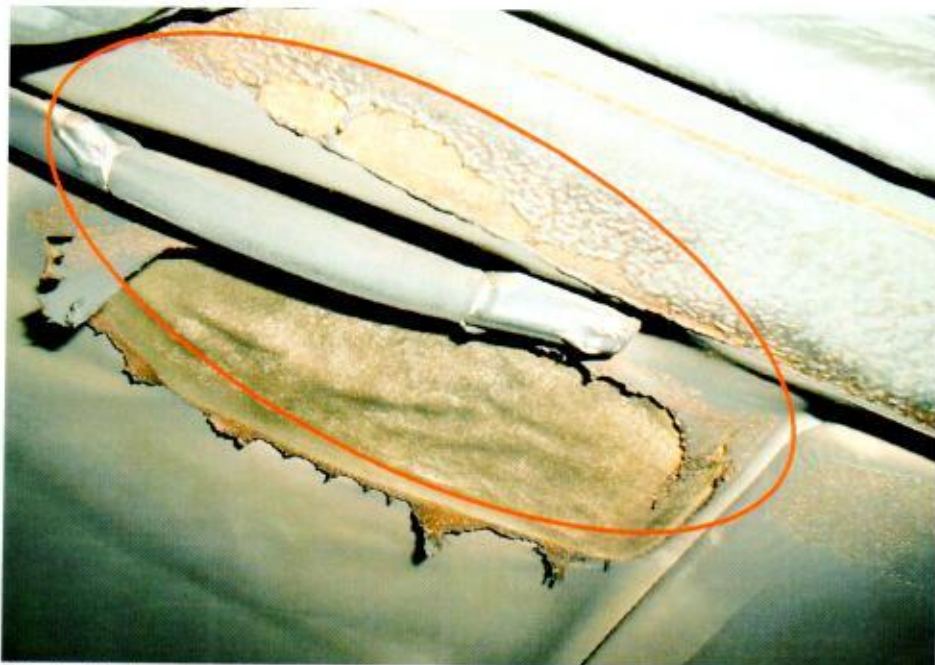
**Photo 8** shows a closer view of the right side of the interior roof top of the Insured Vehicle at the time of our inspection. It was found to be slightly burnt and/or melted as a result of the fire.

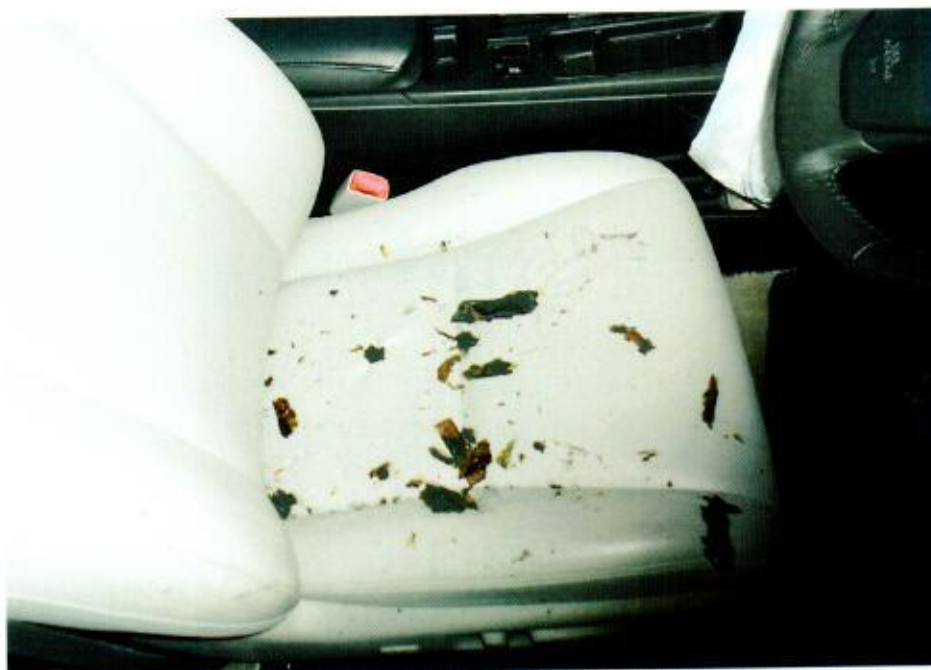
**Photo 9** shows the charred rubber substance fell onto the Insured Vehicle seat. The debris was from the burnt materials from the driver's door portion.

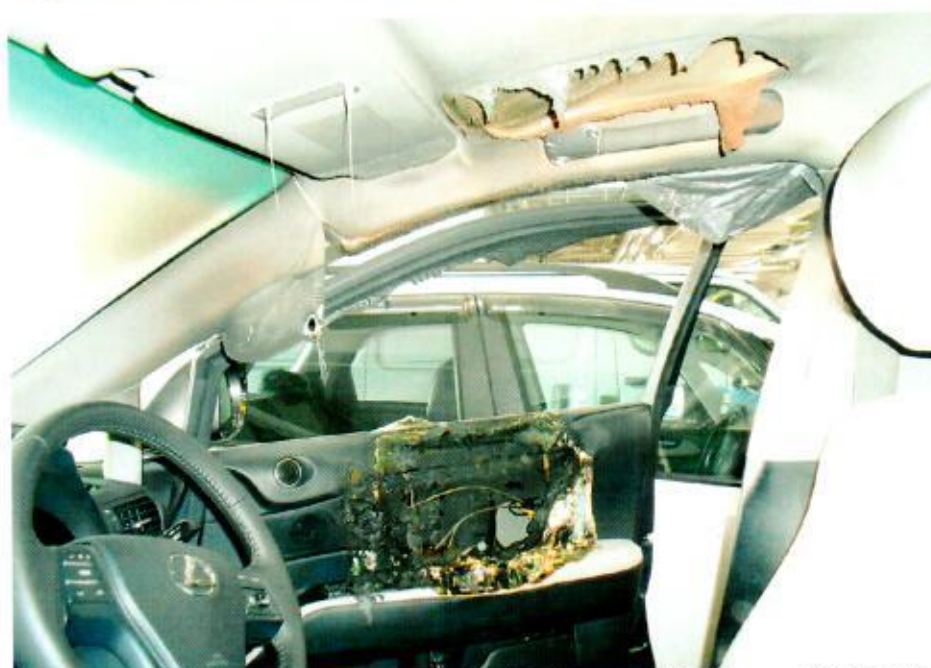
**Photo 10** shows the general view of the driver's seat of the Insured Vehicle (as viewed from the front passenger's seat) at the time of our inspection. The affected area was observed only around the driver's seat area.

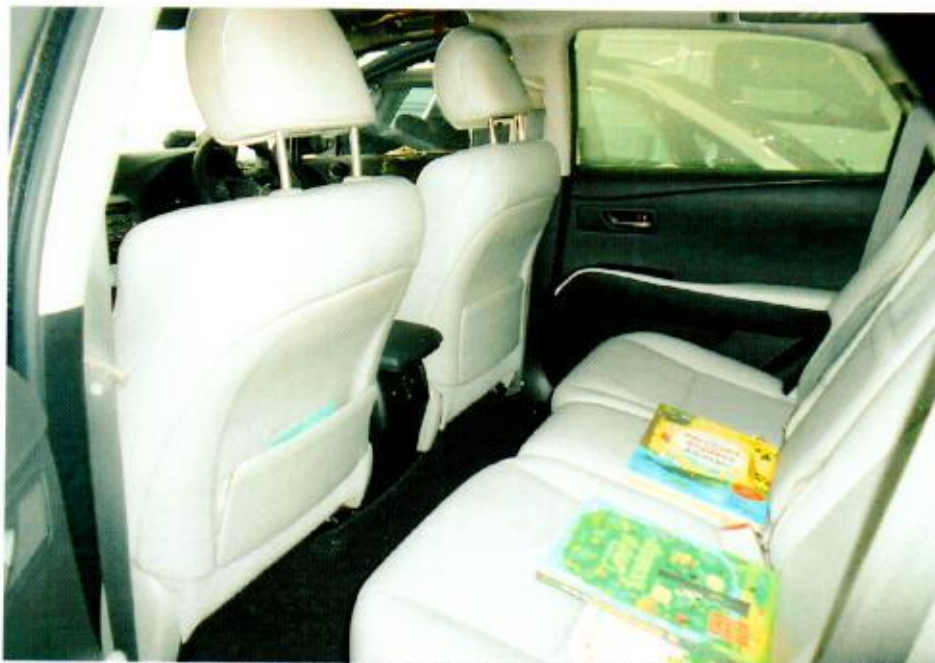
**Photo 11** shows the passenger's interior compartment of the Insured Vehicle which was not affected by the fire incident.

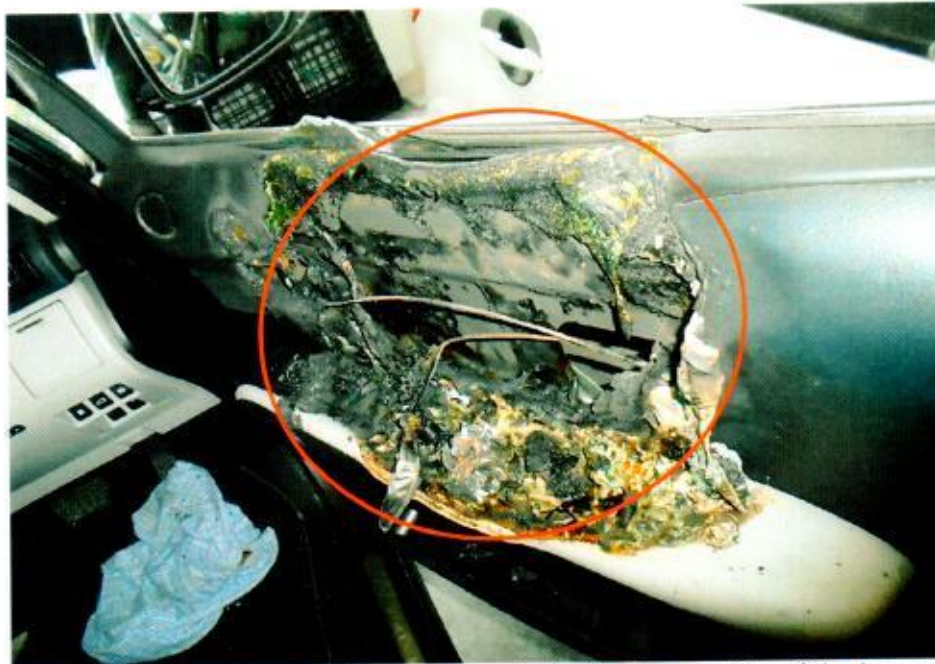
7. For this particular case, the fire appears to have originated from the interior cabin of the Insured Vehicle, at the front right portion (driver's interior door panel). This was determined basing on the area where the extent of fire damage was most severe. The burnt damages were observed to be only affecting around the interior door panel of the driver's seat portion. The melted materials that were affected by the fire damages would also support our findings of where the fire to the Insured Vehicle had originated. See photo 12 below.

**Photo 12** shows a closer view of the driver's interior door portion of the Insured Vehicle at the time of our inspection. It was observed to be significantly burnt and/or melted as a result of the fire.

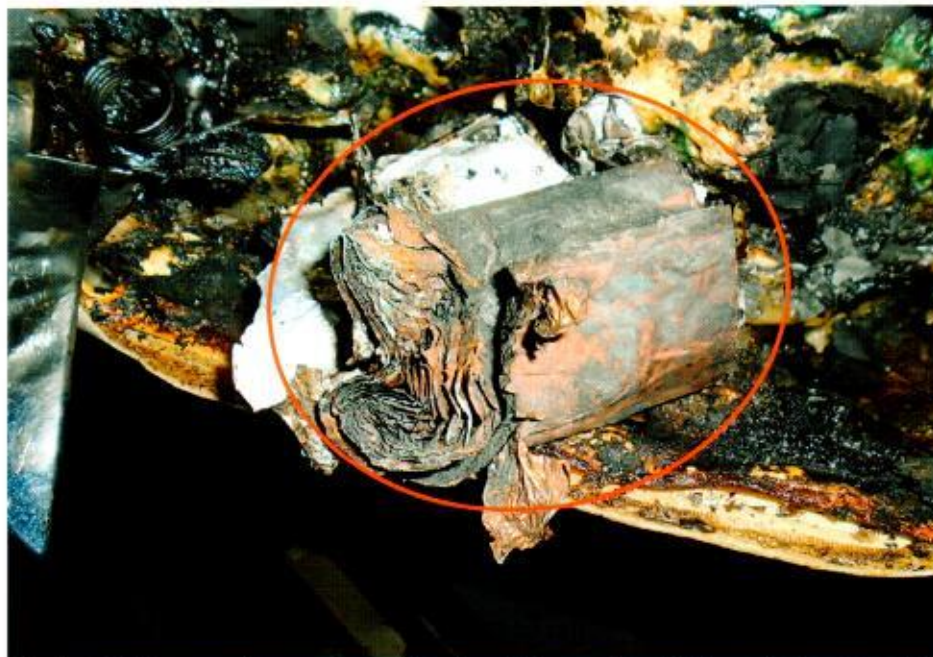
10. It was believed that the 'Power Bank' was left inside the Insured Vehicle next to the driver's seat interior door panel compartment. The Insured Vehicle was parked at an open space car park prior to the incident. Due to the hot weathered afternoon, high temperature heat will formed in the Insured Vehicle when parked for a long period of time. This would then appear to suggest that the cause of fire to the Insured Vehicle could have possibly been due to the chemical re-action that affects the 'Power Bank' from the high temperature heat inside the Insured Vehicle that caused overloaded heat & eventually creates spark to the 'Power Bank' hence ignite into fire. See photo 13 - 15 below.

**Photo 13** shows a closer view of the burnt 'Power Bank'. It was taken from the driver's interior door compartment.

25. Having investigated and technically analysed the damages of burnt nature to the Insured Vehicle, we are of the view that the cause of fire to the Insured Vehicle was likely due to external factors. The fire had most probably originated from the 'Power Bank' that was left inside the driver's door panel compartment. The Insured Vehicle was parked at an open space car park prior to the incident. Due to the hot weathered afternoon, high temperature heat was formed in the Insured Vehicle when parked for a long period of time. This would then appear to suggest that the cause of fire to the Insured Vehicle could have possibly been due to the chemical re-action that affects the 'Power Bank' from the high temperature heat inside the Insured Vehicle that caused overloaded heat & eventually creates spark to the 'Power Bank' hence ignite into fire.

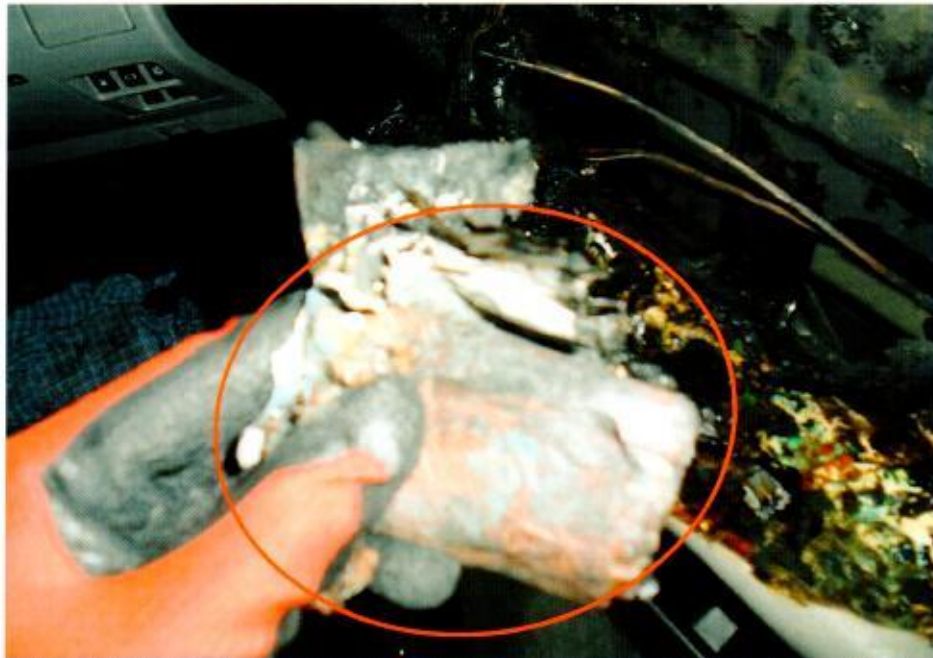
**Photo 14** shows a closer view of the burnt 'Power Bank'. It was taken from the driver's interior door compartment.

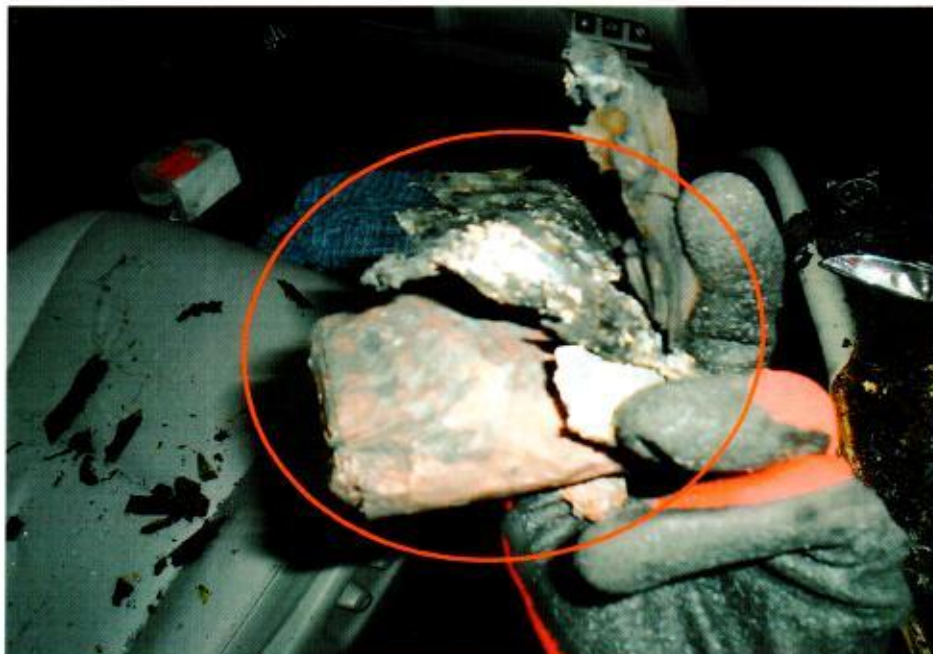
**Photo 15** shows a closer view of the burnt 'Power Bank'. It was taken from the driver's interior door compartment.

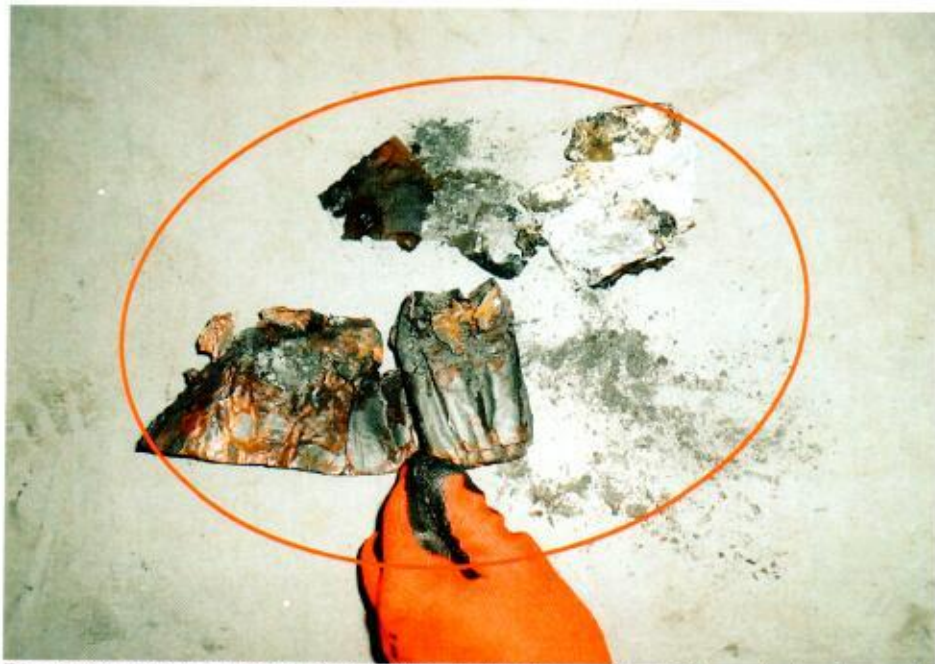
21. With regards to the burnt object which was not part of the factory fitted components for the door, we had asked Mr Singh on the identification of the object. Mr Singh acknowledged that the burnt object was a 'Power Bank' which was placed in the driver's door compartment. See photo 16 below.

**Photo 16** shows a closer view of the burnt 'Power Bank'. It was taken from the driver's interior door compartment.

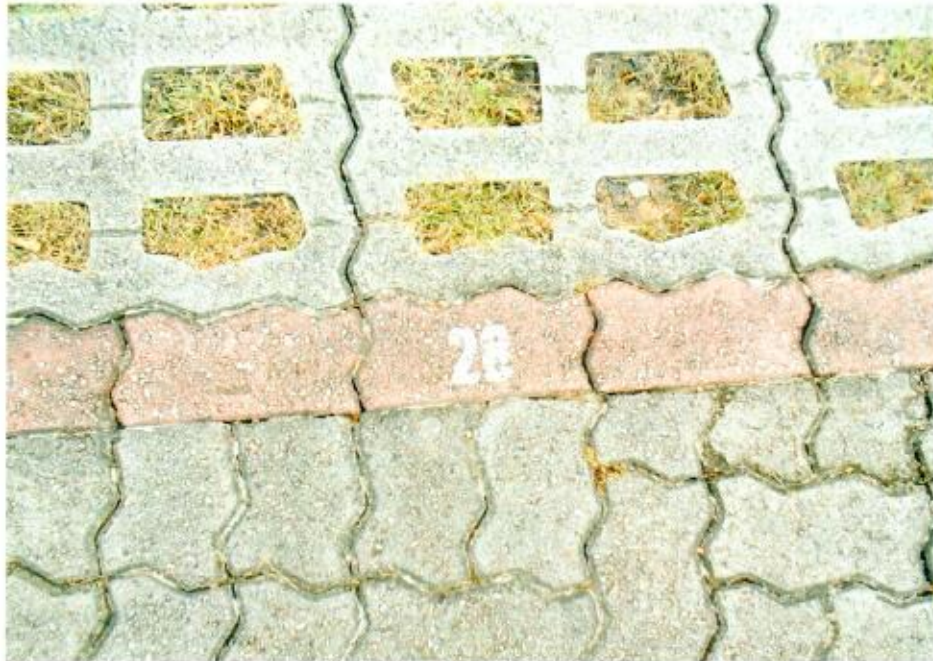
**Photo 20** shows the lot no. 20 at the Changi Golf Club open car park.

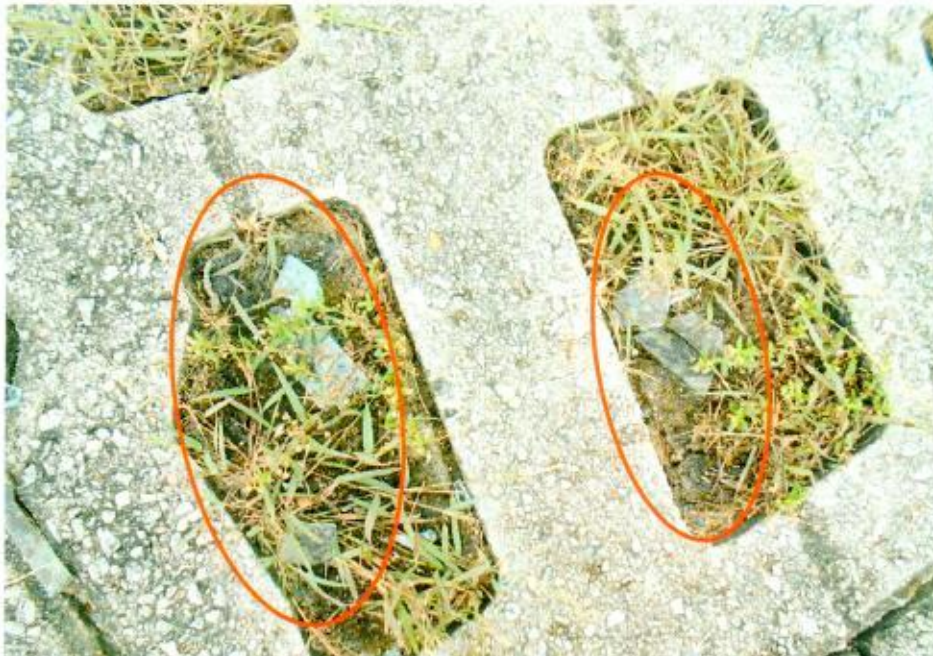
**Photo 21** shows a close-up view of the broken glass debris from the driver's window that was smashed to extinguish the fire.
