Your Ref: TP/IP/00221/2018
Our Ref : CI/TPD18008369/Z

08th May 2018

MECHANICAL INSPECTION REPORT OF MOTORCYCLE JSF 7518

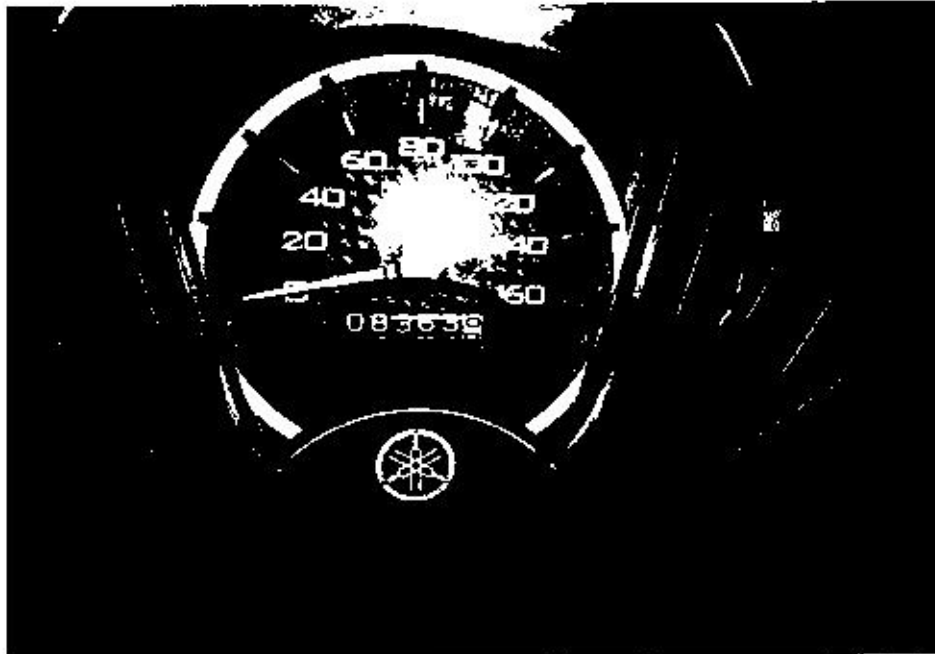
Photo 1 shows the mileage at the time of inspection was recorded to be 083636km.

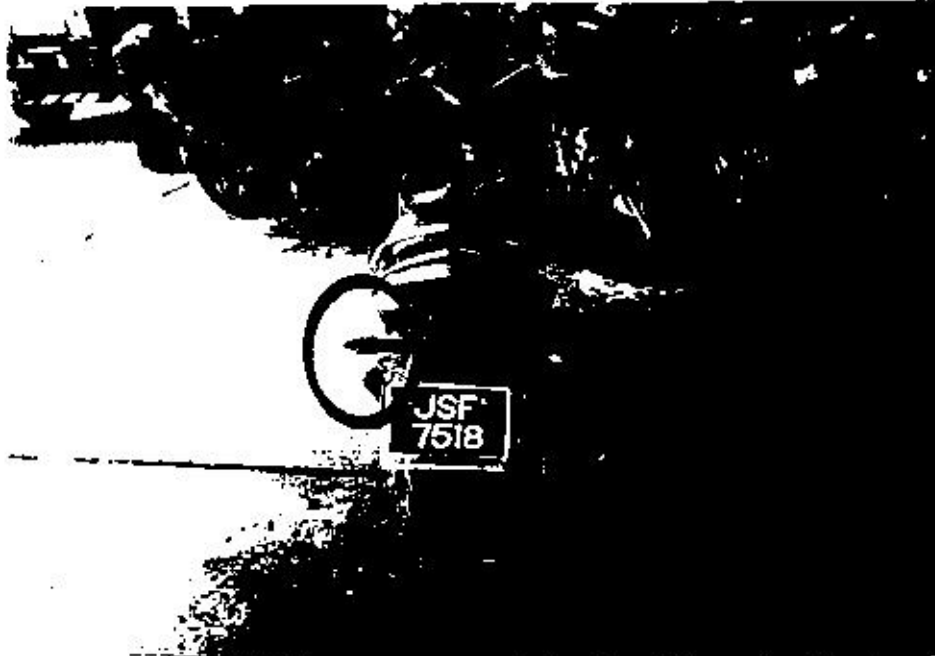
Photo 3 shows a general view of the rear body of the Motorcycle at the time of our inspection. The Motorcycle was observed to have sustained damages at the rear left portion.

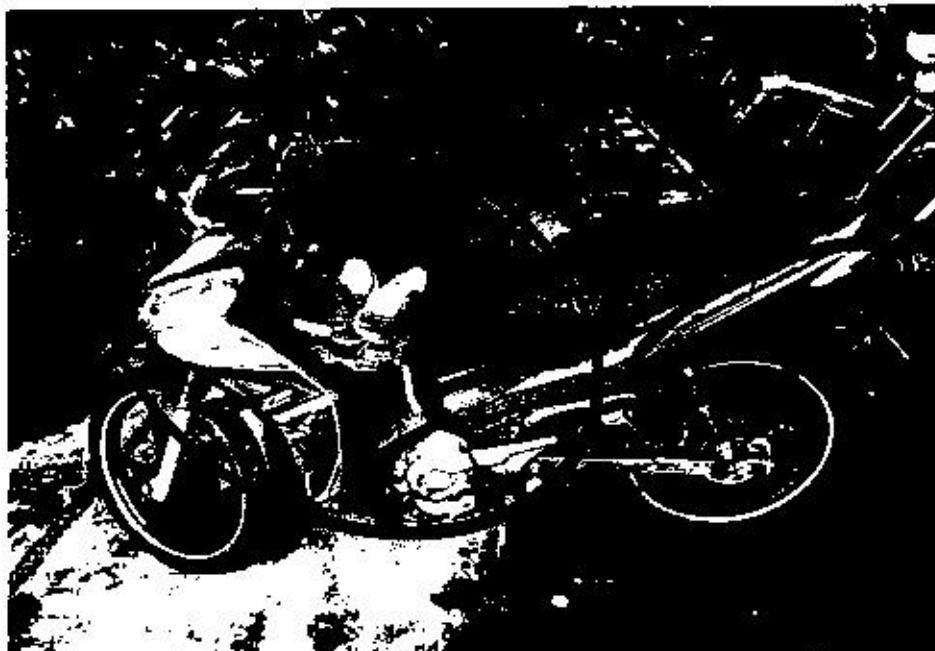
Photo 4 shows a general view of the left portion of the Motorcycle at the time of our inspection. The Motorcycle was observed to have sustained damages due to the accident collision.

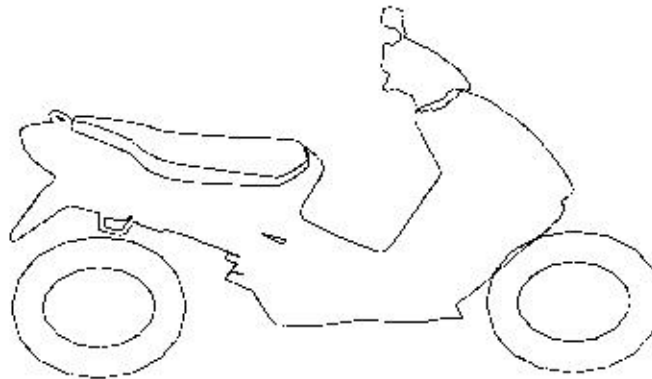
Vee Rubber V420R
80/90 - 17 (4mm)

Vee Rubber V420F
70/90 - 17 (2mm)

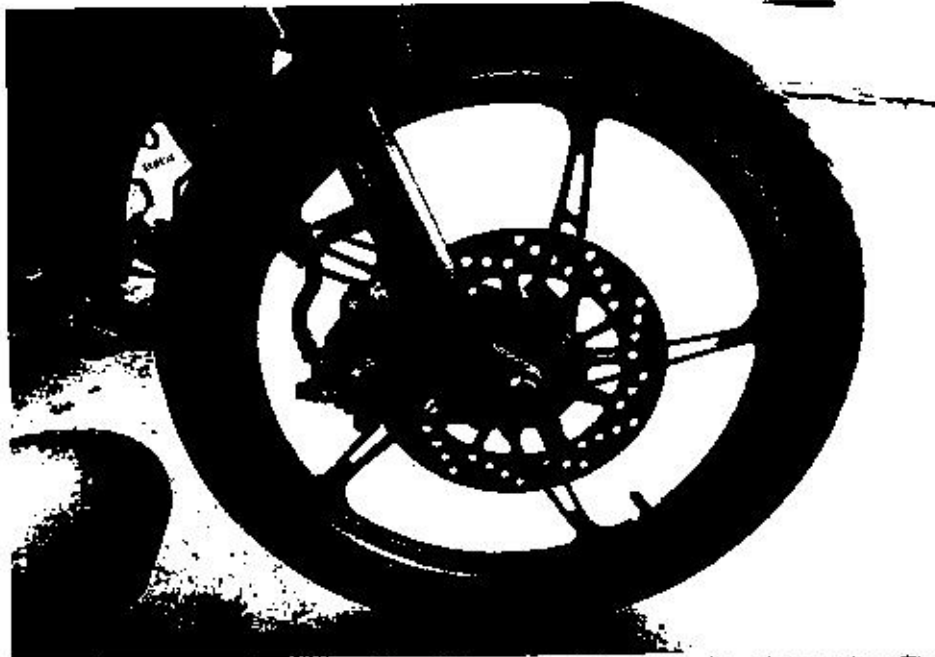
Photo 8 shows the front tyre of the Motorcycle at the time of our inspection. The tyre was observed to be wrapped around alloy wheel rim. There was no significant damage observed on the front wheel rim & tyre.

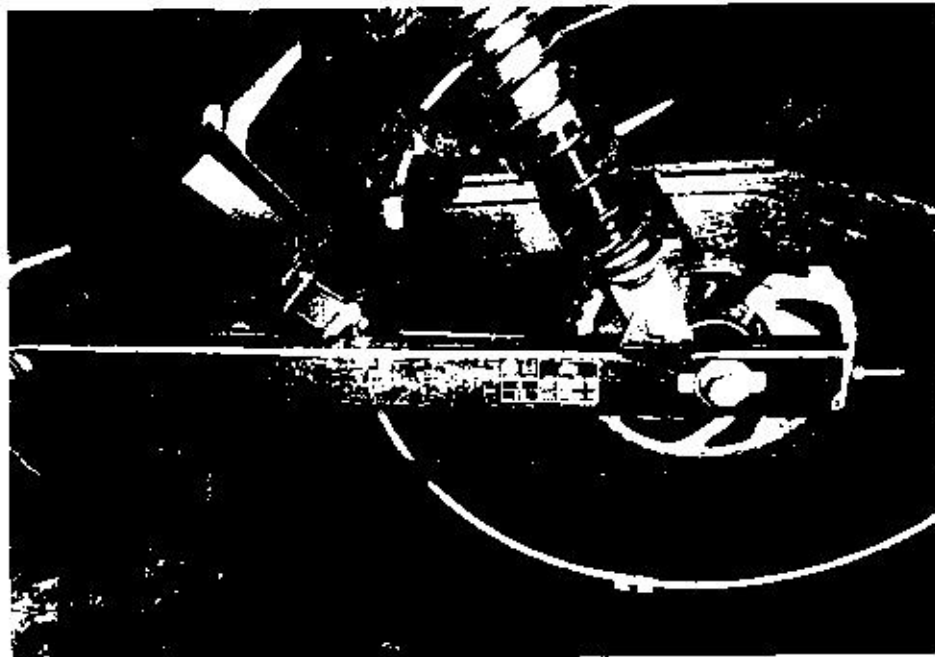
Photo 9 shows the rear tyre of the Motorcycle at the time of our inspection. The tyre was observed to be wrapped around alloy wheel rim. There was no significant damage observed on the rear wheel rim & tyre.

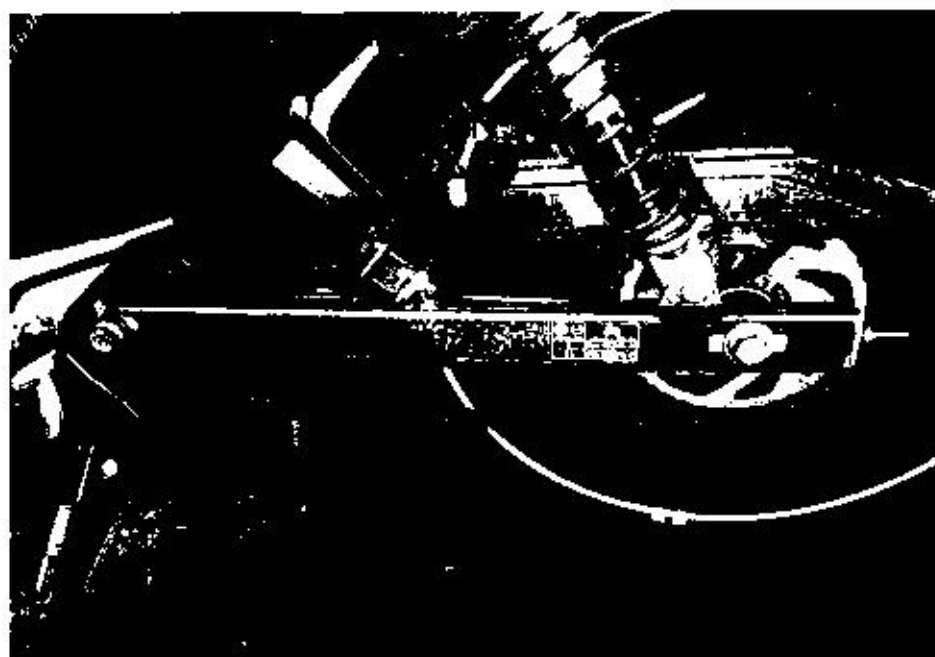
Photo 12 shows the general view of the gear train (arrowed) of the Motorcycle, which was observed to be intact with no misalignment. It was also adequately lubricated for operating purposes.

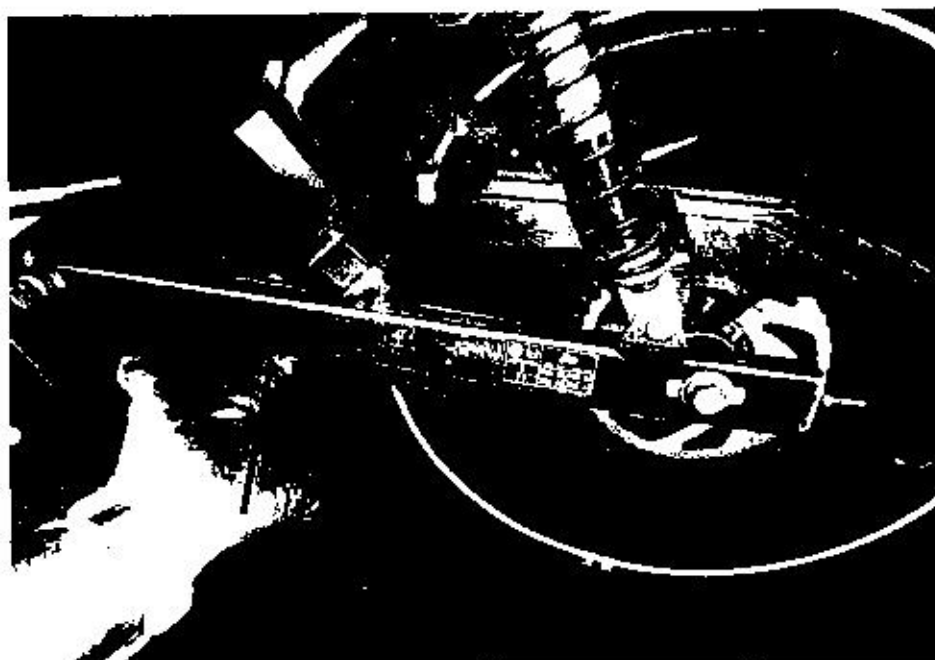
Photo 13 shows the general view of the gear train (arrowed) of the Motorcycle, which was observed to be intact with no misalignment. It was also adequately lubricated for operating purposes. Free play tension was also observed & found adequately acceptable.
