AUTOMOBILE ASSESSMENT REPORT

ASSESSMENT OF VEHICLE NO. SJG 9784 G DATE OF LOSS: 22/02/2018

VEHICLE DAMAGE INSPECTION REPORT

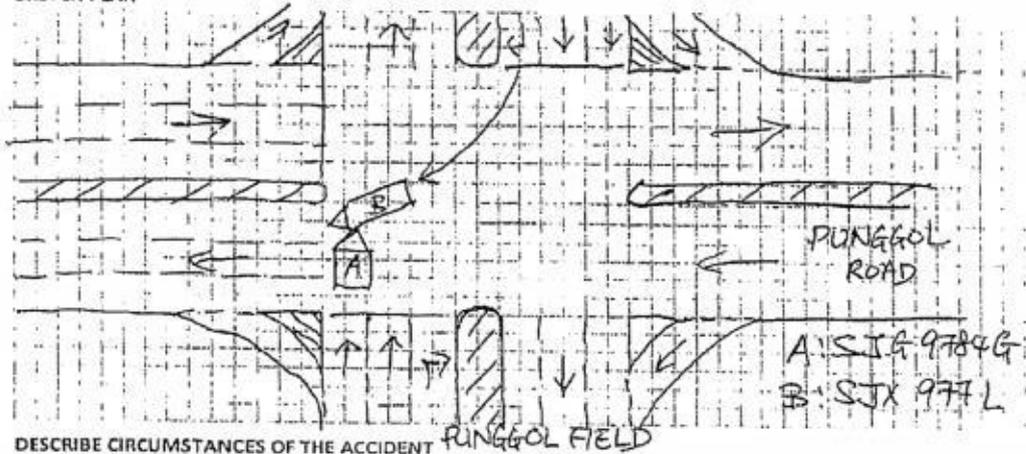
SKETCH PLAN

DESCRIBE CIRCUMSTANCES OF THE ACCIDENT

On 22/02/18, At about 11.55pm along Junction Punggol Field and Punggol Road, When I'm in the right of way to go straight, suddenly there was a car (car B) dash out from the other side of the road.

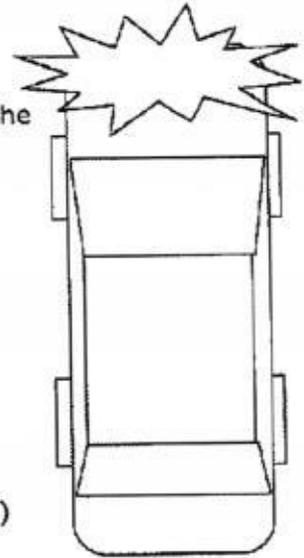
4. DESCRIPTION OF DAMAGE

At the time of the inspection, the vehicle sustained damages to the FRONT portion.
