Your Ref: TP/IP/01231/2018
Our Ref : CI/TPD18008684/Z

MECHANICAL INSPECTION REPORT OF MOTOR CAR SLA 7573U

1. We refer to your request on 13th April 2018 to conduct a physical inspection of a motor car bearing registration number SLA 7573U (herein referred to as "Motor Car"), which was involved in a fatal road traffic accident on 06th January 2018.
2. The objective of the inspection is to determine if there was any possible mechanical failure to the Motor Car that may have contributed to the accident.
3. Following the request, we had carried out a physical inspection of the Motor Car on 08th May 2018 at the premises of Traffic Police vehicle pound, 517 Airport Road Singapore 539942. We now set out below our observations and comments with respect to this inspection.

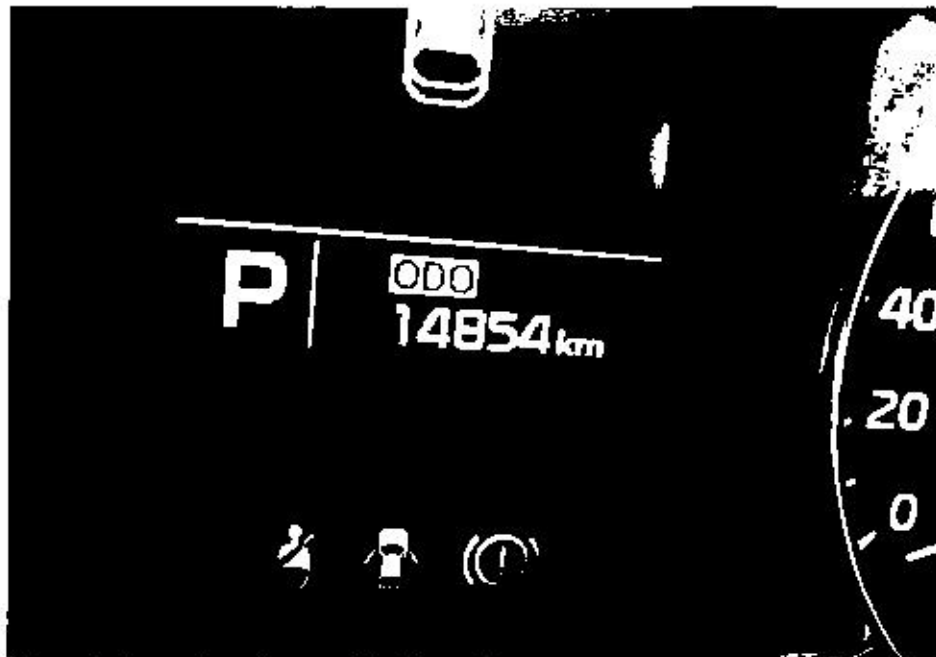
Photo 1 shows the mileage of the Motor Car was 14854 km.

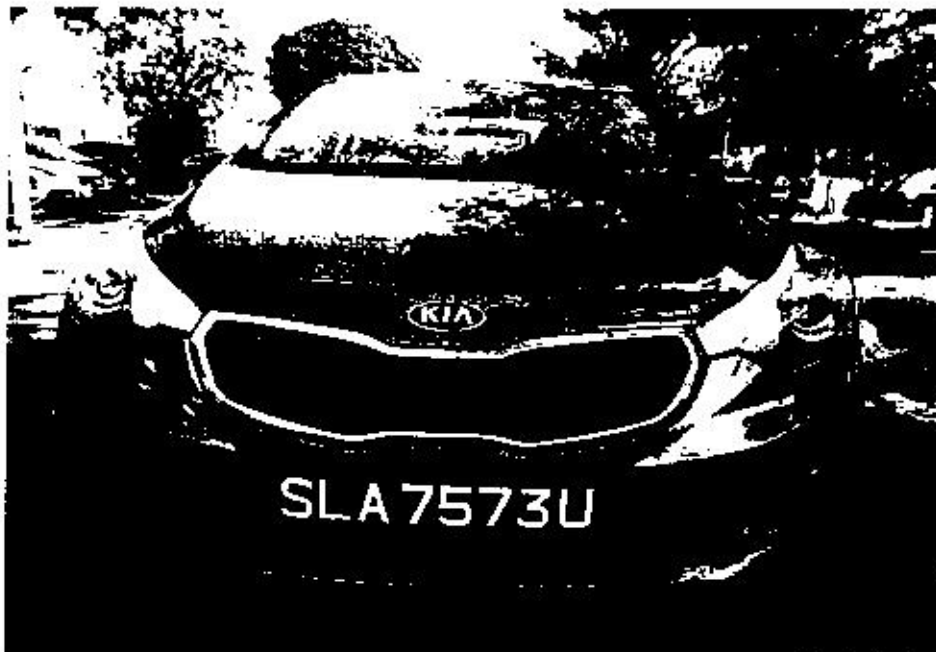
Photo 2 shows a general view of the front body of the Motor Car at the time of our inspection. The Motor Car was observed to be in good condition unaffected by the accident's collision.

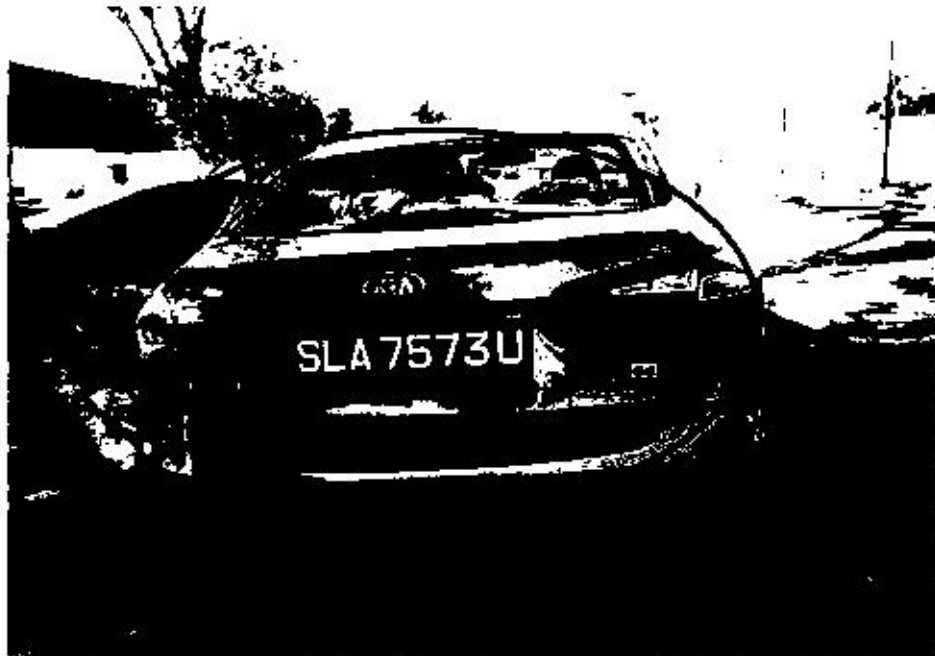
4. The mileage of the Motor Car at the time of our inspection was 14854 km.
5. The Motor Car had sustained a relatively minor impact damages that was confined to its rear portion. Its rear windscreen was observed to have been cracked; its rear left bumper was observed to be dented; its rear tail lamp was observed to be cracked; its rear boot lid was noted to be buckled & misaligned from its original installation.
6. This was likely due to the consistency of the accident's case facts that the Motor Car driver was travelling along Yishun Avenue 1 towards the direction of Yishun Dam, near lamp post 49. The Motor Car was said to have made a U-turn along the said location resulting in a collision with a Motorcycle who was travelling straight on the opposite direction of the Motor Car. See photo 1 to 8 below.

Photo 3 shows a general view of the rear body of the Motor Car at the time of our inspection. The Motor Car was observed to have sustained with minor damages as a result of the accident.

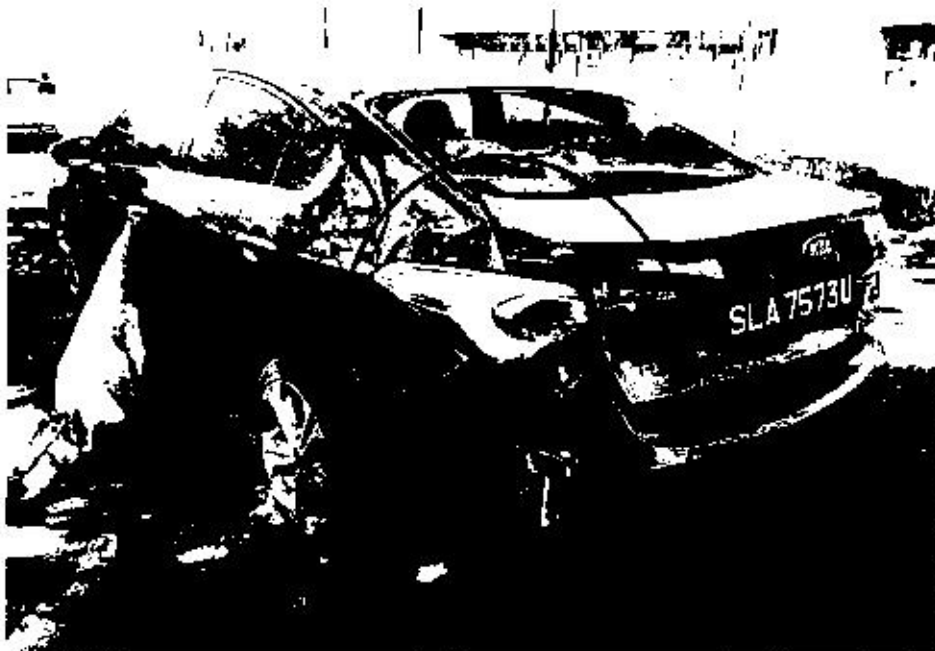
Photo 4 shows a semi close up view of the rear left of the Motor Car at the time of our inspection. The Motor Car had sustained relatively minor impact at the rear left of the Motor Car.

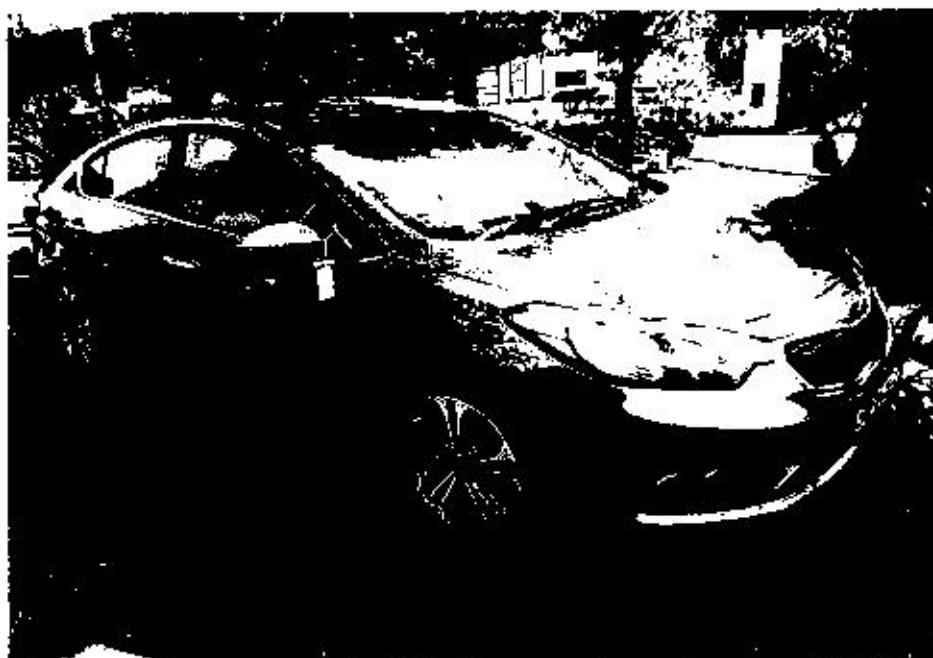
Photo 7 shows a general view of the front right of the Motor Car. It was observed to be in good condition & unaffected by the accident's collision.

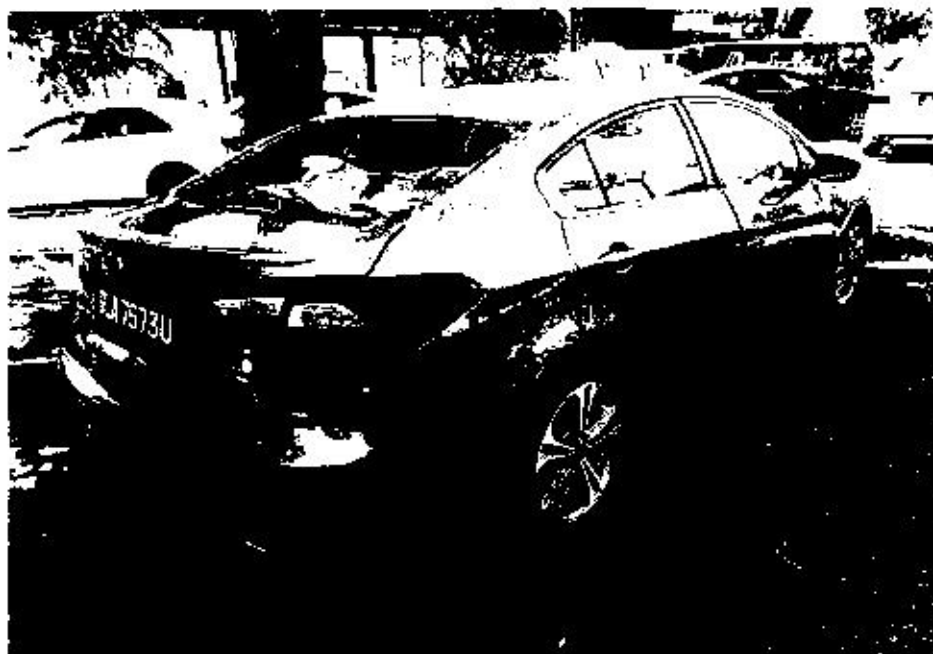
Photo 8 shows a general view of the rear right of the Motor Car. It was observed to be in good condition & unaffected by the accident's collision.

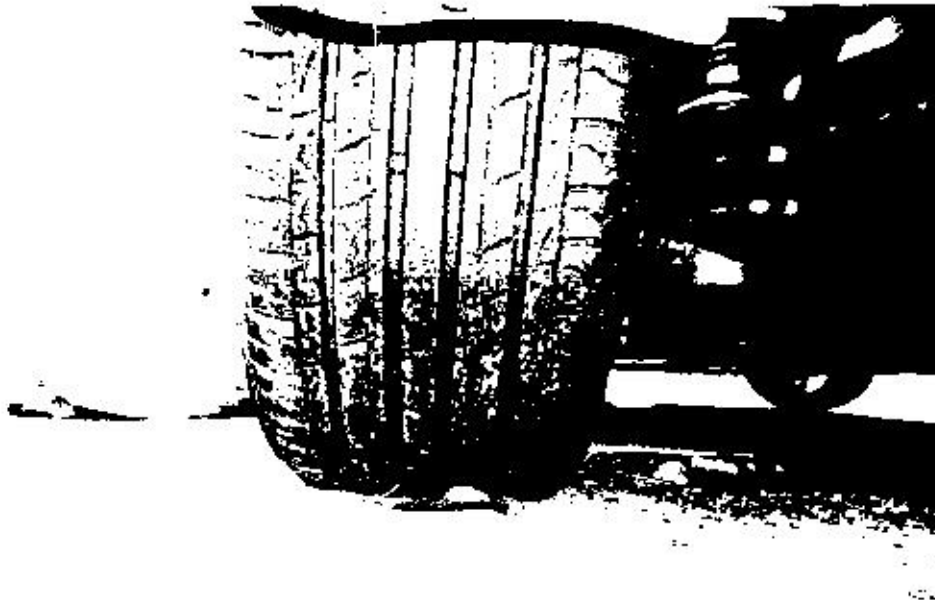
Photo 11 shows the condition of the rear left tyre of the Motor Car, which was observed to be in serviceable condition with remaining tread depth of approximately 6mm. The tyre, which was wrapped around alloy wheel rim, was also observed to be sufficiently inflated for vehicular operation.

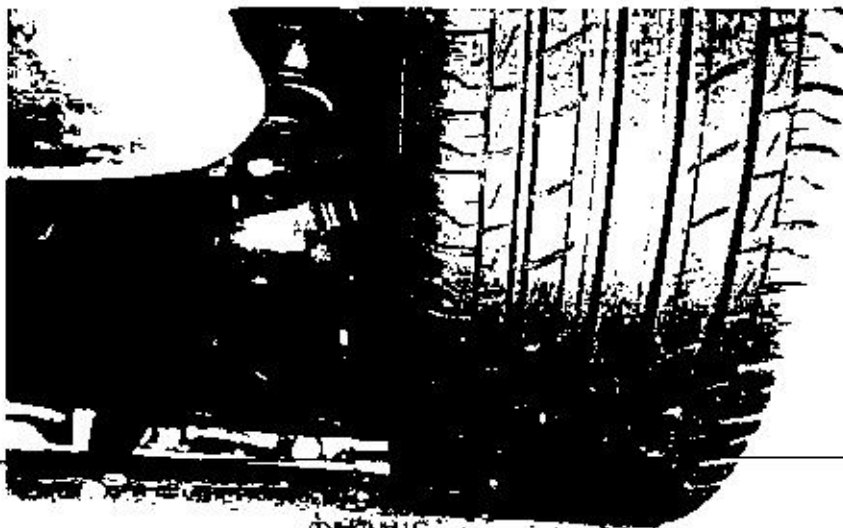
Photo 12 shows the condition of the rear right tyre of the Motor Car, which was observed to be in serviceable condition with remaining tread depth of approximately 6mm. There was also no tear, cut or burst mark(s) on the outer and the inner sidewalls as well as across the tread of the 4 tyres.

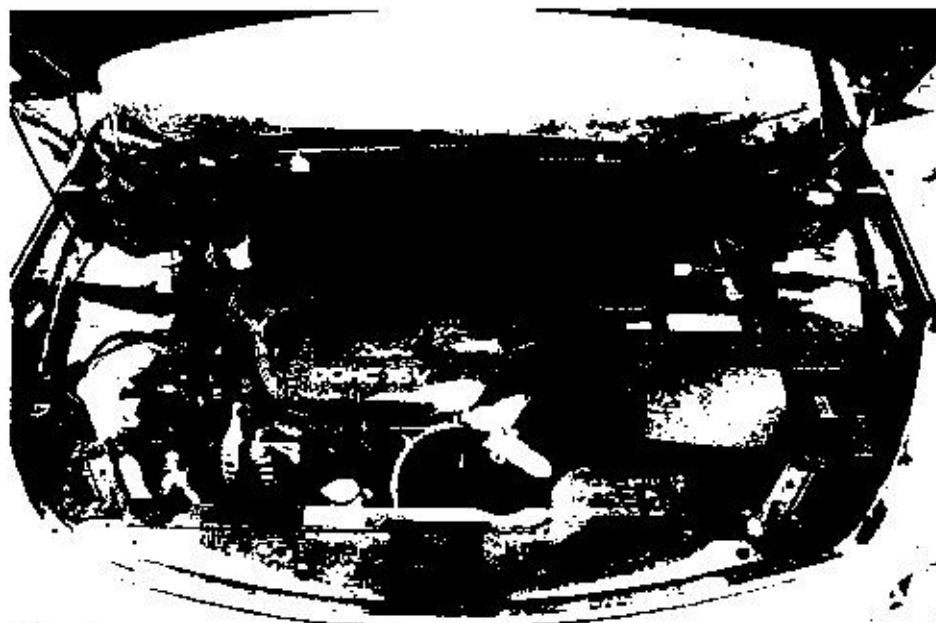
Photo 13 shows a general view of the Motor Car's engine compartment. The various parts and components inside the engine compartment were unaffected by the accident. There was also no sign(s) or indication(s) of fluid leakage and/or fluid stain within the engine compartment.

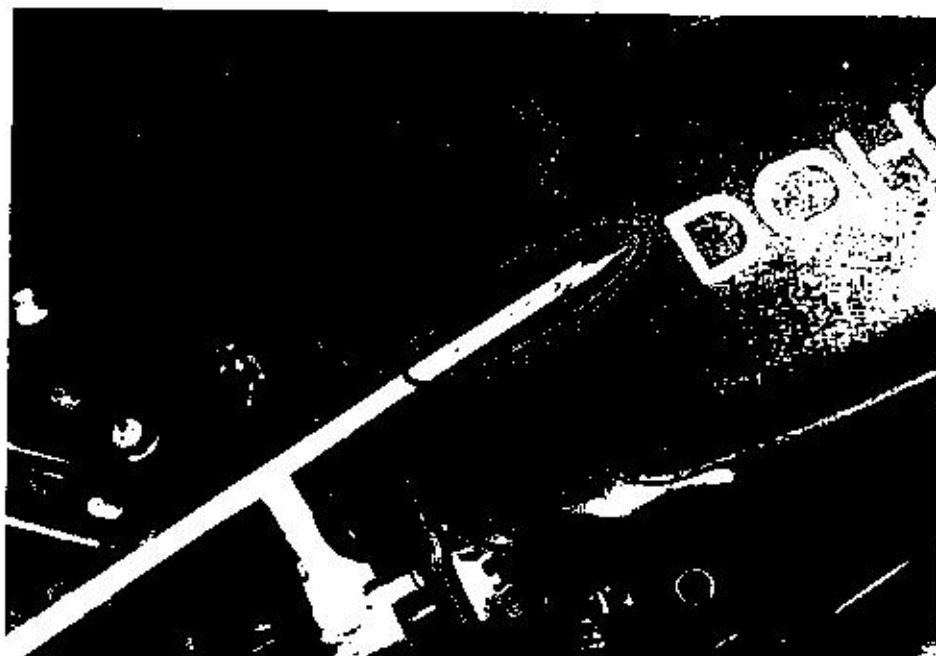
Photo 16 shows the engine oil dip stick of the Motor Car at the time of our inspection. The engine oil was observed to be of sufficient level and without any visible contamination.

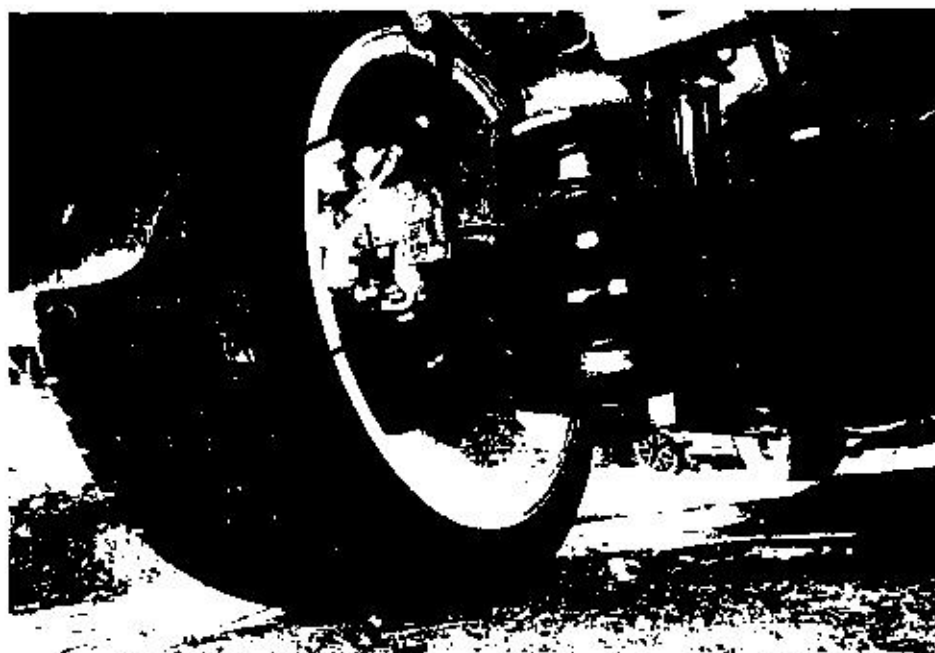
Photo 17 shows the brake hose (arrowed) at the rear left wheel of the Motor Car. We did not observe any leakage of brake fluid at the time of our inspection of the Motor Car. Our visual inspection of the various mechanical components of the Motor Car's braking system revealed all to be intact and without visible damages.

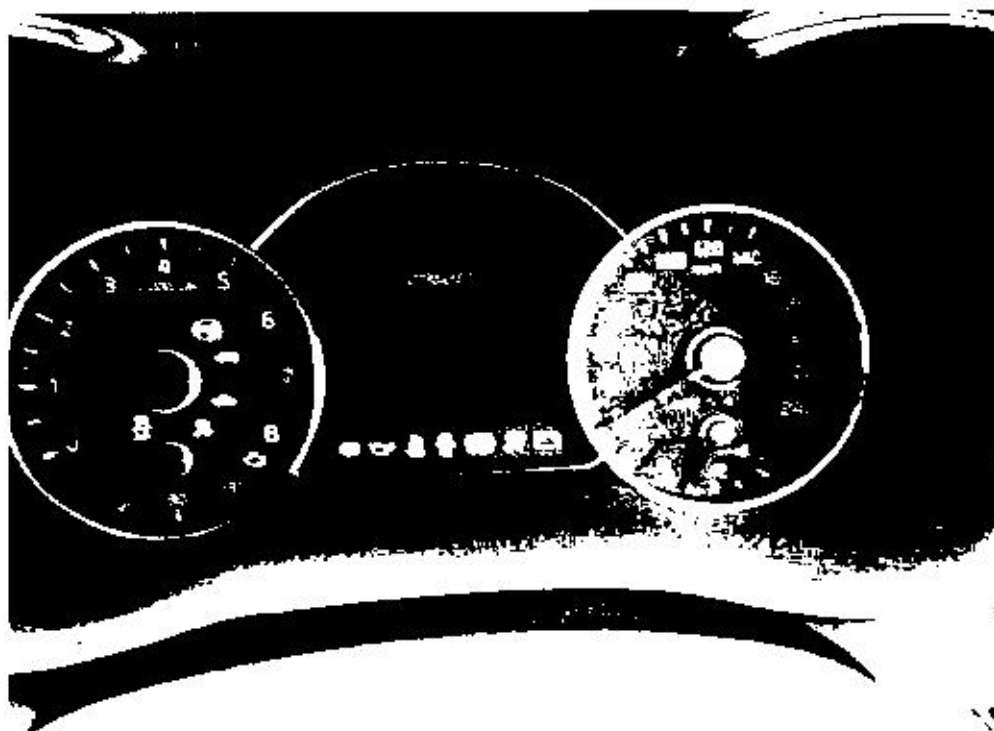
Photo 21 shows the warning lights for the various electronic operating systems of the Motor Car appearing on its instrument panel during the self-test when the engine is cranked, in particular the ABS light and SRS light.

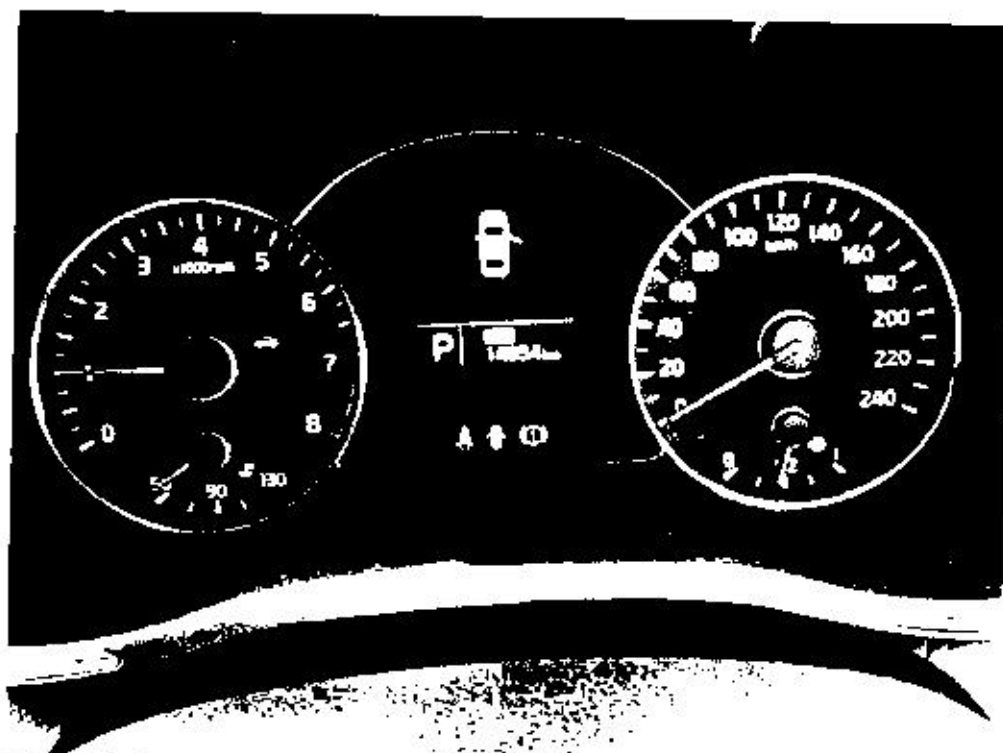
Photo 22 shows no warning lights illuminated on the instrument panel of the Motor Car after the engine was cranked. This would suggest that there was no abnormality to the various electronic operating systems of the Motor Car, like the ABS and SRS.

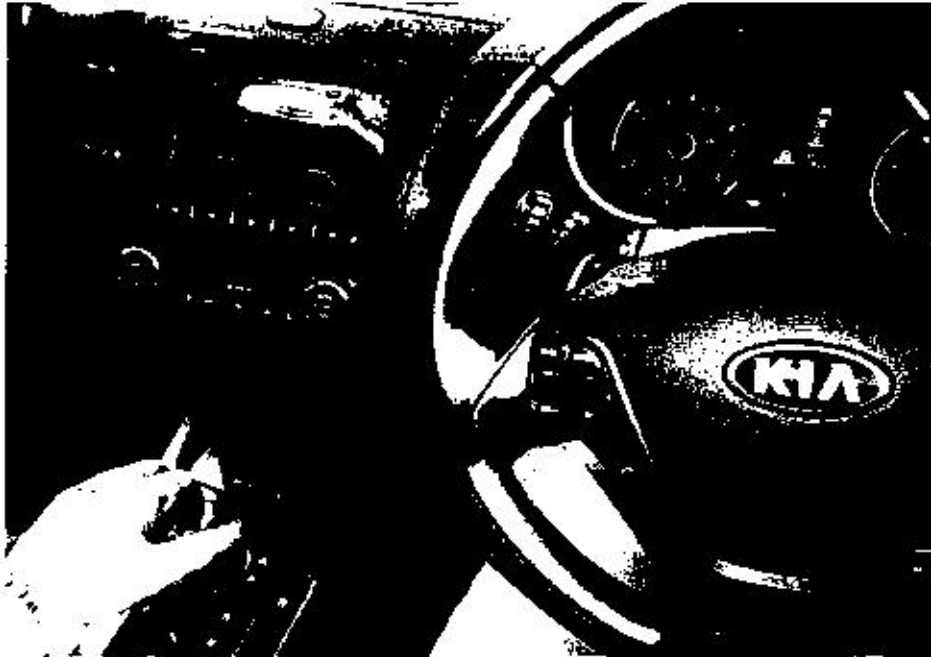
Photo 23 shows we conducted an operational test on the Motor Car. Reverse mode were engaged at time of our test. There was no abnormality observed at time of testing.

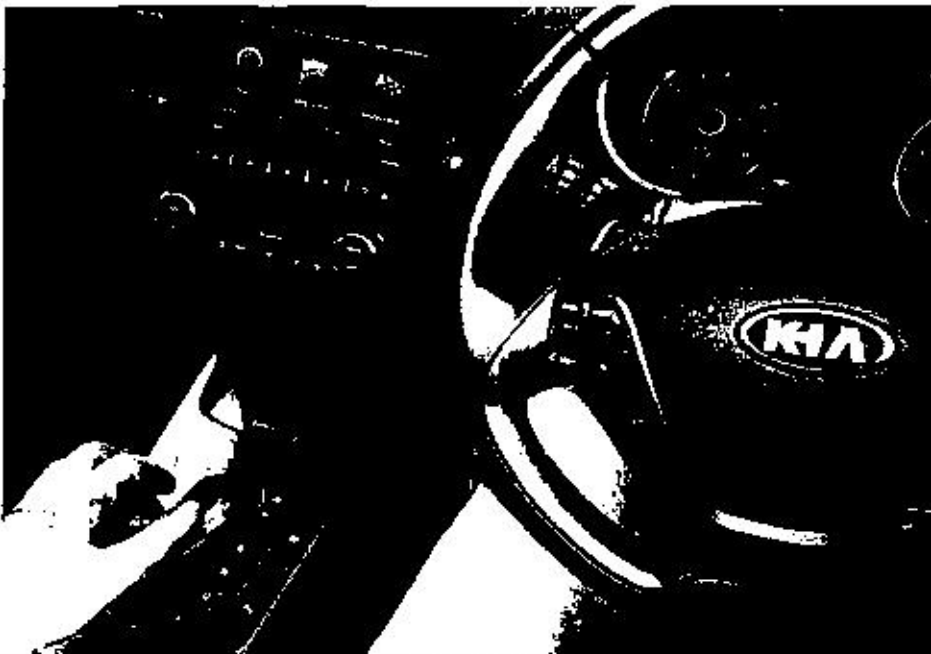
Photo 24 shows we conducted an operational test on the Motor Car. Drive mode were engaged at time of our test. There was no abnormality observed at time of testing.
