Your Ref: TP/IP/06215/2018
Our Ref :CI/TPD18008708/Z

27th February 2018

MECHANICAL INSPECTION REPORT OF MOTORCYCLE JSC 1471

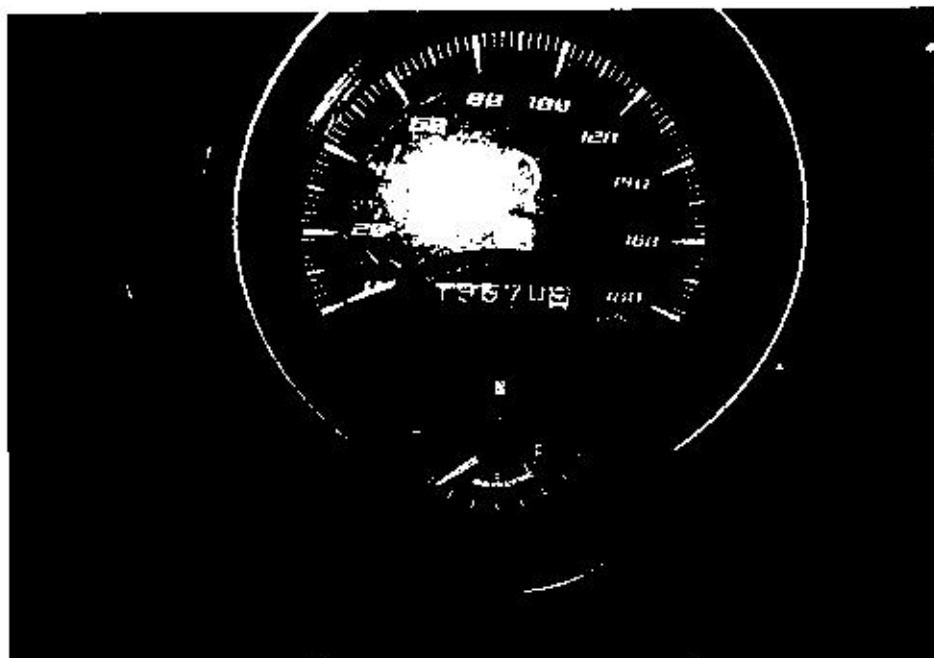
Photo 1 shows the mileage at the time of inspection was recorded to be 195,709km.

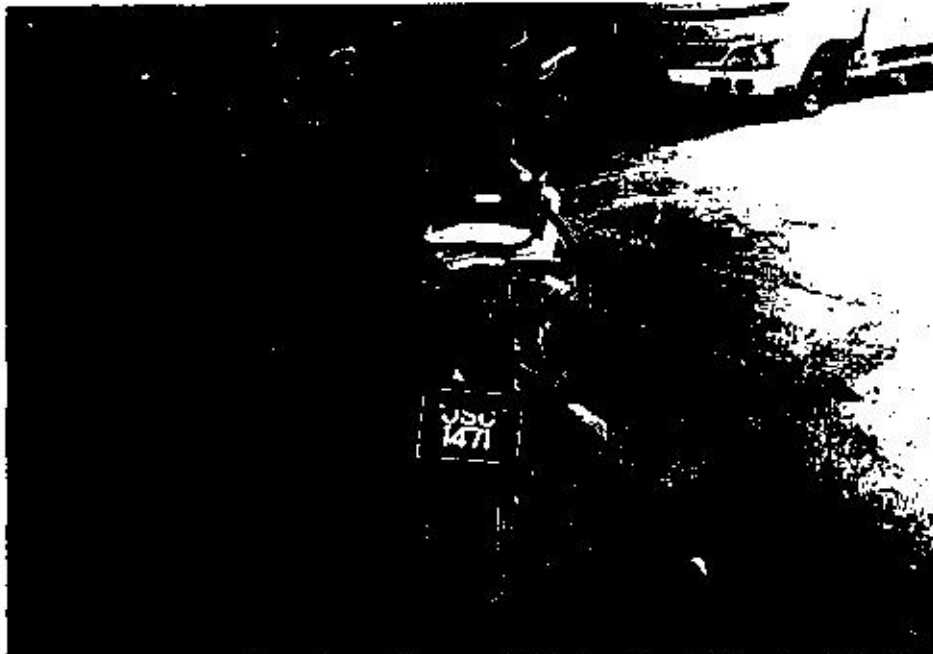
Photo 3 shows a general view of the rear left body of the Motorcycle at the time of our inspection. The Motorcycle was observed to have sustained damages at the rear portion.

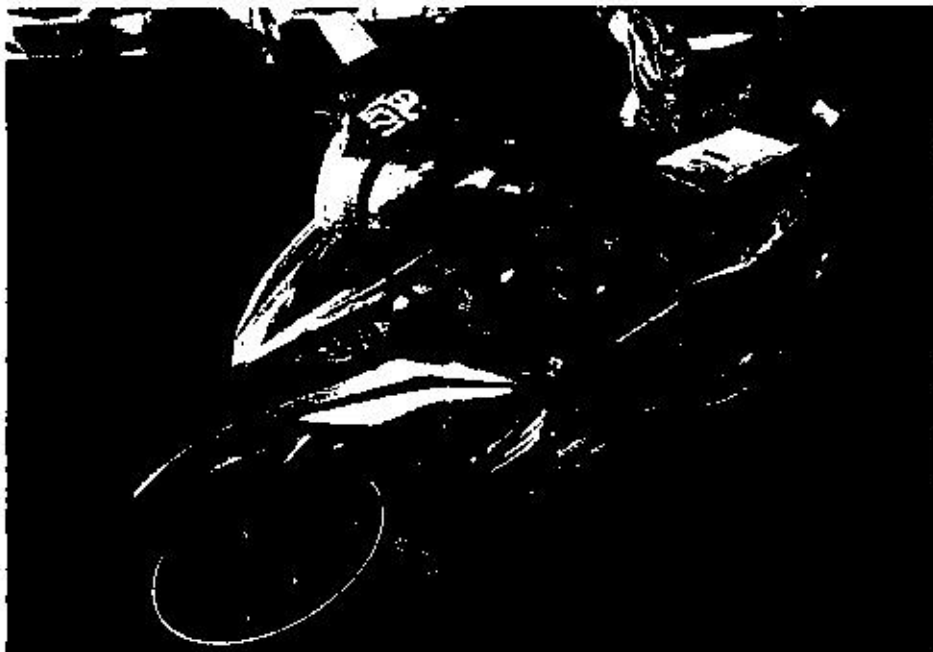
Photo 4 shows a general view of the frontal left portion of the Motorcycle at the time of our inspection. The Motorcycle was observed to be sustained relatively extensive impact due to the accident collision.

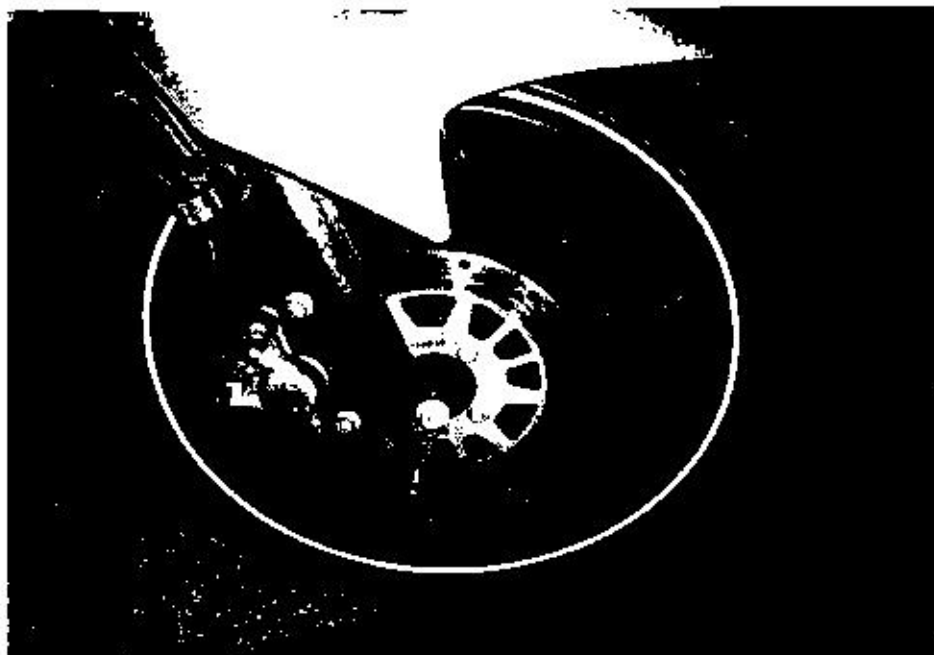
8. The front tyre was wrapped around alloy wheel rim that was found to be without any significant damage. Except for the rear alloy wheel rim that was observed to be slightly bent likely due to the accident's collision impact at the material time of the accident. However, it was still observed to be inflated for operational purposes. See photo 8 & 9 below.

Photo 8 shows the front tyre of the Motorcycle at the time of our inspection. The rear tyre was observed to be in serviceable condition with remaining tread depth of approximately 1.6mm. The tyre was also observed to be sufficiently inflated for vehicular operation. There was no significant damage observed on the rear wheel rim & tyre.

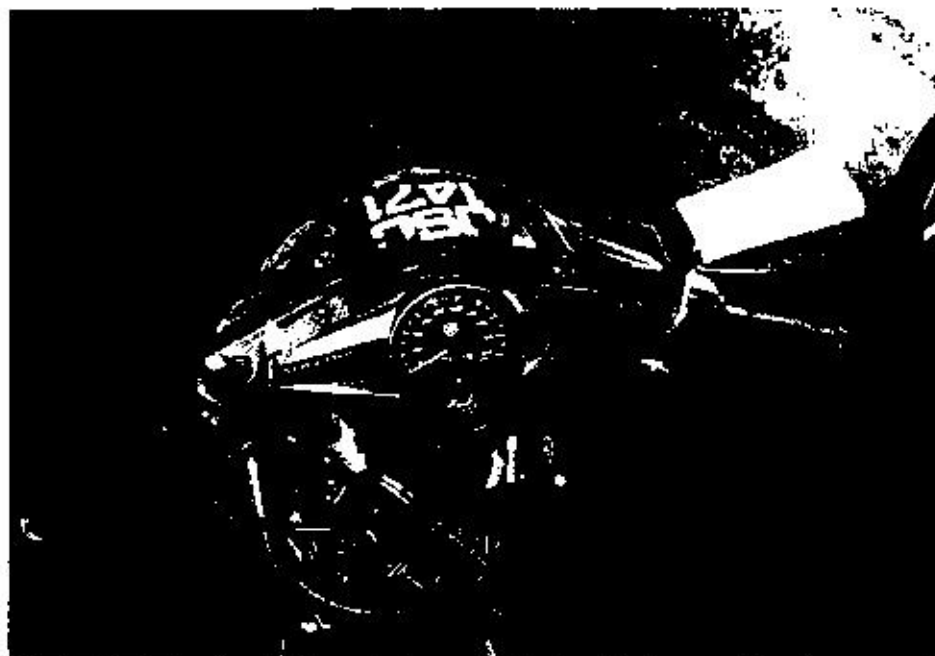
11. For this case, we were not able to conduct any test(s) on the steering system of the Motorcycle due to the damage on its handle bar. It was found to be misaligned as a result of the accident, hence causing the whole steering system not to be in a serviceable condition.
12. The brake system of the Motorcycle was of a semi-hydraulic type, where hydraulic (brake fluid) pressure controls the brake for the front wheel while the brake for the rear wheel is controlled by mechanical means (cables and springs). Our visual examination of the various components in the brake system, like the brake disc, brake calliper, drum and brake foot pedal, revealed all to be intact and without damage. There was also no visible tear or cut observed on the connecting hoses and cables.

Photo 13 shows the front handle bar was observed to be misaligned as a result of the accident. Hence, we are not able to conduct any tests on the steering system of the Motorcycle.
