Your Ref: TP/IP/06211/2017
Our Ref :CI/TPD18008709/Z

28th February 2018

MECHANICAL INSPECTION REPORT OF MOTORCYCLE FBH 8168G

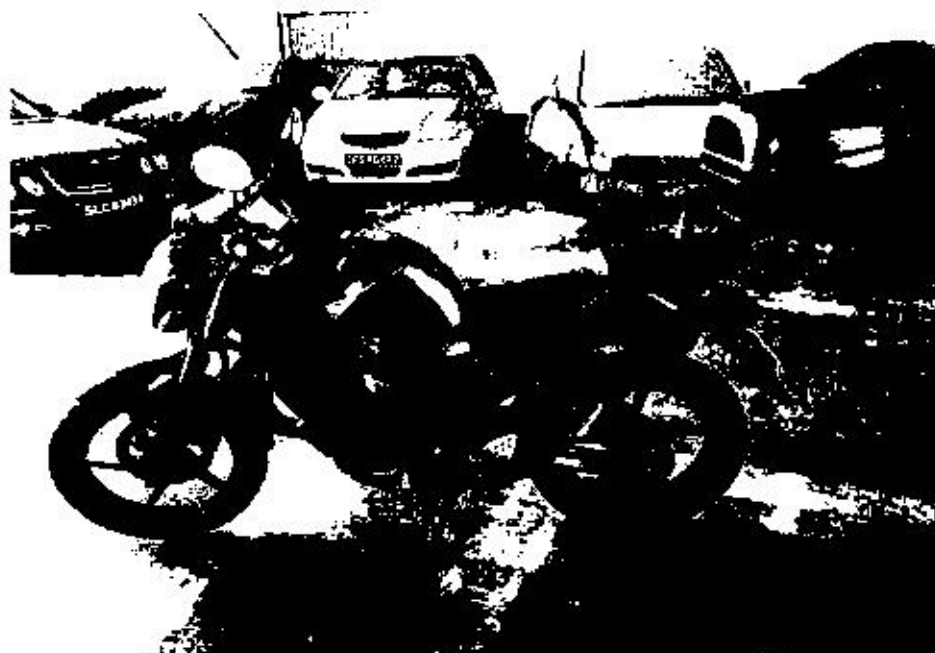
Photo 2 shows a general view of the left side body of the Motorcycle at the time of our inspection. The Motorcycle was observed to be in good general condition unaffected by the accident.

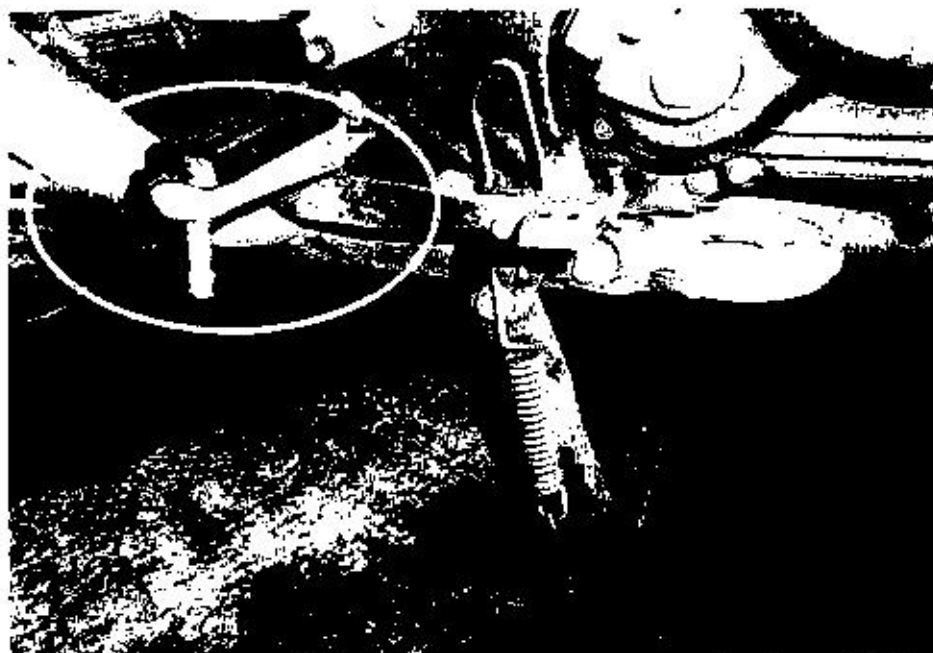
Photo 8 shows a close-up view of the minor damage on the foot rest of the Motorcycle due to the accident collision.

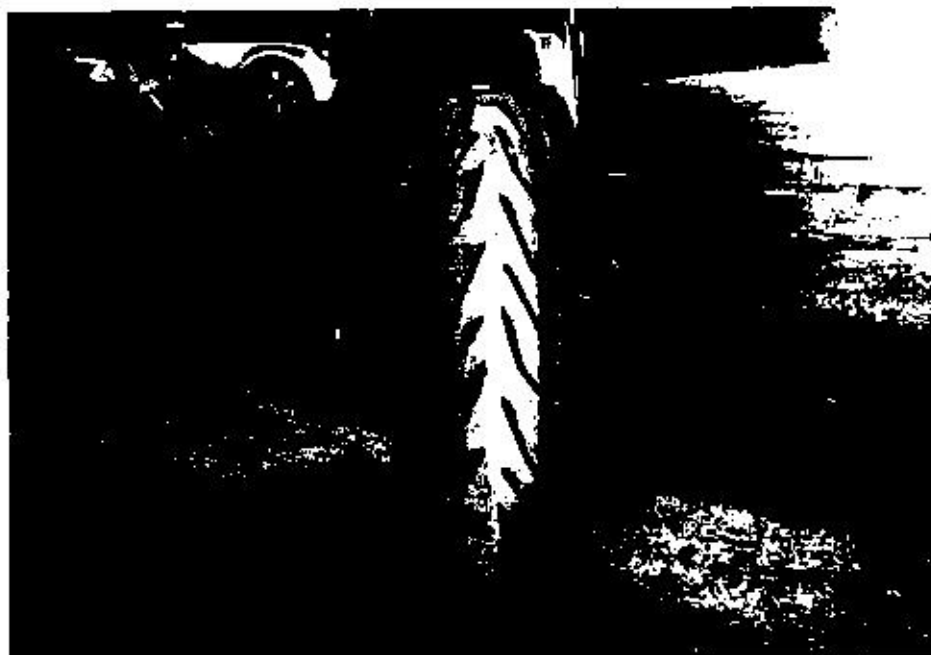
Photo 11 shows the front tyre of the Motorcycle. There was no tear, burst mark(s) and/or punctured hole(s) on the sidewalls as well as across the tread of the front tyre.

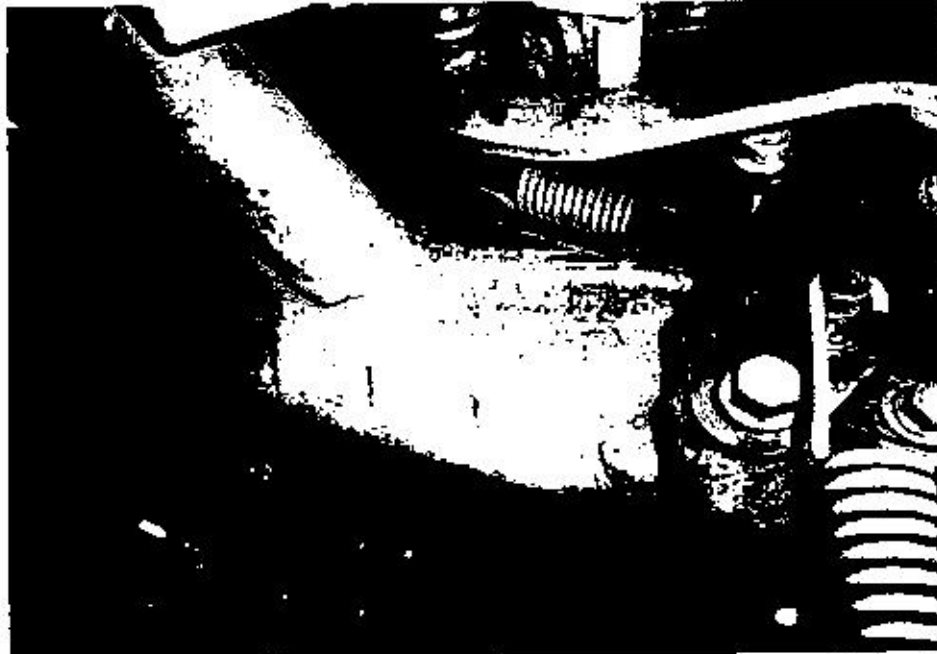
Photo 13 shows the engine area view. There was also no sign(s) or indication(s) of fluid leak observed around the engine area of the Motorcycle.

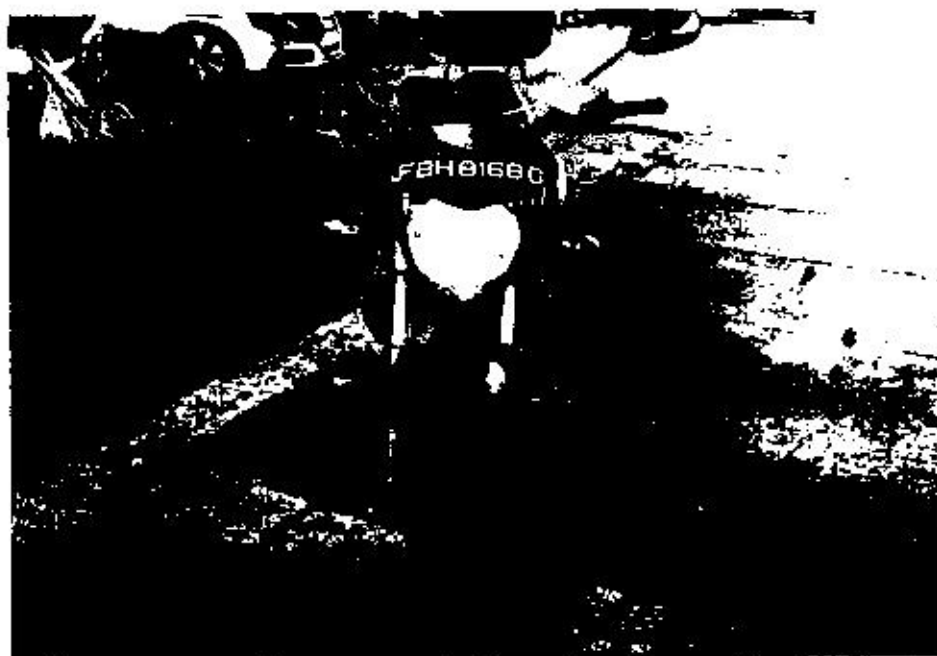
11. For this case, we were not able to conduct any test(s) on the steering system of the Motorcycle due to the damage on its front fork. Its front fork assembly was observed to be bent slightly to the left as a result of the accident.

Photo 16 shows the front fork was observed to have sustained with minor misalignment as a result of the accident. Hence, we are not able to conduct any tests on the steering system of the Motorcycle.

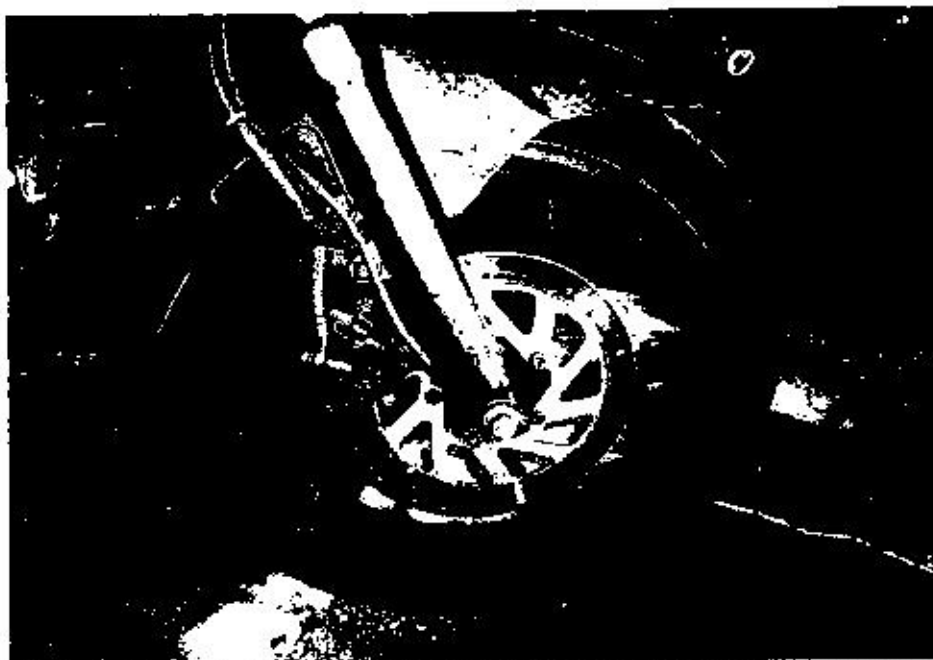
Photo 17 shows the front brake calliper, front brake disc and front brake hose of the Motorcycle (arrowed), which are all part of the components in the front brake system of the Motorcycle. Our visual checks of these various components had revealed all to be intact with no visible damage. No leakage of brake fluid was also observed.
