Your Ref: TP/IP/02637/2018
Our Ref : CI/TPD18008886/Z

Fatal Accident Investigation Team
Traffic Police Department
Singapore Police Force
10 Ubi Avenue 3
Singapore 408865

MECHANICAL INSPECTION REPORT OF MOTOR CAR SJZ 1297Z

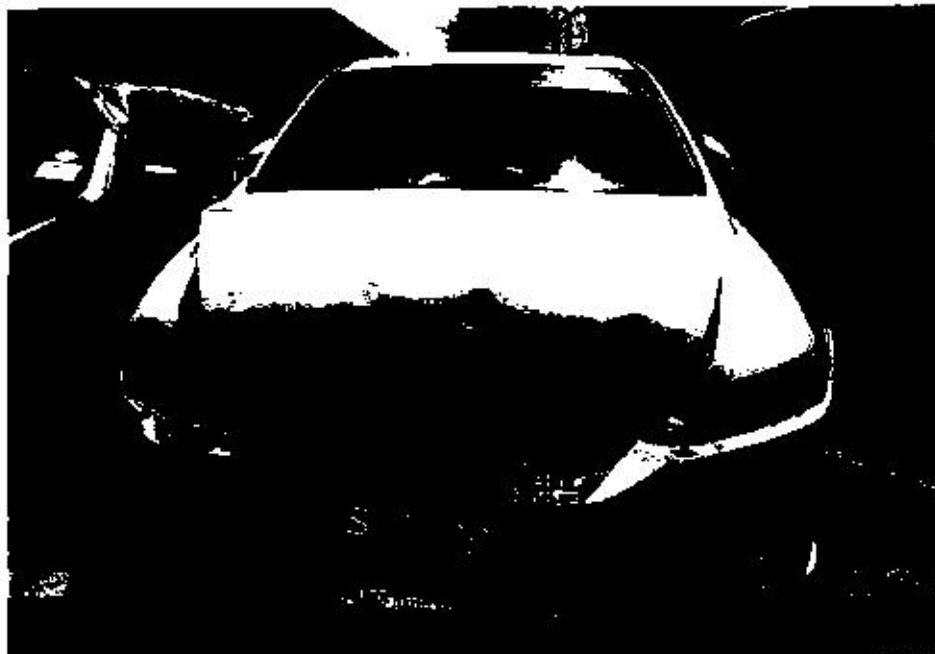
Photo 1 shows a general view of the frontal portion of the Motor Car at the time of our inspection. The Motor Car was observed to have sustained extensive impact damage at its frontal portion. The impact force was significant, causing the various parts and components inside the engine compartment to be damaged.

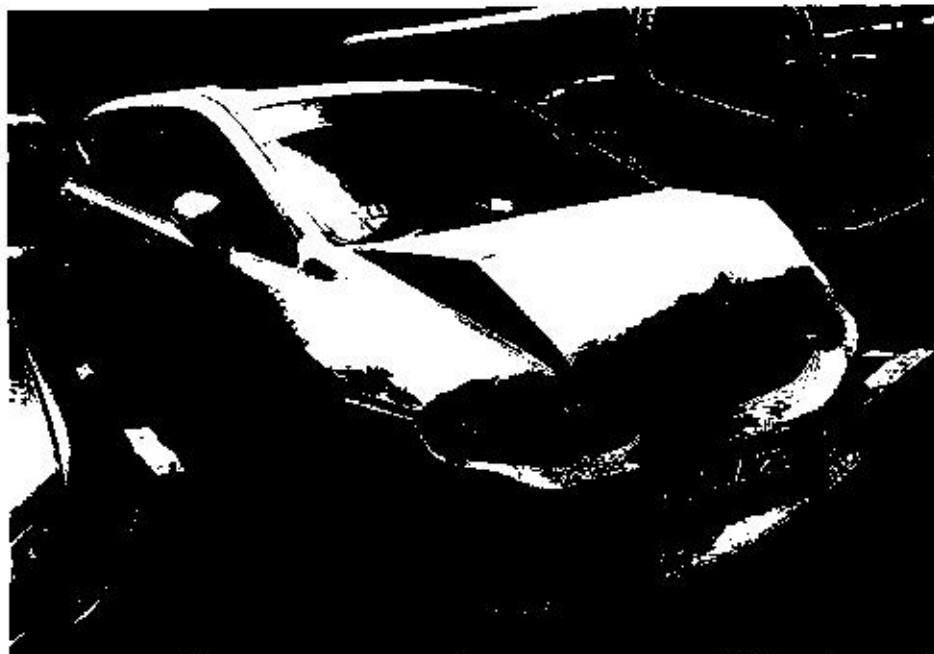
Photo 2 shows a general view of the front right portion of the Motor Car at the time of our inspection. The Motor Car was observed to have sustained extensive impact damage at its front right portion.

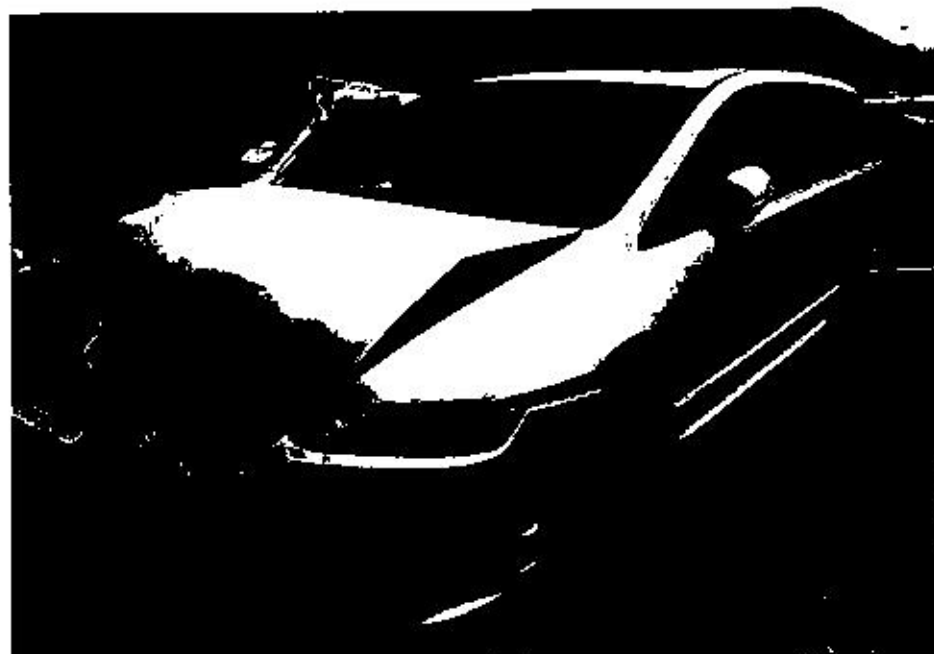
Photo 3 shows a general view of the front left portion of the Motor Car at the time of our inspection. The Motor Car was observed to have sustained extensive impact damage at its front left portion.

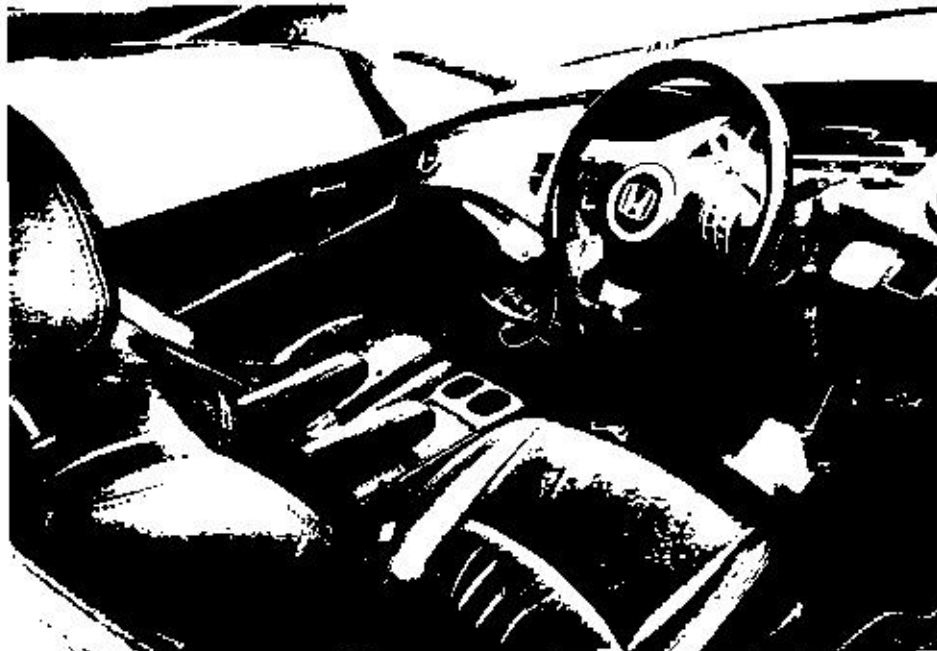
Photo 8 shows the interior portion of the Motor Car. The impact force did not affect the interior portion.

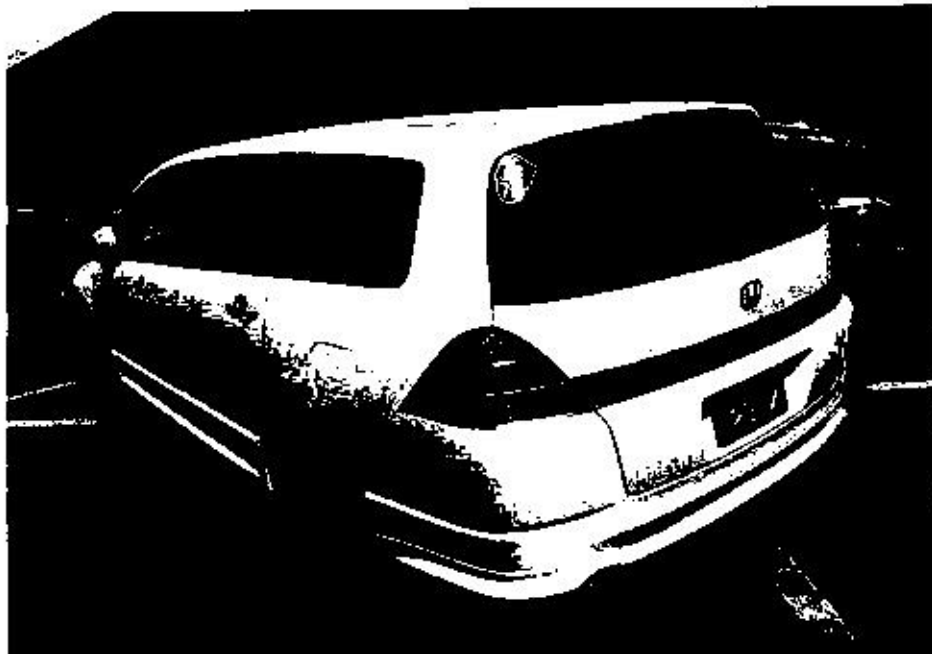
Photo 9 shows a general view of the rear left portion of the Motor Car at the time of our inspection. The rear portion was observed to be relatively unaffected by the accident.

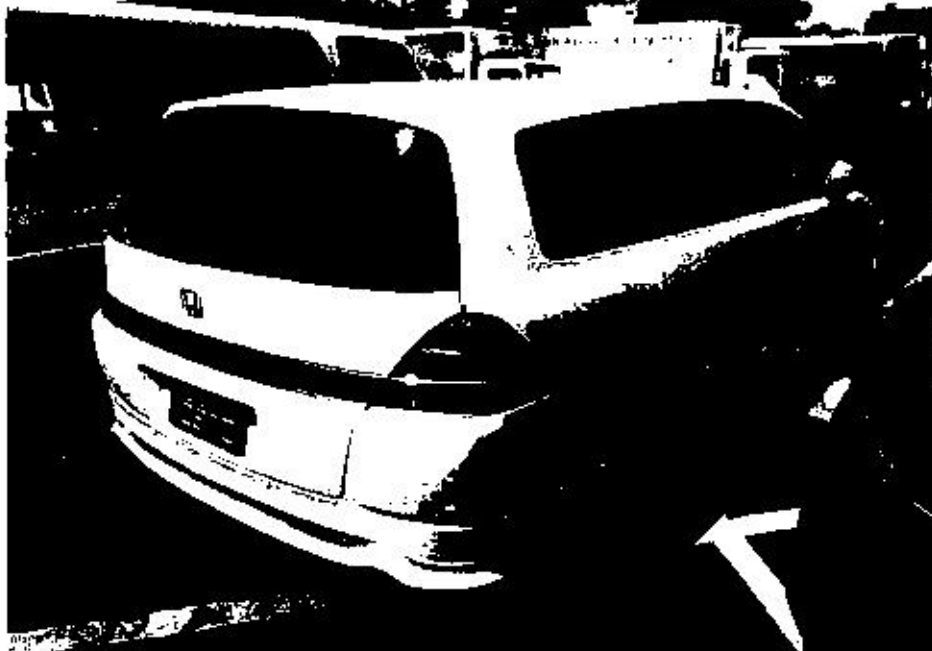
Photo 10 shows a general view of the rear right portion of the Motor Car at the time of our inspection. The rear portion was observed to be relatively unaffected by the accident.

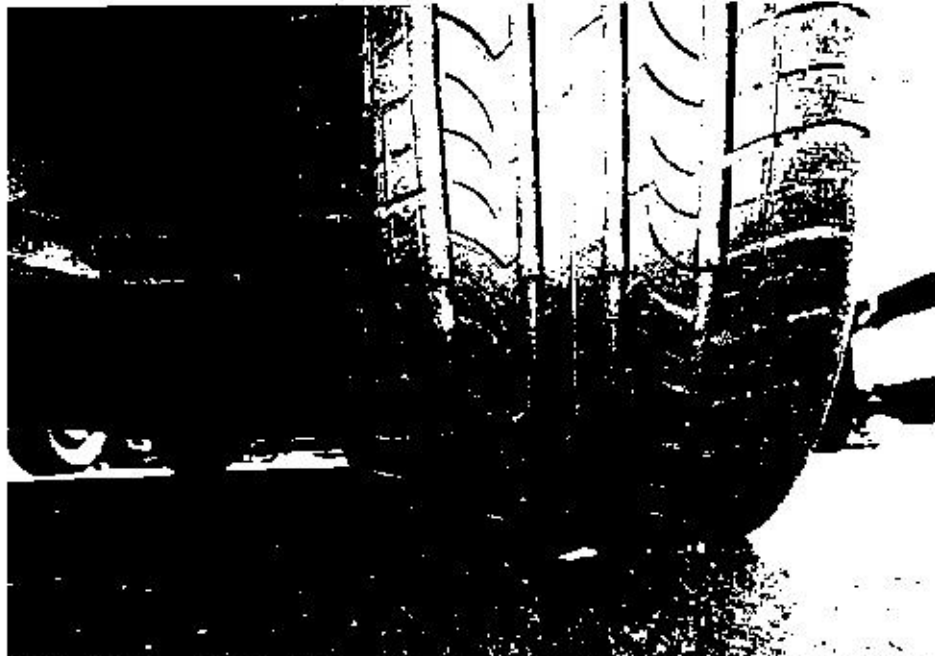
Photo 12 shows the condition of the front left tyre of the Motor Car, which was observed to be in serviceable condition with remaining tread depth of approximately 8mm. There was no tear, cut or burst mark(s) on the outer and the inner sidewalls as well as across the tread of this tyre, which was also sufficiently inflated for vehicular operation.
