## VEHICLE DAMAGE INSPECTION REPORT

Our File No: CC3/MSG18008887/SRBN2

Handling Insurer:	MSIG Insurance (Singapore) Pte. Ltd.	Policy No:	P4022801DMV
Claimant Vehicle No :	SMB47B	Insured Vehicle No :	SKU3889S
Date of Loss:	05/05/2018	Nature of Claim:	TP
		Claim No:	557752

Reg No:	SMB47B	Engine No:	45796600148842
Make & Model:	MERCEDES-BENZ OC500LE1830H, 12.0 D (A)	Chassis No:	WEB63442021000119
Reg. Date:	18/12/2008 (Man. Year: 2008)	Odometer:	0 km
Colour:	Multi-colour		
Engine Capacity:	11967 cc		
Market Value/New Car Price:	N/A		
Sum Insured (\$\$):	Market Value/New Car Price

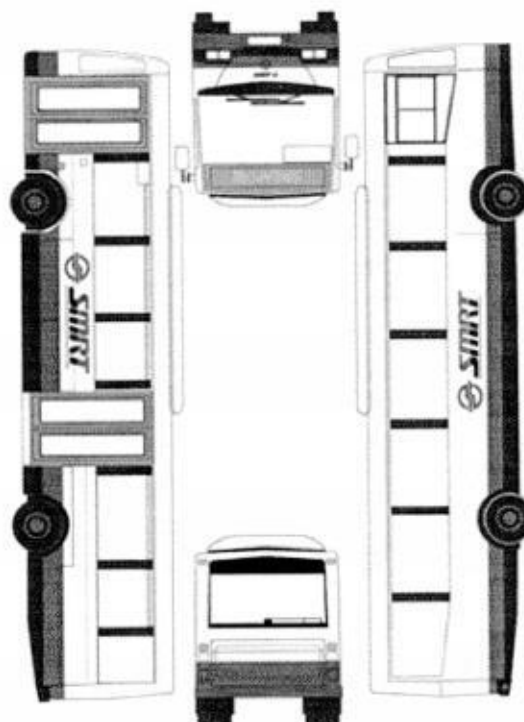
Reg. No : SMB47B  
 Ref. No : BUS/05/18/1003  
 Reg. Date : 10/05/2018  
 Vehicle Type : BUS -12M  
 Make : MBOC500 (MERCEDES)  
 Model : MERCEDES MBOC500  
 Name of Driver : He Dengke  
 Type of Accident : SIDE SWIPE  
 Date / Time of Accident : 05/05/2018 02:21:00 PM  
 Accident Reported Date / Time : 07/05/2018 12:00:00 AM  
 Surveyor is Required? : Yes  
 Survey by : MSIG  
 Vehicle is Towed Back? : No  
 Towed Back Date/Time :  
 Replacement Vehicle issued? : No  
 Accident Repair Job Card No :  
 Special Instruction to ARC,if any :  
 SMB47B - RIGHT FRONT PORTION  
 SKU3889S (TP) - INSURED WITH MSIG  
 Prepared Date : 10/05/2018 12:40:33 PM

- Lump Sum Repair  
 - Photo After Paint

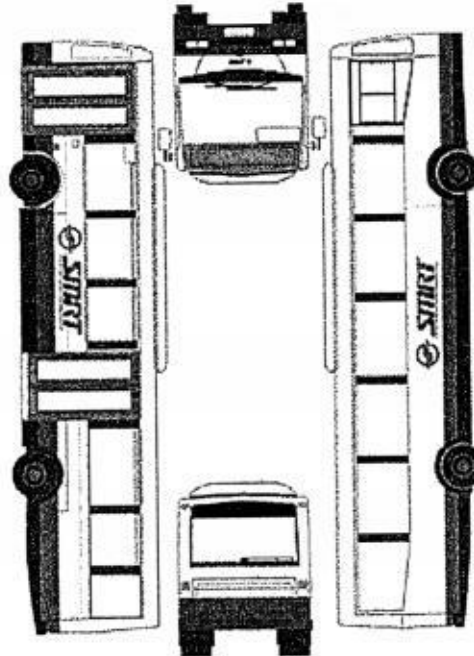
Reg. No : SMB47B  
Ref. No : BUS/05/18/1003  
Reg. Date : 18/12/2008  
Vehicle Type : BUS -12M  
Make : MBOC500 (MERCEDES)  
Model : MERCEDES MBOC500  
Name of Driver : He Dengke  
Type of Accident : SIDE SWIPE  
Date / Time of Accident : 05/05/2018 02:21:00 PM  
Accident Reported Date / Time : 07/05/2018 12:00:00 AM  
Surveyor is Required? : Yes  
Survey by : MSIG  
Vehicle is Towed Back? : No  
Towed Back Date/Time : 01/01/2000  
Replacement Vehicle issued? : No  
Accident Repair Job Card No : 000024096024  
Special Instruction to ARC, if any :  
SMB47B - RIGHT FRONT PORTION  
SKU3889S (TP) - INSURED WITH MSIG  
Prepared Date : 10/05/2018 12:40:33 PM
