Your Ref : 558307
Our Ref : CS/MSG18008900/N

7 September 2018

**AUTOMOBILE TECHNICAL INVESTIGATION REPORT OF ACCIDENT
INVOLVING SHD 9303B AND YN 2522C ON 11 MAY 2018**

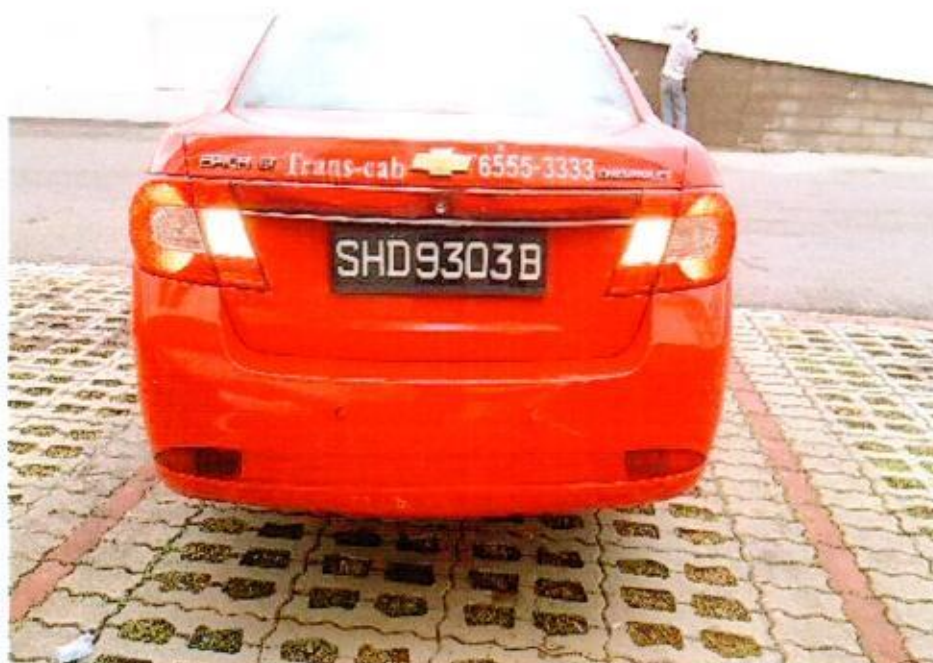
Photo 1 shows a general view of the rear portion of the Taxi at the time of reporting, which was taken the same day after the accident. Based on the circumstances of the case contained in the Singapore Accident Statement, we note that the Taxi had sustained damages to its rear portion.

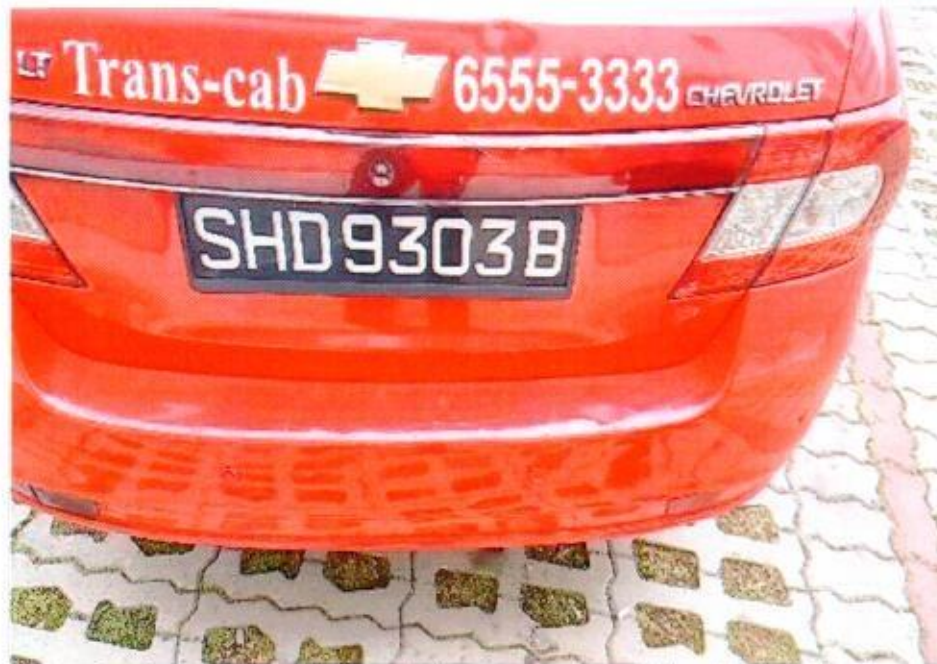
Photo 2 shows a closer view of the rear portion of the Taxi at the time of reporting, which was taken the same day after the accident. Based on the circumstances of the case contained in the Singapore Accident Statement, the damage to the Taxi was observed to be confined to its rear portion. However our review of the photographs showing the Taxi at the time of reporting did not produce any significant information as the photographs were all taken from afar, without any close up photographs of the damaged body parts at the rear portion of the Taxi.

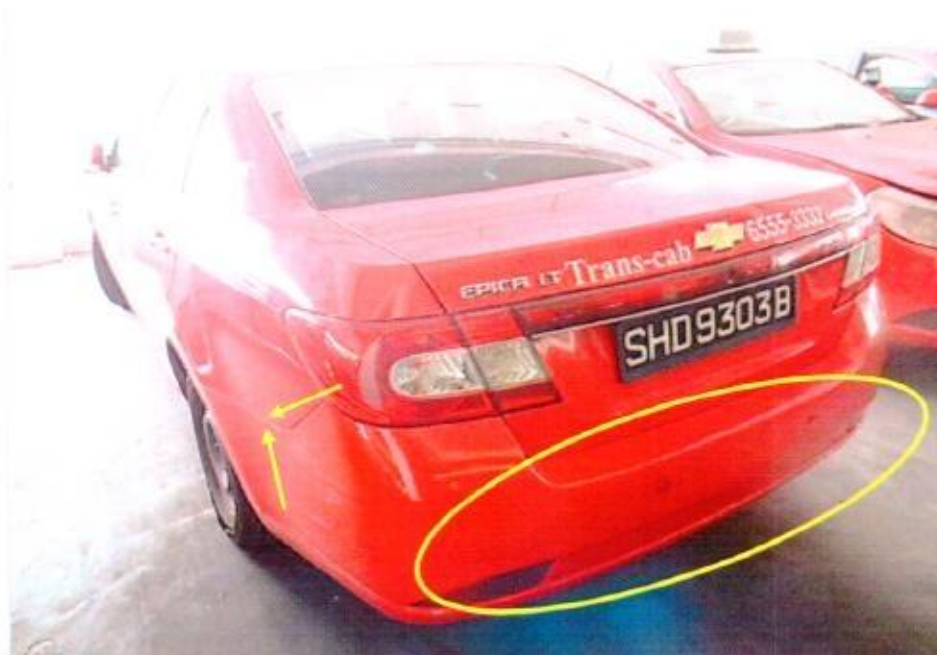
Photo 3 shows a left view of the rear portion of the Taxi at the time of the Pre-Repair Survey conducted by LKK Auto Consultants Pte. Ltd. taken 5 days after the accident. The damages were concentrated at the lower left portion and the top portion of the rear bumper (circled). We did not observe any obvious misalignment at the left corner edges of the rear bumper (arrowed).

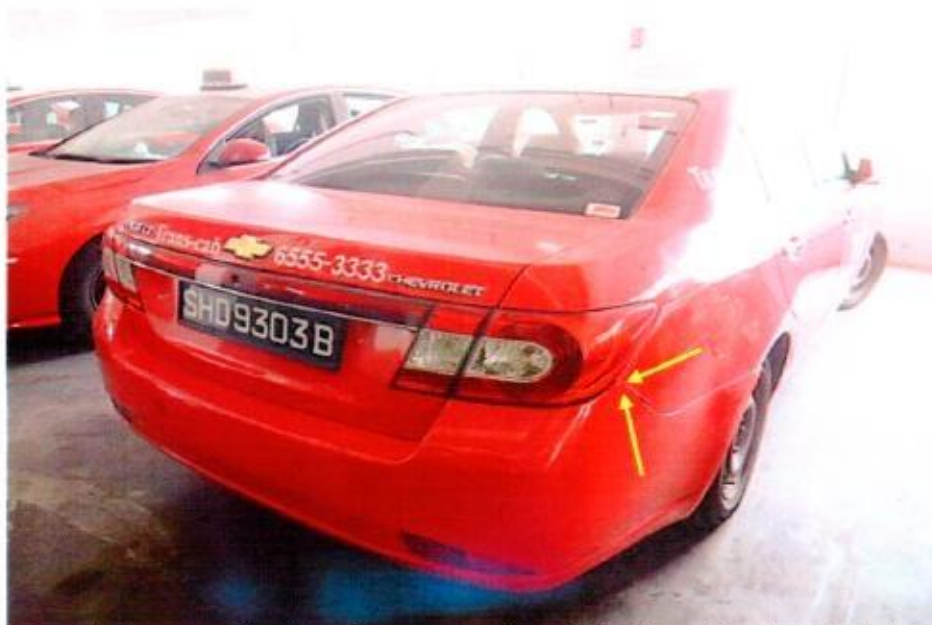
Photo 4 shows a right view of the rear portion of the Taxi at the time of the Pre-Repair Survey conducted by LKK Auto Consultants Pte. Ltd. taken 5 days after the accident. We did not observe any obvious misalignment at the right corner edges of the rear bumper (arrowed).

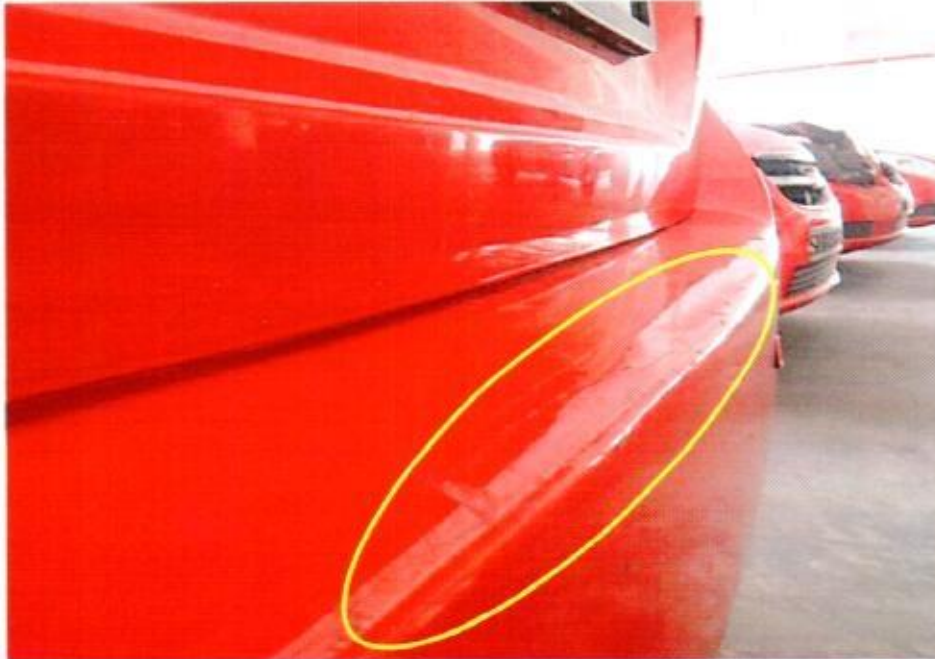
Photo 5 shows the paint cracks on the top portion of the rear bumper of the Taxi (circled).

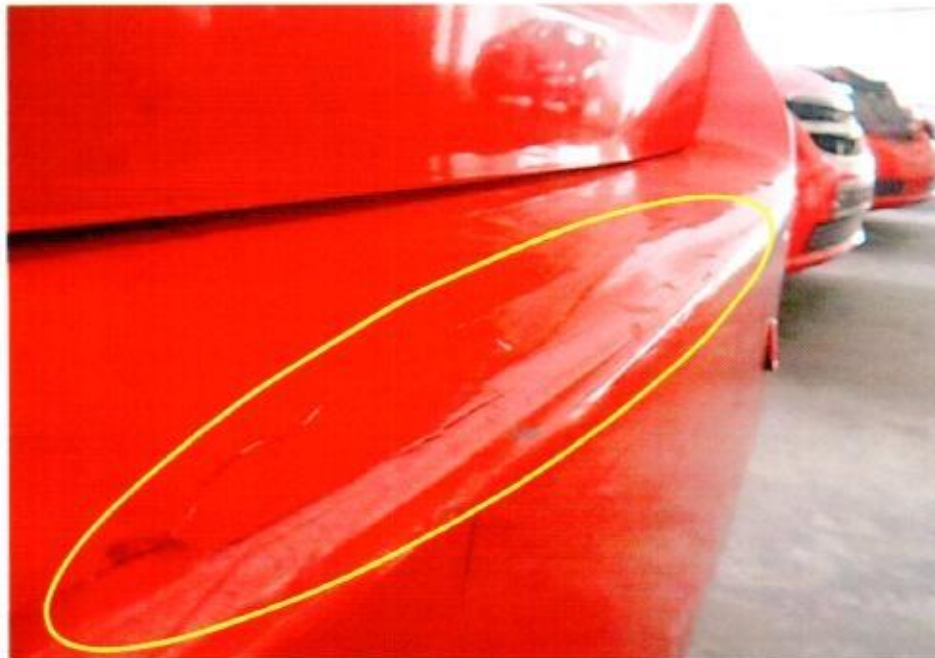
Photo 6 shows a close up view of the paint cracks on the top portion of the rear bumper of the Taxi (circled).

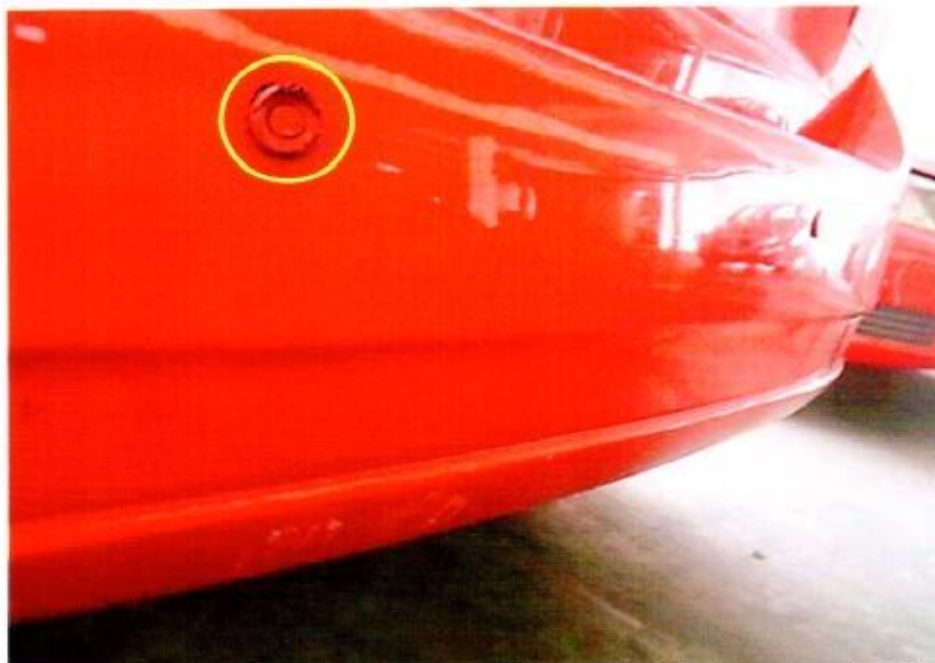
Photo 7 shows the left reverse sensor which was dislodged as a result of the rear bumper being pushed inwards (circled).

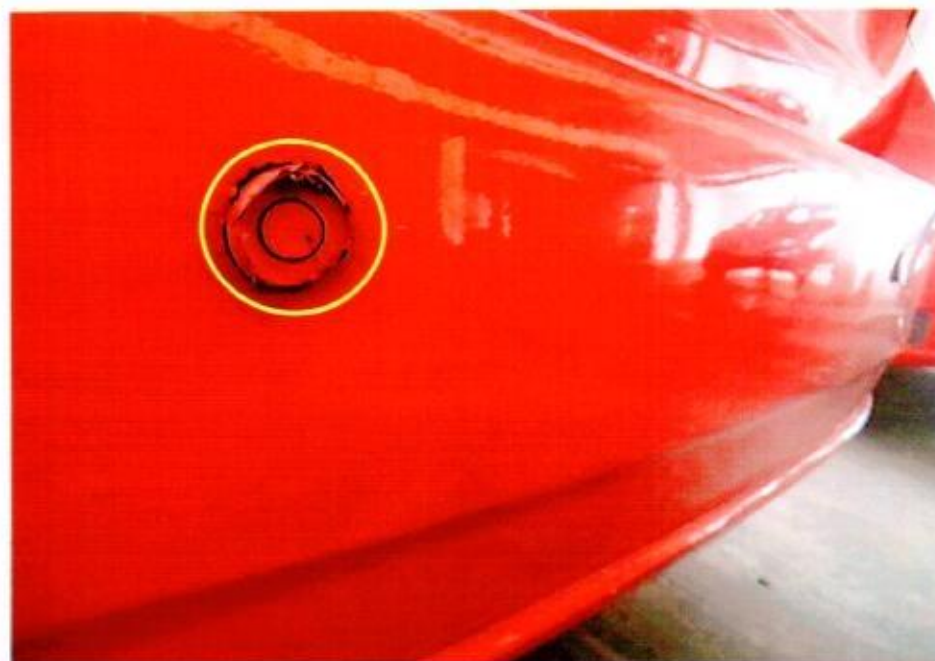
Photo 8 shows a close up view of the left reverse sensor which was dislodged as a result of the rear bumper being pushed inwards (circled).

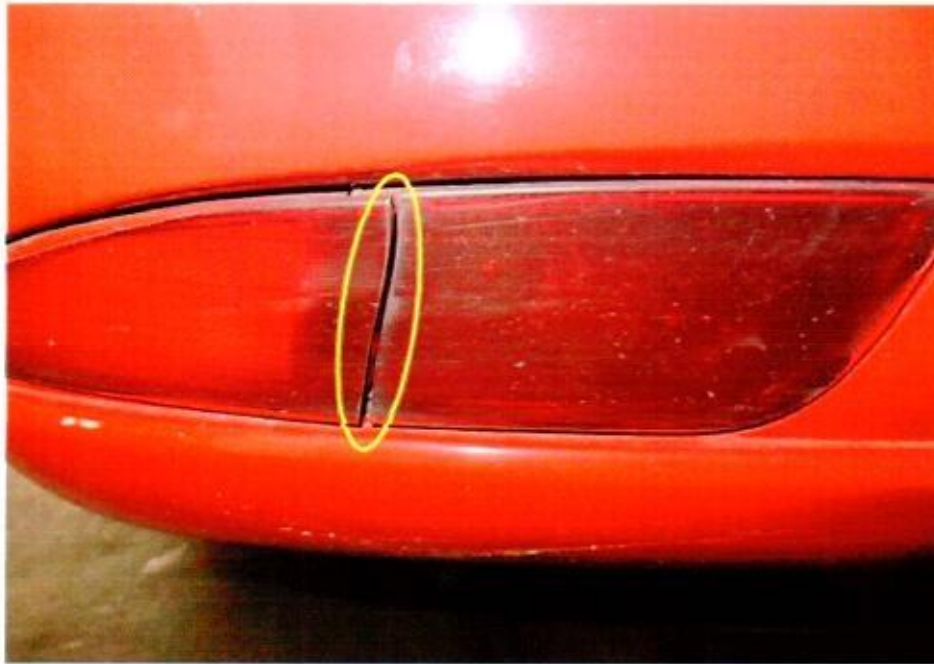
Photo 9 shows the cracked left reflector lamp of the Taxi (circled).

15. Firstly, the vertical crack on the left reflector lamp of the Taxi was caused by an object pressing onto the rear portion of the Taxi. If one was to consider the vertical dent on the lower left portion of the Lorry's front bumper, it would then appear that these dents were caused by the front bumper of the Lorry.

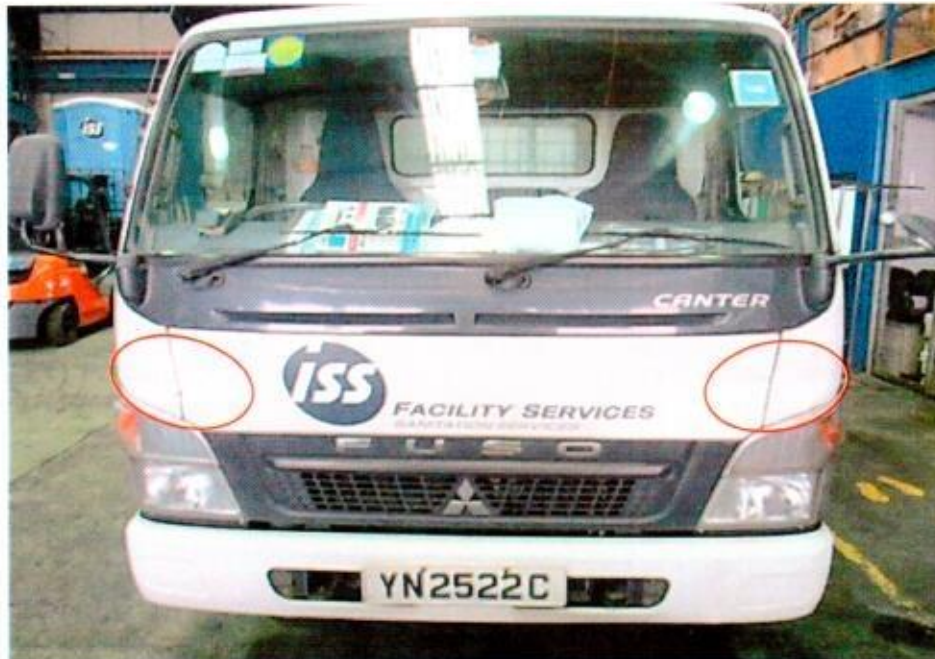
Photo 10 shows the general view of the front portion of the Lorry at the time of our physical inspection. We observed that the Lorry had sustained numerous damages on its front portion (circled) as a result of past accidents as mentioned by Mr Yew who was present during our physical inspection.

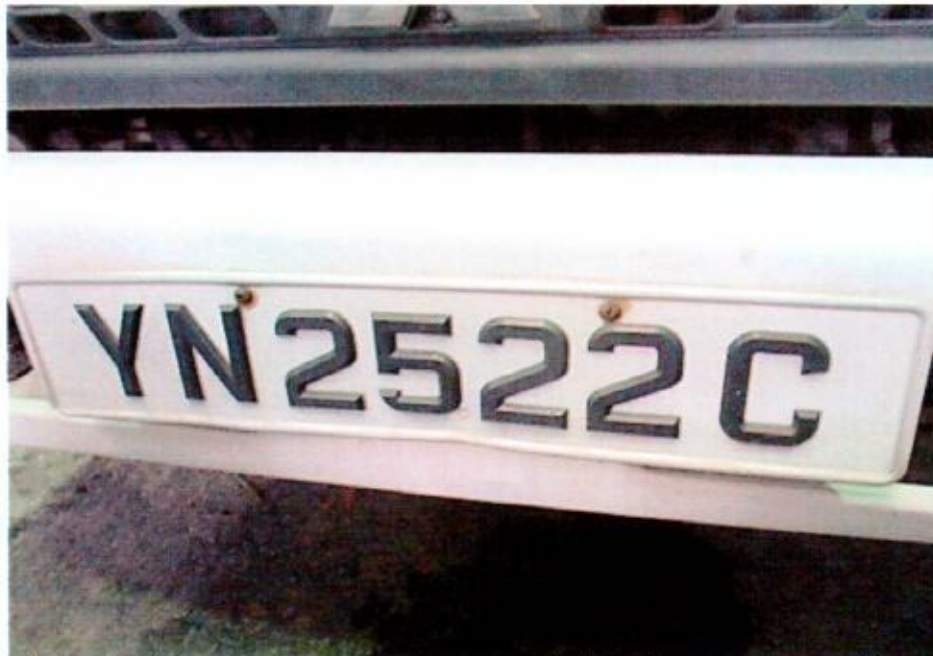
Photo 11 shows the Lorry's front number plate which was observed to be distorted.

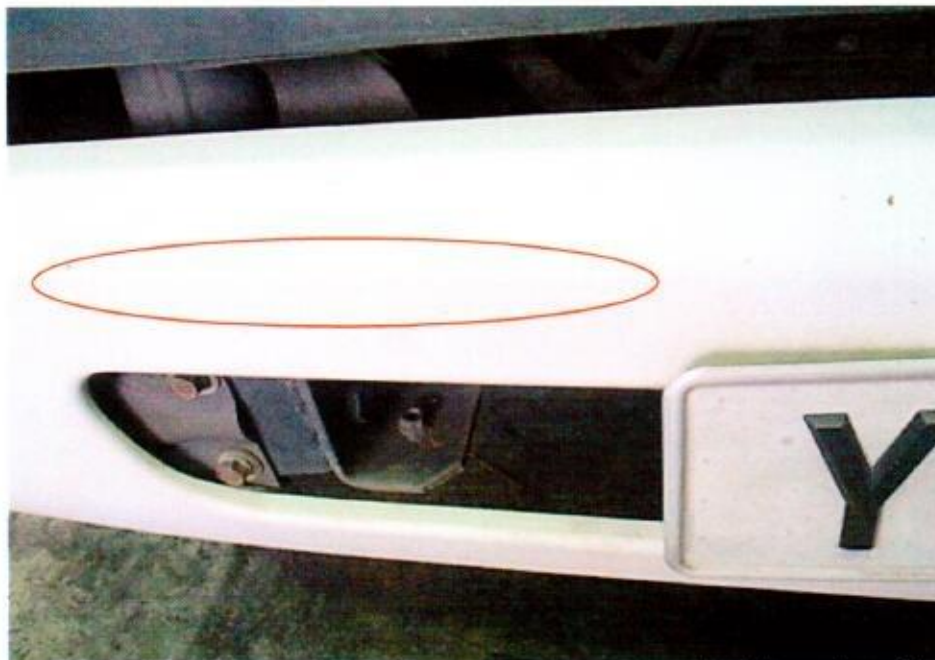
Photo 12 shows horizontal paint graze marks observed on the right portion of the Lorry's front bumper (circled).

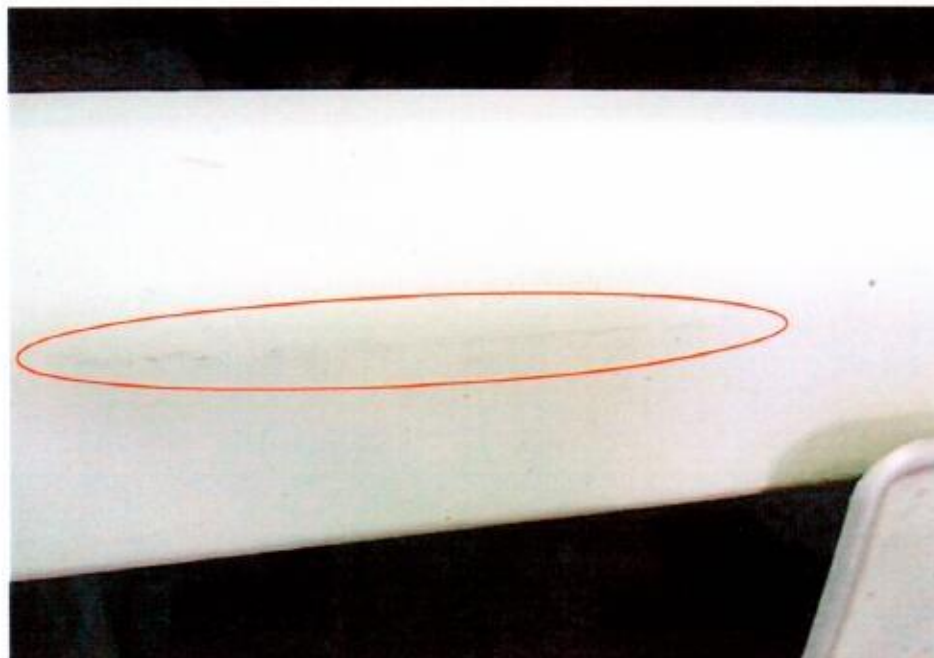
Photo 13 shows a close up view of the horizontal paint graze marks observed on the right portion of the Lorry's front bumper (circled).

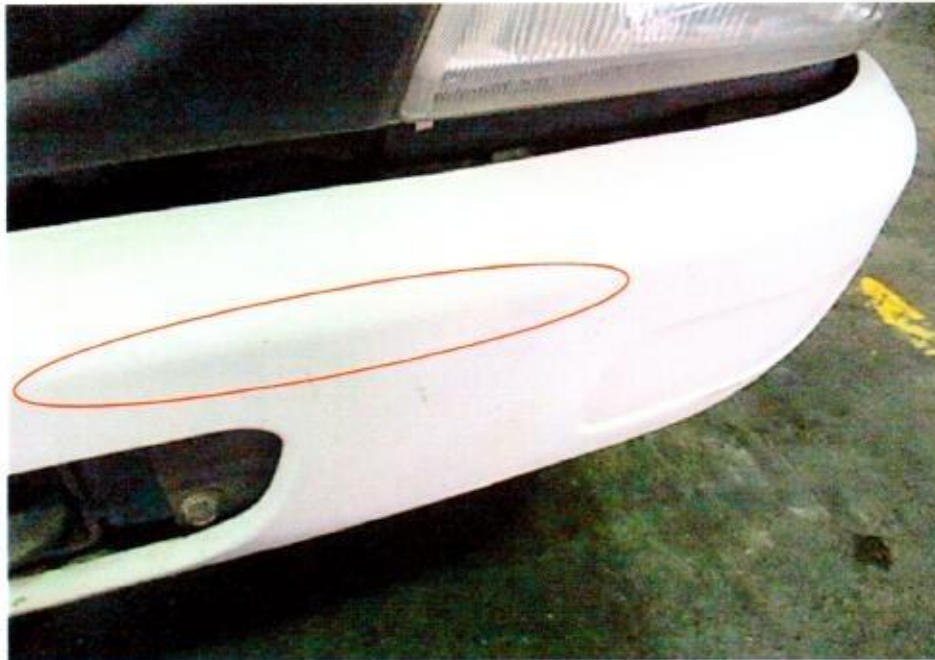
Photo 14 shows horizontal paint graze marks observed on the left portion of the Lorry's front bumper (circled).

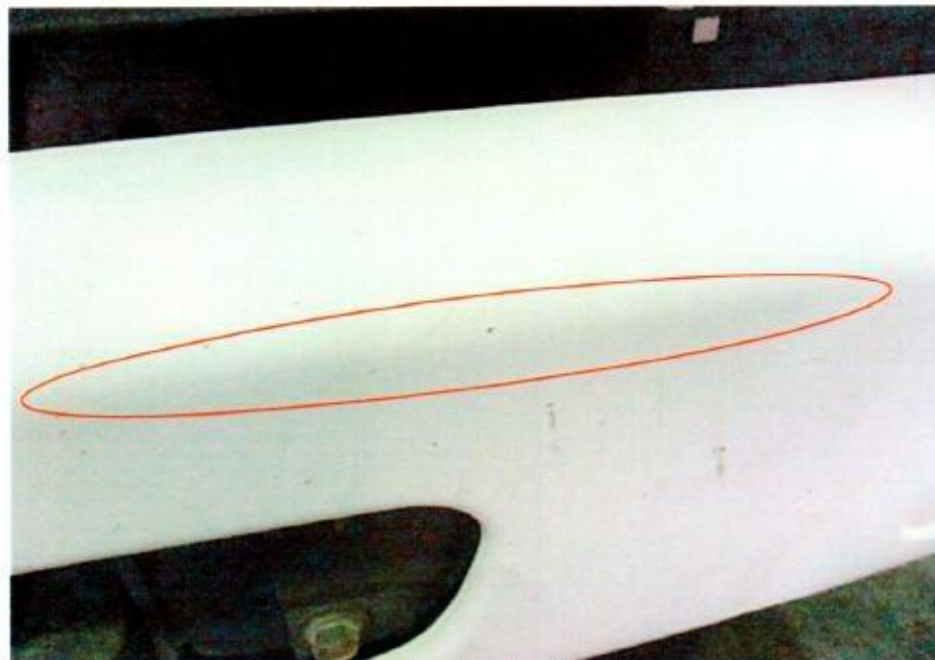
Photo 15 shows a close up view of the horizontal paint graze marks observed on the left portion of the Lorry's front bumper (circled).

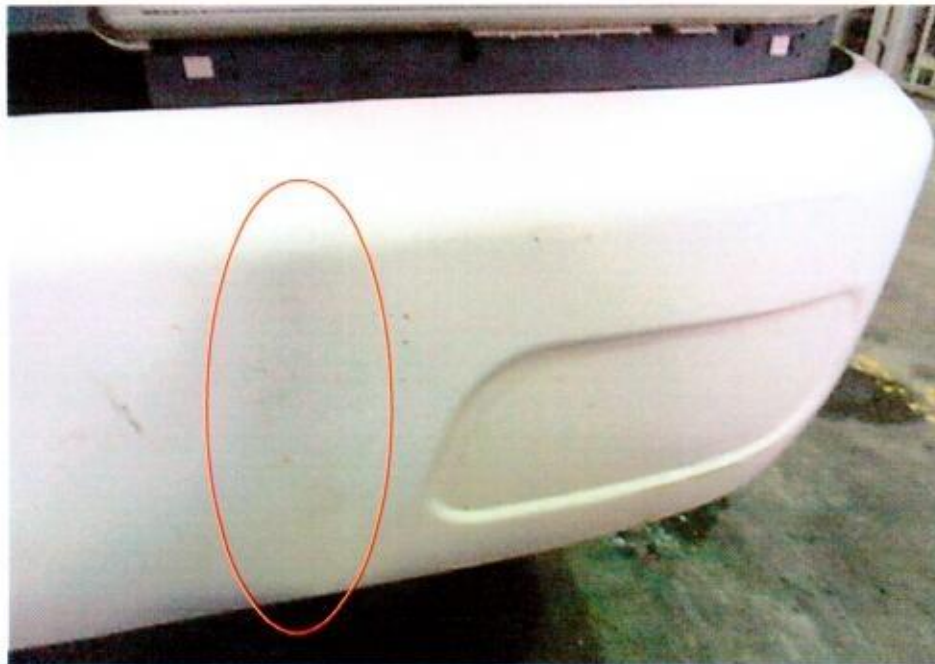
Photo 16 shows a closer view of the vertical dent found on the lower left portion of the Lorry's front bumper (circled).

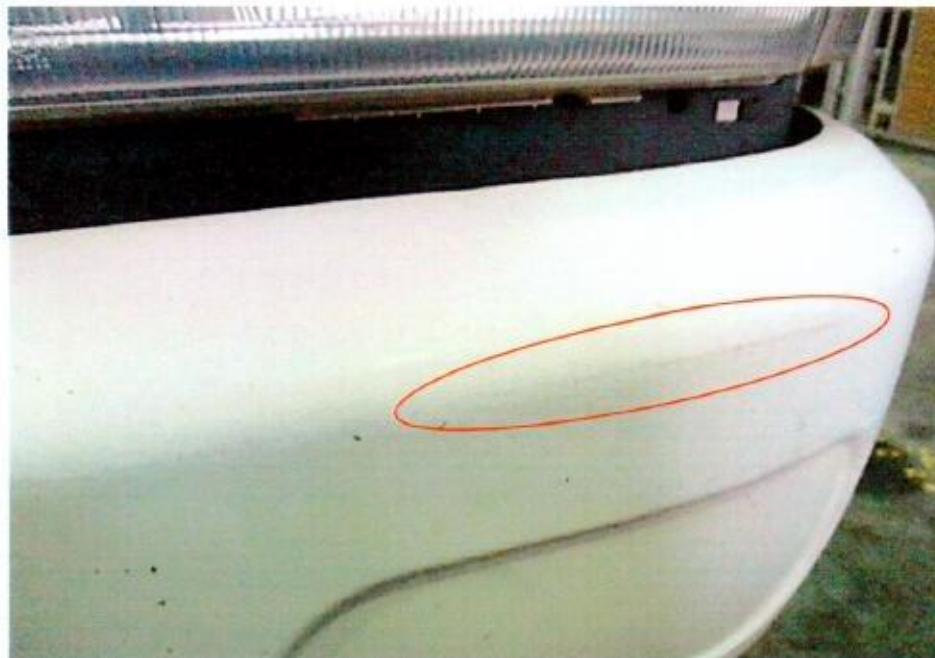
Photo 17 shows upon closer examination of the left portion of the Lorry's front bumper, we found faint red paint transfer marks (circled).

16. Secondly, the red paint transfer marks were found on the left portion of the Lorry's front bumper at the area directly above the vertical dent which was found on the lower left portion of the Lorry's front bumper, suggesting that there was contact between the Involved Motor Vehicles. See photos 19 - 22 below.

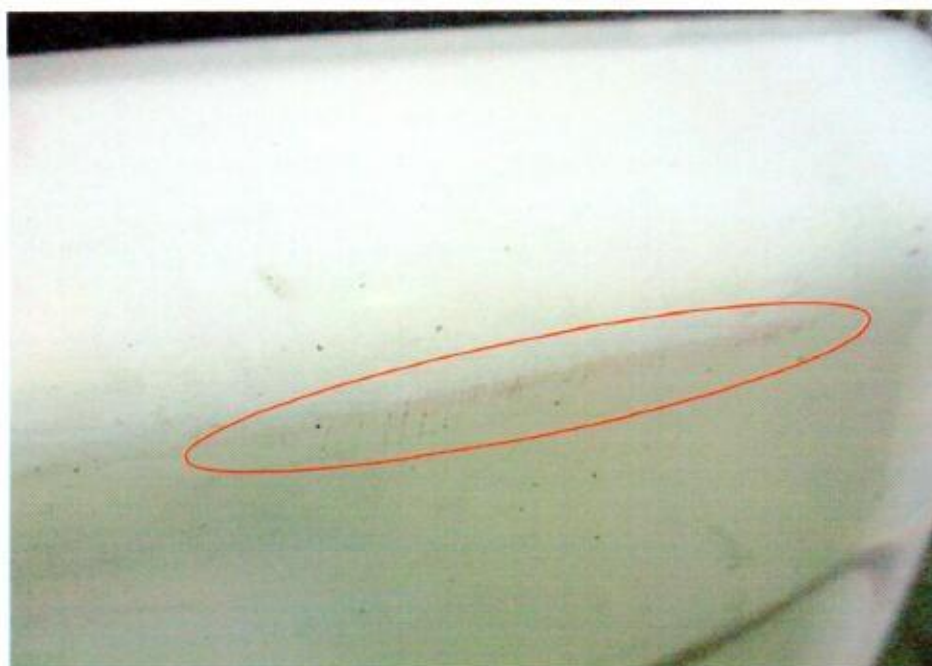
Photo 18 shows a close up view of the faint red paint transfer marks upon our closer examination of the left portion of the Lorry's front bumper (circled).

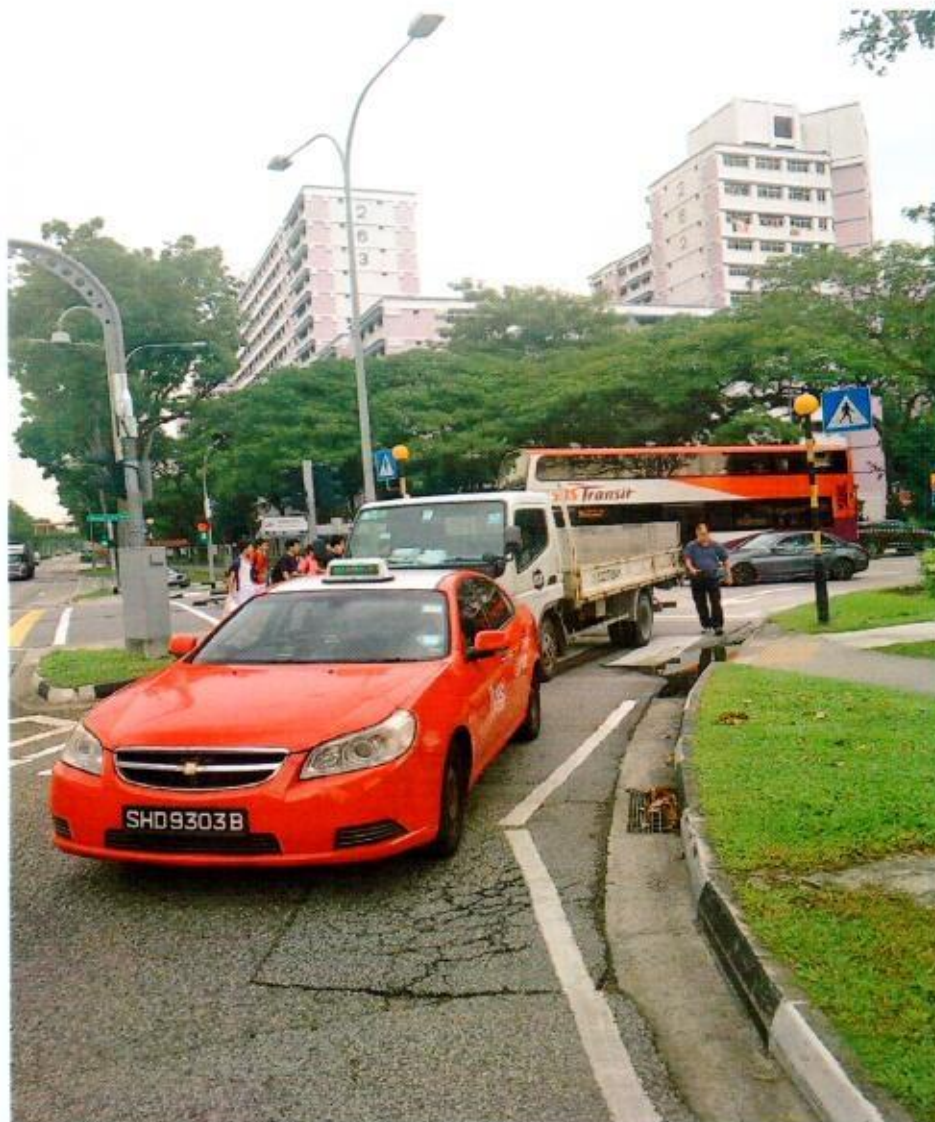
Photo 19 shows a front view of the position of the Involved Motor Vehicles after the accident. The Lorry was observed to be directly behind the Taxi.

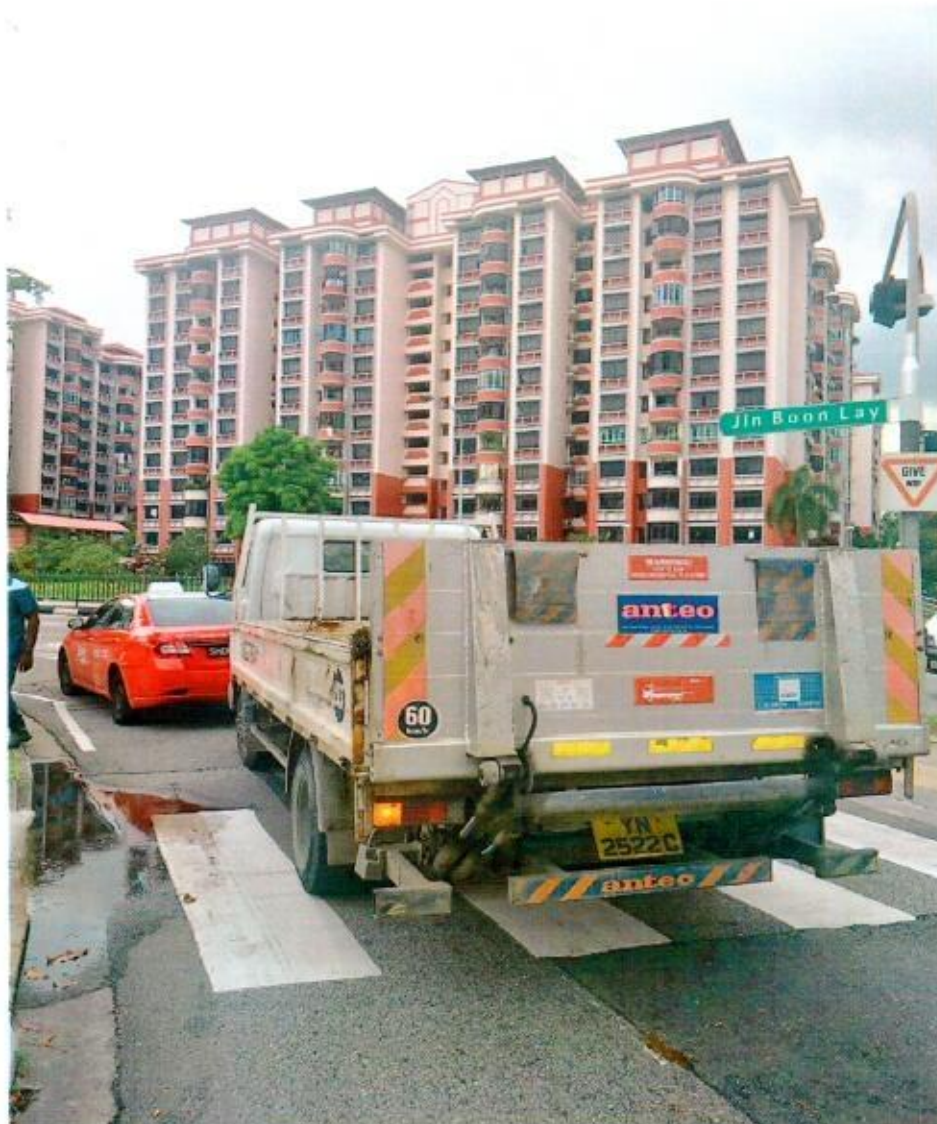
Photo 20 shows a rear view the position of the Involved Motor Vehicles after the accident. The Lorry was observed to be directly behind the Taxi.

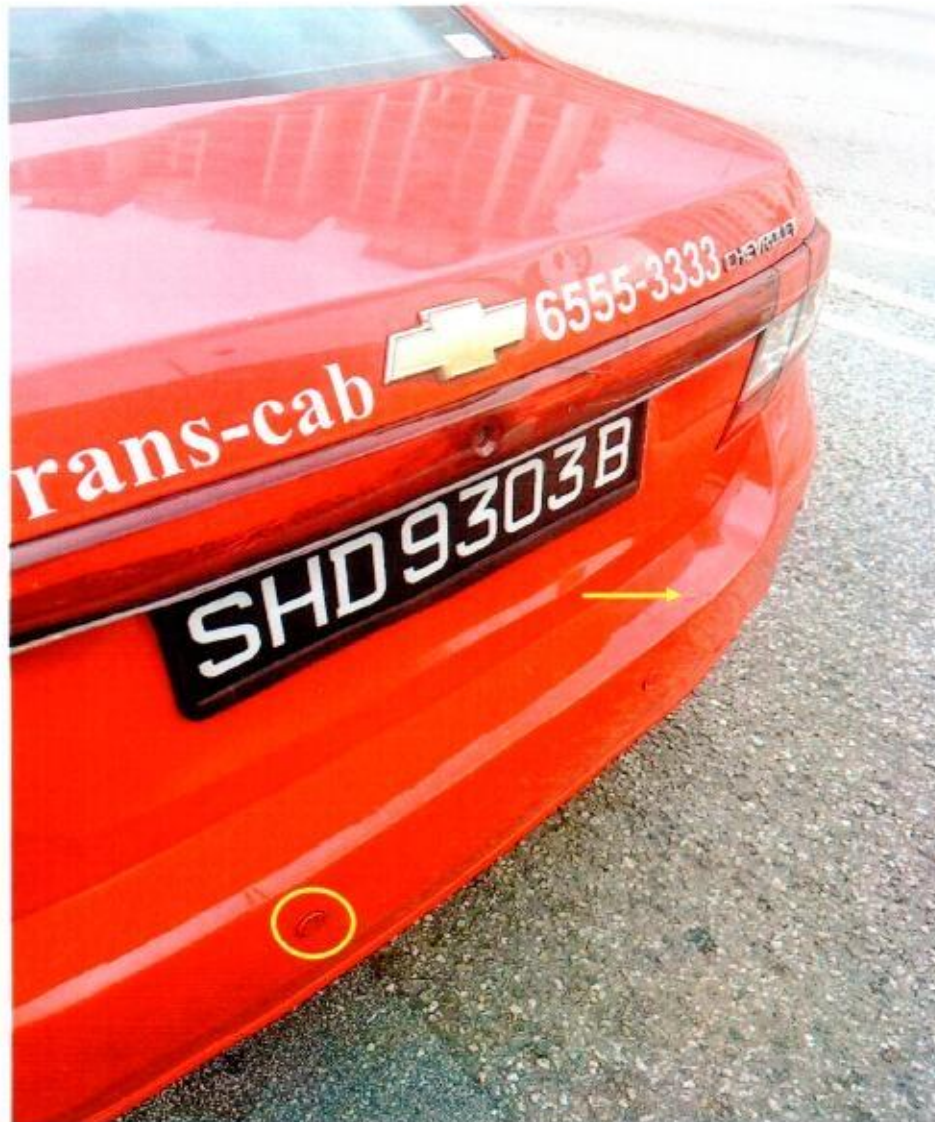
Photo 21 shows the rear portion of the Taxi post-accident. We observed the same paint cracks on the top portion of the Taxi's rear bumper (arrowed) as well as the dislodged left reverse sensor (circled).

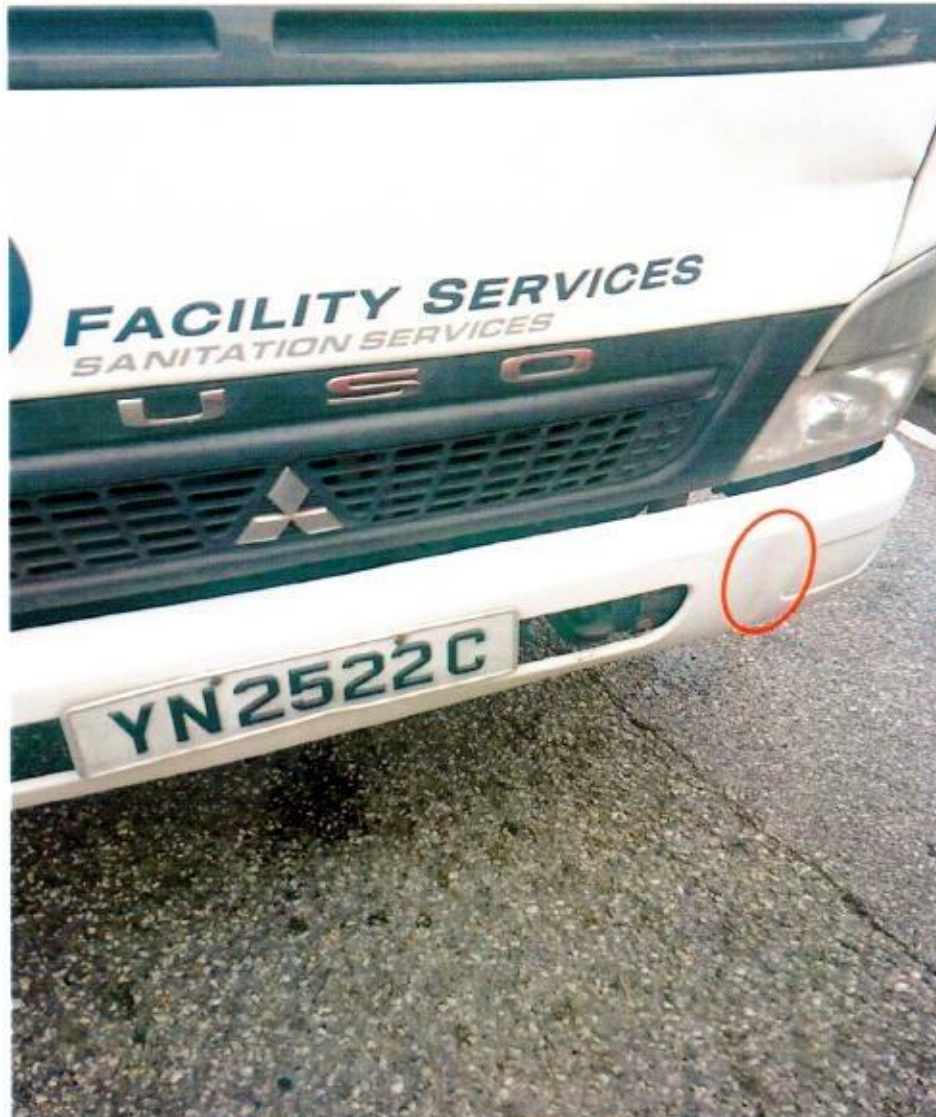
Photo 22 shows the front portion of the Lorry post-accident. We observed the same vertical dent on the lower left portion of the Lorry's front bumper (circled).

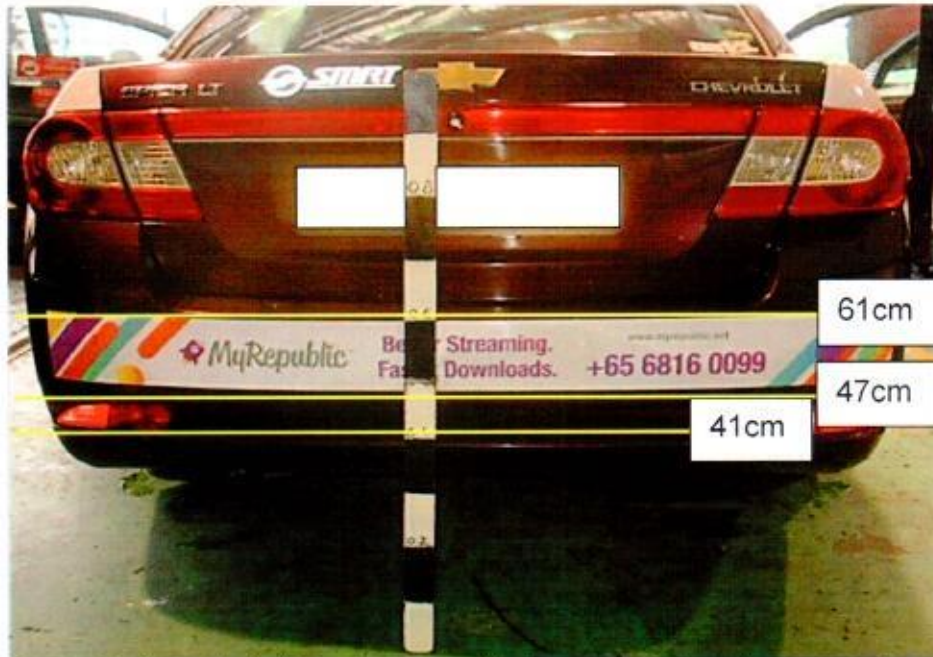
Photo 23 shows the height measurement being conducted on the rear portion of the Taxi (using a similar make and model). The height range above ground level of the Taxi's left reflector lamp where the vertical crack was found was measured to be approximately between 41cm to 47cm. The height above ground level of the top portion of the Taxi's rear bumper at the area where the paint cracks were found was measured to be approximately 61cm.

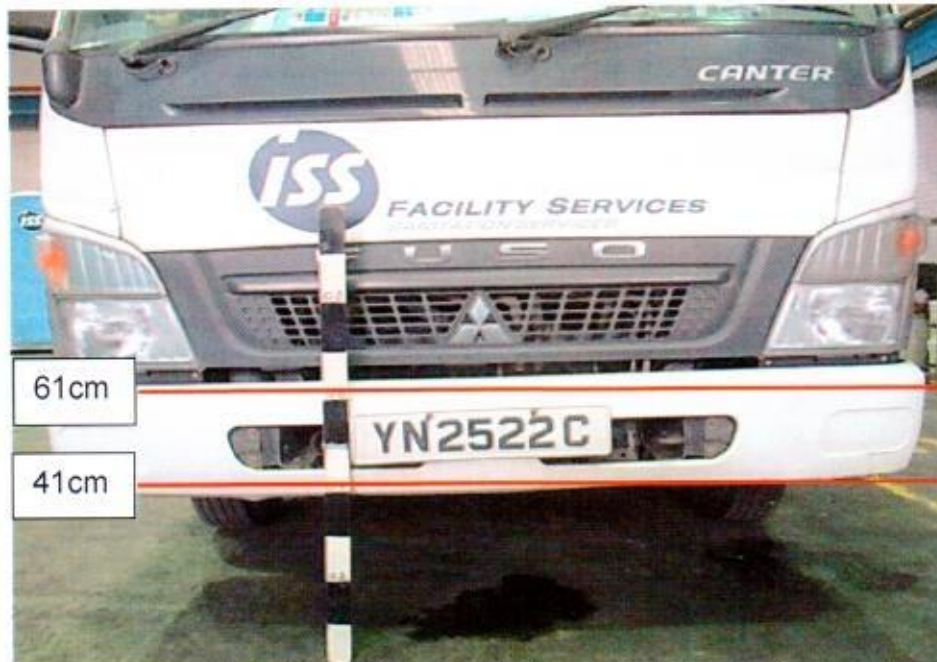
Photo 24 shows the height measurement being conducted on the front portion of the Lorry. The vertical dent found on the lower left portion of the Lorry's front bumper is within the 41cm to 47cm height range. The bodypart at 61cm above ground level was the left upper portion of the Lorry's front bumper which corresponded to the height of the red paint transfer marks found on the Lorry as well as the height of the paint cracks found on the top portion of the Taxi's rear bumper.
