Auto
Consultants
Pte Ltd

Your Ref: AN3163908
Our Ref : CS/AXA18008992/Z

**TECHNICAL INVESTIGATION REPORT OF FIRE INCIDENT INVOLVING THE
INSURED VEHICLE FBE 3832X ON 05th May 2018**

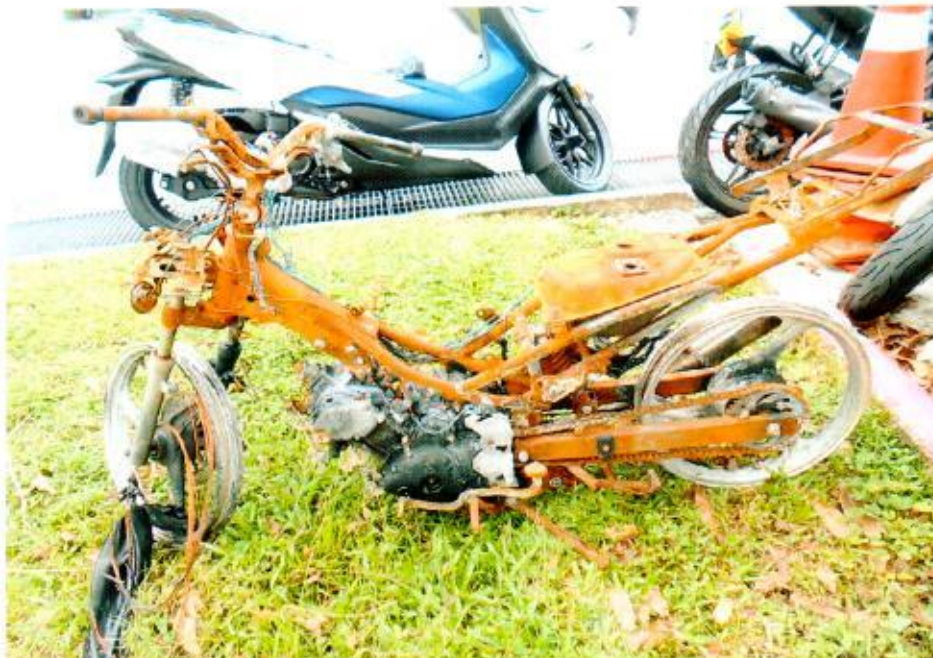
Photo 1 shows the left portion view of the Insured Vehicle at the time of our inspection. The Insured Vehicle was noted to have sustained fire damages that severely effected on the entire parts of the Insured Vehicle.

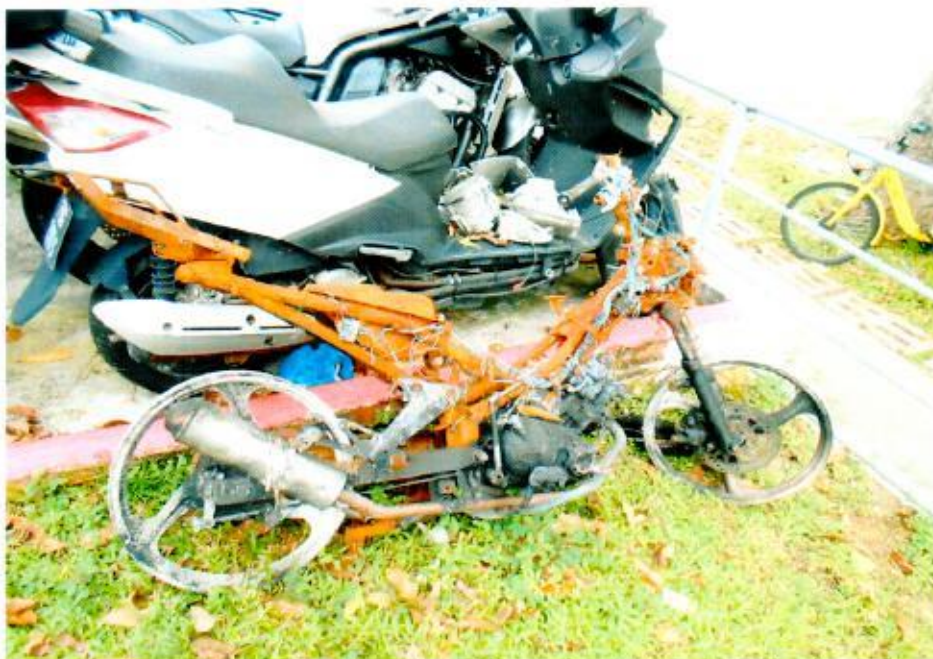
Photo 2 shows the right portion view of the Insured Vehicle at the time of our inspection. The Insured Vehicle was noted to have sustained fire damages that severely effected on the entire parts of the Insured Vehicle.

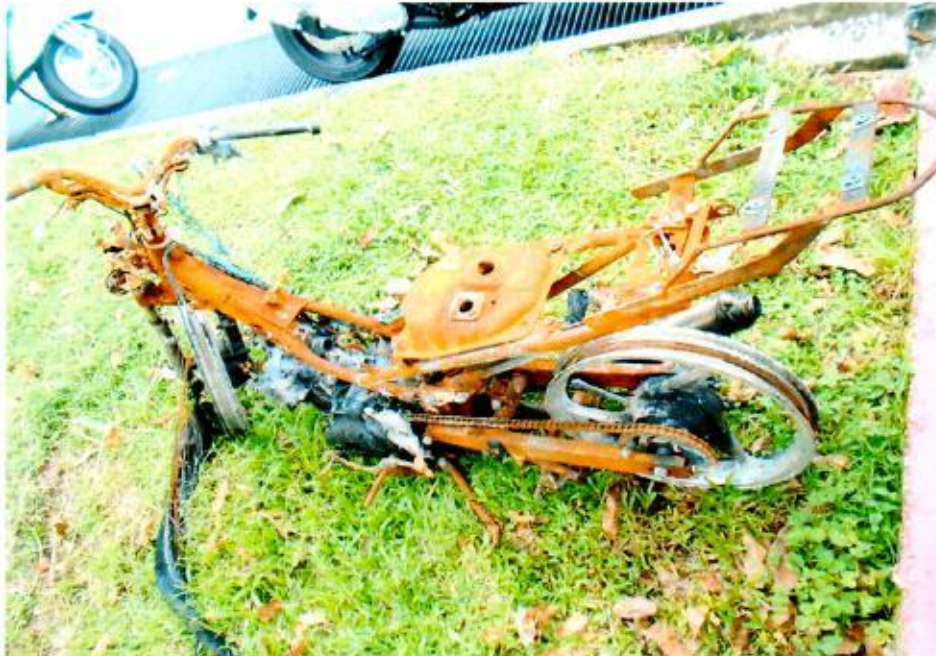
Photo 3 shows the rear left side of the Insured Vehicle at the time of our inspection. The Insured Vehicle was noted to have sustained fire damages that severely effected on the entire parts of the Insured Vehicle.

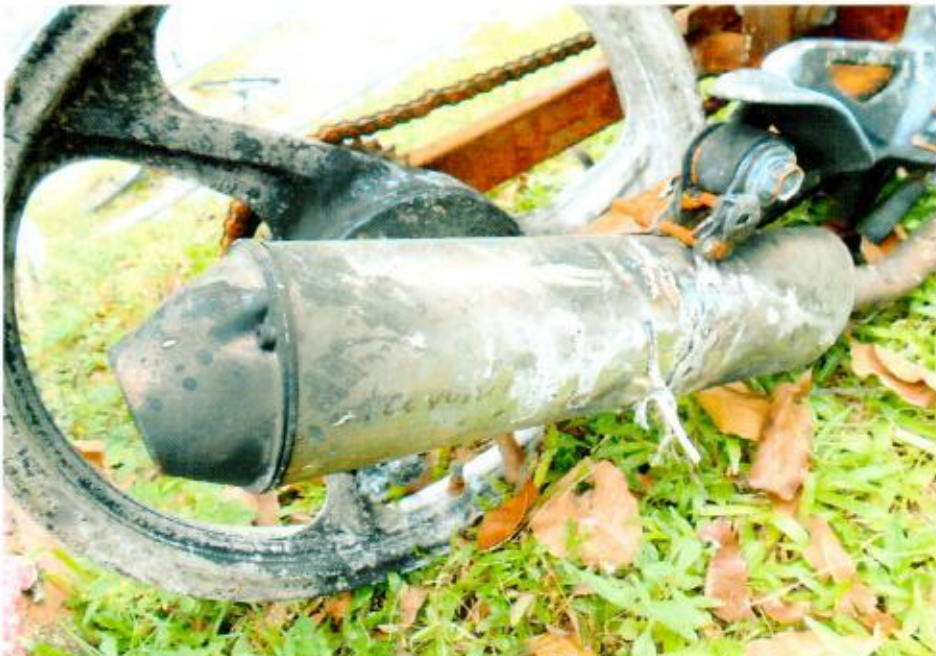
Photo 4 shows the after-market exhaust pipe. It was believe from manufacture called 'LeoVince'. It was said to be an approved LTA after-market exhaust pipe.

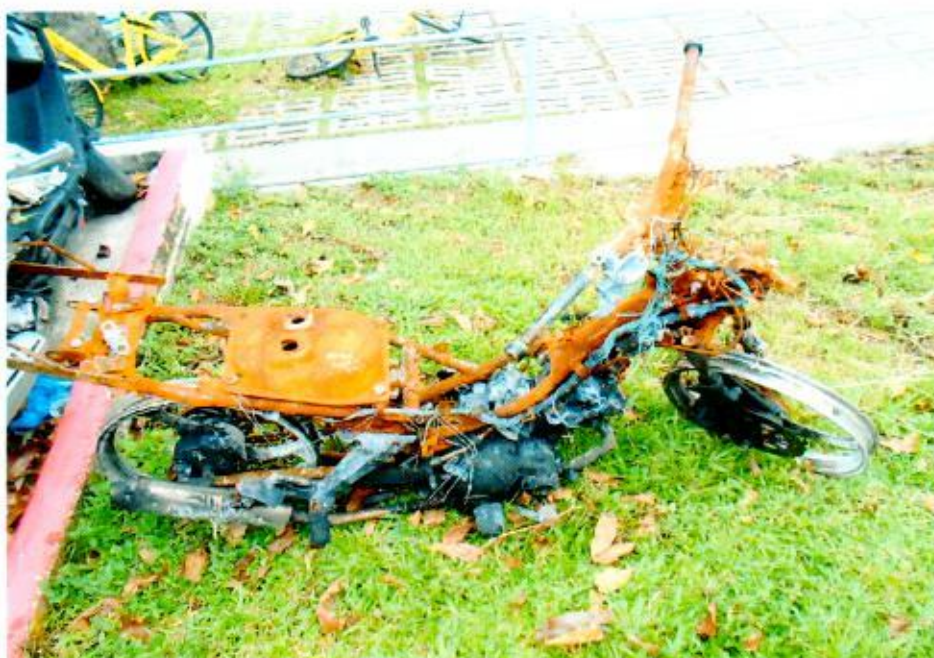
6. Rust would normally start to develop around areas soon after a fire as prolonged exposure to high heat intensity usually causes steel/metal material body parts to be exposed to natural environmental condition. The rust that had developed on the Insured Vehicle is an indication that it had sustained exposure to prolonged high heat intensity. See photo 5 below.

Photo 5 shows rust would normally start to develop around these areas soon after a fire as prolonged exposure to high heat intensity usually causes steel/metal material body parts to be exposed to natural environmental condition. The rust that had developed on the Insured Vehicle is an indication that it had sustained exposure to prolonged high heat intensity.

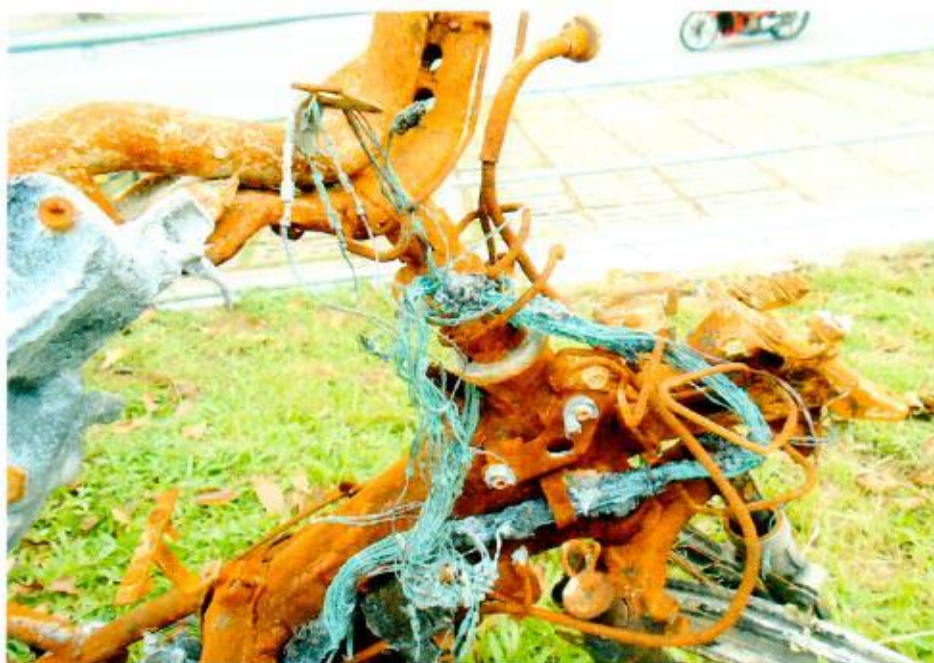
8. Upon closer examination of the area around the body structure of the engine compartment, which was in the immediate vicinity of where the fire to the Insured Vehicle had likely started, we had found several stretches of wiring burnt internally to its bare copper state. The wirings were likely to be the original engine wire harness. Such condition normally indicate internal heating of copper wires which is a sign of an electrical short circuit occurring. A greenish residual on the wires also indicated the focal point of where the area fire had ignited. This would then appear to suggest that the cause of fire to the Insured Vehicle could have possibly been due to electrical in nature. See photo 6 & 7 below.

Photo 6 shows the front portion of the Insured Vehicle at the time of our inspection. Wirings were noted to have greenish residual likely due to an electrical short circuit.

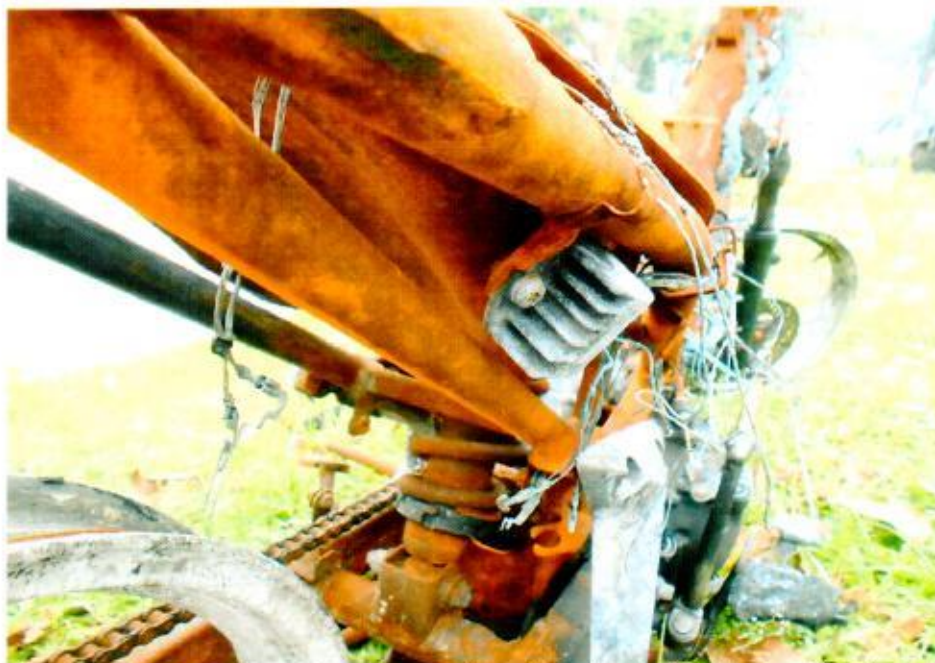
Photo 7 shows the view from rear portion of the Insured Vehicle at the time of our inspection. Stretches of wires were noted to have greenish residual likely due to an electrical short circuit.

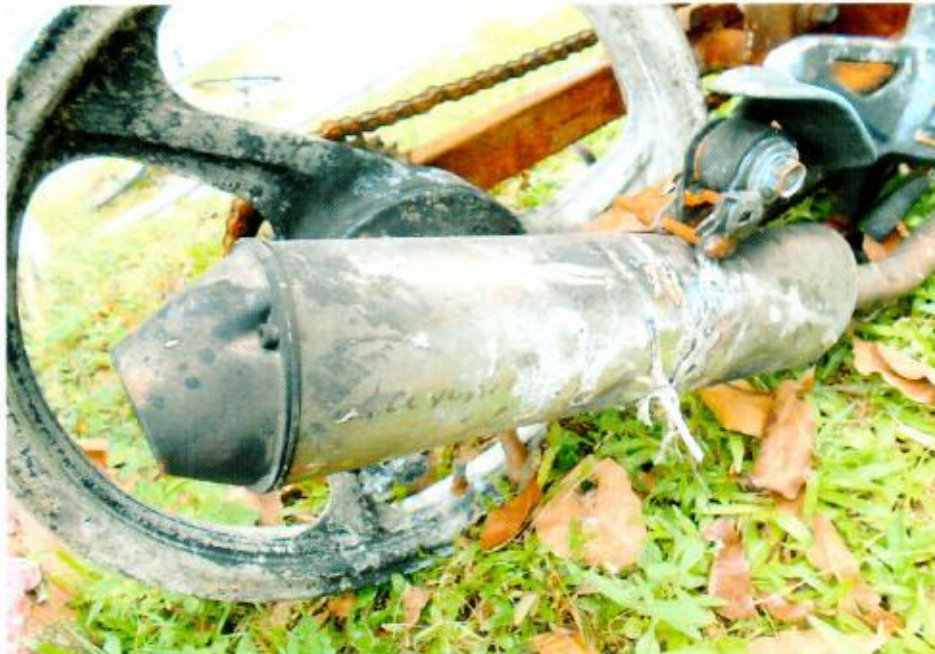
17. Further in our investigation, we found that the exhaust pipe was not the original factory fitted. Our research found that it was an after-market exhaust pipe known as 'LeoVince'. We were informed by Mr Izad that the exhaust pipe was already installed upon purchased of the Insured Vehicle. When asked, Speedway acknowledge of the after-market exhaust pipe was installed by them. They had issued a certificate for the exhaust pipe & it was said to be in-compliance with LTA regulations. However, the certificate was burnt together with the Insured Vehicle. No duplicate copy was kept by Mr Izad or Speedway to proof the legality of the exhaust pipe. See photo 8 & 9 below for similar model comparison. See photo 8 & 9 below.

Photo 8 shows the after-market exhaust pipe. It was believe from manufacturer called 'LeoVince'. It was said to be an approved LTA after-market exhaust pipe.

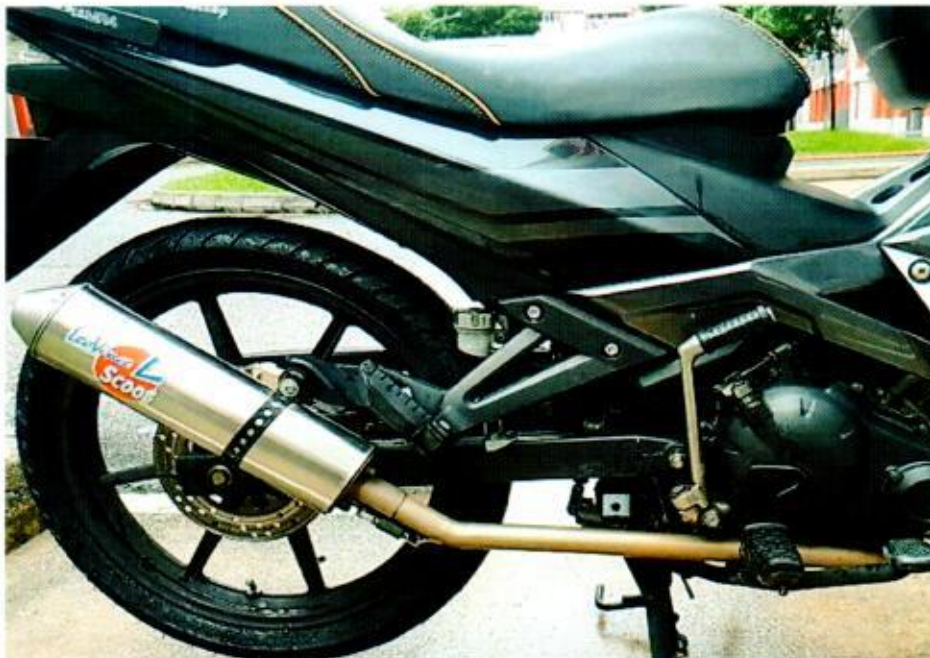
Photo 9 shows a similar after-market exhaust pipe installed on a similar model of motorcycle from a manufacturer called 'LeoVince'. It was said to be an approved LTA after-market exhaust pipe.

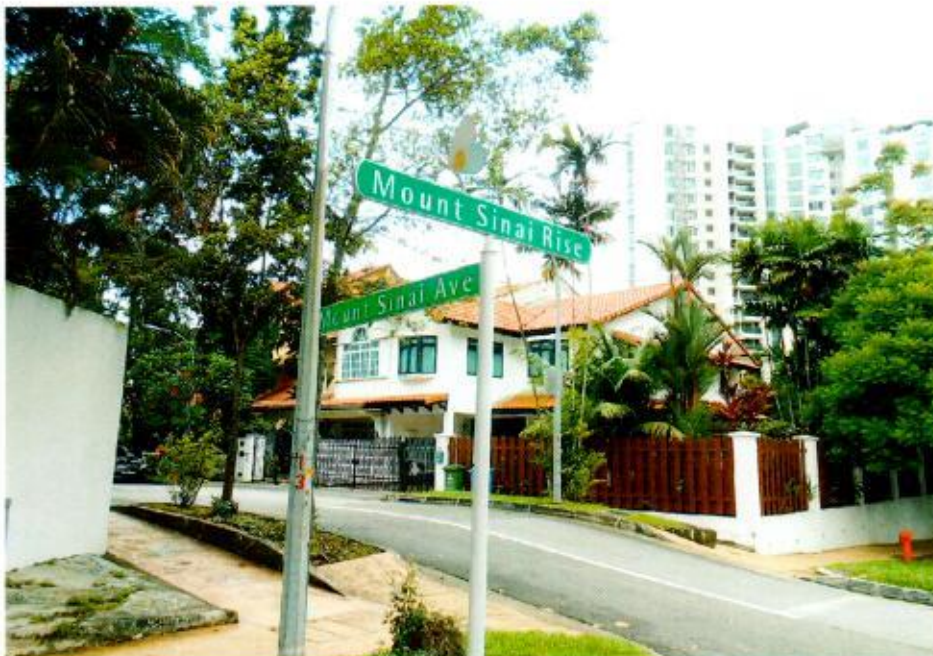
Photo 10 shows lamp post 13 & Mount Sinai Road sign where the fire incident took place.

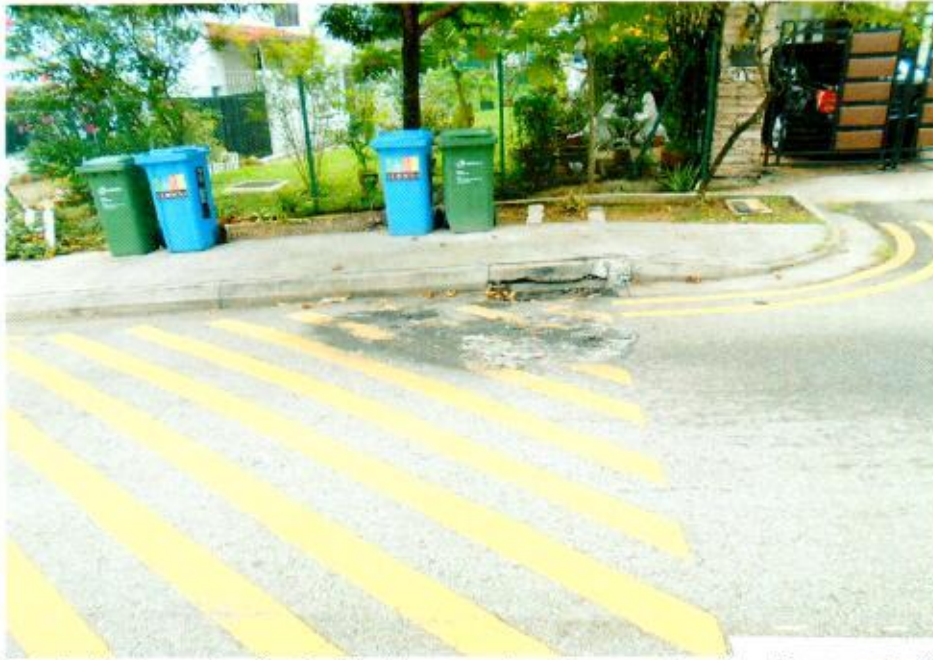
Photo 11 shows the fire incident happened on the opposite site of lamp post 13 of Mount Sinai Road.

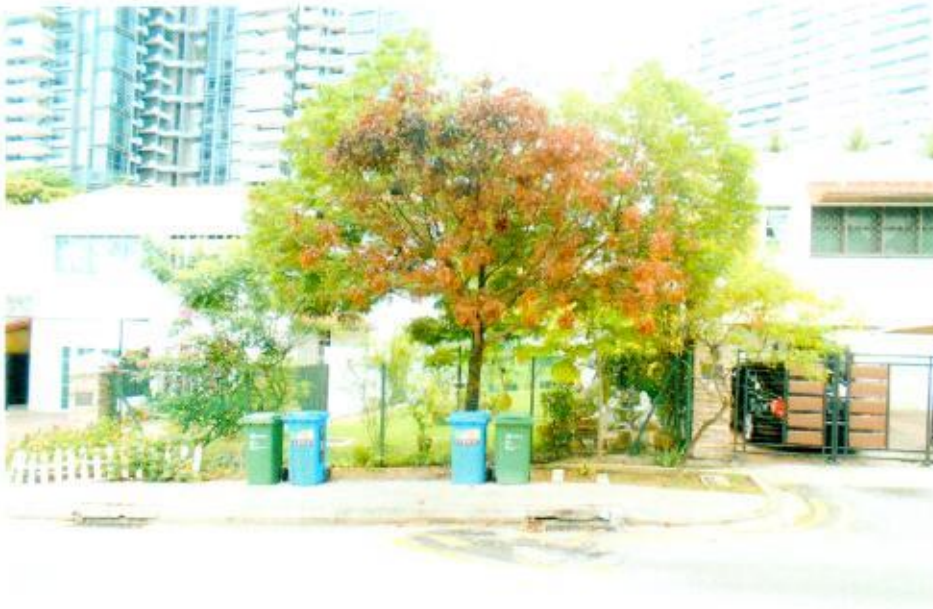
Photo 12 shows the burnt portion of the nearby tree indicates that fire incident did took place at the said location.

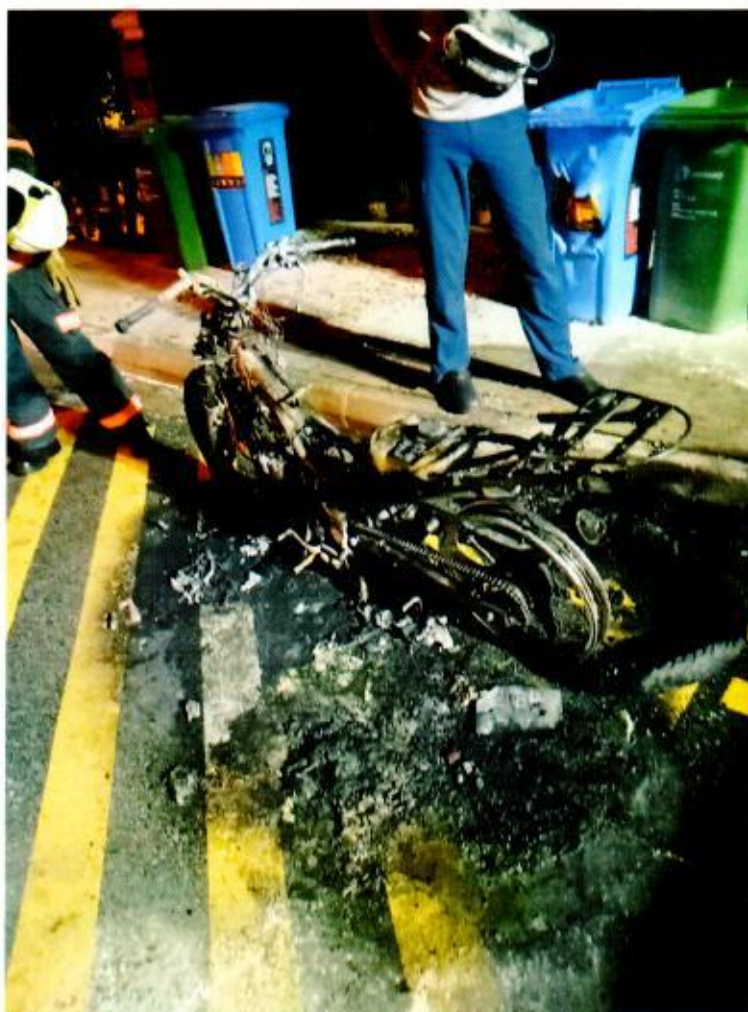
24. In general, the information that could be gathered from these photographs had corresponded to the events that were related to us by Mr Izad. Our close examination of these photographs also showed no unusual foreign material(s) and/or object(s) found on the ground in the immediate area of the side of the road where the Insured Vehicle was positioned. See photos 13 -14 below.

Photo 13 shows the burnt Insured Vehicle after the fire was extinguished by SCDF officers.

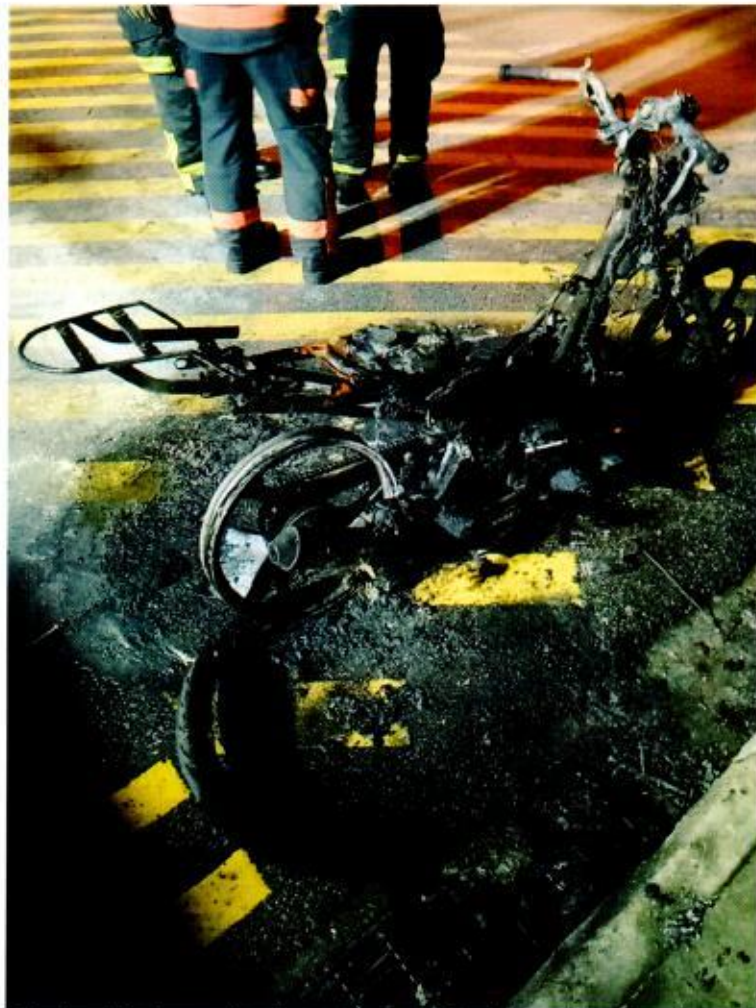
Photo 14 shows the burnt Insured Vehicle after the fire was extinguished by SCDF officers.
