Auto
Consultants
Pte Ltd

04th June 2018

**TECHNICAL INVESTIGATION REPORT OF FIRE INCIDENT INVOLVING THE
INSURED VEHICLE FBE 3832X ON 05th May 2018**

Vehicle Registration No.	: FBE 3832X
Make / Model	: Yamaha T135-135CC
Chassis No	: 5YP302269
Year of Registration	: 2010 (March)
Mileage	: N.A. (wiring affected)

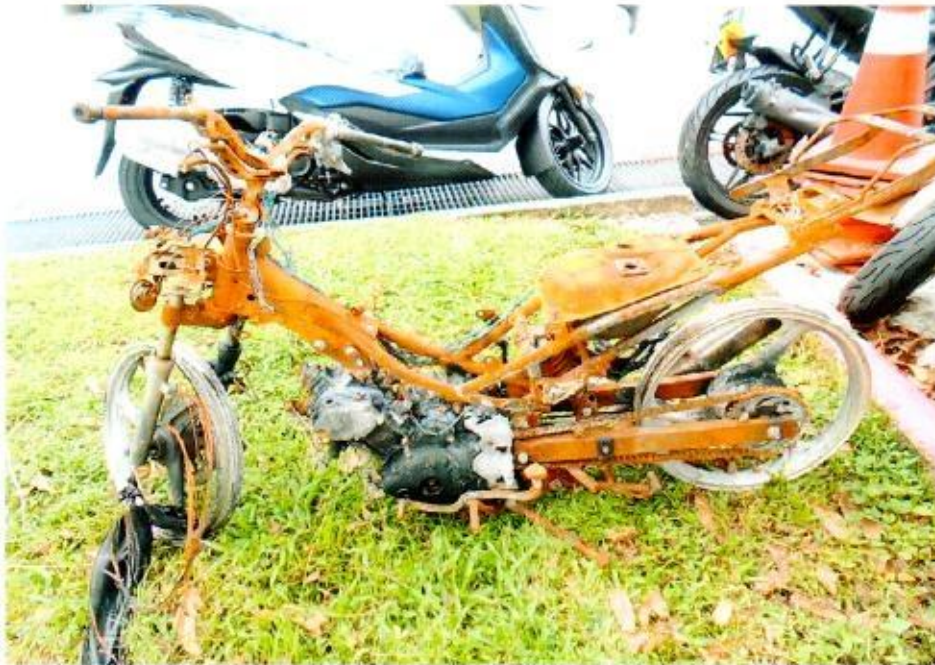
5. The Insured Vehicle was noted to have sustained fire damages that severely effected on the entire parts of the Insured Vehicle. The fire damages were observed on its engine compartment, front portion, left portion, right portion & rear portion. Rust had accumulated all over the Insured Vehicle as a result of exposure to environmental condition for a period of time. See photos 1 to 4 below.

Photo 1 shows the left portion view of the Insured Vehicle at the time of our inspection. The Insured Vehicle was noted to have sustained fire damages that severely effected on the entire parts of the Insured Vehicle.

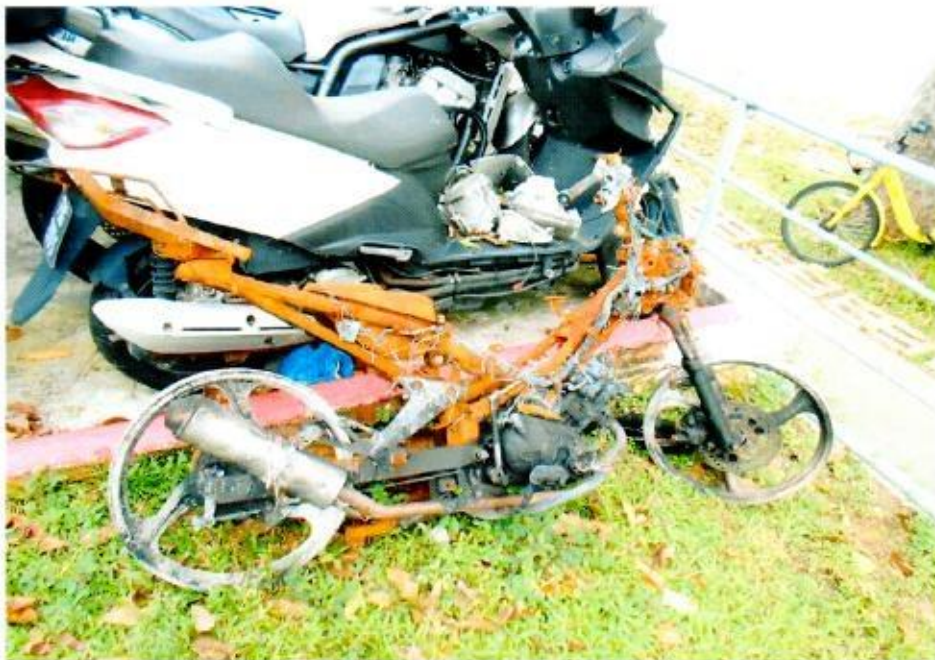
Photo 2 shows the right portion view of the Insured Vehicle at the time of our inspection. The Insured Vehicle was noted to have sustained fire damages that severely effected on the entire parts of the Insured Vehicle.

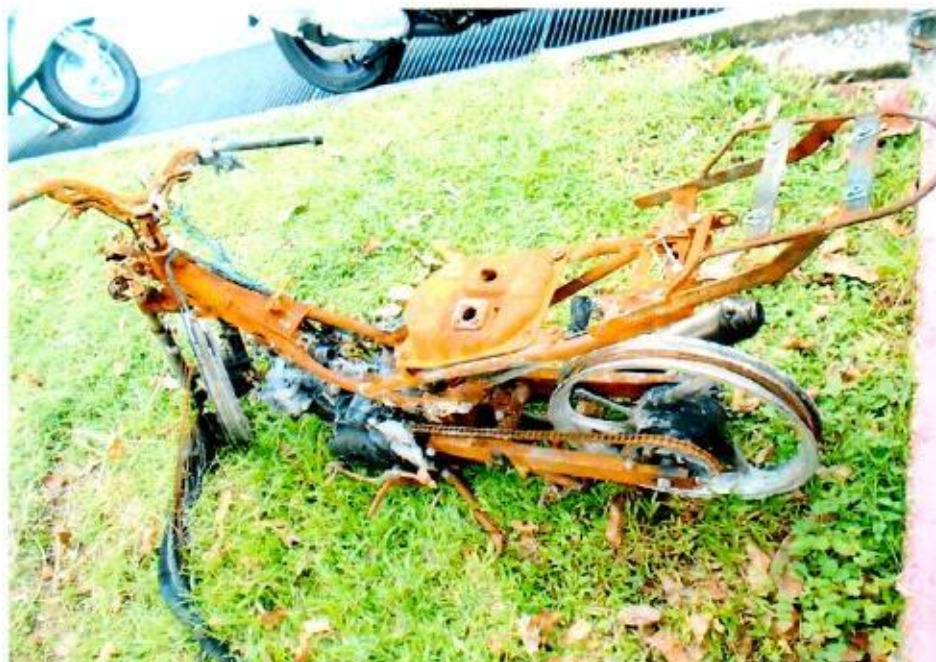
Photo 3 shows the rear left side of the Insured Vehicle at the time of our inspection. The Insured Vehicle was noted to have sustained fire damages that severely effected on the entire parts of the Insured Vehicle.

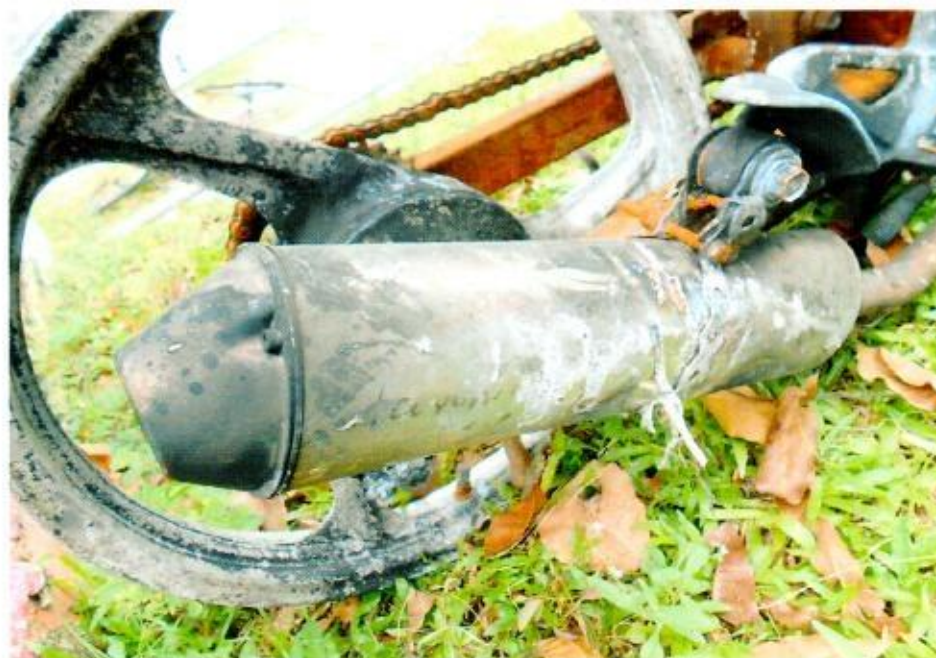
Photo 4 shows the after-market exhaust pipe. It was believe from manufacture called 'LeoVince'. It was said to be an approved LTA after-market exhaust pipe.

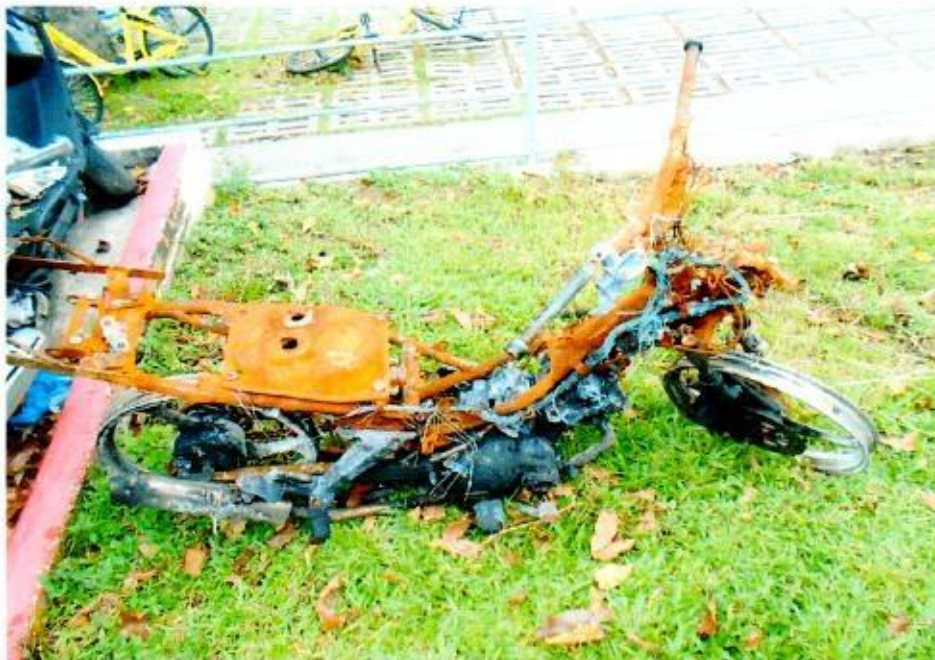
6. Rust would normally start to develop around areas soon after a fire as prolonged exposure to high heat intensity usually causes steel/metal material body parts to be exposed to natural environmental condition. The rust that had developed on the Insured Vehicle is an indication that it had sustained exposure to prolonged high heat intensity. See photo 5 below.

Photo 5 shows rust would normally start to develop around these areas soon after a fire as prolonged exposure to high heat intensity usually causes steel/metal material body parts to be exposed to natural environmental condition. The rust that had developed on the Insured Vehicle is an indication that it had sustained exposure to prolonged high heat intensity.

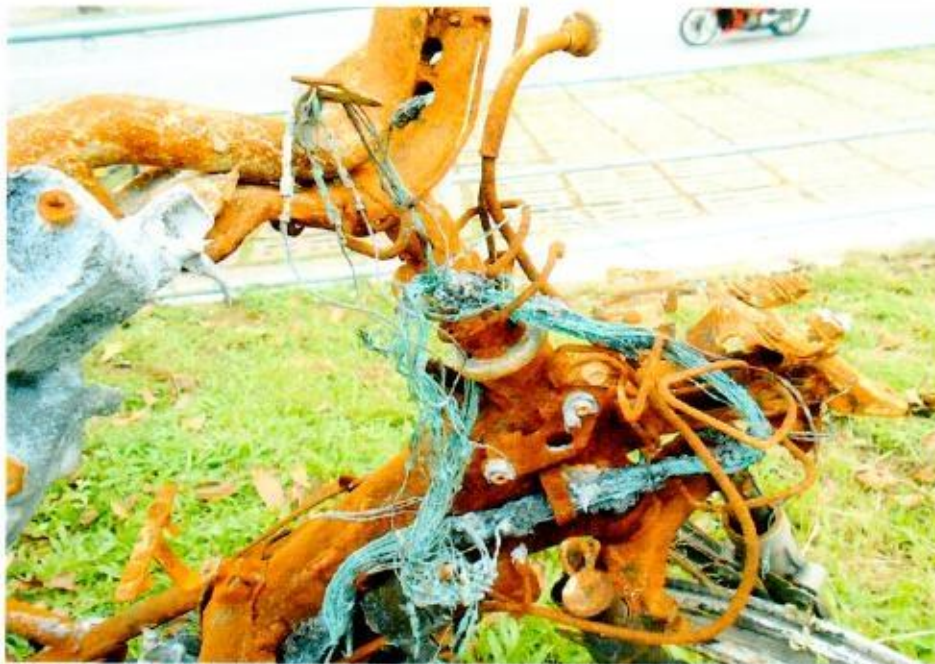
8. Upon closer examination of the area around the body structure of the engine compartment, which was in the immediate vicinity of where the fire to the Insured Vehicle had likely started, we had found several stretches of wiring burnt internally to its bare copper state. The wirings were likely to be the original engine wire harness. Such condition normally indicate internal heating of copper wires which is a sign of an electrical short circuit occurring. A greenish residual on the wires also indicated the focal point of where the area fire had ignited. This would then appear to suggest that the cause of fire to the Insured Vehicle could have possibly been due to electrical in nature. See photo 6 & 7 below.

Photo 6 shows the front portion of the Insured Vehicle at the time of our inspection. Wirings were noted to have greenish residual likely due to an electrical short circuit.

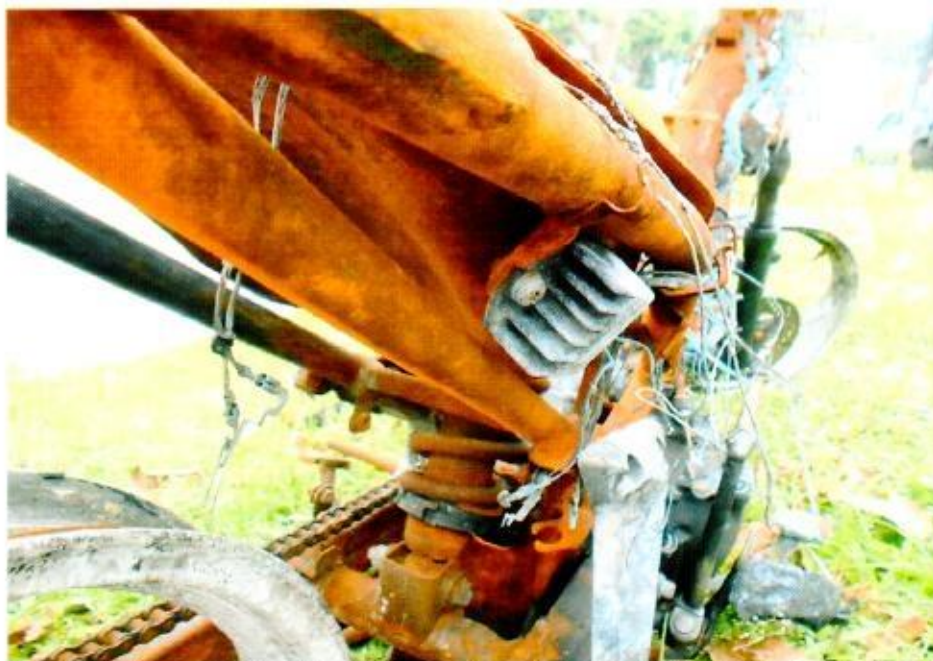
Photo 7 shows the view from rear portion of the Insured Vehicle at the time of our inspection. Stretches of wires were noted to have greenish residual likely due to an electrical short circuit.

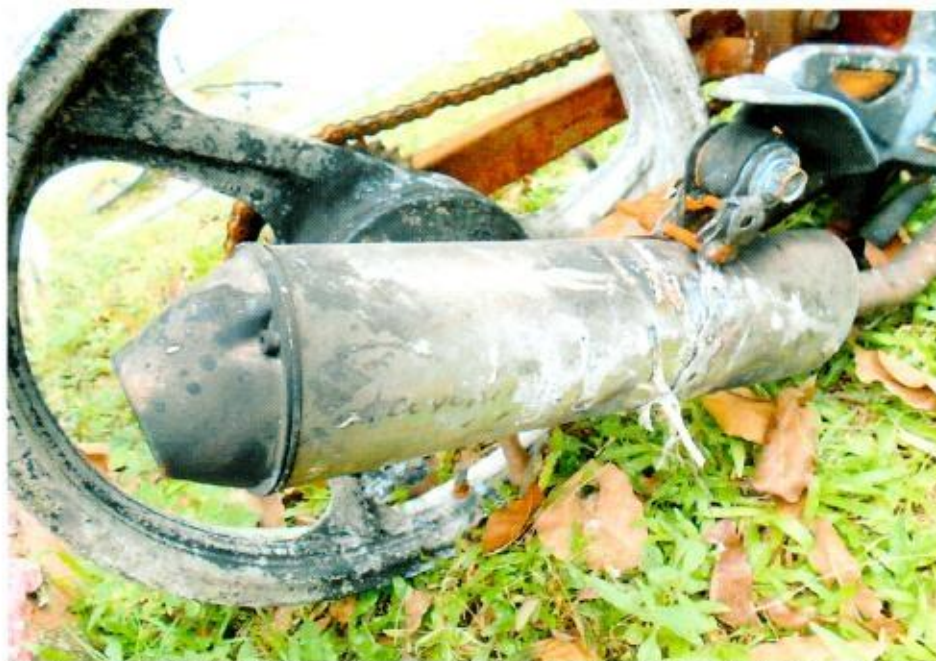
17. Further in our investigation, we found that the exhaust pipe was not the original factory fitted. Our research found that it was an after-market exhaust pipe known as 'LeoVince'. We were informed by Mr Izad that the exhaust pipe was already installed upon purchased of the Insured Vehicle. When asked, Speedway acknowledge of the after-market exhaust pipe was installed by them. They had issued a certificate for the exhaust pipe & it was said to be in-compliance with LTA regulations. However, the certificate was burnt together with the Insured Vehicle. No duplicate copy was kept by Mr Izad or Speedway to proof the legality of the exhaust pipe. See photo 8 & 9 below for similar model comparison. See photo 8 & 9 below.

Photo 8 shows the after-market exhaust pipe. It was believe from manufacturer called 'LeoVince'. It was said to be an approved LTA after-market exhaust pipe.

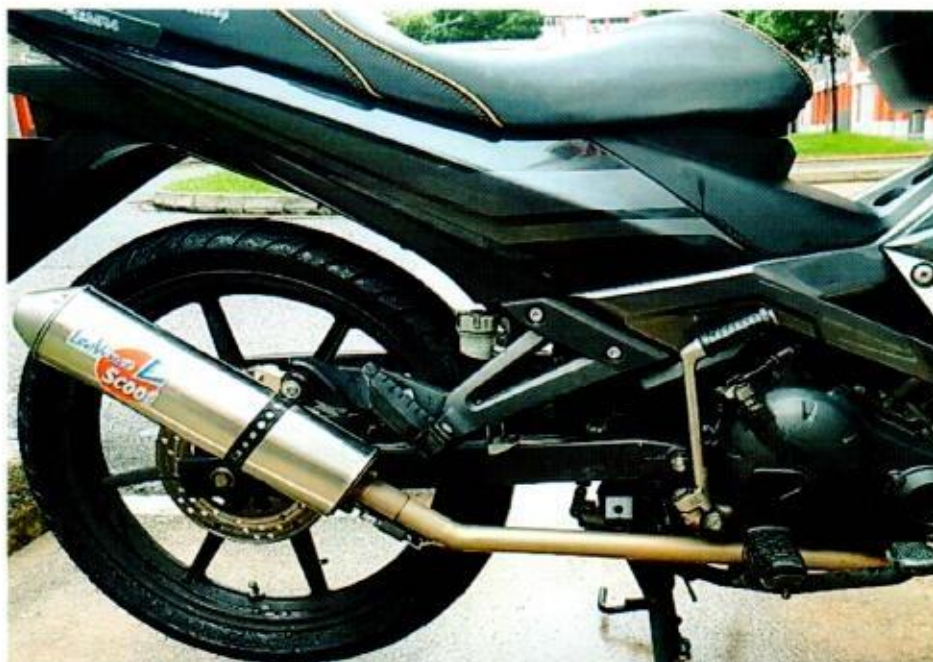
Photo 9 shows a similar after-market exhaust pipe installed on a similar model of motorcycle from a manufacturer called 'LeoVince'. It was said to be an approved LTA after-market exhaust pipe.

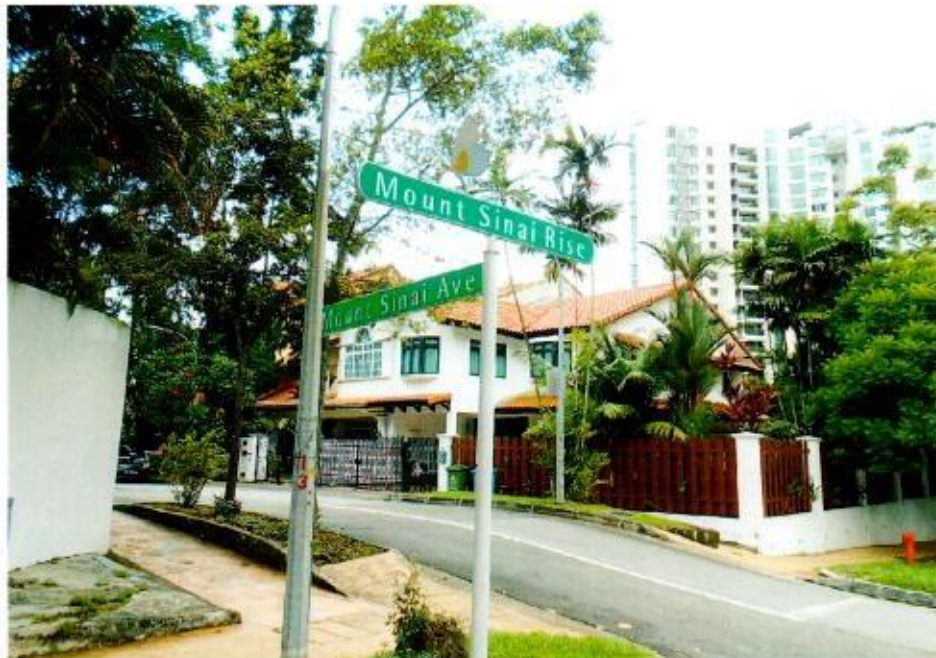
Photo 10 shows lamp post 13 & Mount Sinai Road sign where the fire incident took place.

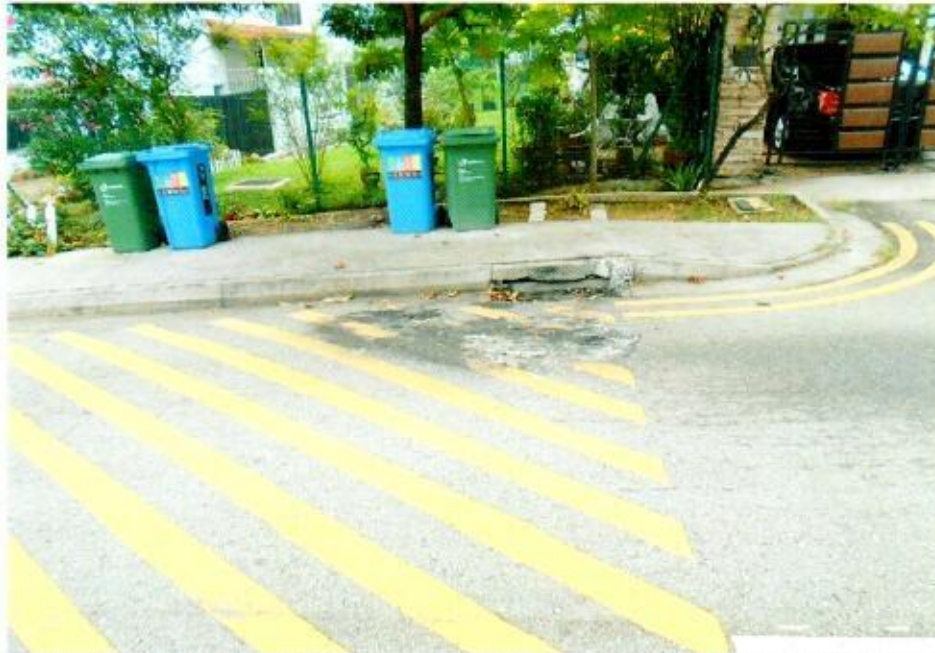
Photo 11 shows the fire incident happened on the opposite site of lamp post 13 of Mount Sinai Road.

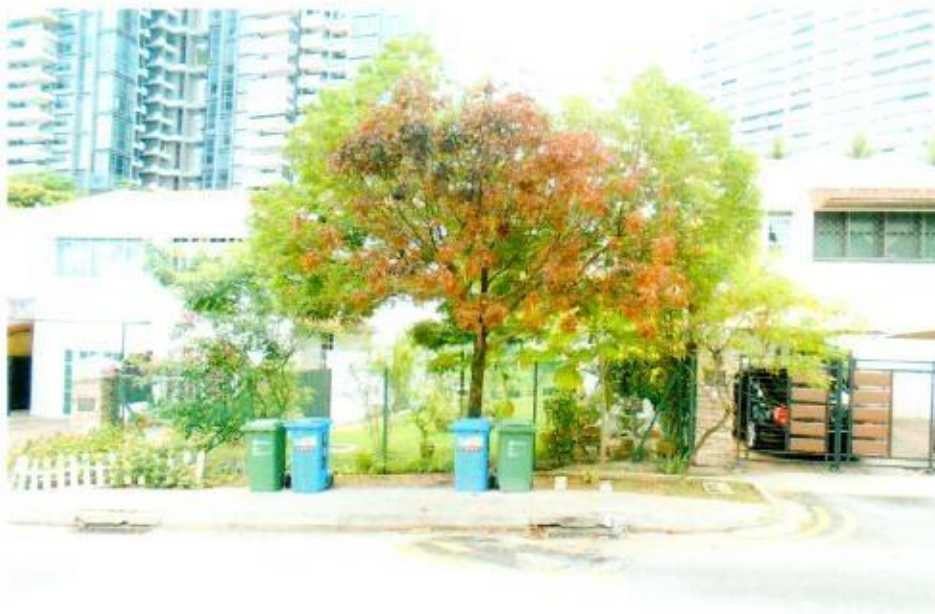
Photo 12 shows the burnt portion of the nearby tree indicates that fire incident did took place at the said location.

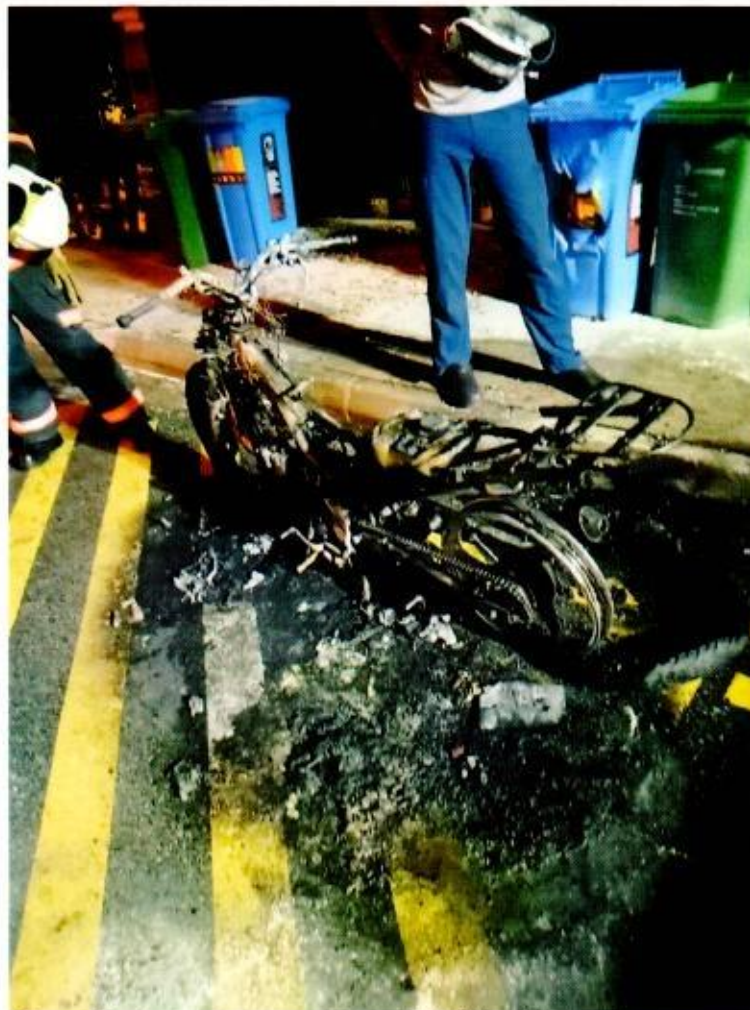
Photo 13 shows the burnt Insured Vehicle after the fire was extinguished by SCDF officers.

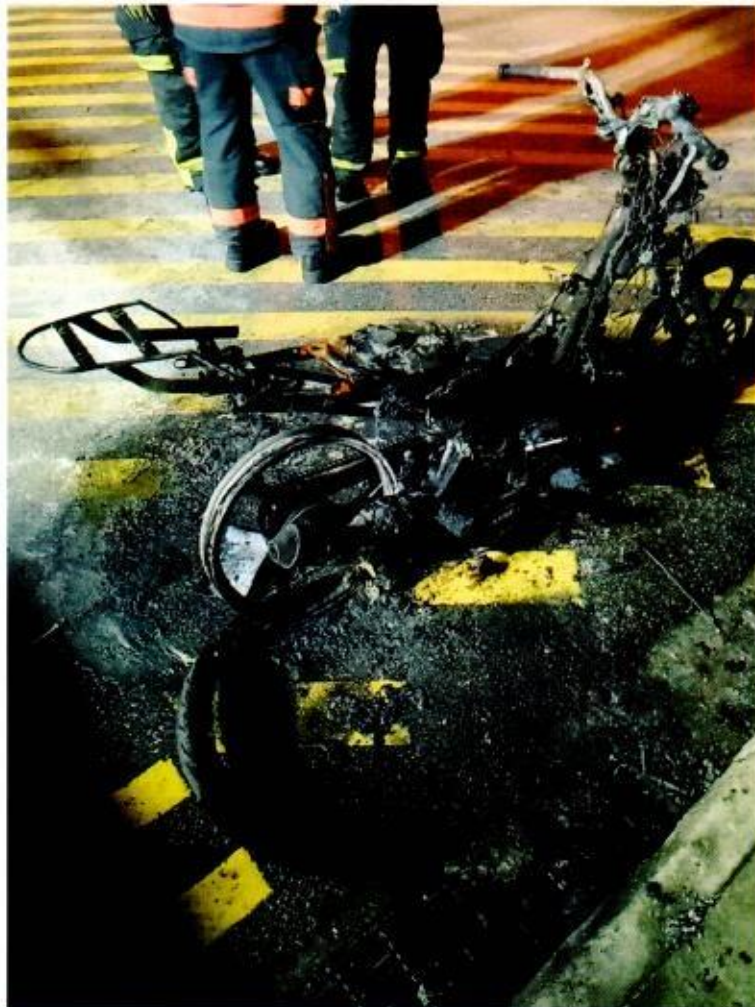
Photo 14 shows the burnt Insured Vehicle after the fire was extinguished by SCDF officers.
