Your Ref: IA2018-37264
Our Ref : CI/IAS18009114/N

TECHNICAL INVESTIGATION REPORT OF ENGINE DAMAGE TO THE INSURED VEHICLE SKR 1163G

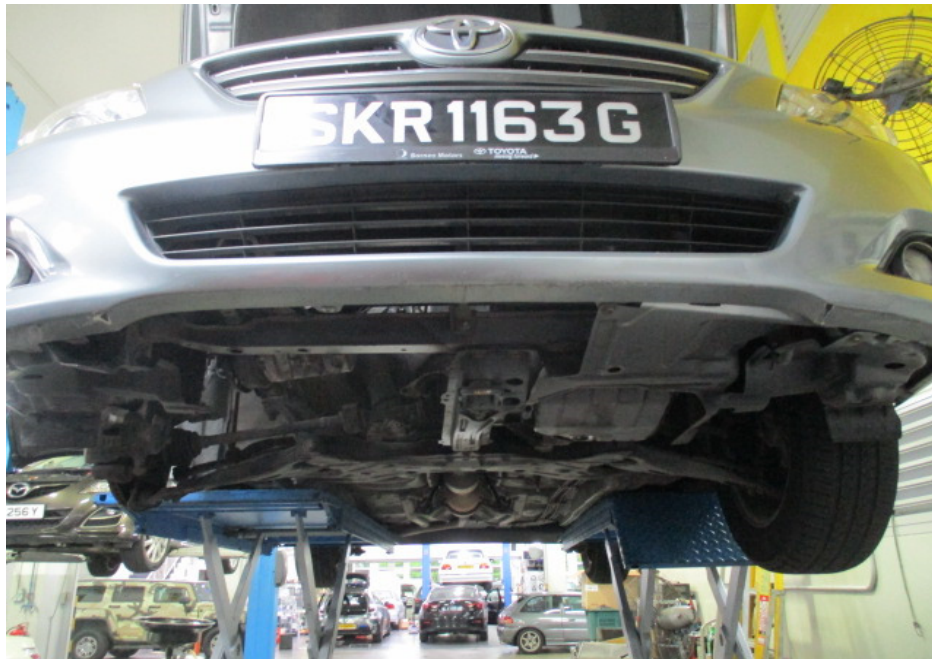
Photo 1 shows the general view of the Insured Vehicle being hoisted for checks on its undercarriage at the time of our inspection. The Insured Vehicle was observed to be in good general condition with no visible damage to the exterior body.

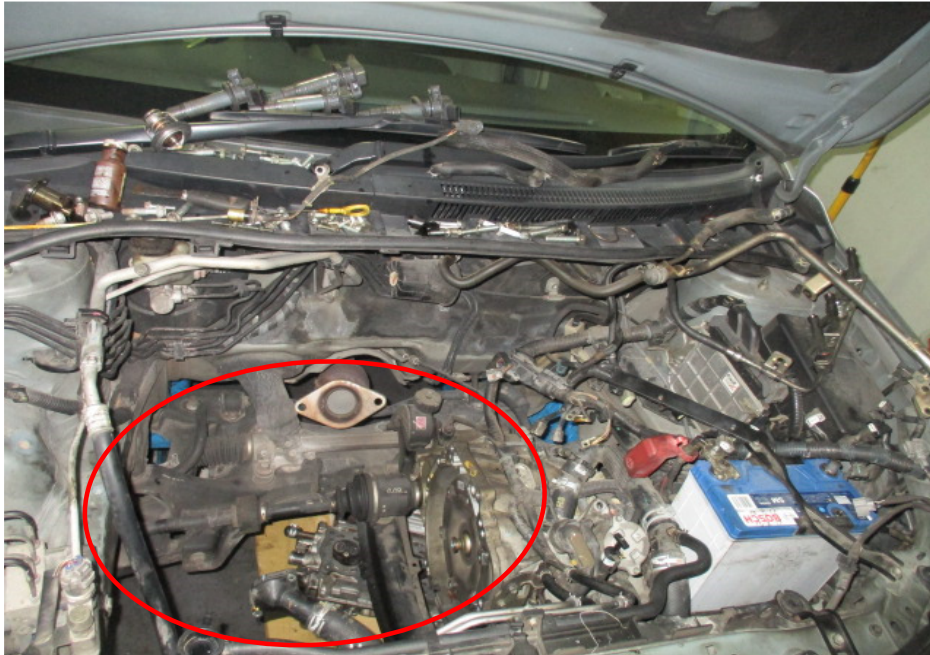
Photo 2 shows the general view of the engine compartment of the Insured Vehicle at the time of our inspection. We observed that the engine had been dismounted from the engine bay and dismantled. The various components of the Insured Vehicle's cooling system had also been removed from the front portion of the engine compartment (circled).

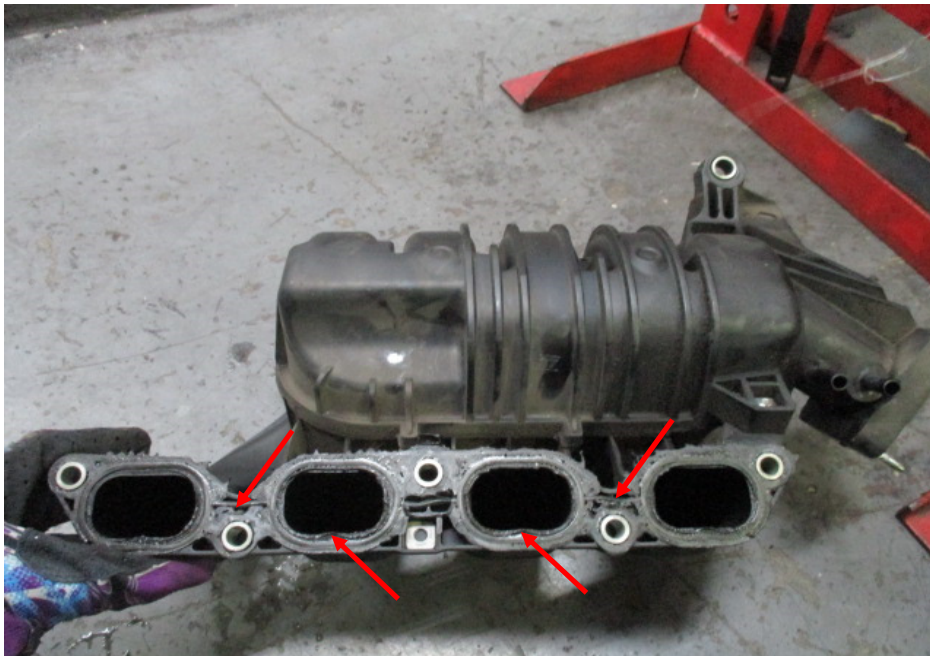
10. Upon further examination, we had found the engine inlet manifold, engine block cylinder heads, engine valves and engine valve seals to be partially burnt and/or melted. The pistons and piston rings were observed to be severely burnt and cracked. There were also scoring marks on the sides of the burnt pistons. Scoring marks were also found on the cylinder walls of the engine block.

Photo 3 shows the engine inlet manifold of the Insured Vehicle which was observed to be partially burnt and/or melted (arrowed).

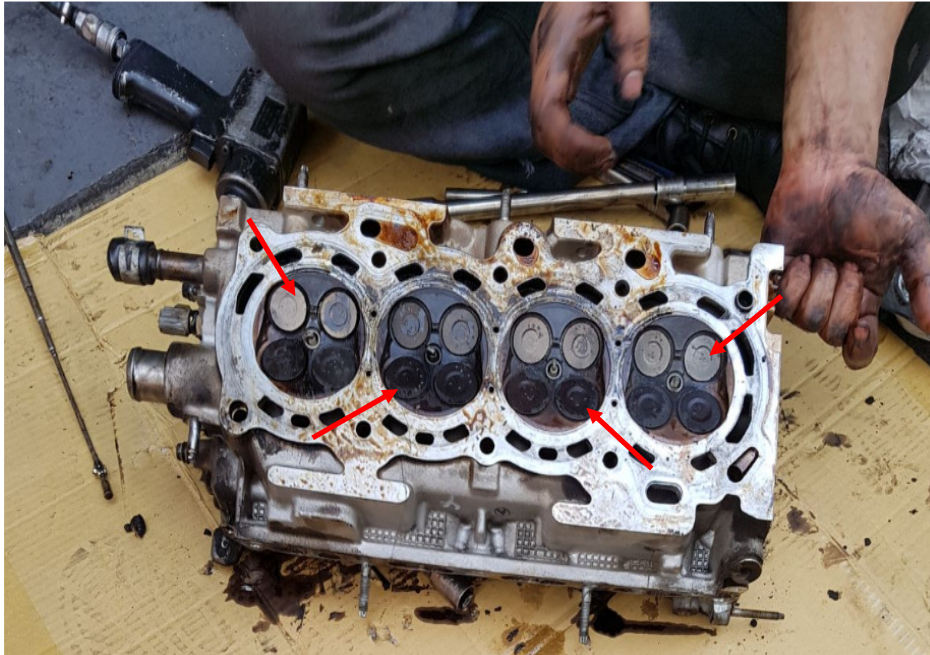
Photo 4 shows the engine valves and engine valve seals of the Insured Vehicle which were observed to be partially burnt and/or melted (arrowed).

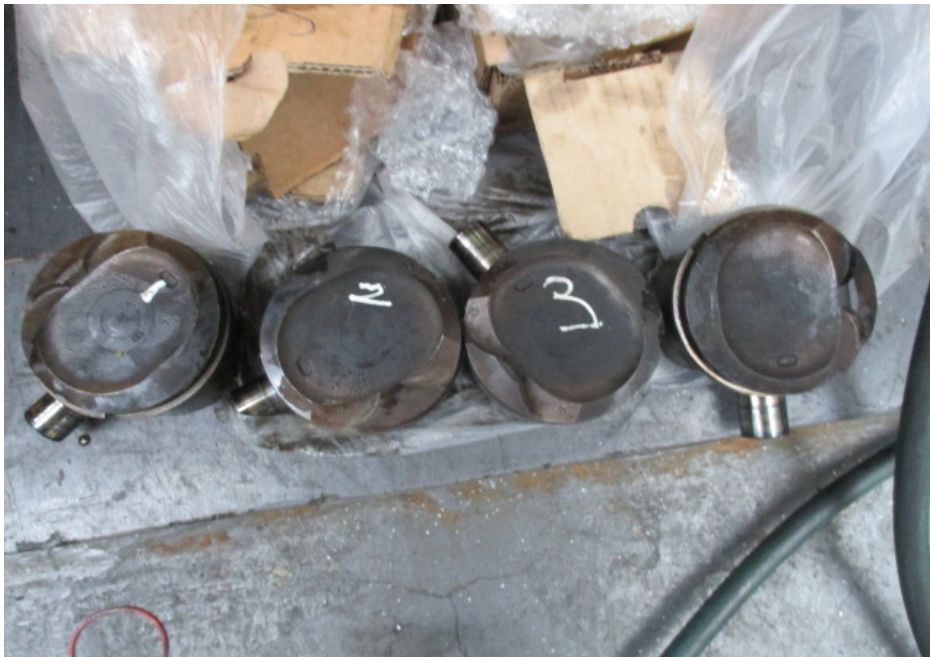
Photo 5 shows the pistons of the Insured Vehicle which were observed to be severely burnt.

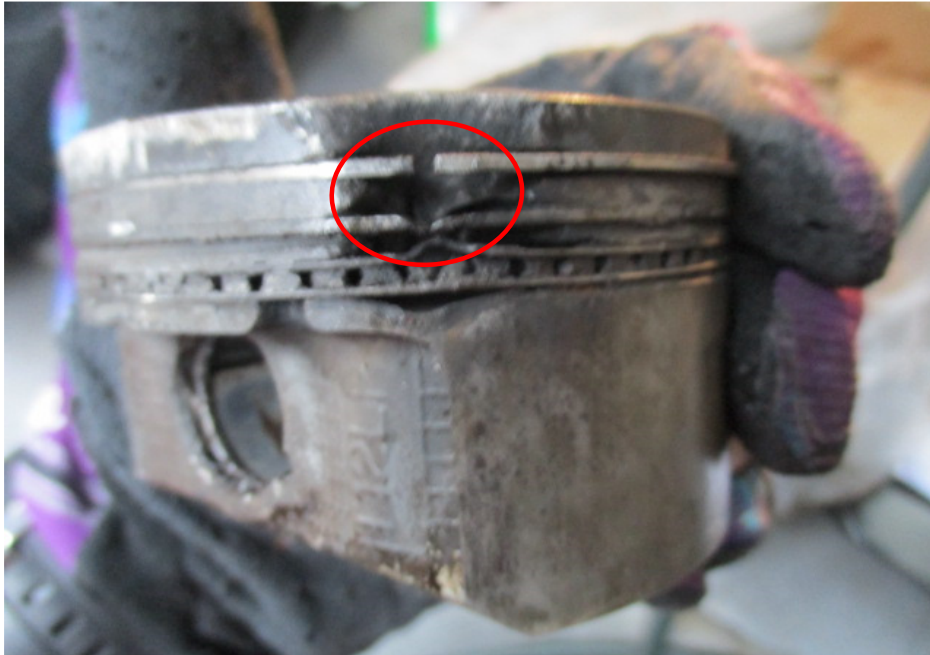
Photo 6 shows the cracked piston rings on the severely burnt pistons of the Insured Vehicle (circled).

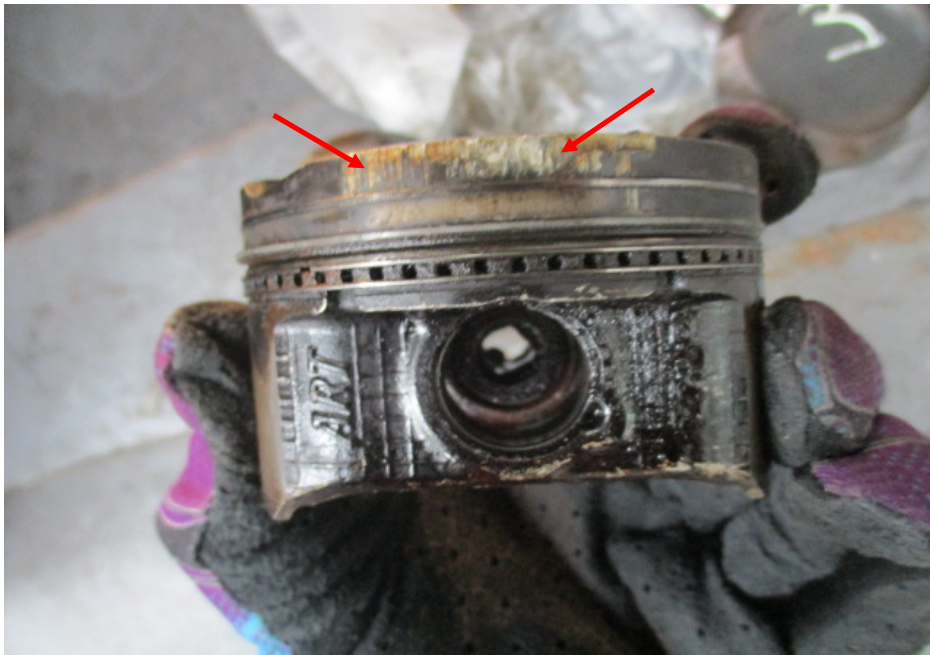
11. Causation of such scoring marks is due to the pistons which are made of aluminium heating up faster than the engine block. Due to the overheating of the engine, the pistons will expand radically as they get hot, which is not the case for the cylinders of the engine block. The pistons will bind against the cylinder walls thus badly scoring those walls, burning and cracking the pistons as well as the piston rings. This will cause the pistons and eventually the engine of the Insured Vehicle to seize. The damage profile of these parts corresponds to the Insured Vehicle overheating. See photos 1 – 8 below.

Photo 7 shows the scoring marks observed on the sides of 1 of the severely burnt pistons (arrowed). Causation of such scoring marks is due to the pistons which are made of aluminium heating up faster than the engine block. Due to the overheating of the engine, the pistons will expand radically as they get hot, which is not the case for the cylinders of the engine block. The pistons will bind against the cylinder walls thus badly scoring those walls, burning and cracking the pistons as well as the piston rings.

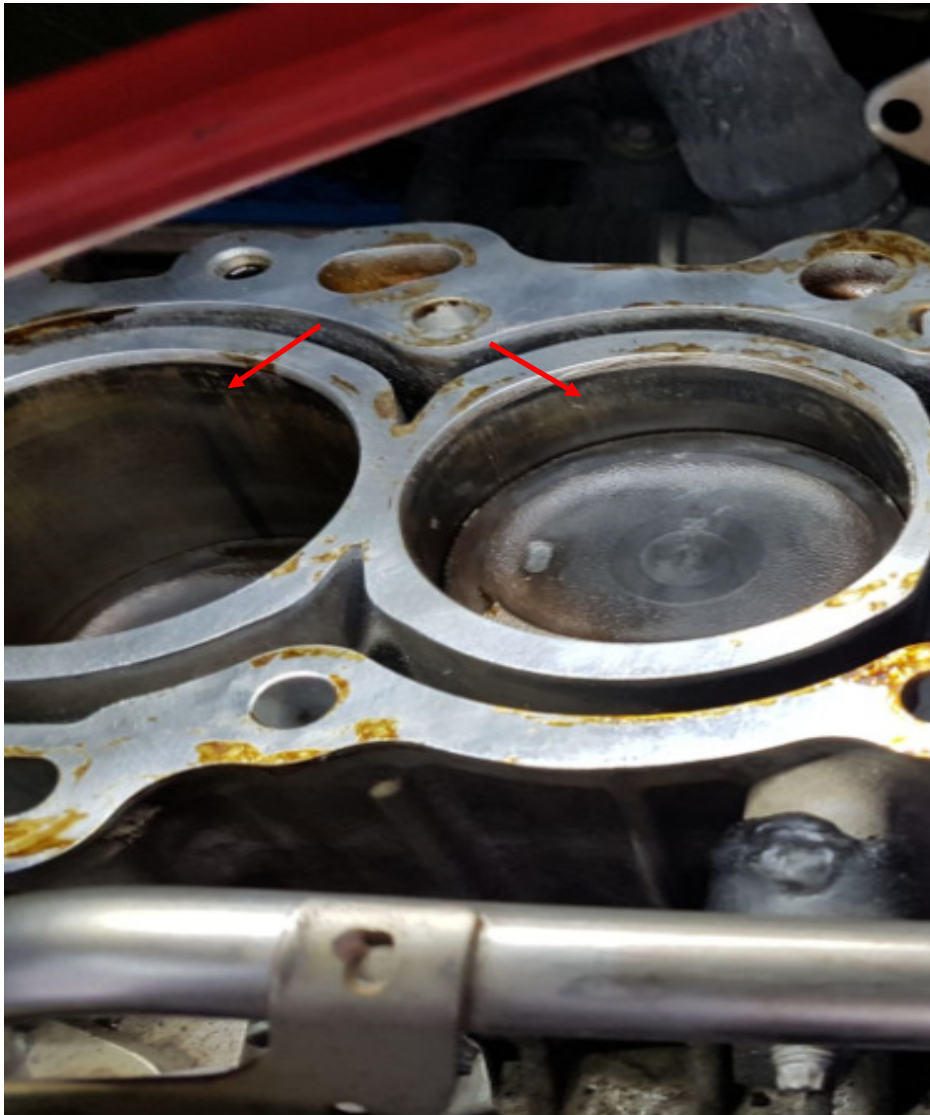
Photo 8 shows the scoring marks observed on the cylinder walls of the engine block (arrowed). Causation of such scoring marks is due to the pistons which are made of aluminium heating up faster than the engine block. Due to the overheating of the engine, the pistons will expand radically as they get hot, which is not the case for the cylinders of the engine block. The pistons will bind against the cylinder walls thus badly scoring those walls.

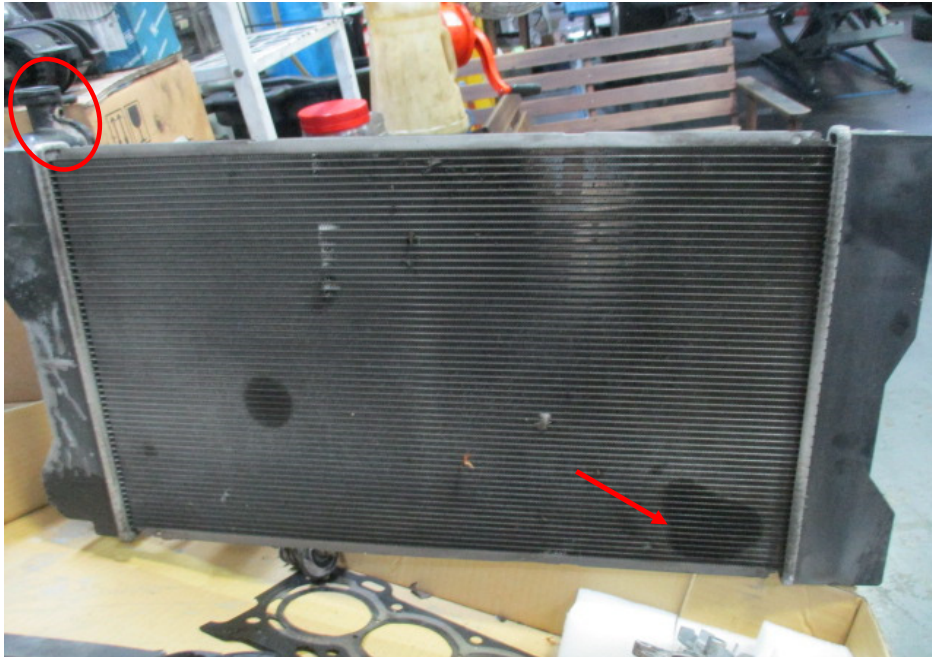
12. We had also found damages to the dismantled components of the Insured Vehicle's cooling system. These had included the radiator, radiator outlet joint, radiator hoses, water pump and thermostat. Upon further examination, we had found the radiator and thermostat to partially burnt and/or melted. The radiator outlet joint and radiator hoses were broken. The cooling system is designed to maintain ideal engine operating temperature as tremendous heat is produced while the engine is in operation. See photos 9 – 13 below.

Photo 9 shows the radiator of the Insured Vehicle which was observed to be partially burnt and/or melted (arrowed) and the broken radiator outlet joint (circled).

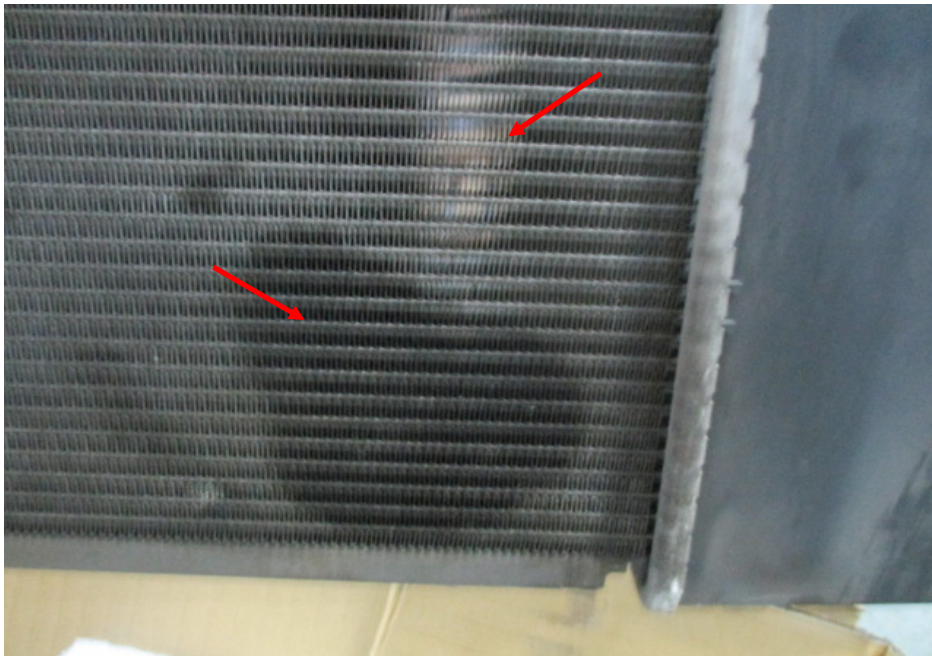
Photo 10 shows a close up view of the radiator of the Insured Vehicle which was observed to be partially burnt and/or melted (arrowed).

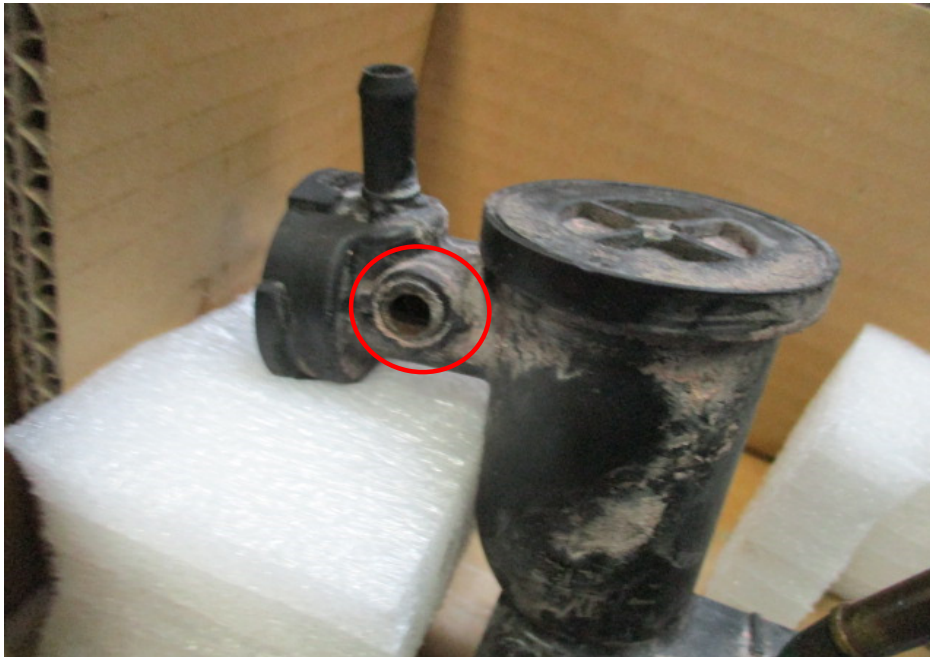
Photo 11 shows a close up view of the broken radiator outlet joint (circled).

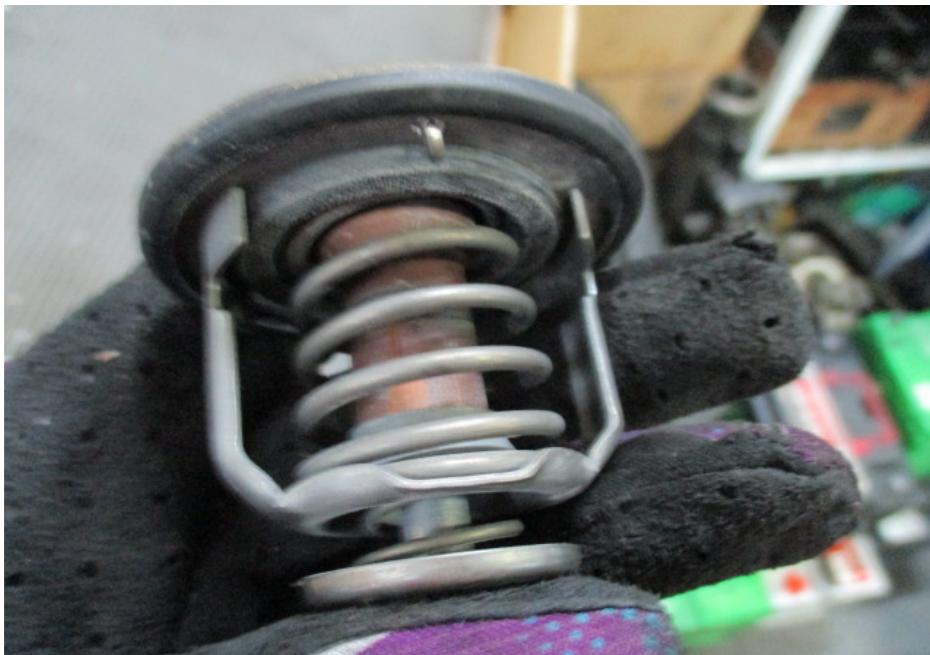
Photo 12 shows a close up view of the Insured Vehicle's thermostat which was observed to be partially burnt and/or melted.

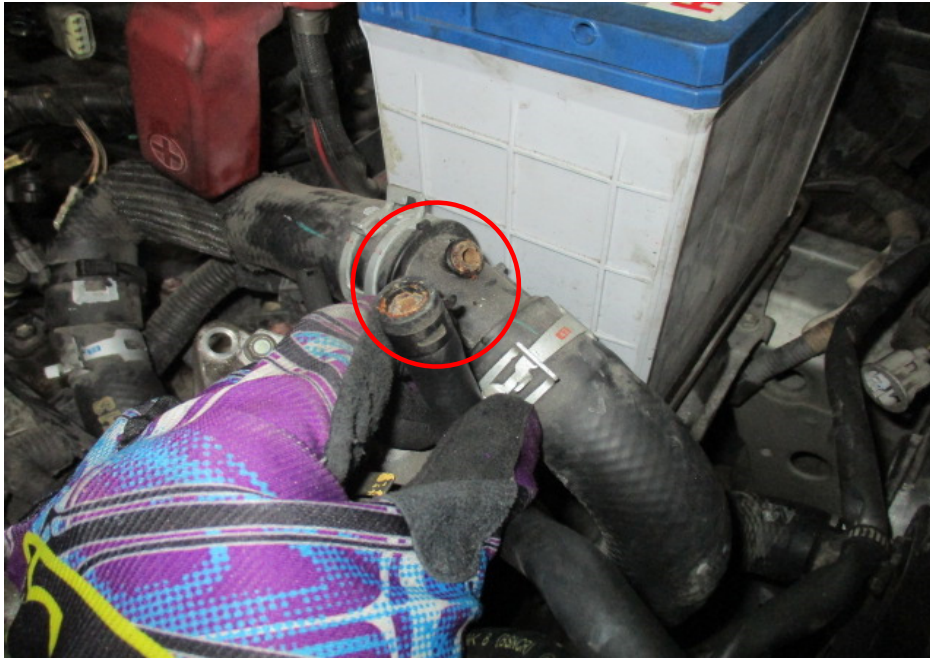
Photo 13 shows the broken radiator hose caused by overheating of the Insured Vehicle (circled).
