Your Ref: IA2018-37264
Our Ref : CI/IAS18009114/N

7 May 2018

**TECHNICAL INVESTIGATION REPORT OF ENGINE DAMAGE TO THE
INSURED VEHICLE SKR 1163G**

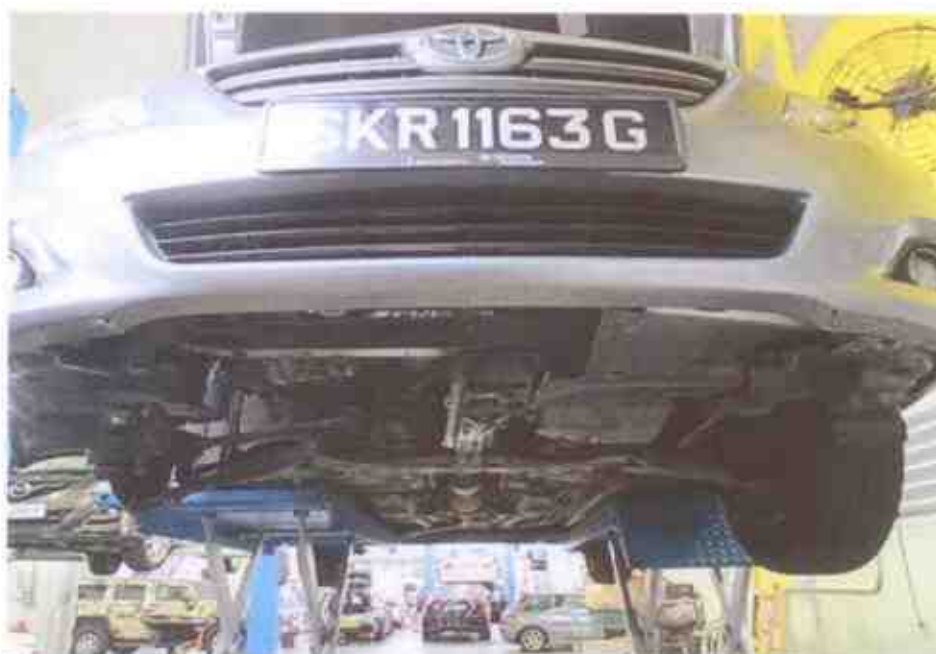
Photo 1 shows the general view of the Insured Vehicle being hoisted for checks on its undercarriage at the time of our inspection. The Insured Vehicle was observed to be in good general condition with no visible damage to the exterior body.

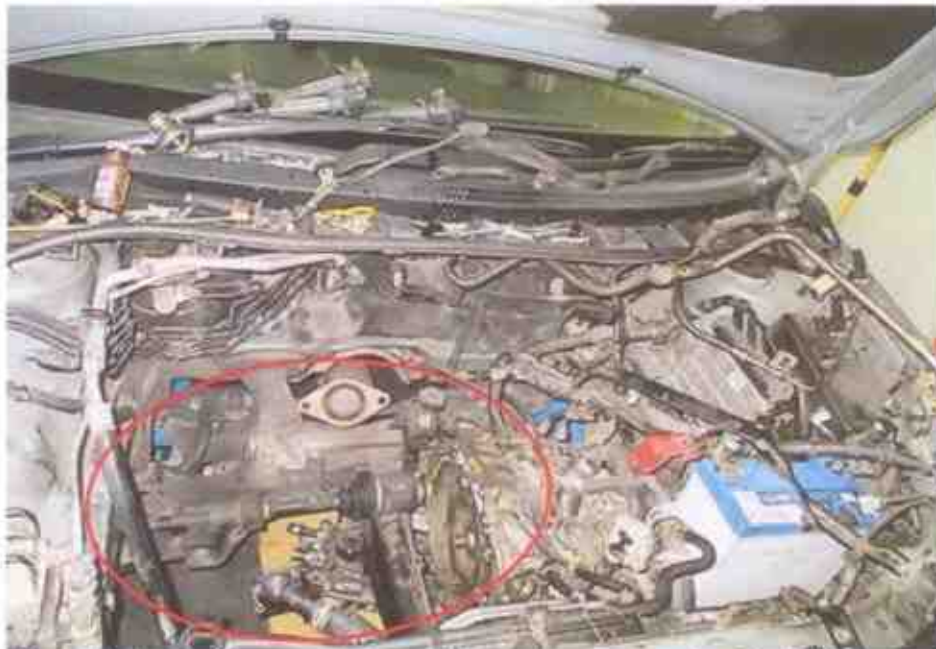
Photo 2 shows the general view of the engine compartment of the Insured Vehicle at the time of our inspection. We observed that the engine had been dismantled from the engine bay and dismantled. The various components of the Insured Vehicle's cooling system had also been removed from the front portion of the engine compartment (circled).

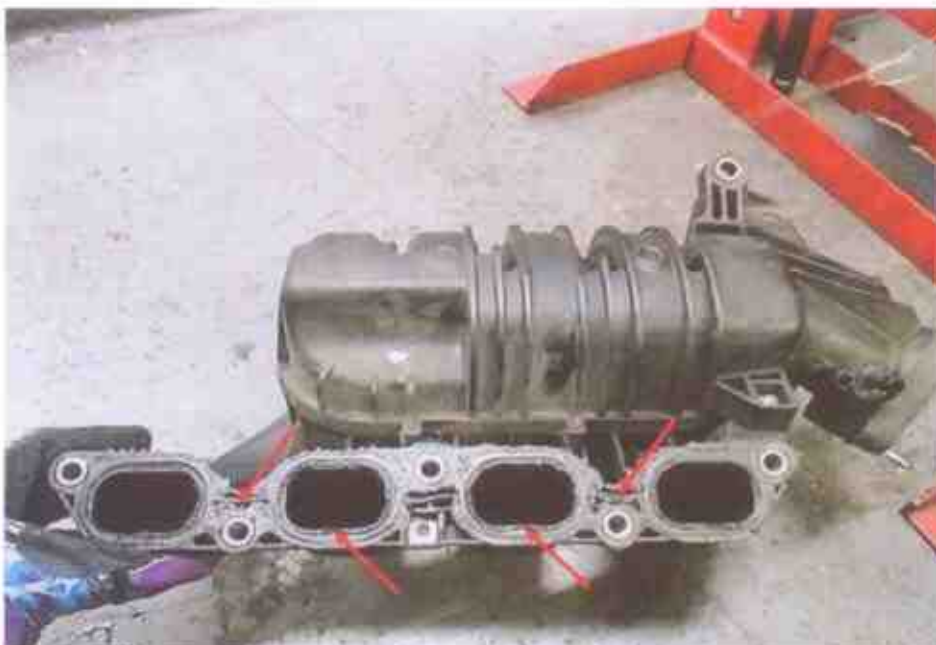
10. Upon further examination, we had found the engine inlet manifold, engine block cylinder heads, engine valves and engine valve seals to be partially burnt and/or melted. The pistons and piston rings were observed to be severely burnt and cracked. There were also scoring marks on the sides of the burnt pistons. Scoring marks were also found on the cylinder walls of the engine block.

Photo 3 shows the engine inlet manifold of the Insured Vehicle which was observed to be partially burnt and/or melted (arrowed).

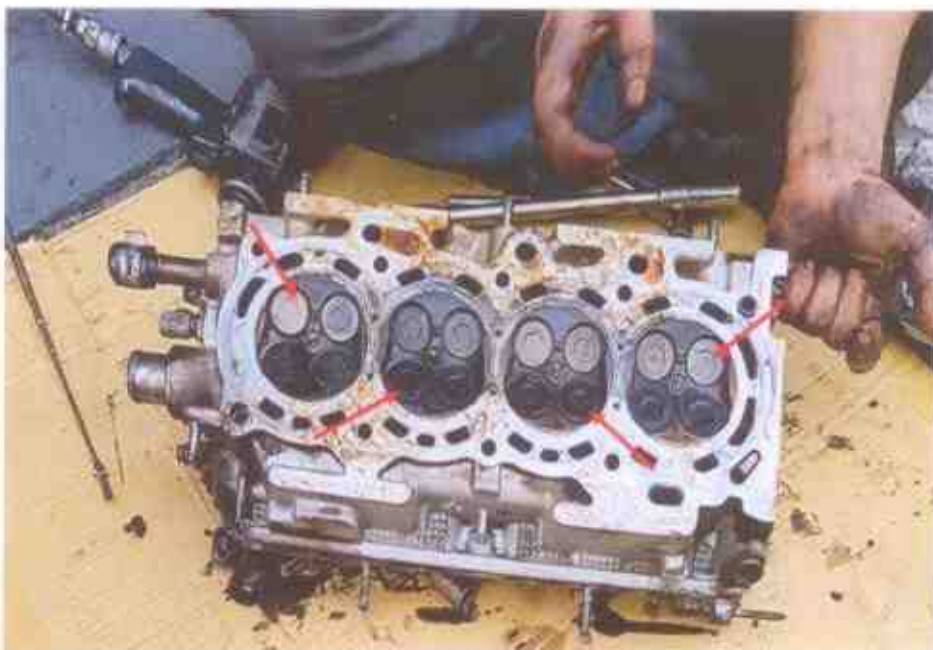
Photo 4 shows the engine valves and engine valve seals of the Insured Vehicle which were observed to be partially burnt and/or melted (arrowed).

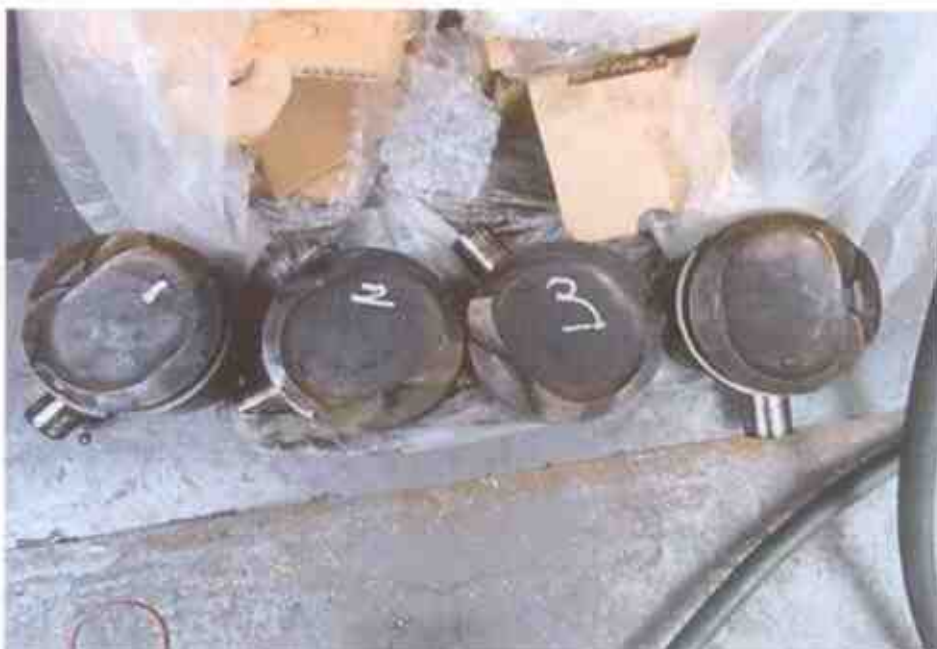
Photo 5 shows the pistons of the Insured Vehicle which were observed to be severely burnt

20. This would have then led to overheating of the engine components, ultimately affecting and burning the mechanical parts inside the engine in particular the pistons. Hence, resulting in the pistons seizing which eventually caused the engine of the Insured Vehicle to stop operating.

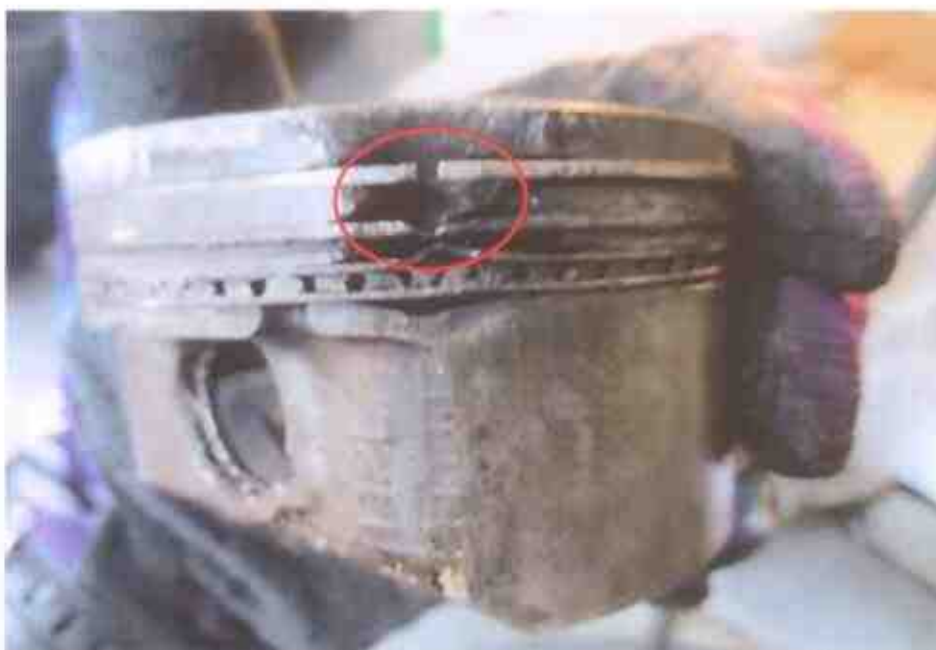
Photo 6 shows the cracked piston rings on the severely burnt pistons of the insured Vehicle (circled).

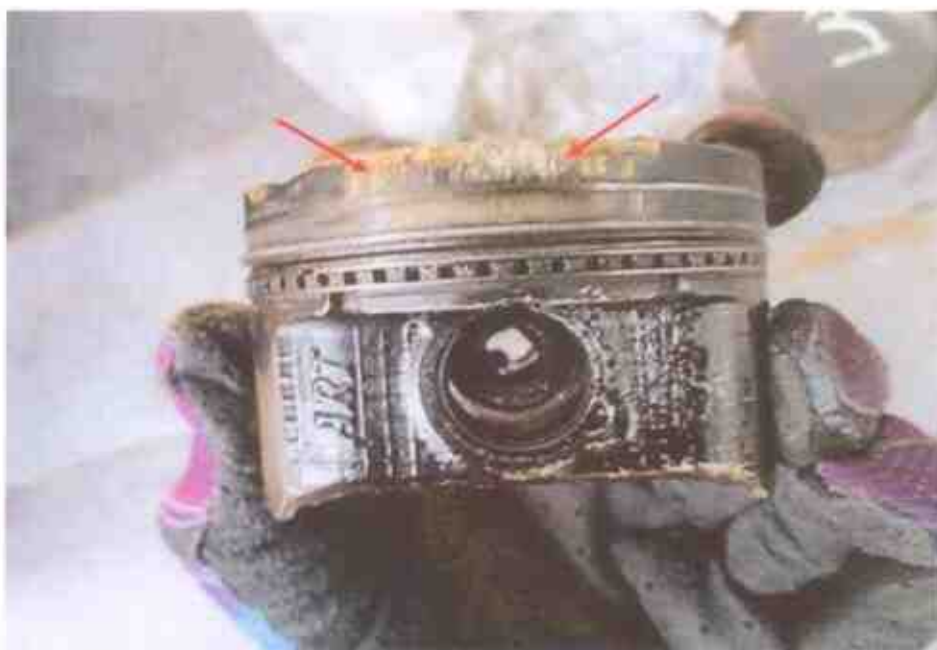
11. Causation of such scoring marks is due to the pistons which are made of aluminium heating up faster than the engine block. Due to the overheating of the engine, the pistons will expand radically as they get hot, which is not the case for the cylinders of the engine block. The pistons will bind against the cylinder walls thus badly scoring those walls, burning and cracking the pistons as well as the piston rings. This will cause the pistons and eventually the engine of the Insured Vehicle to seize. The damage profile of these parts corresponds to the Insured Vehicle overheating. See photos 1 – 8 below.

Photo 7 shows the scoring marks observed on the sides of 1 of the severely burnt pistons (arrowed). Causation of such scoring marks is due to the pistons which are made of aluminium heating up faster than the engine block. Due to the overheating of the engine, the pistons will expand radically as they get hot, which is not the case for the cylinders of the engine block. The pistons will bind against the cylinder walls thus badly scoring those walls, burning and cracking the pistons as well as the piston rings.

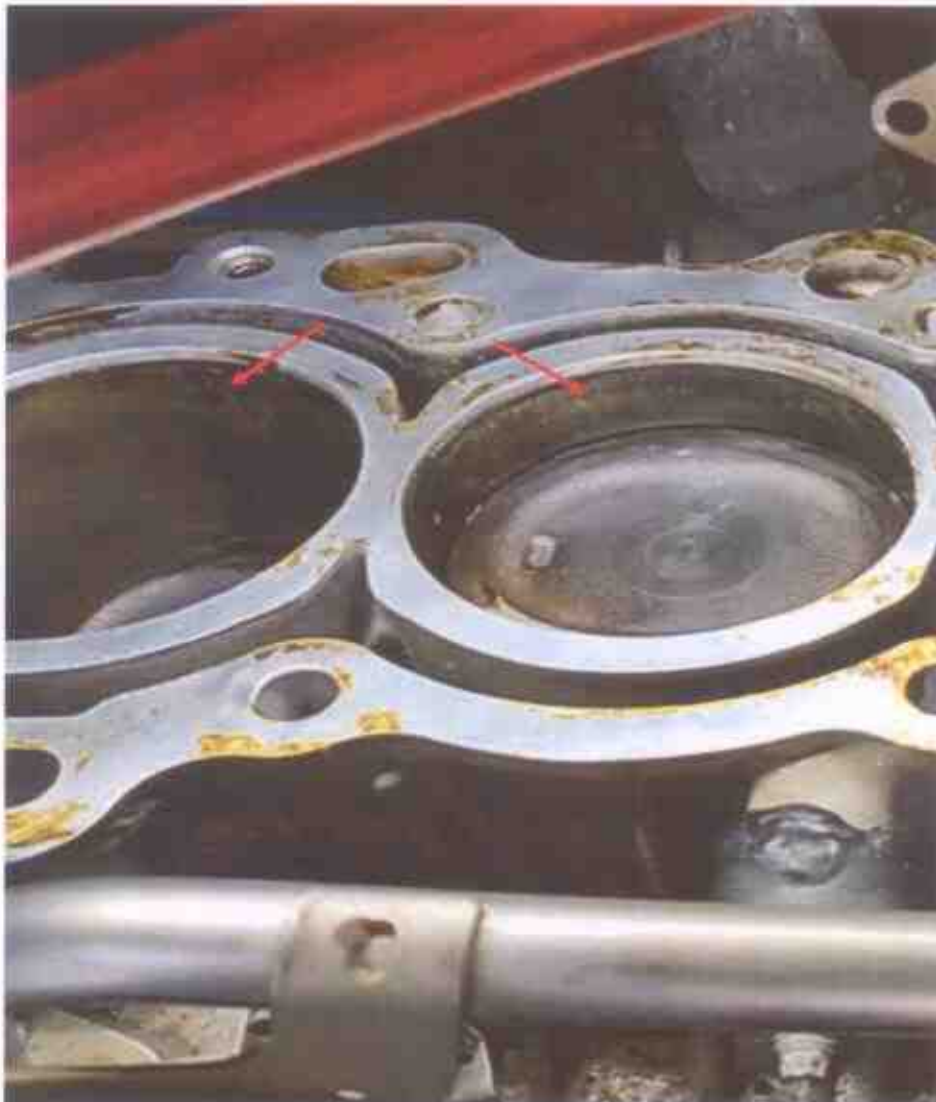
Photo 8 shows the scoring marks observed on the cylinder walls of the engine block (arrowed). Causation of such scoring marks is due to the pistons which are made of aluminium heating up faster than the engine block. Due to the overheating of the engine, the pistons will expand radically as they get hot, which is not the case for the cylinders of the engine block. The pistons will bind against the cylinder walls thus badly scoring those walls.

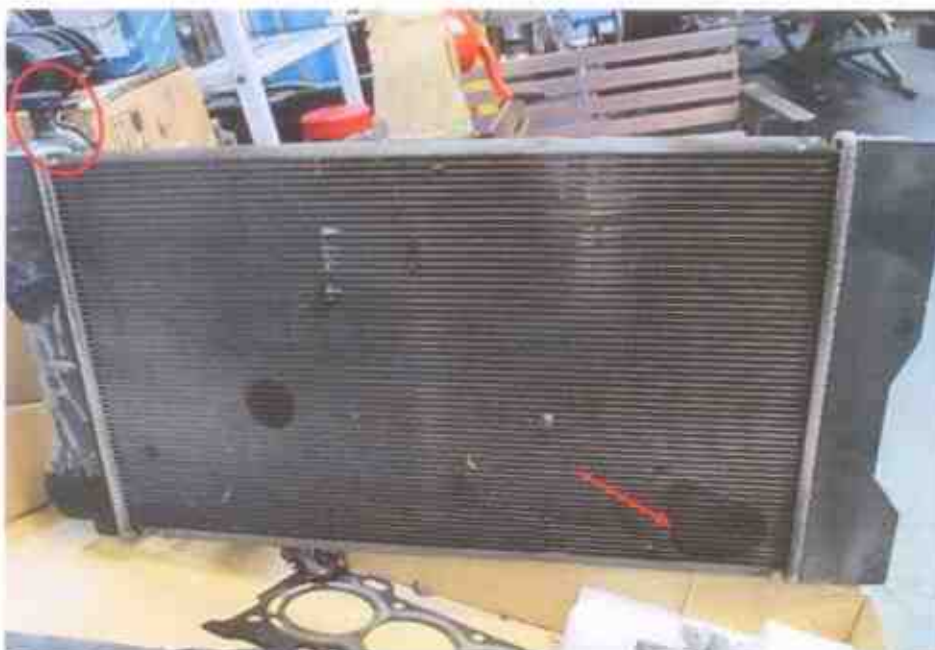
12. We had also found damages to the dismantled components of the Insured Vehicle's cooling system. These had included the radiator, radiator outlet joint, radiator hoses, water pump and thermostat. Upon further examination, we had found the radiator and thermostat to partially burnt and/or melted. The radiator outlet joint and radiator hoses were broken. The cooling system is designed to maintain ideal engine operating temperature as tremendous heat is produced while the engine is in operation. See photos 9 – 13 below.

Photo 9 shows the radiator of the Insured Vehicle which was observed to be partially burnt and/or melted (arrowed) and the broken radiator outlet joint (circled).

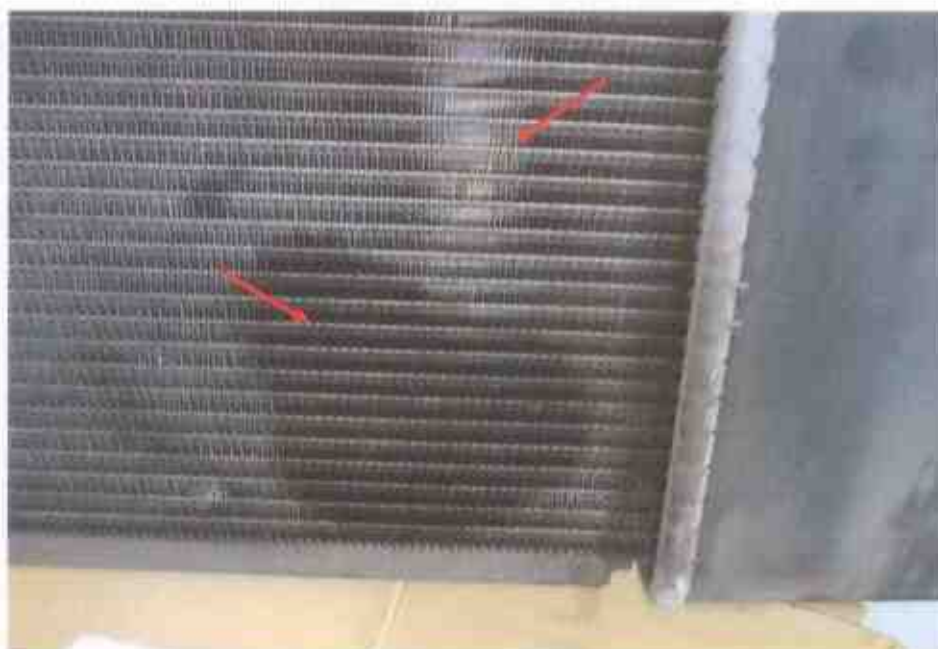
Photo 10 shows a close up view of the radiator of the Insured Vehicle which was observed to be partially burnt and/or melted (arrowed).

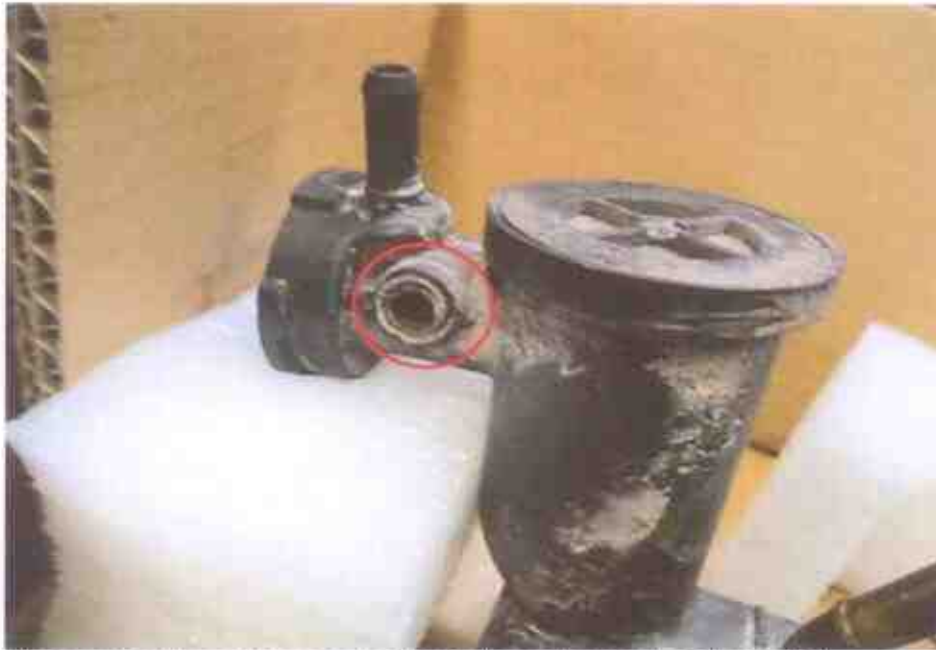
Photo 11 shows a close up view of the broken radiator outlet joint (circled).

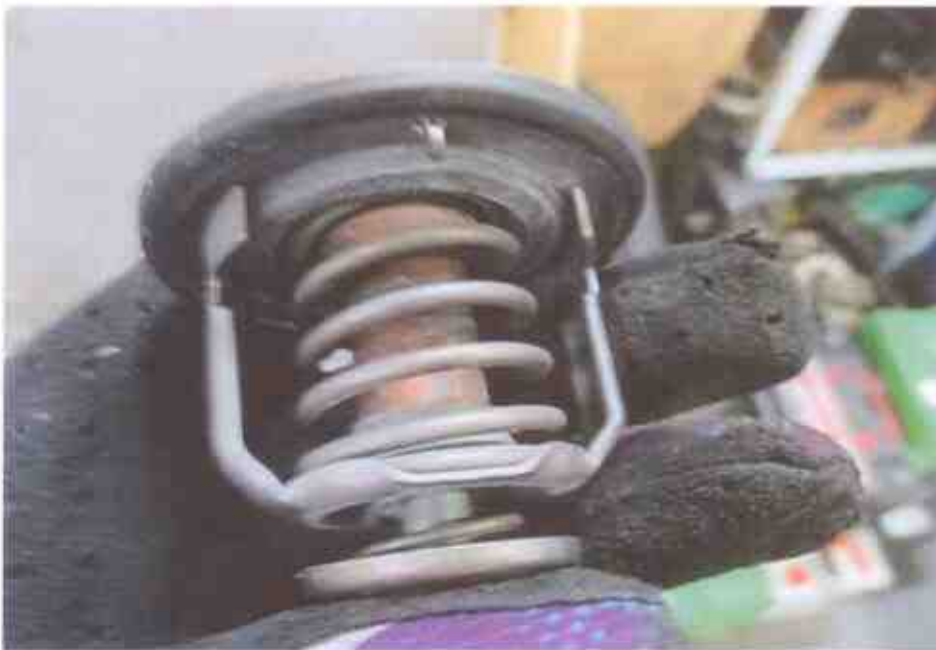
Photo 12 shows a close up view of the Insured Vehicle's thermostat which was observed to be partially burnt and/or melted.

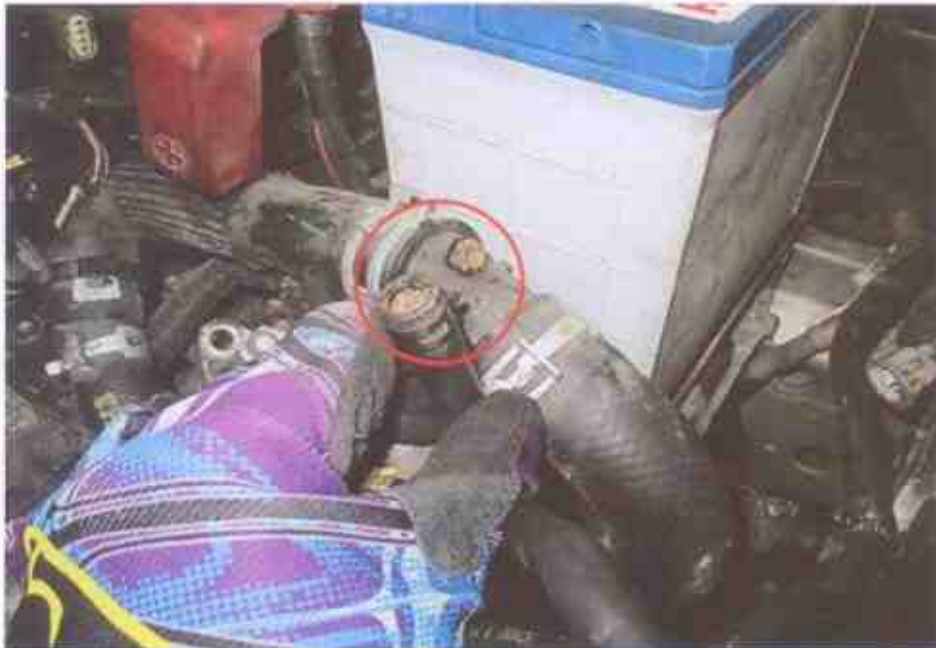
Photo 13 shows the broken radiator hose caused by overheating of the Insured Vehicle (circled).

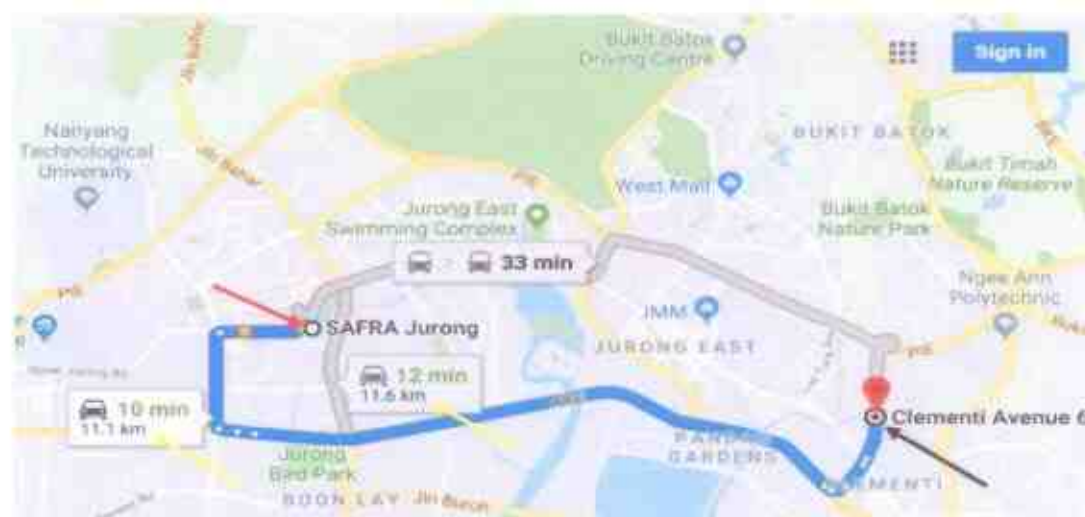
18. For this case, the Insured Vehicle was driven from SAFRA Jurong to RSA where it broke down along Clementi Avenue 6. Basing on Google Map, the approximate distance from SAFRA Jurong to the reported location where the Insured Vehicle broke down along Clementi Avenue 6 (where it was towed) was approximately between 11.1km to 11.6km. See screenshot extracted from Google Map below.

Screenshot extracted from Google Map shows the shortest distance where the Insured Vehicle would have been driven from SAFRA Jurong (red arrow) to Clementi Avenue 6 (black arrow) which was approximately between 11.1km to 11.6km (yellow arrows). Co-relating this distance with this particular case, the Insured Vehicle had travelled a distance of at least 11.1km before it broke down.

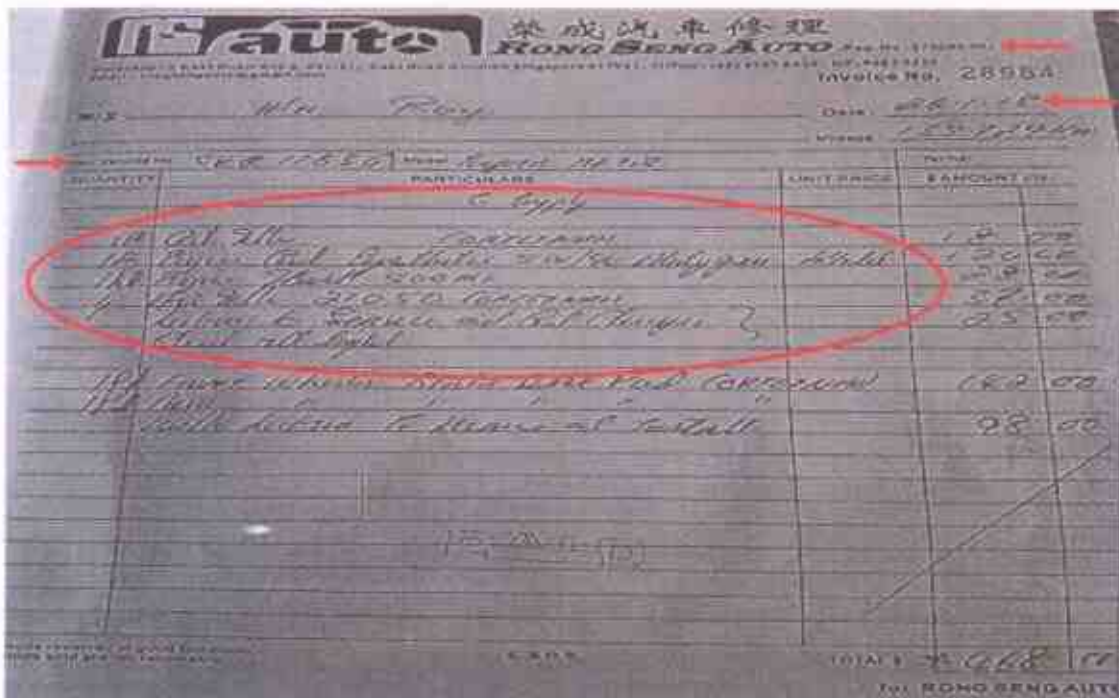
22. During the course of our investigations, we were able to obtain from RSA the latest servicing and repair records of the Insured Vehicle. The last servicing was done on 26 January 2018. The servicing package included changing of engine oil and oil filter. The front and rear brakes were checked and serviced. All fluid levels were also checked. Refer to Invoice 1 below.

Invoice 1 shows the last servicing package done on the Insured Vehicle on 26 January 2018 at RSA (arrowed) which included changing of engine oil and oil filter. The front and rear brake pads were replaced. All fluid levels were also checked (circled).
