Your Ref : 2100352154-04
Our Ref : CI/AIG18009117/Z

23th May 2018

TECHNICAL INVESTIGATION REPORT OF FIRE INCIDENT INVOLVING THE INSURED VEHICLE SJY 7966S ON 12th May 2018

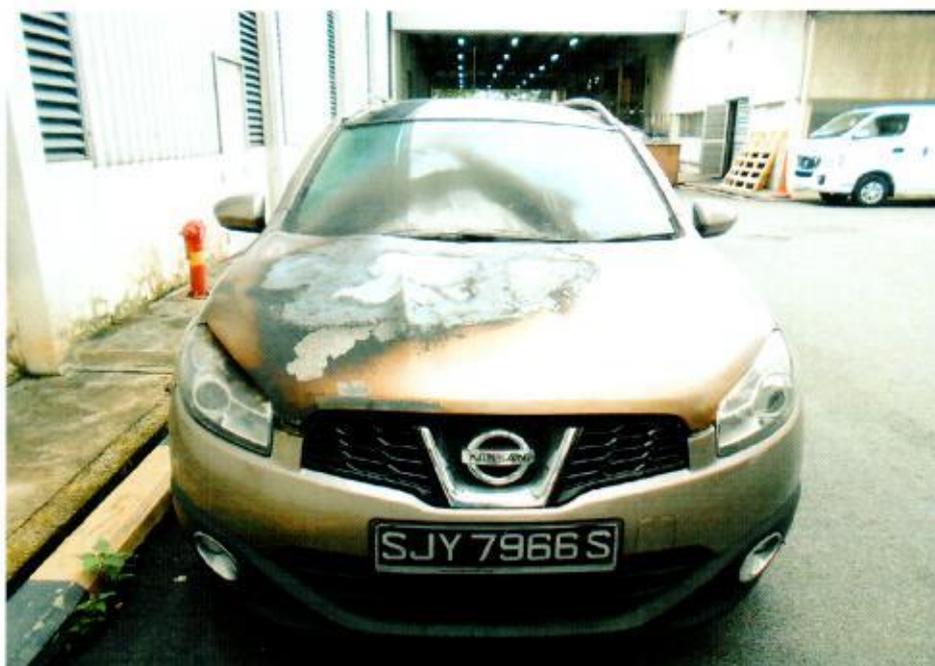
Photo 1 shows the general view of the front right portion of the Insured Vehicle at the time of our inspection. The fire damage to the Insured Vehicle was confined to its front portion. Its front bonnet, front grille and front right headlamp were amongst the body parts that were found to have been affected as a result of the fire.

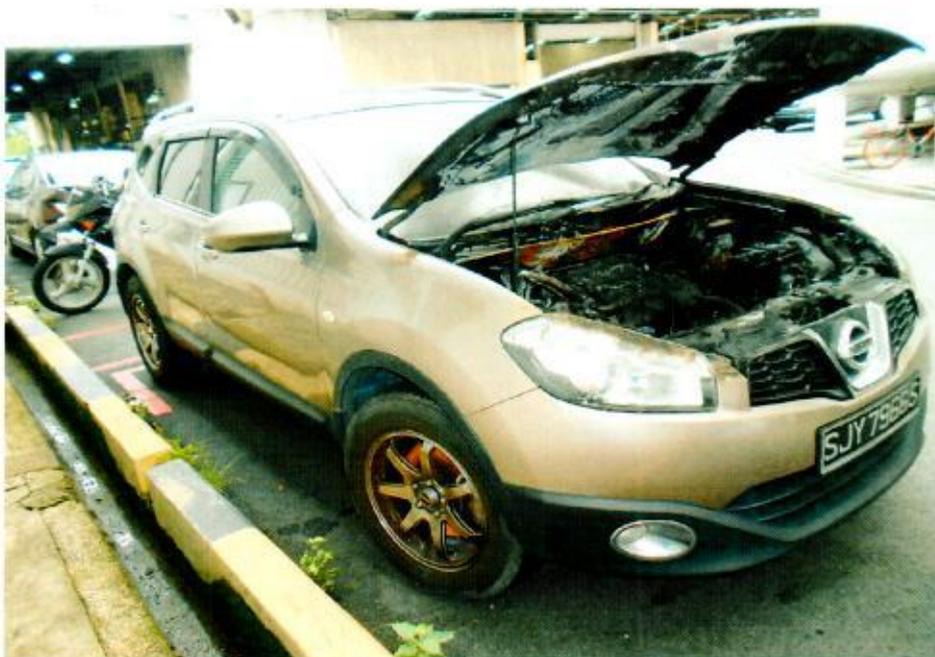
Photo 2 shows the general view of the front right portion of the Insured Vehicle at the time of our inspection. The fire damage to the Insured Vehicle was confined to its front portion. Its front bonnet and front left headlamp were amongst the body parts that were found to have been affected as a result of the fire.

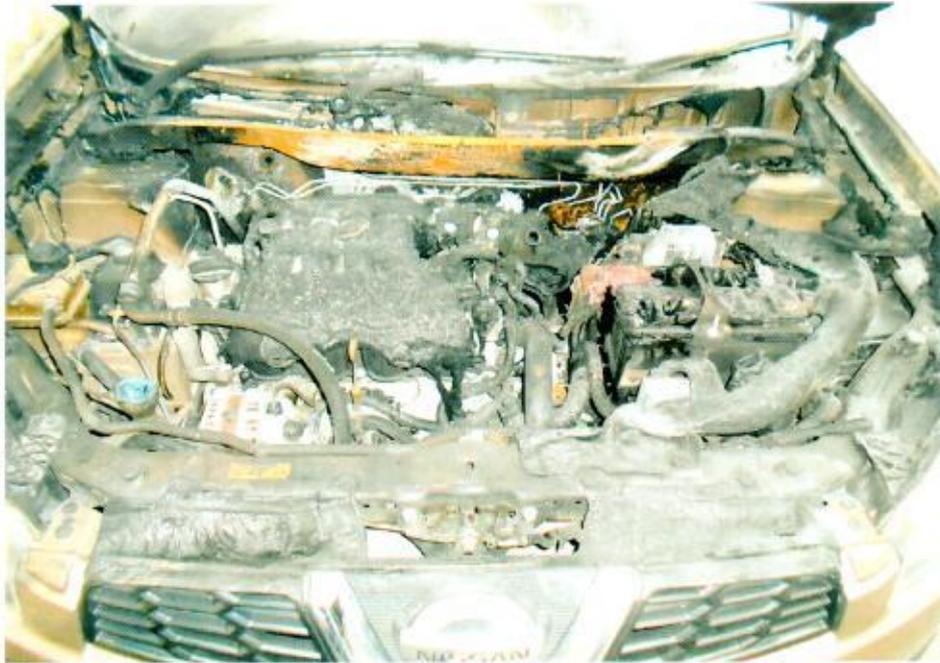
Photo 3 shows the engine compartment of the Insured Vehicle at the time of our inspection. The entire engine compartment of the Insured Vehicle was observed to be severely burnt. Most of the parts inside the engine compartment were found to be burnt and/or melted as a result of the fire.

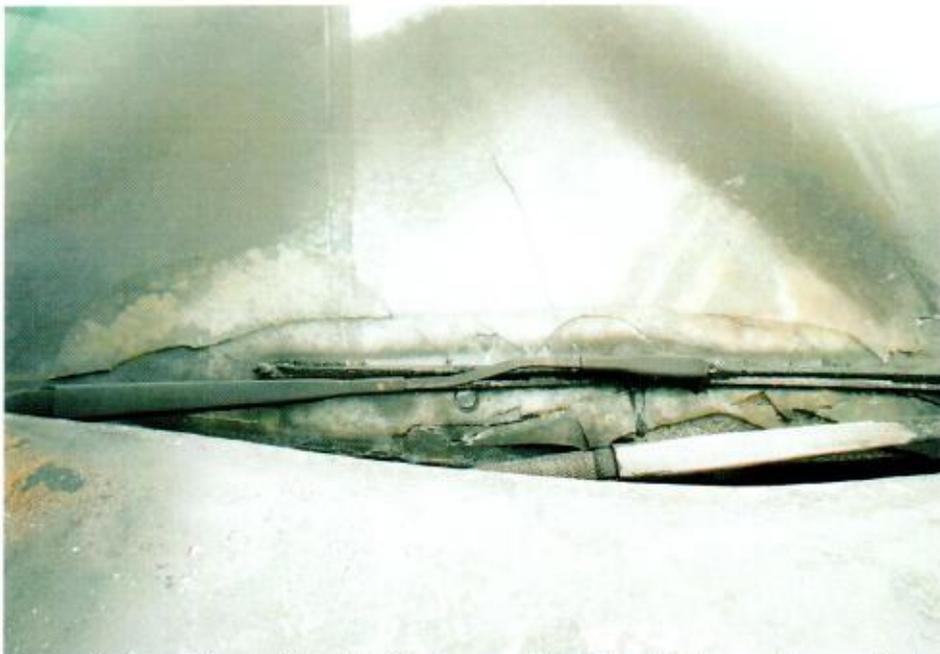
Photo 4 shows the windshield of the Insured Vehicle, which was observed to be cracked were amongst the parts that were found to have been damaged as a result of the fire.

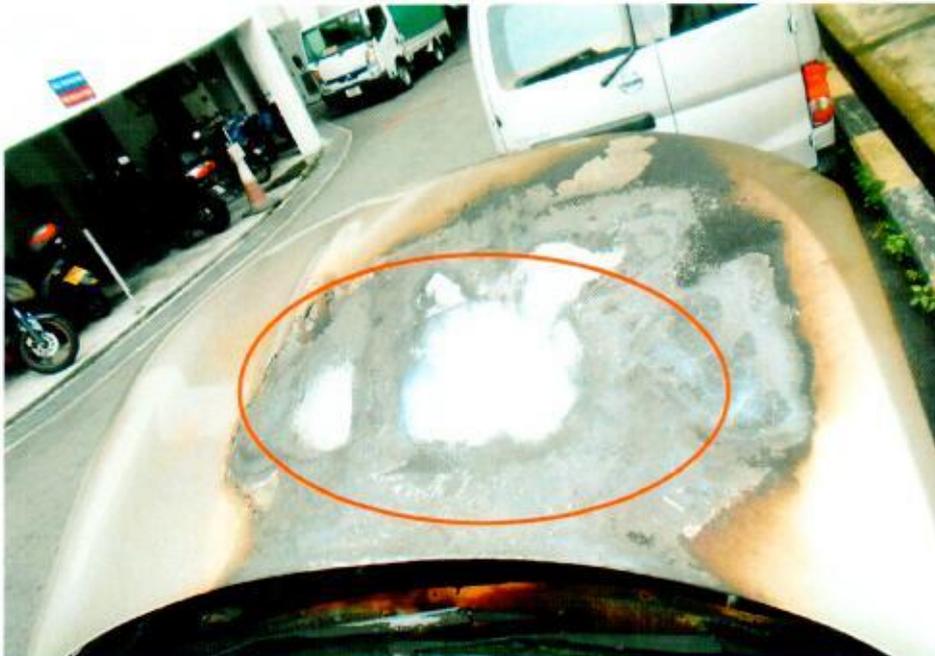
8. For this particular case, the fire appears to have originated within the engine compartment of the Insured Vehicle, somewhere around the centre and towards the rear of the engine compartment. This can be determined from the burn pattern and the high heat intensity burn marks (whitish burn marks) found on the front bonnet of the Insured Vehicle, at both its top and under side.
9. These whitish burn marks are a result of exposure to prolong heat intensity. Rust would normally start to develop around these areas soon after a fire as prolonged exposure to high heat intensity usually causes steel/metal material body parts to be exposed to natural environmental condition. See photo 5 & 6 below.

Photo 5 shows the burn pattern and whitish burn marks (circled) that were found on the top side of the front bonnet of the Insured Vehicle. Such whitish burn marks are a result of exposure to prolong heat intensity, which may indicate where the fire had started. Rust would also begin to develop on these areas soon after the fire.

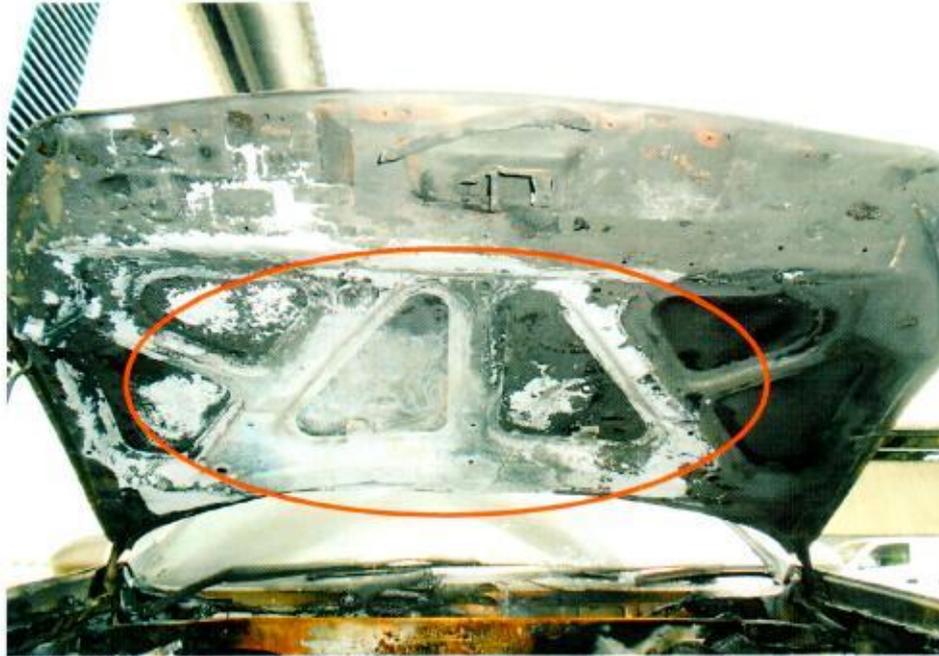
Photo 6 shows the whitish burn marks that were found on the underside of the front bonnet, directly under the area where the same whitish burn marks were found on the top side of the front bonnet. The rust (circled) that had developed around this area was a result of prolonged exposure to high heat intensity, which had caused the steel/metal material of the front bonnet to be exposed to natural environmental condition.

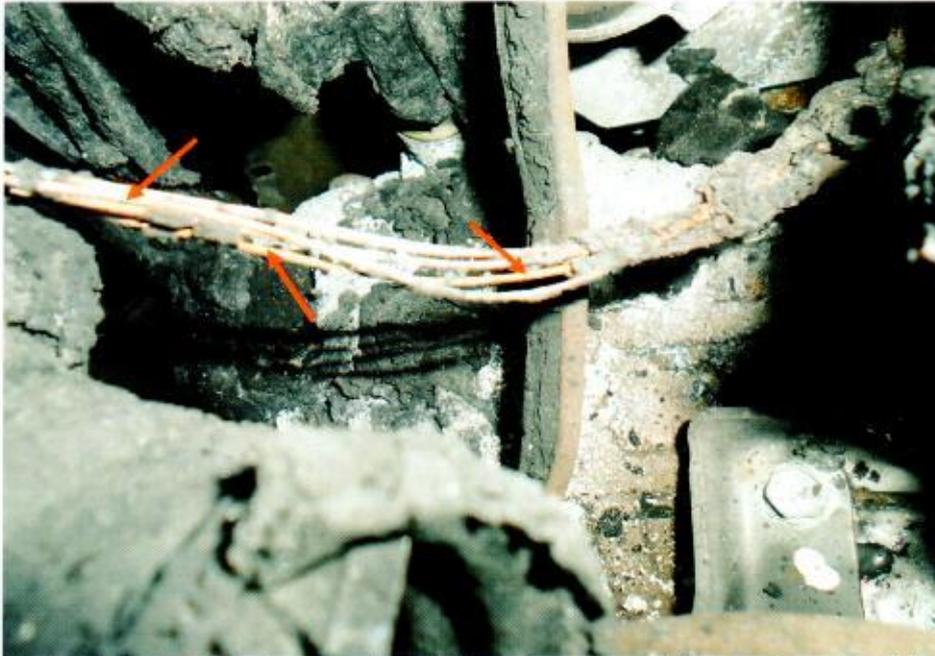
10. Upon closer examination of the area around the centre rear of the engine compartment, which was in the immediate vicinity of where the fire to the Insured Vehicle had likely started, we had found several stretches of wiring burnt internally to its bare copper state. The wirings of the Insured Vehicle and are likely to be the original engine wire harness. Such condition normally indicate internal heating of copper wires which is a sign of an electrical short circuit occurring. This would then appear to suggest that the cause of fire to the Insured Vehicle could have possibly been due to electrical in nature. See photo 7 - 8 below.

Photo 7 shows the close-up view of the wirings around the centre rear of the engine compartment, which was in the immediate vicinity where the fire to the Insured Vehicle had likely started. The wirings (red arrow) were found to have been burnt internally, suggesting occurrence of an electrical short circuit. The wirings also appear to be an original engine wire harness of the insured vehicle.

33. Having investigated and technically analysed the damages of burnt nature to the Insured Vehicle, we are of the view that the cause of fire to the Insured Vehicle was of electrical in nature. For this particular case, the fire had originated along the wiring inside the engine compartment, somewhere around the centre rear of the engine compartment. The wiring was an original factory fitted on the Insured Vehicle.
34. Notwithstanding that we was not provided with any servicing record, basing on STA Inspection Certificate 'passed' result which was done on 05th July 2017, we did not find any evidence which had suggested that the cause of fire to the Insured Vehicle was due to poor maintenance and/or recurring electrical problem.

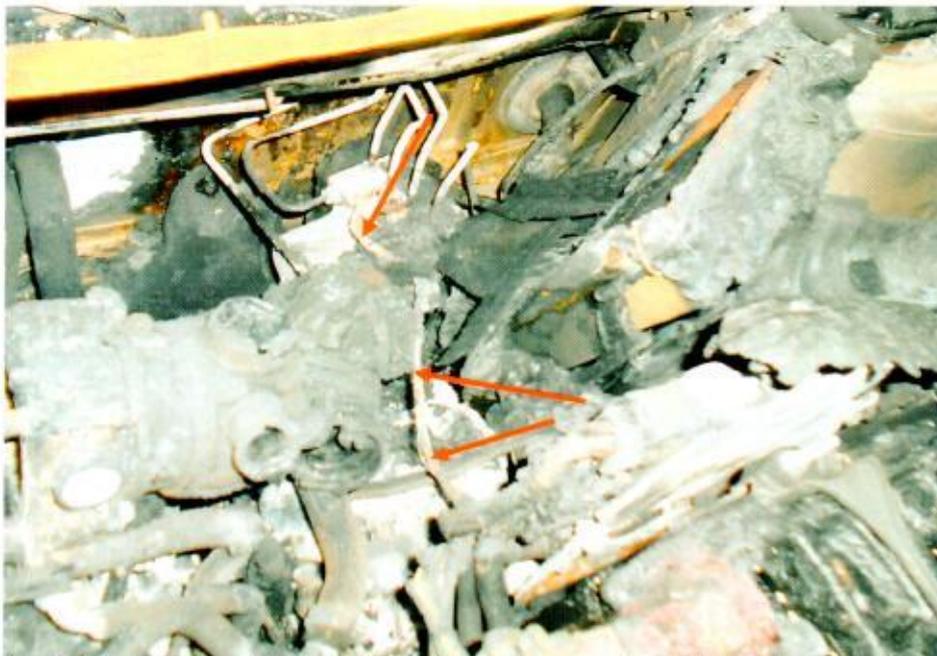
Photo 8 shows a wider view of the wirings (red arrow) which were found to have been burnt internally, suggesting occurrence of an electrical short circuit.

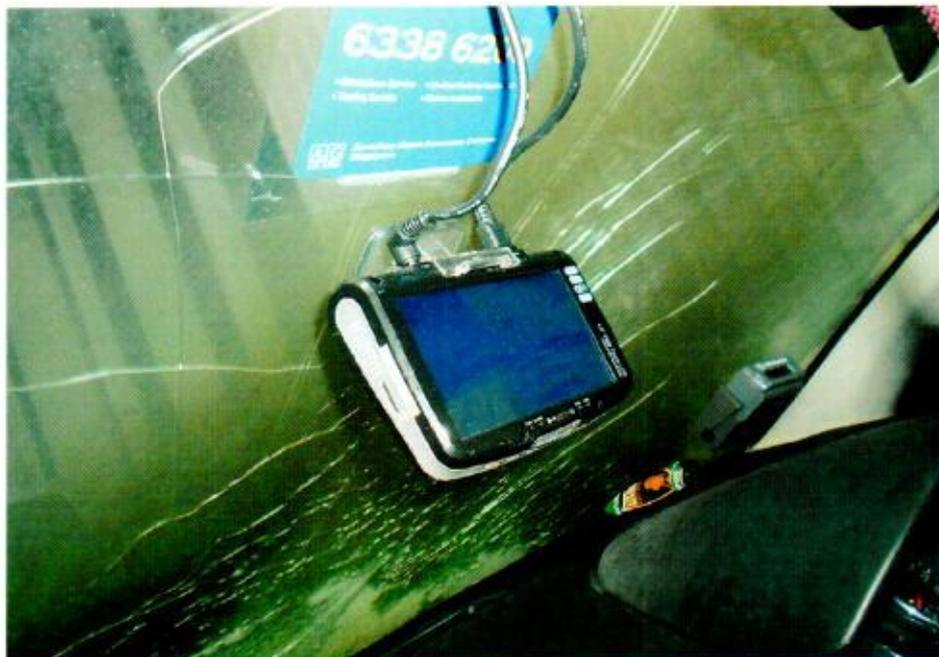
24. Notwithstanding that both The Owner & The Driver informed me that there was no modification(s) and/or additional electronic or electrical component(s) fitted on the Insured Vehicle, our observation found that the Insured Vehicle was installed with an additional video camera recorder fitted on the front windshield.

Photo 11 shows the Insured Vehicle was installed with an additional video camera recorder fitted on the front windshield.

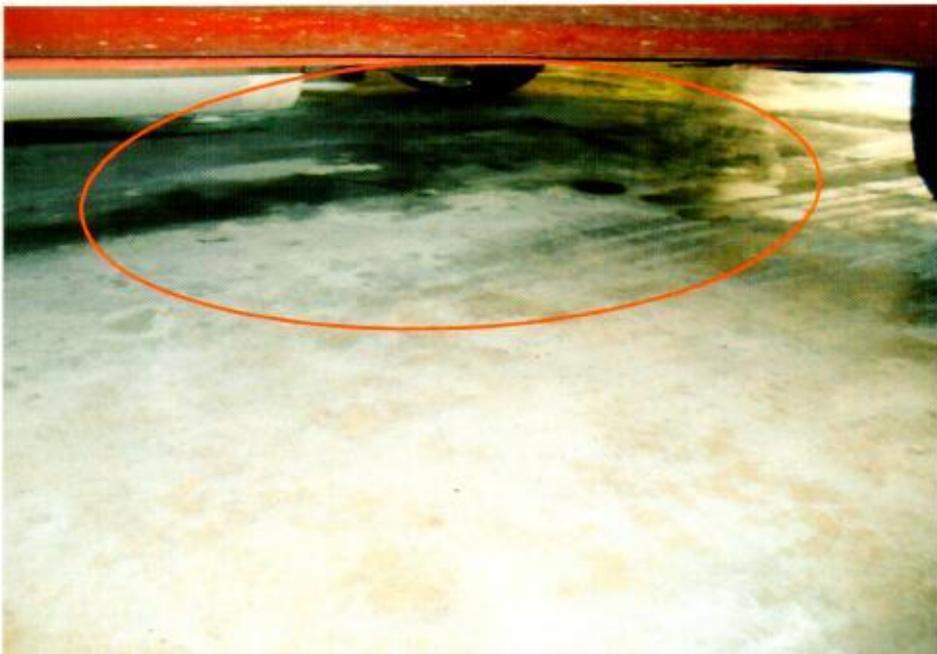
Photo 14 shows the close-up view of where the Insured Vehicle was parked at the time of incident. Further observations on the cement floor, we found burnt marks/ burnt residual at the parking lot. This reveals that there's evidence that fire incident happen at the said spot.

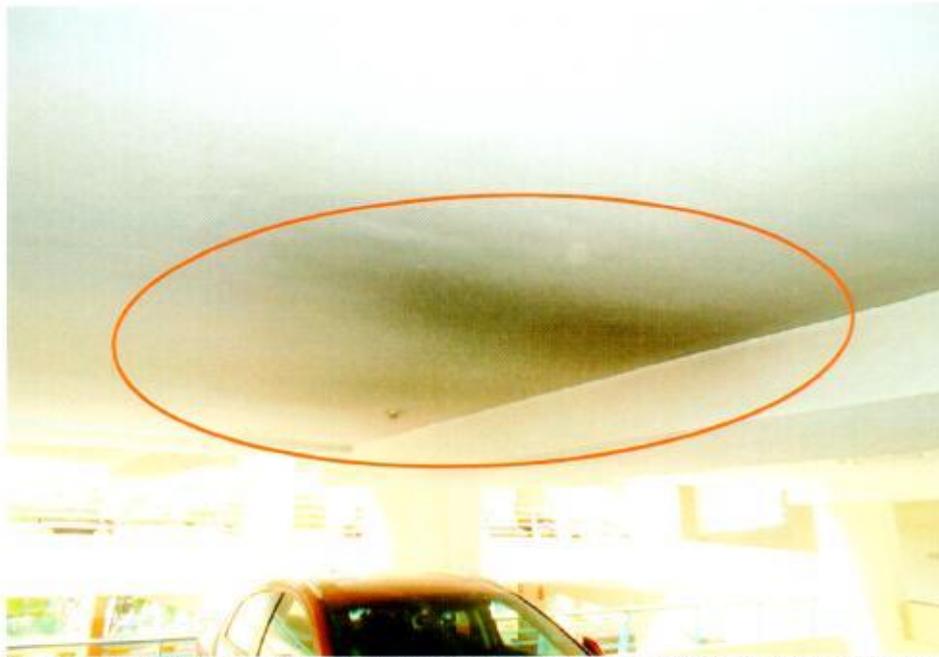
Photo 15 shows the close-up view of where the Insured Vehicle was parked at the time of incident. Further observations, we also found burnt marks/ burnt residual at the concrete ceiling above the parking lot. This reveals that there's evidence that fire incident happen at the said spot.

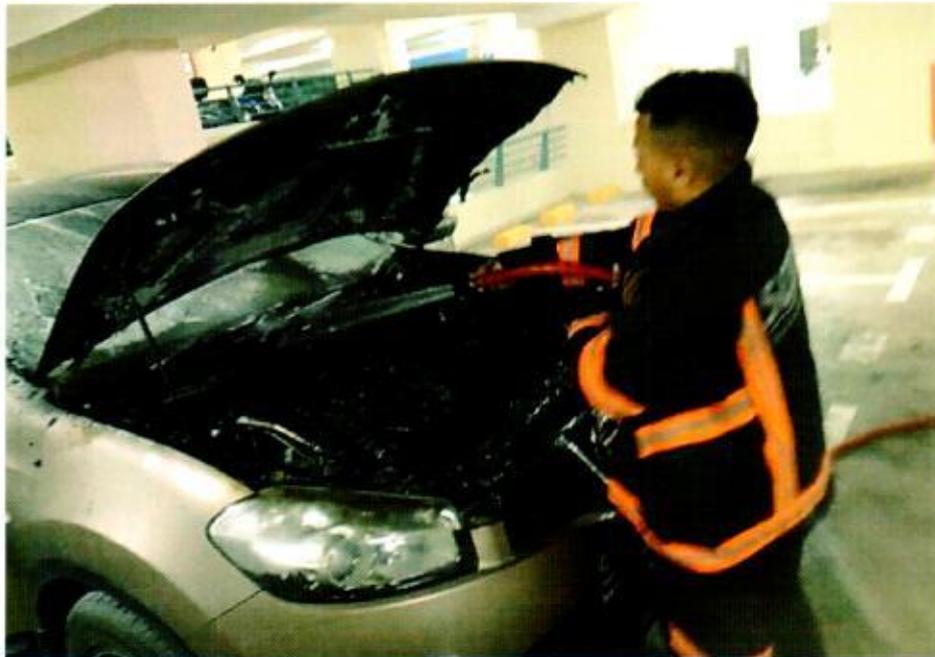
Photo 16 shows the Insured Vehicle at the incident scene. An SCDF fire fighter was seen trying to extinguish the fire from the Insured Vehicle.

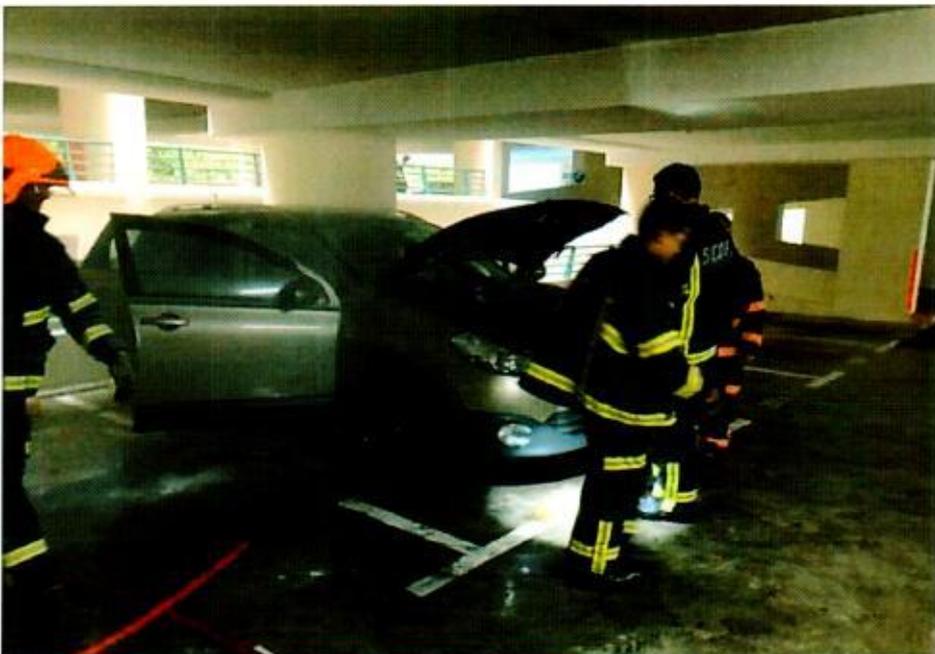
Photo 17 shows the Insured Vehicle at the incident scene. SCDF fire fighters were seen trying to extinguish the fire from the Insured Vehicle.

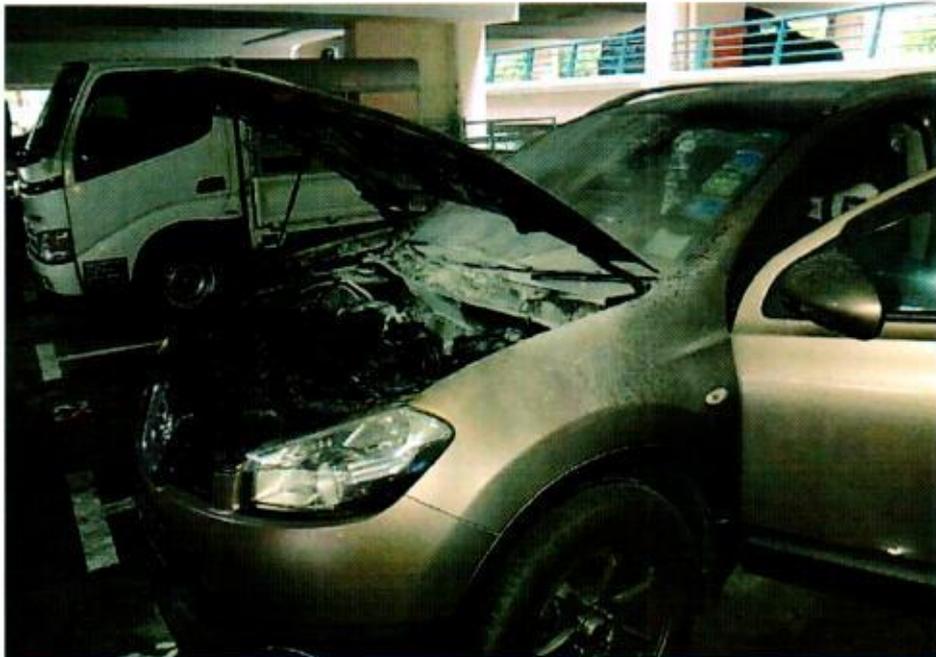
Photo 18 shows a semi close-up view of where the Insured Vehicle was parked at the time of incident. It was after the fire-fighter's had extinguished the fire.

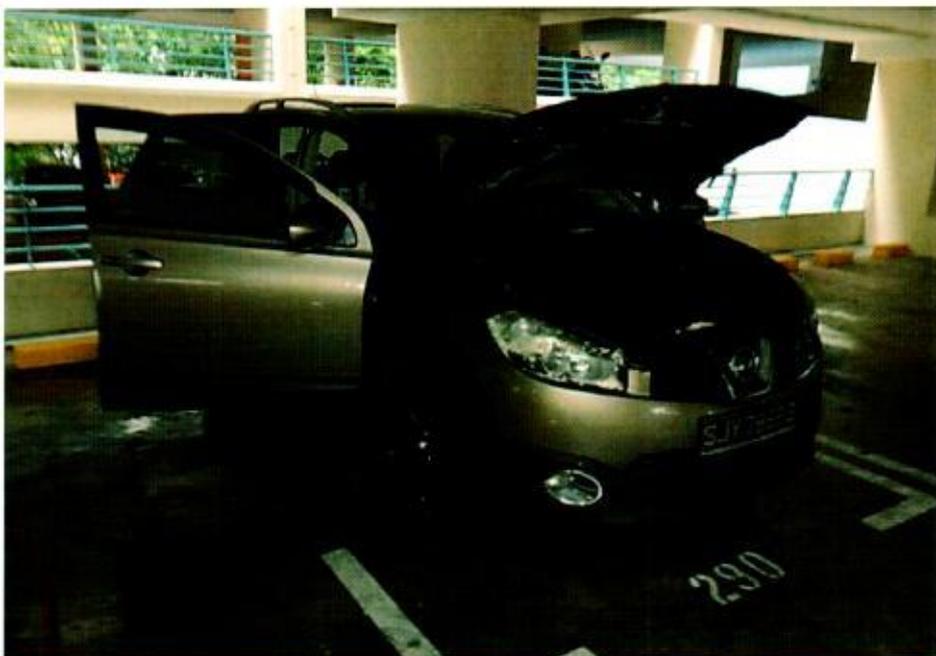
Photo 19 shows the close-up view of the Insured Vehicle after SCDF fire fighters had extinguished the fire.
