INVESTIGATION REPORT:

Our Ref : CI/EQI18009124/N
Claim No : DM18HO00977-JG
Insured : YL 1675L
Date of Accident : 12 April 2018
Location : Carpark of Tanjong Pagar Distripark

Interview Summary of the Driver of the Insured Vehicle YL 1675L

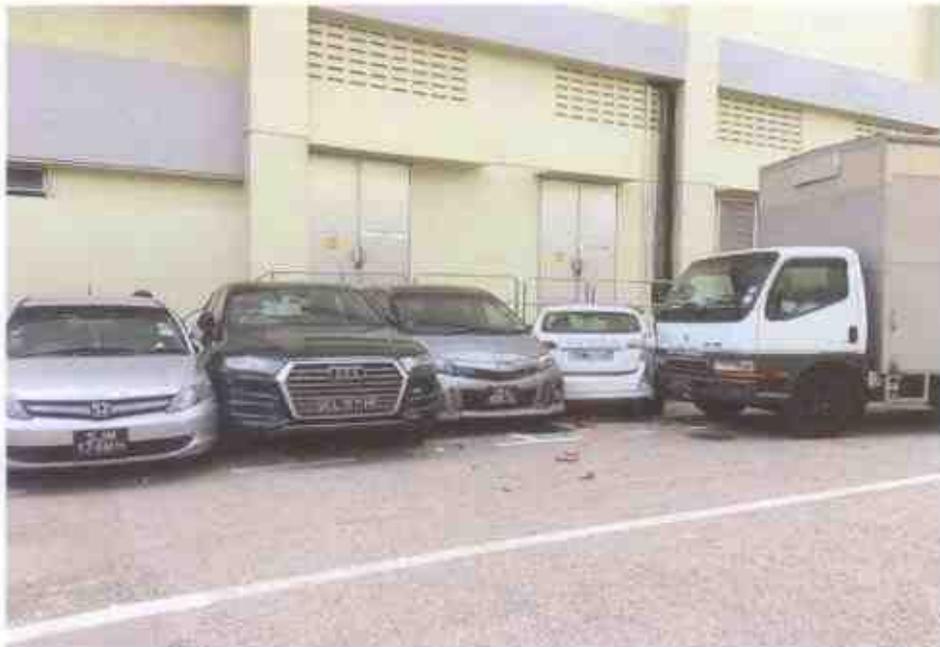
16. Our review of the post- accident photographs provided to us by Mr Kumar and all 4 vehicle owners seem to correlate with their accounts of the accident. The impact force of the Insured Vehicle's collision with the right rear portion of the parked Volvo subsequently caused a chain collision with the other 3 parked vehicles. The Volvo sustained the most damage due to direct contact with the Insured Vehicle.
17. Upon closer examination of these photographs, we observed that there were dents to the right rear side panel of the Volvo. The boot lid and rear bumper were dislodged. The tail lights and signal lights had cracked. The Toyota and Audi sustained damages to the left as well as right front portions. The Honda sustained damages to its left front portion as it was the last parked vehicle involved in the accident. See photos 2 - 8 below.

Photo 2 shows the final position of the Insured Vehicle and the 4 parked vehicles after the accident. The impact force of the Insured Vehicle's collision with the right rear portion of the parked Volvo subsequently caused a chain collision with the other 3 parked vehicles.

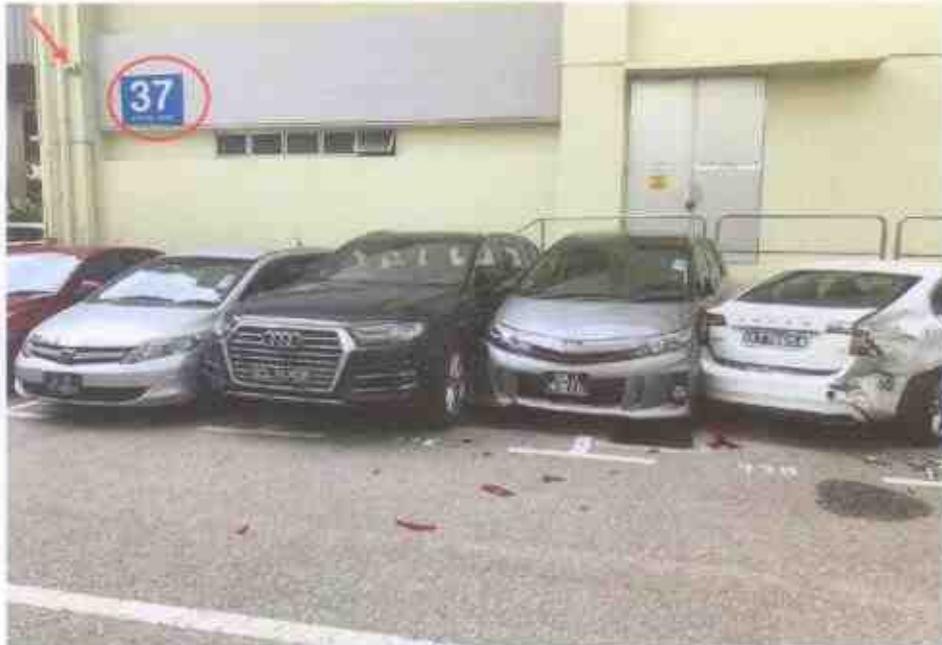
Photo 3 shows the final position of the Insured Vehicle and the 4 parked vehicles after the accident. The accident had occurred at the open carpark of Block 37 of TPD as described by Mr Kumar (circled). We also observed that there was a CCTV camera affixed at Block 37 which had captured video footage of the accident, as mentioned by Mr Tiang (arrowed).

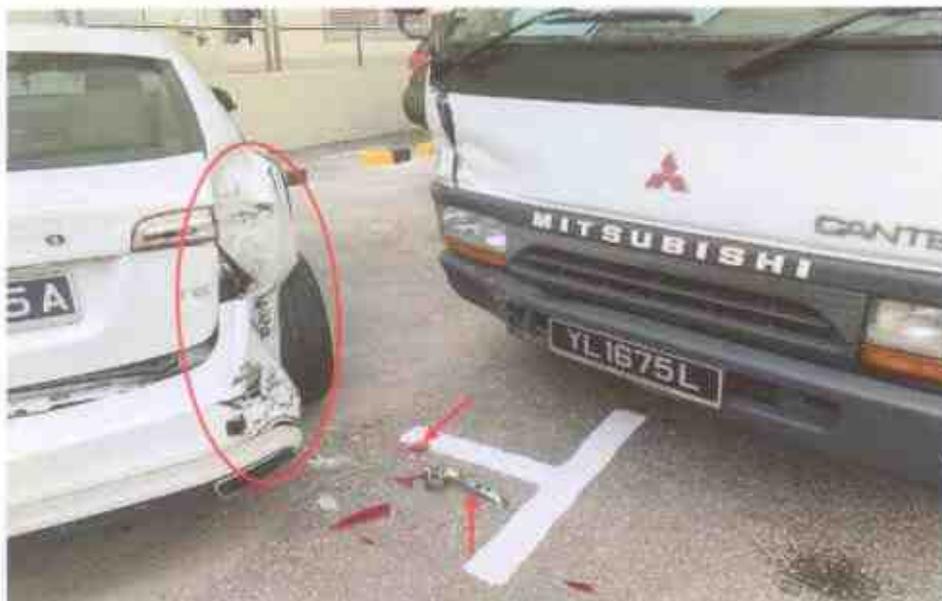
Photo 4 shows the Volvo post- accident which had sustained the most damages due to direct contact with the Insured Vehicle. Upon closer examination, we observed that there were dents to the right rear side panel of the Volvo. The boot lid and rear bumper were dislodged (circled). The tail lights and signal lights had cracked (arrowed).

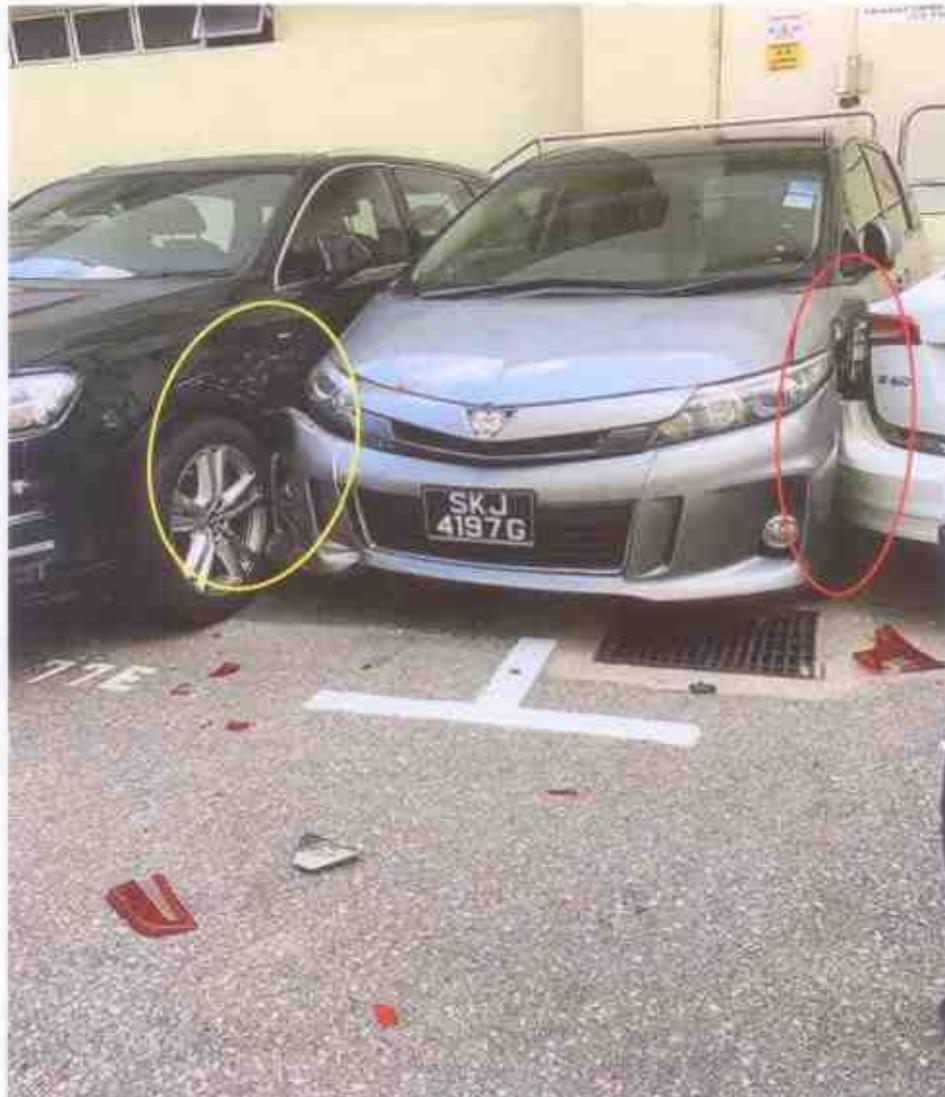
Photo 5 shows the Toyota post- accident which had sustained damages to its left front portion as a result of the contact with the right rear portion of the Voivo (red circle). The impact force of the collision also resulted in a slight dislodgement of the Toyota's front bumper, causing it to hit the left front portion of the Audi (yellow circle).

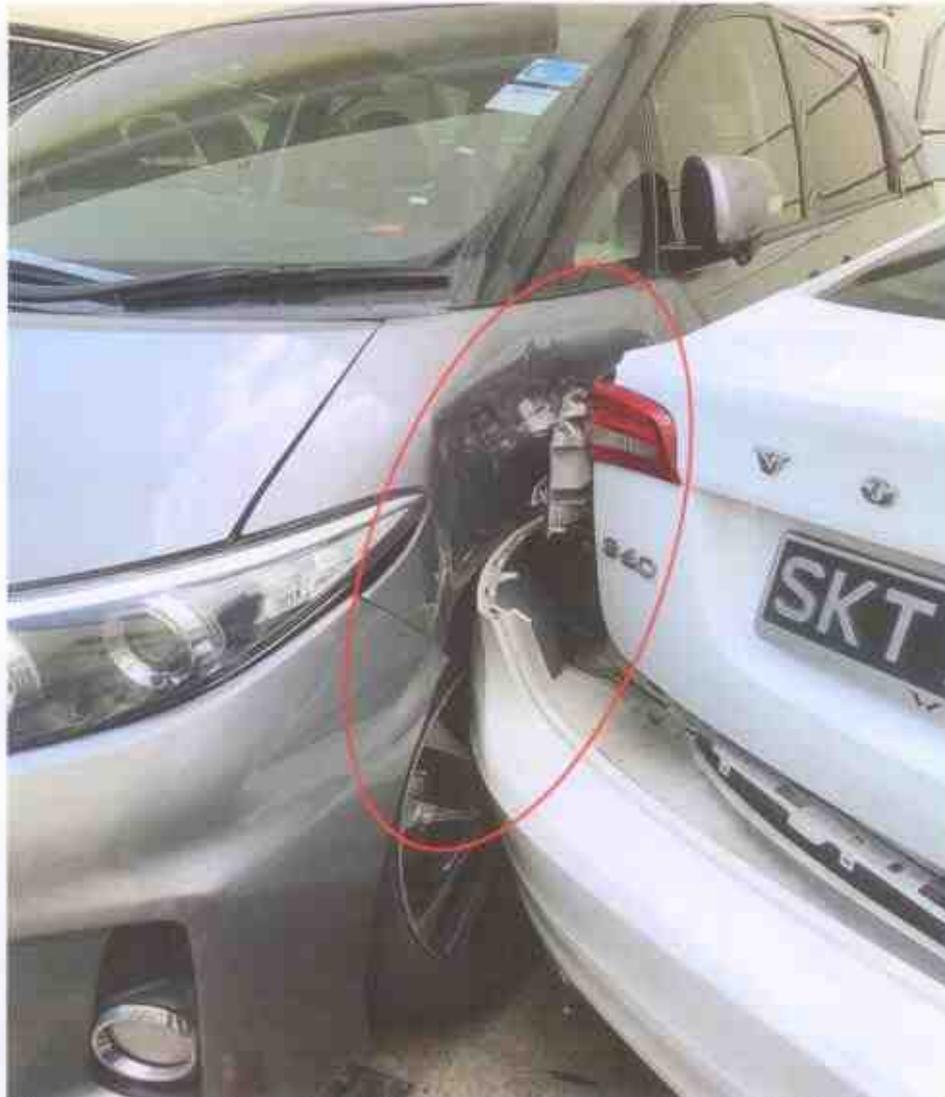
Photo 6 shows a closer view of the damaged left front portion of the Toyota post-accident. We observed that the Toyota had sustained dents and paint graze marks on its left front side-panel as well as some relatively minor marks of grazing nature on the edges of the left front wheel rim as a result of contact with the right rear portion of the Volvo (circled).

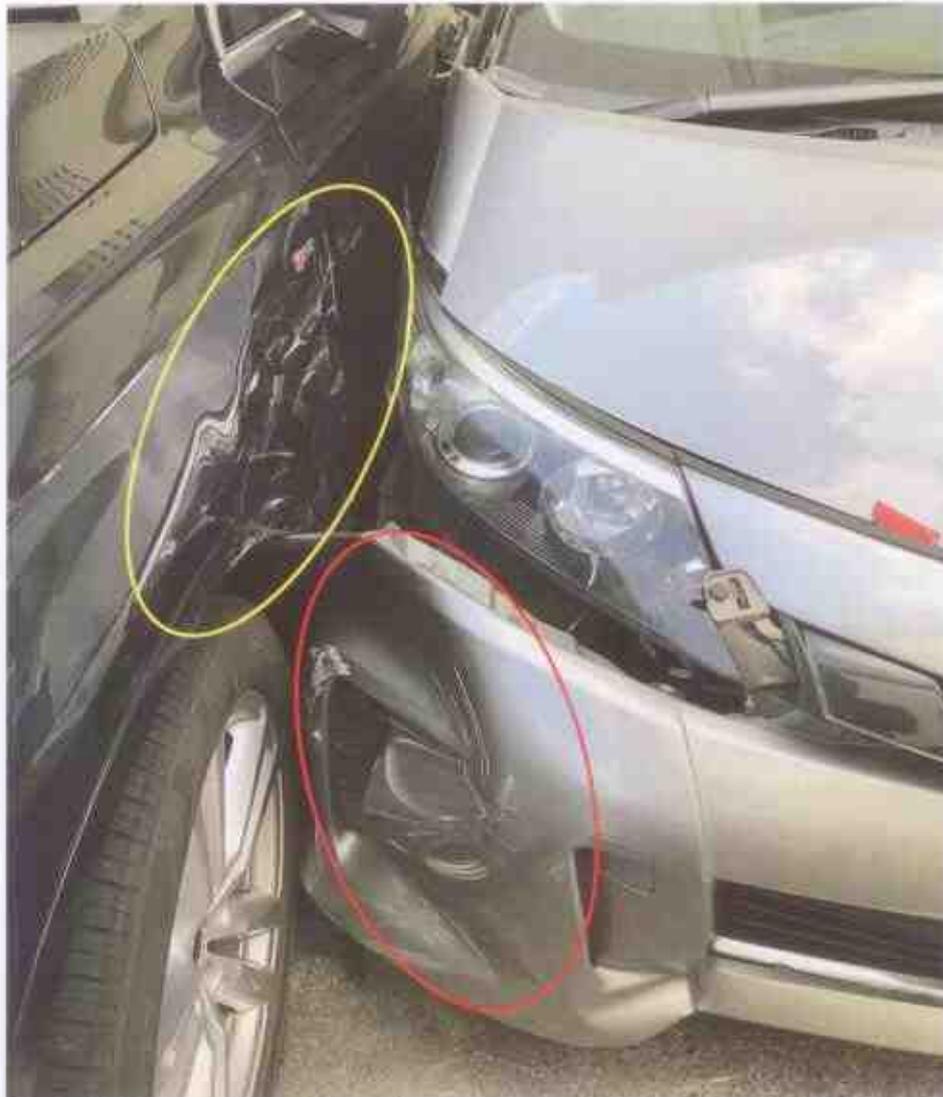
Photo 7 shows a closer view of the damaged left front portion of the Audi post-accident. The impact force of the collision had resulted in a slight dislodgement of the Toyota's front bumper (red circle), causing it to hit the left front portion of the Audi. We observed that the Audi had sustained dents and paint graze marks on its left front portion (yellow circle).

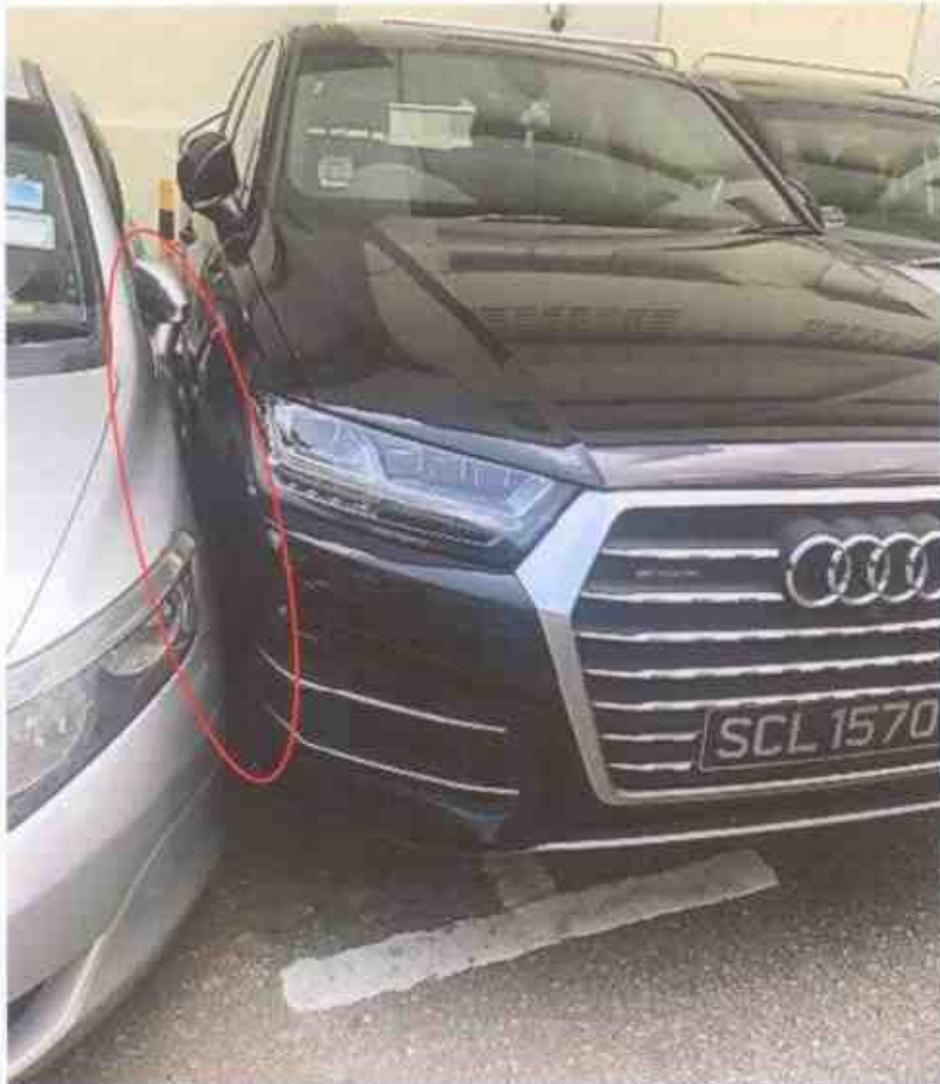
Photo 8 shows the Honda post- accident which was the least damaged amongst all 4 parked vehicles. The impact force of the collision had caused the Audi to hit the left front portion of the Honda. We observed that the Honda had sustained slight dents and paint graze marks on its left front portion and left side mirror (circled).

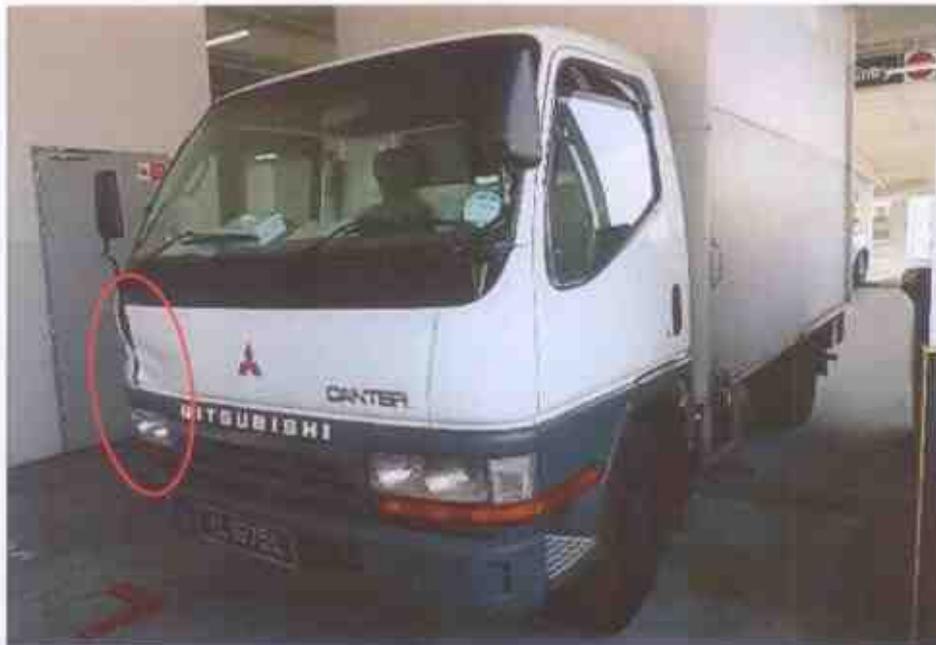
Photo 10 shows the general left front view of the Insured Vehicle at the time of accident reporting at Lai Huat, taken on the next day after the accident. The left front portion is undamaged, corroborating with Mr Kumar's account of the accident in which the front right portion of the Insured Vehicle had collided with the right rear portion of the parked Volvo (circled).

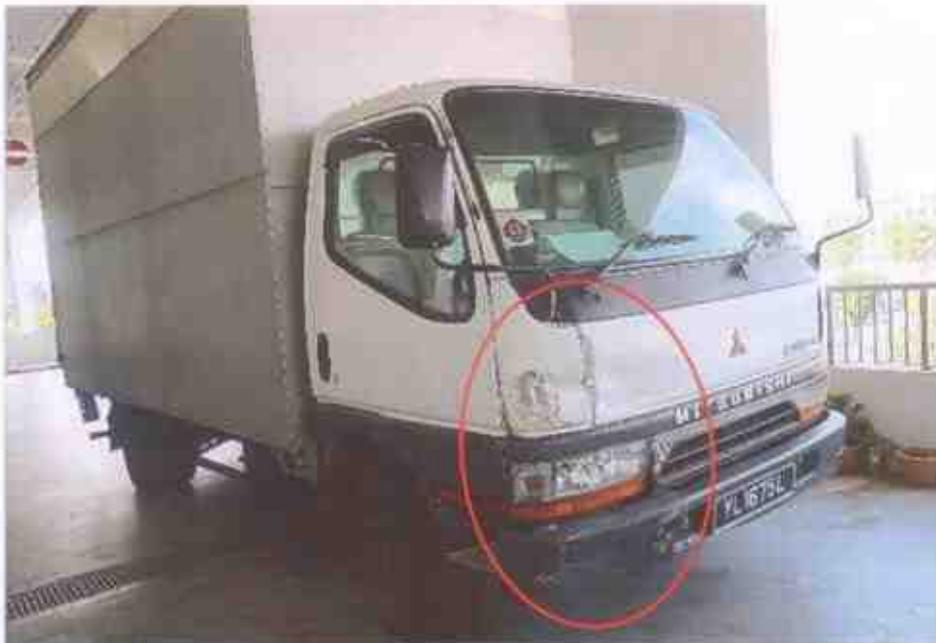
Photo 11 shows the general right front view of the Insured Vehicle at the time of accident reporting at Lai Huat, taken on the next day after the accident. The Insured Vehicle had sustained damages to its front right portion (circled).

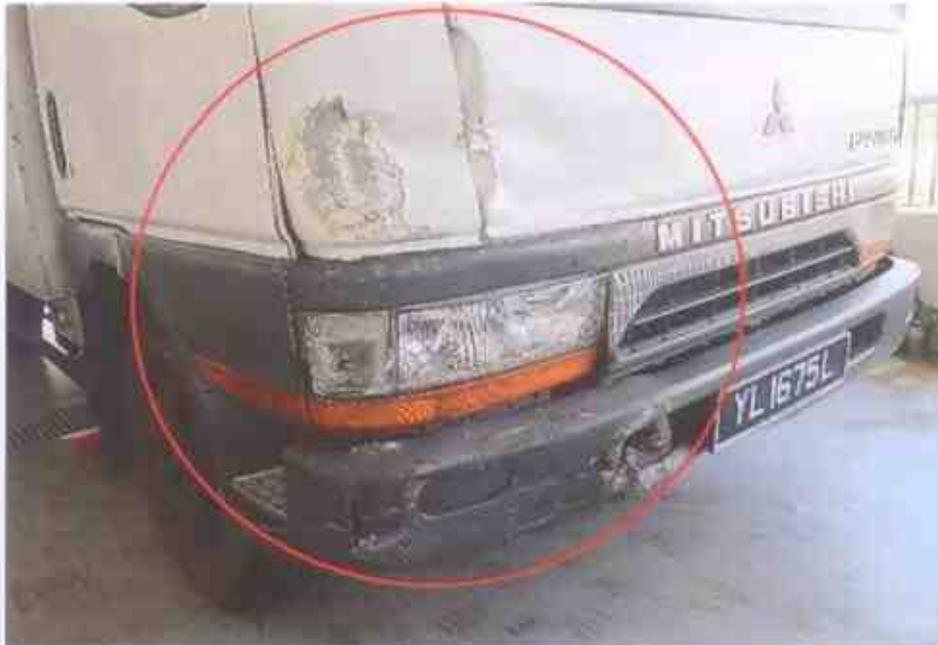
19. We reviewed the photographs showing the Insured Vehicle at the time of accident reporting at Lai Huat which were taken on the next day after the accident. Our close examination of these photographs revealed that the Insured Vehicle had sustained significant damages to its front right portion, particularly to its front bonnet, front right panel, right headlight and front bumper.
20. The front bonnet and front right panel sustained dents due to the impact with the Volvo. There were paint chip marks on the front right panel. The right headlight had cracked and paint graze marks were found on the front right portion of the front bumper which had buckled as a result of the accident. These damages seem to corroborate with Mr Kumar's statement in which the front right portion of the Insured Vehicle had collided with the right rear portion of the parked Volvo. See photos 10 - 12 below.

Photo 12 shows a closer view of the damaged front right portion of the Insured Vehicle. The Insured Vehicle had sustained significant damages to its front right portion particularly to its front bonnet, front right panel, right headlight and front bumper. The front bonnet and front right panel sustained dents due to the impact with the Volvo. There were paint chip marks on the front right panel. The right headlight had cracked and paint graze marks were found on the front right portion of the front bumper which had buckled as a result of the accident. These damages seem to corroborate with Mr Kumar's statement in which the front right portion of the Insured Vehicle had collided with the right rear portion of the parked Volvo (circled).
