To Inspect Vehicle No: SHD 6732R

Affiliated to Federation Internationale Des Experts En Automobile			
CHINA TAIPING INSURANCE (S) PTE LTD		Ref : CS/CTI18009185/Dqb	
3 ANSON ROAD #16-00 SPRINGLEAF TOWERSINGAPORE 079909		Date : 21-05-2018

VEHICLE DAMAGE INSPECTION REPORT

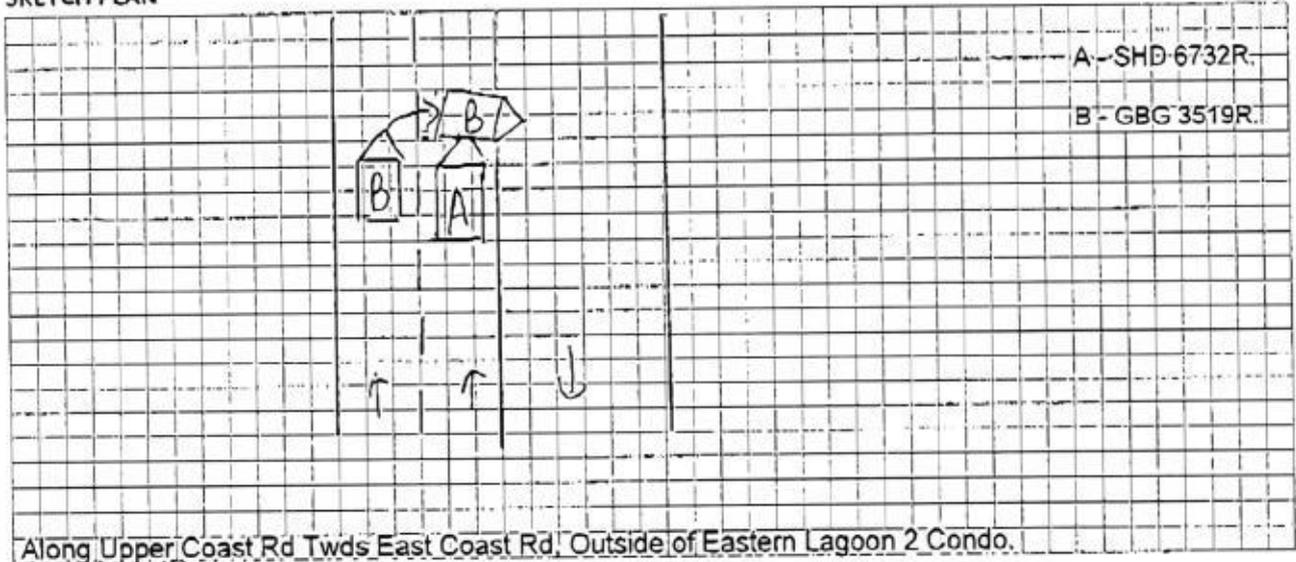
SKETCH PLAN

On 17.05.2018 at about 10:25 Hrs, I was travelling along Upper Coast Rd towards East Coast Rd with no passenger on board.

As I reached outside of Eastern Lagoon 2 Condo, a lorry (GBG 3519R) which was travelling on my left made a U-turn in a sudden manner. This resulted veh (B) to collide onto my taxi (A) front left portion.
