Your Ref: Honda Engine  
Our Ref : CI/TP18009298/D

**Mdm Png Beng Hua**  
Block 326 Hougang Avenue 7  
#03-339  
Singapore 530326

### **INSPECTION REPORT OF A HONDA ENGINE**

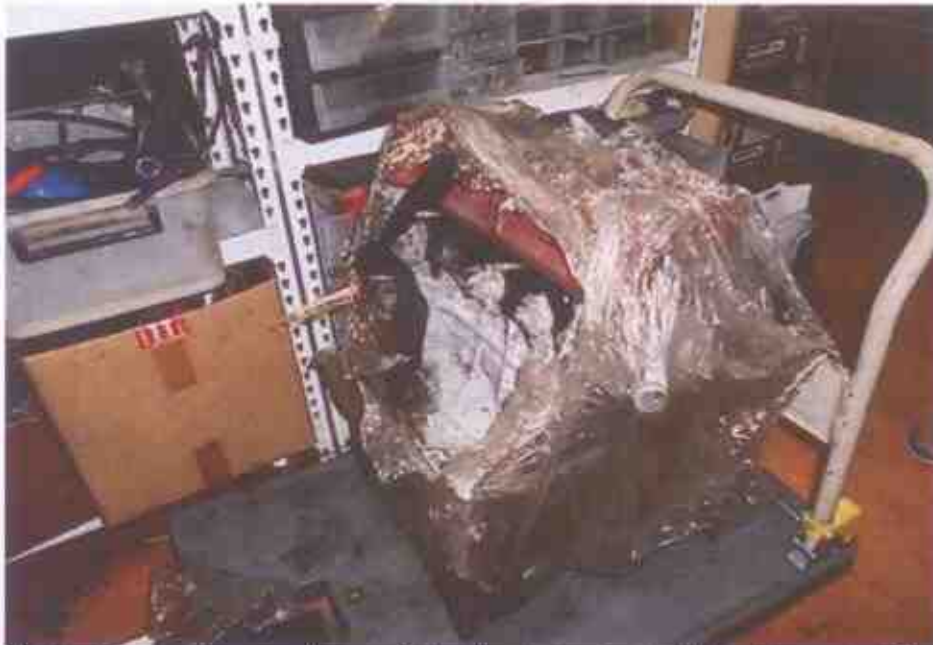
**Photo 1** shows a general view of the Honda engine that I had inspected. The Honda engine was observed to be a used engine and was not fitted on any motor car. It was also observed to be a complete assembly with all mechanical parts still intact, within the engine housing.

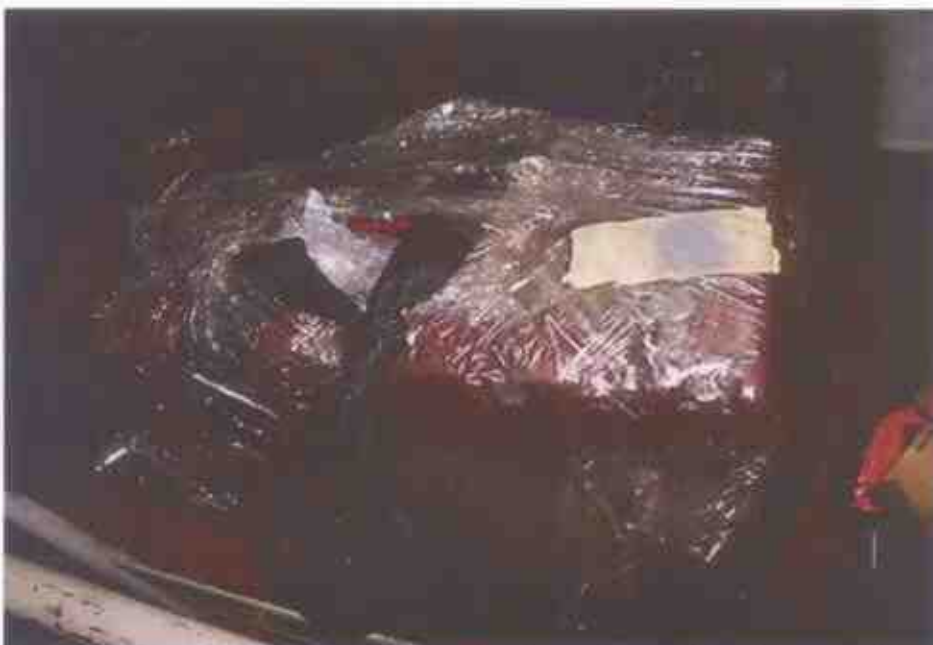
**Photo 2** shows a general view of the Honda engine that I had inspected. The Honda engine was observed to be a used engine and was not fitted on any motor car. My visual examination of the engine housing revealed the housing to be of serviceable/satisfactory condition. There was no crack and/or hole observed on the engine housing.

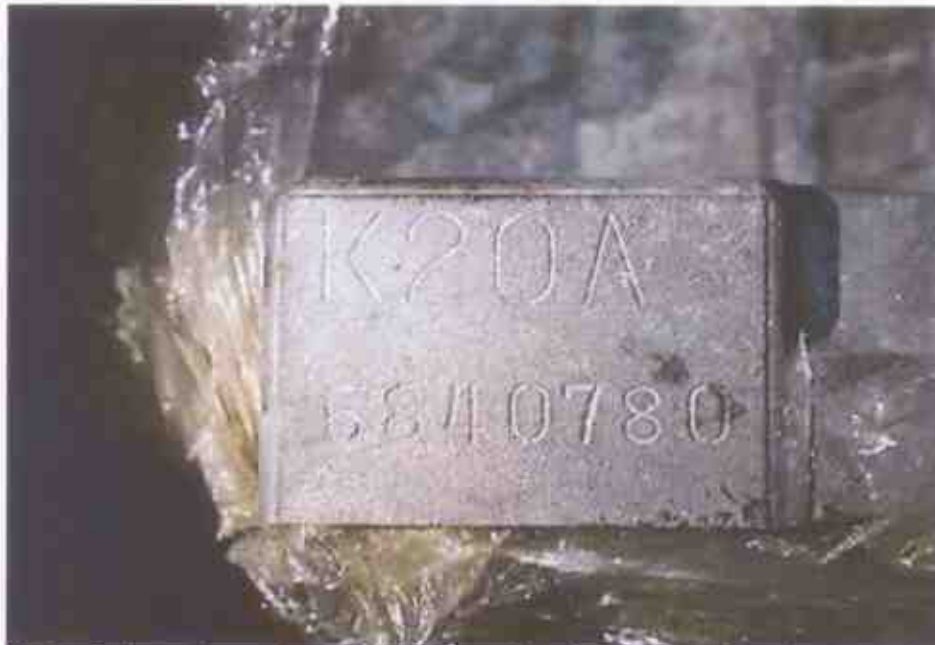
Photo 3 shows the engine number engraved on the housing of the Honda engine that I had inspected. The engine number was K20A5840780.

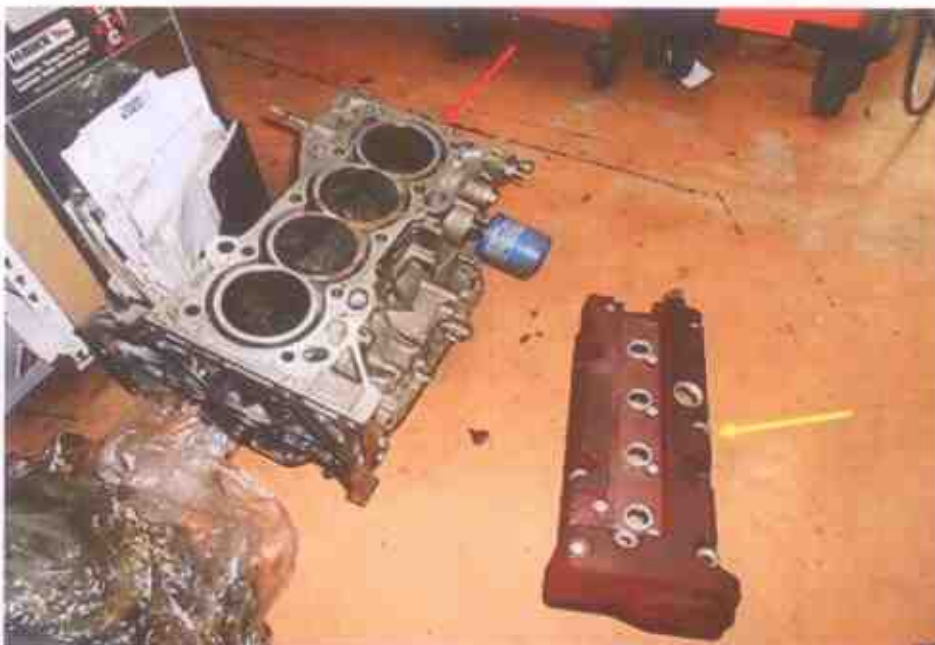
Photo 4 shows the top block (yellow arrow) of the Honda engine separated from its bottom block (red arrow). This was to enable me to carry out measurements of its cylinders, in particular the bore and stroke measurements of each cylinder, which typically can be used to determine the engine displacement or more commonly referred to as engine cc.

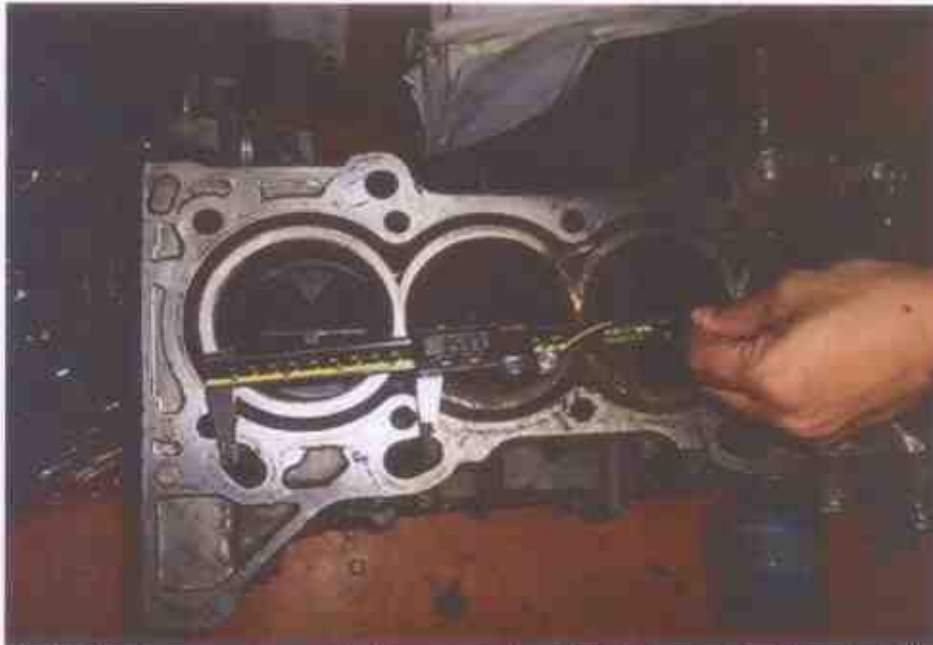
Photo 5 shows measurement being carried out to the bore of cylinder 1 of the Honda engine. The bore and stroke measurements of the Honda engine were carried out using a digital Vernier Caliper, which was calibrated prior to the start of measurements.

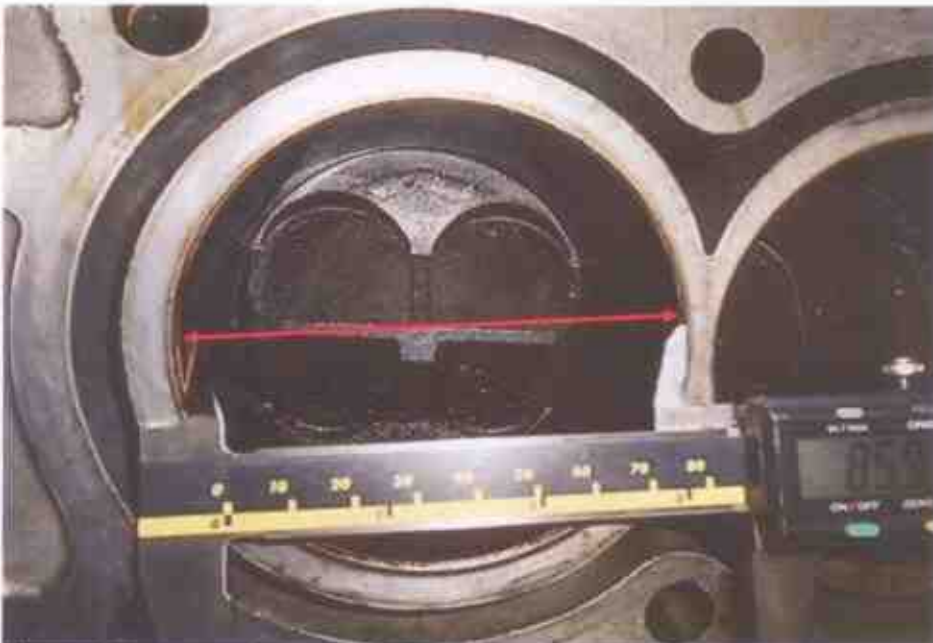
Photo 6 shows measurement being carried out to the bore of cylinder 1 of the Honda engine. The bore and stroke measurements of the Honda engine were carried out using a digital Vernier Caliper.

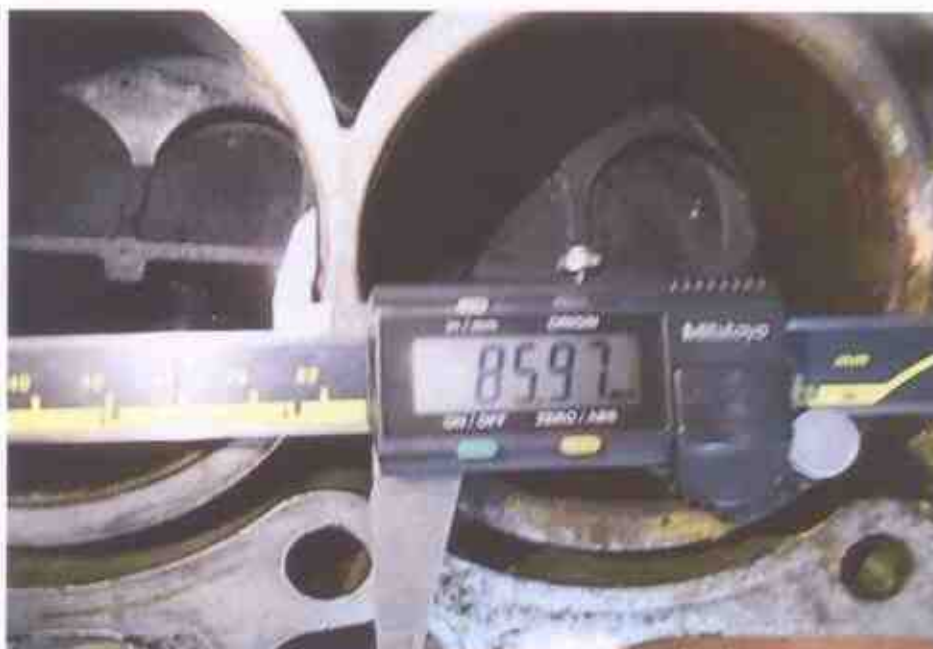
**Photo 7** shows the bore measurement of cylinder 1, which was recorded to be 85.97mm.

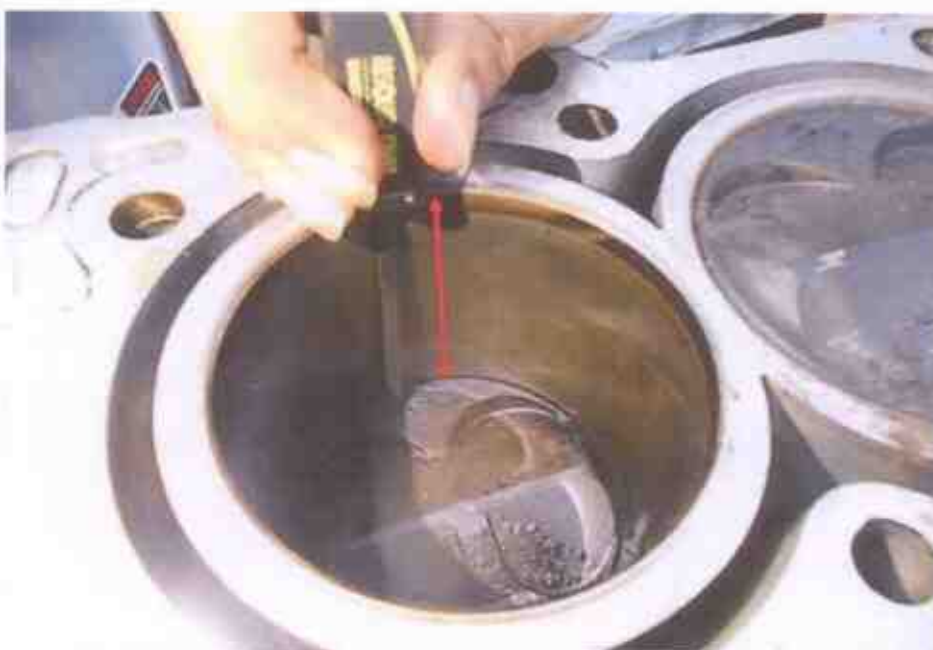
**Photo 8** shows measurement being carried out to the stroke of cylinder 1 of the Honda engine. The bore and stroke measurements of the Honda engine were carried out using a digital Vernier Caliper.

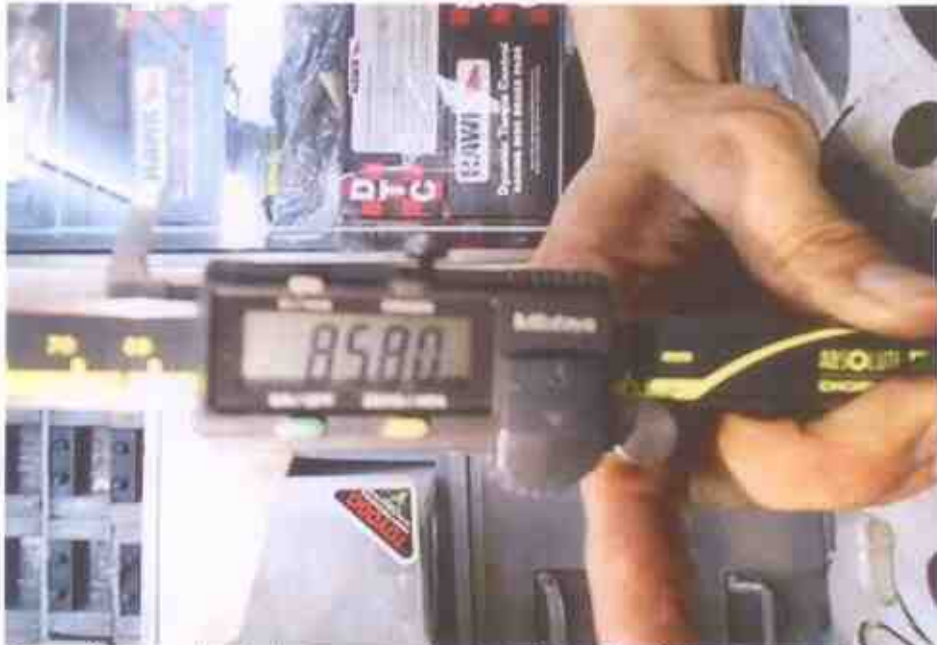
Photo 9 shows the stroke measurement of cylinder 1, which was recorded to be 85.80mm.

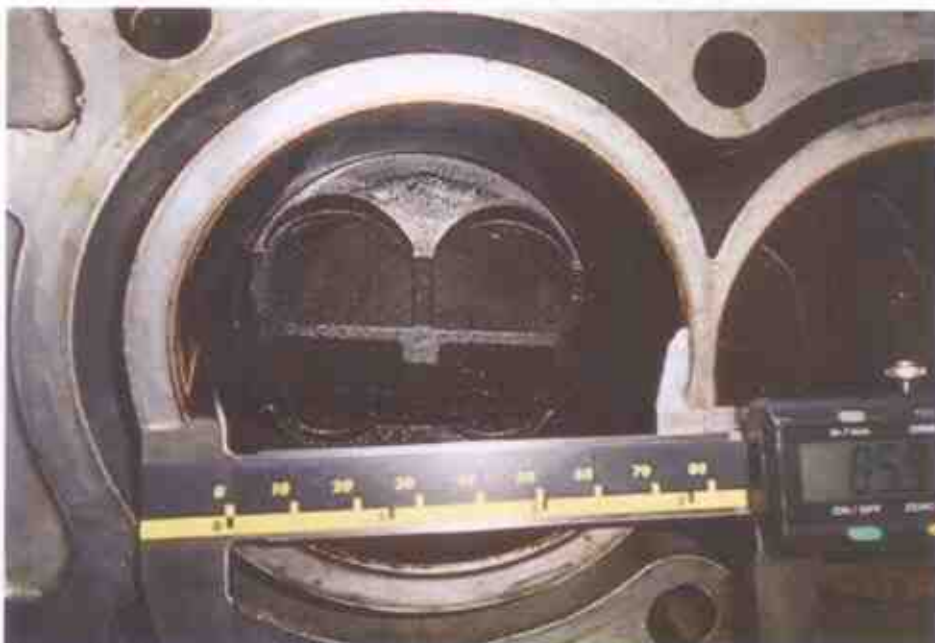
Photo 10 shows measurement being carried out to the bore of cylinder 2 of the Honda engine. The bore and stroke measurements of the Honda engine were carried out using a digital Vernier Caliper, which was calibrated prior to the start of measurements.

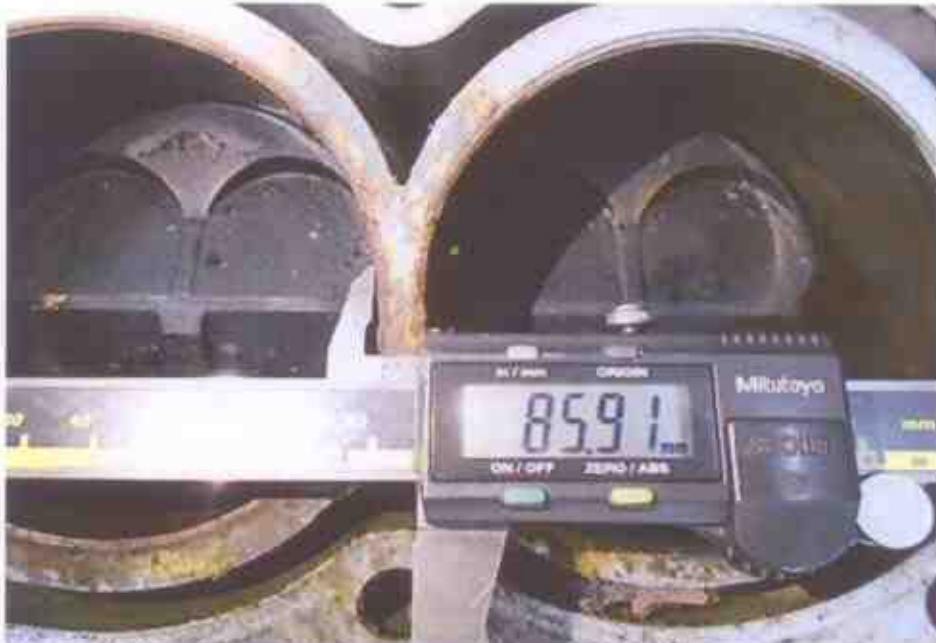
Photo 11 shows the bore measurement of cylinder 2, which was recorded to be 85.91mm.

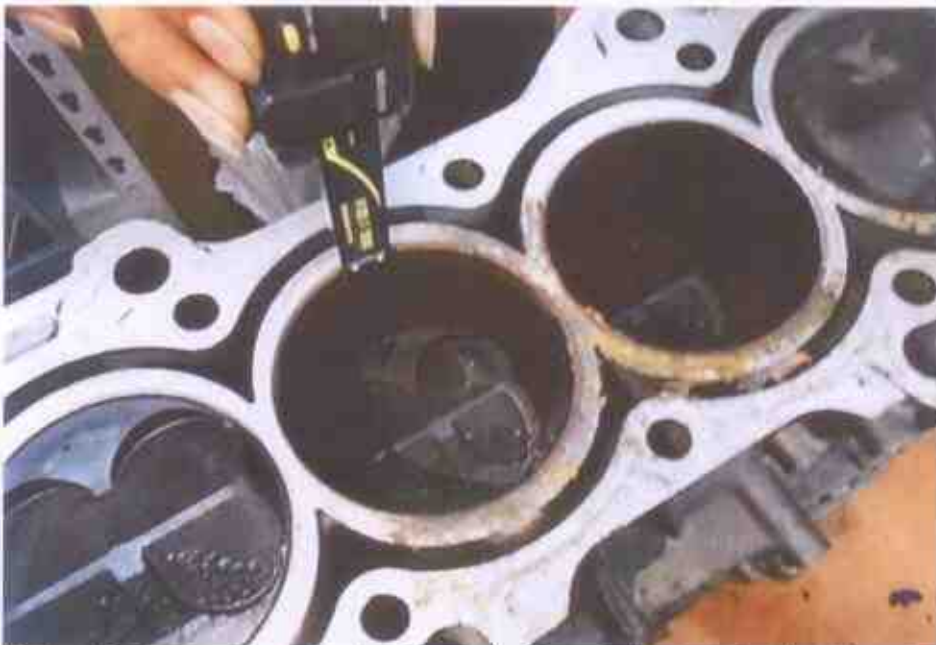
Photo 12 shows measurement of the stroke for cylinder 2 of the Honda engine that I had inspected.

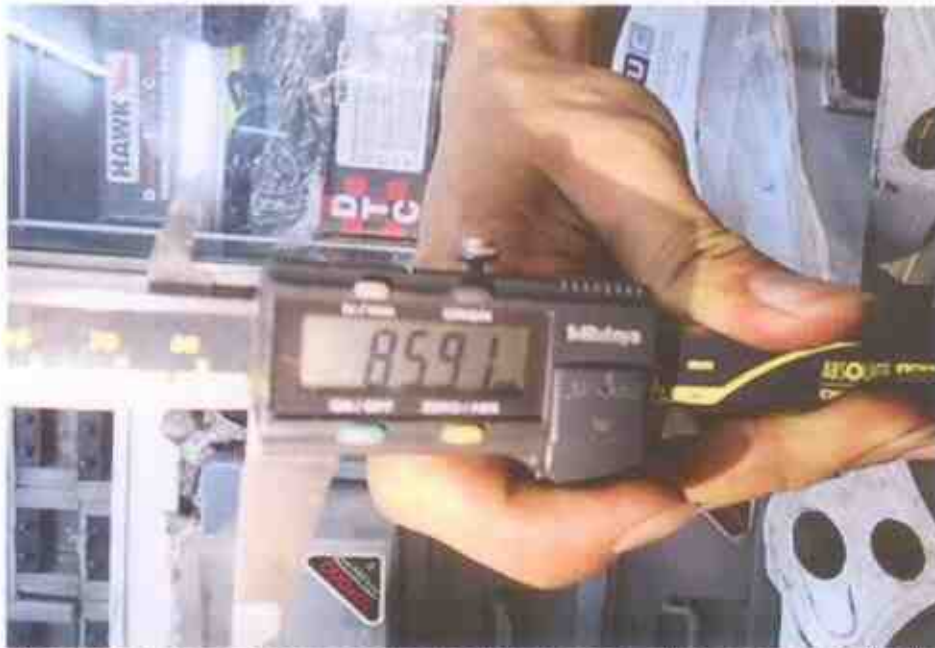
Photo 13 shows the stroke measurement of cylinder 2, which was recorded to be 85.91mm.

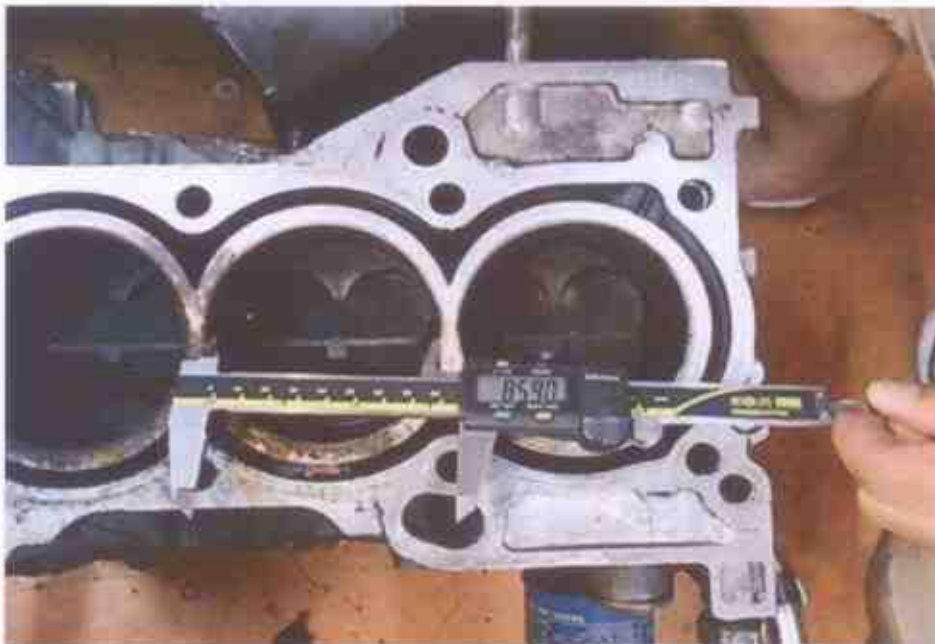
Photo 14 shows measurement being carried out to the bore of cylinder 3 of the Honda engine. The bore and stroke measurements of the Honda engine were carried out using a digital Vernier Caliper. The bore measurement of cylinder 3 was recorded to be 85.90mm.

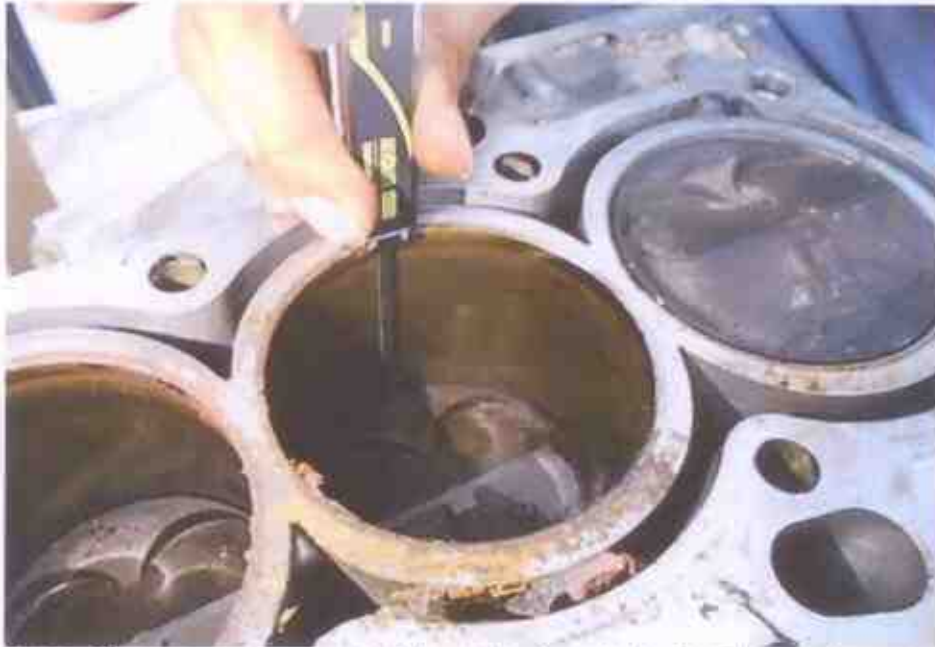
Photo 15 shows measurement of the stroke for cylinder 3 of the Honda engine that I had inspected.

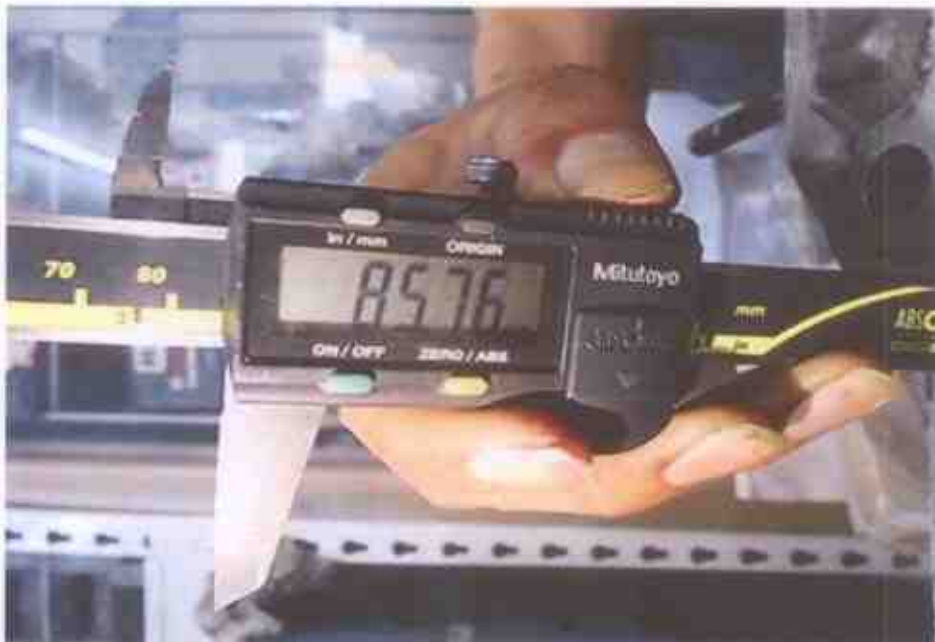
Photo 16 shows the stroke measurement of cylinder 3, which was recorded to be 85.76mm.

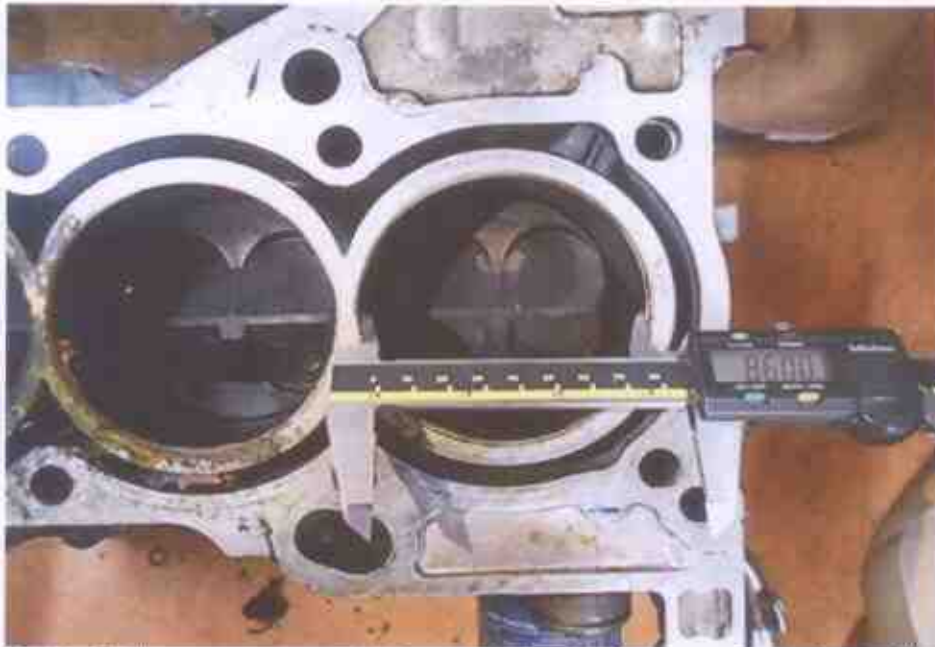
**Photo 17** shows measurement being carried out to the bore of cylinder 4 of the Honda engine. The bore and stroke measurements of the Honda engine were carried out using a digital Vernier Caliper. The bore measurement of cylinder 4 was recorded to be 86.00mm.

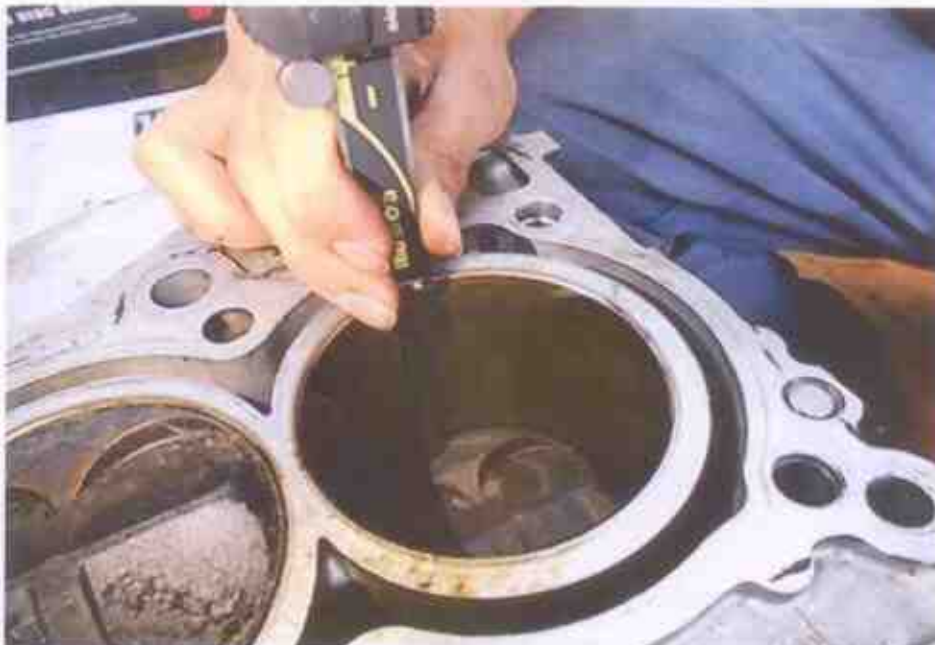
**Photo 18** shows measurement being carried out to the stroke of cylinder 4 of the Honda engine. The bore and stroke measurements of the Honda engine were carried out using a digital Vernier Caliper, which was calibrated prior to the start of measurements.

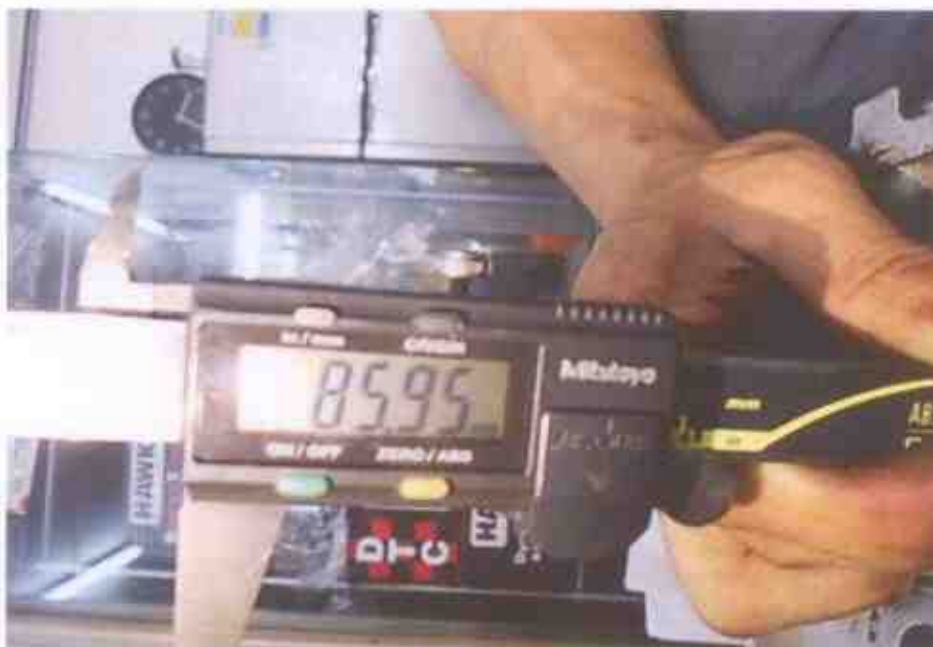
Photo 19 shows the stroke measurement of cylinder 4, which was recorded to be 85.95mm.
