Your Ref: Honda Engine
Our Ref : CI/TP18009298/D

21 May 2018

INSPECTION REPORT OF A HONDA ENGINE

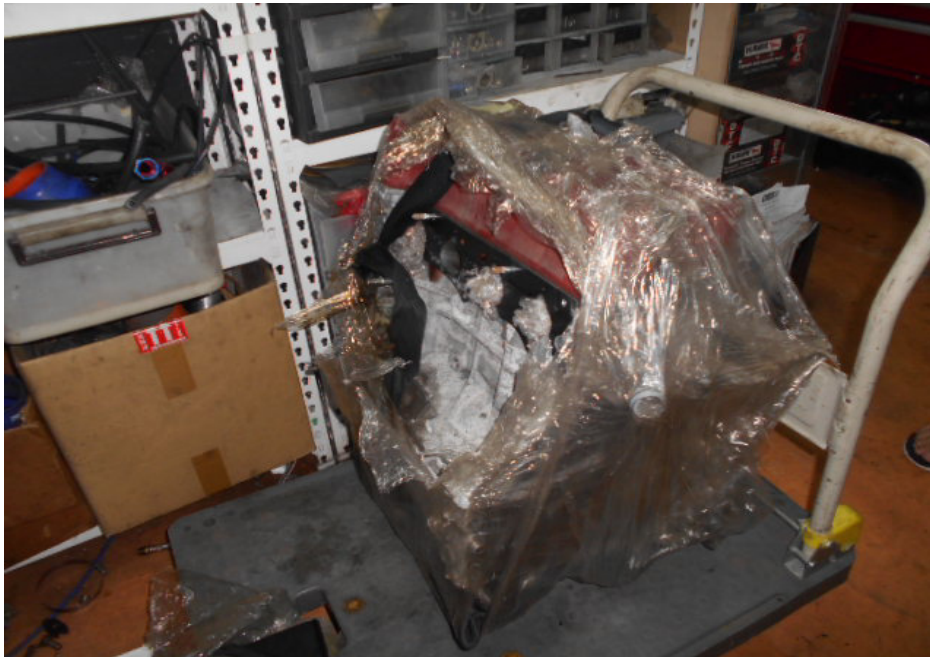
Photo 1 shows a general view of the Honda engine that I had inspected. The Honda engine was observed to be a used engine and was not fitted on any motor car. It was also observed to be a complete assembly with all mechanical parts still intact, within the engine housing.

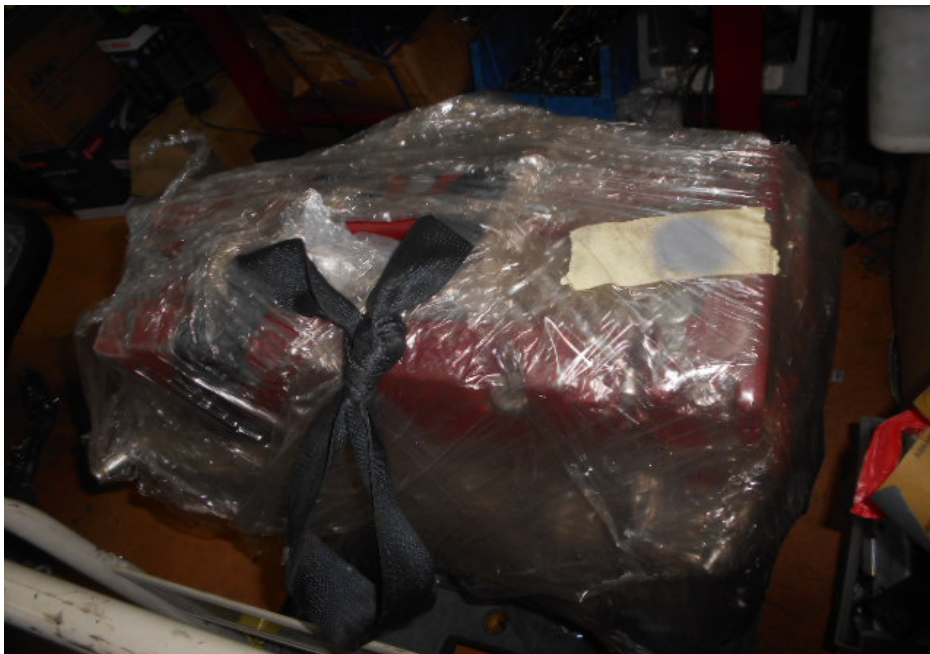
Photo 2 shows a general view of the Honda engine that I had inspected. The Honda engine was observed to be a used engine and was not fitted on any motor car. My visual examination of the engine housing revealed the housing to be of serviceable/satisfactory condition. There was no crack and/or hole observed on the engine housing.

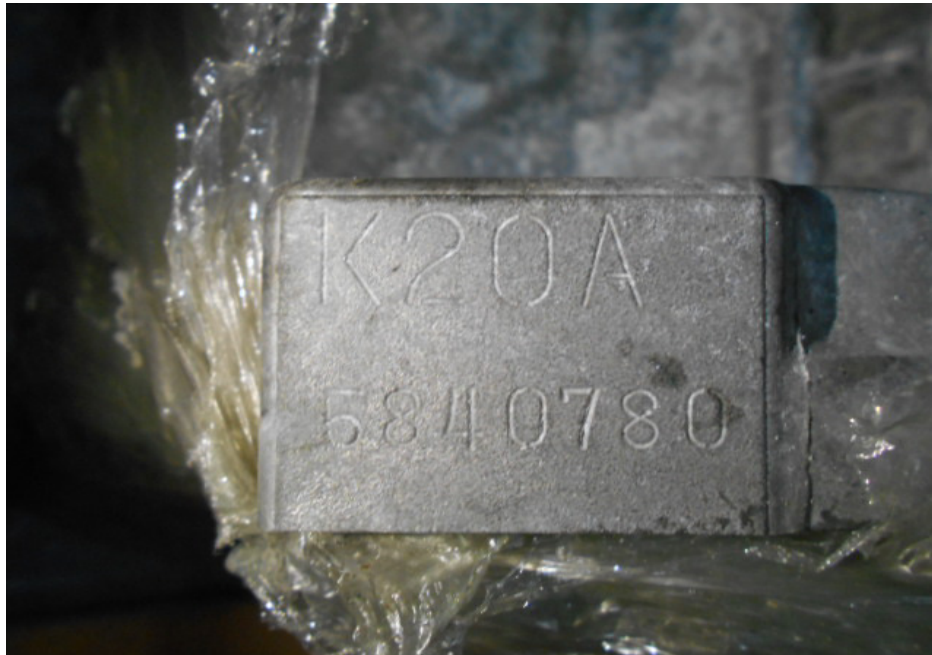
Photo 3 shows the engine number engraved on the housing of the Honda engine that I had inspected. The engine number was K20A5840780.

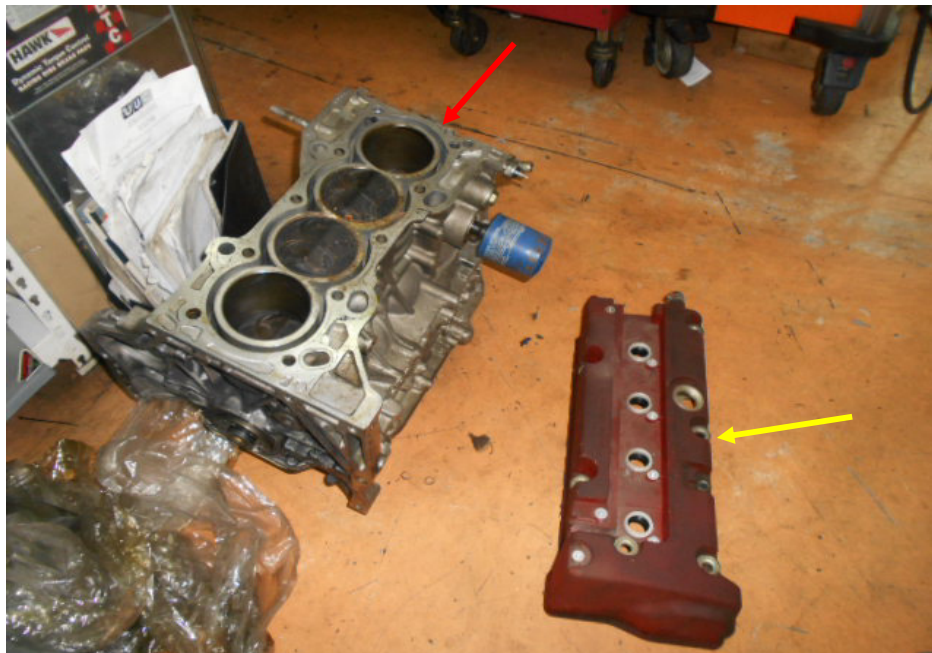
Photo 4 shows the top block (yellow arrow) of the Honda engine separated from its bottom block (red arrow). This was to enable me to carry out measurements of its cylinders, in particular the bore and stroke measurements of each cylinder, which typically can be used to determine the engine displacement or more commonly referred to as engine cc.

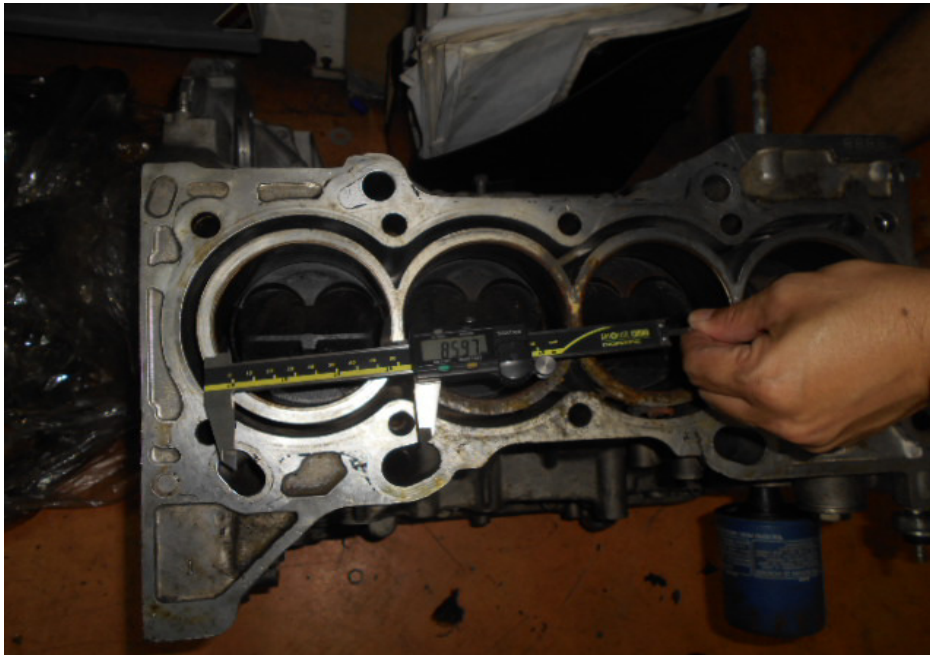
Photo 5 shows measurement being carried out to the bore of cylinder 1 of the Honda engine. The bore and stroke measurements of the Honda engine were carried out using a digital Vernier Caliper, which was calibrated prior to the start of measurements.

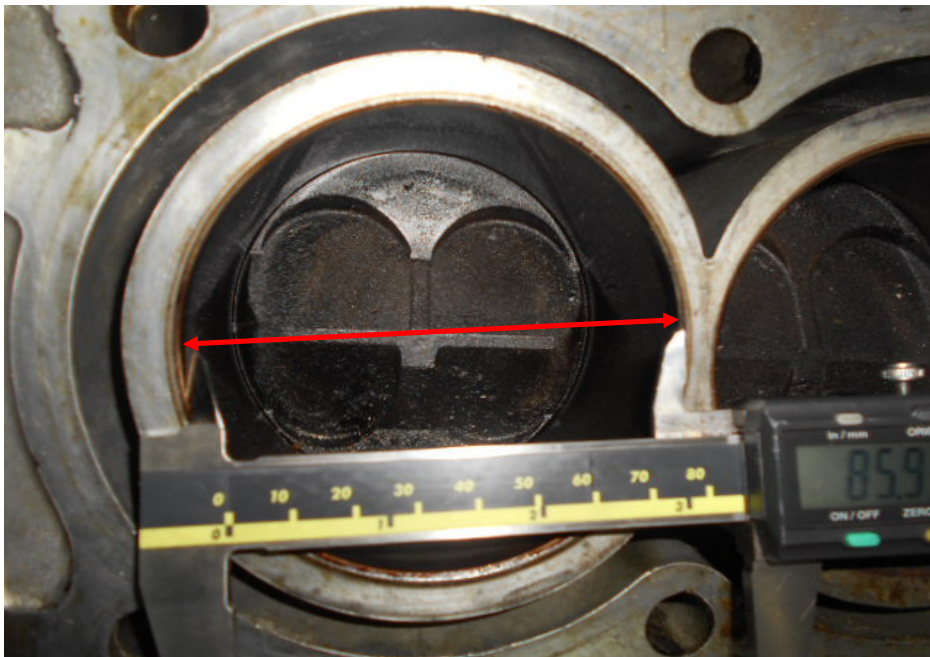
Photo 6 shows measurement being carried out to the bore of cylinder 1 of the Honda engine. The bore and stroke measurements of the Honda engine were carried out using a digital Vernier Caliper.

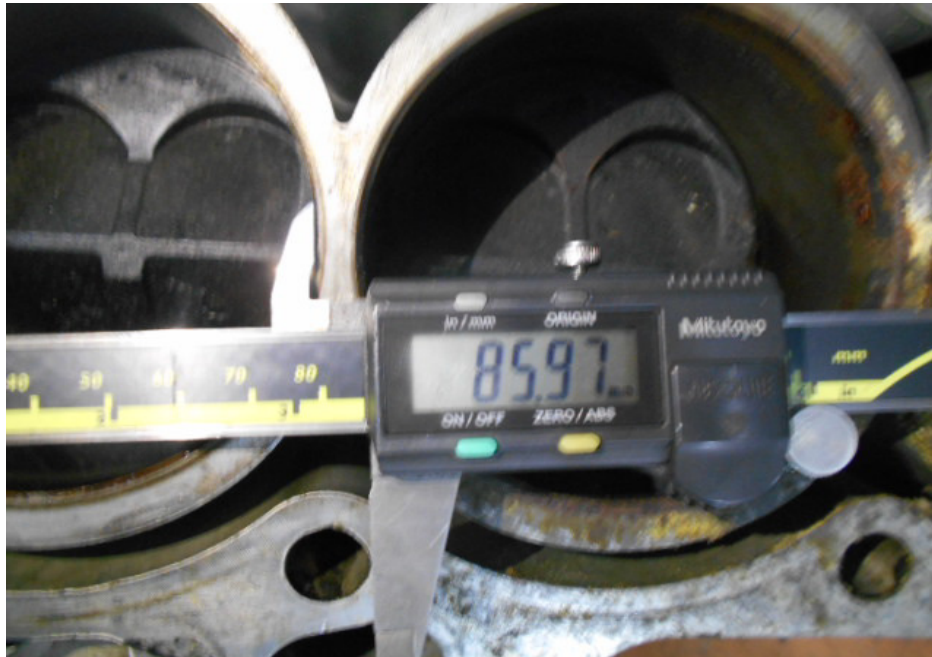
Photo 7 shows the bore measurement of cylinder 1, which was recorded to be 85.97mm.

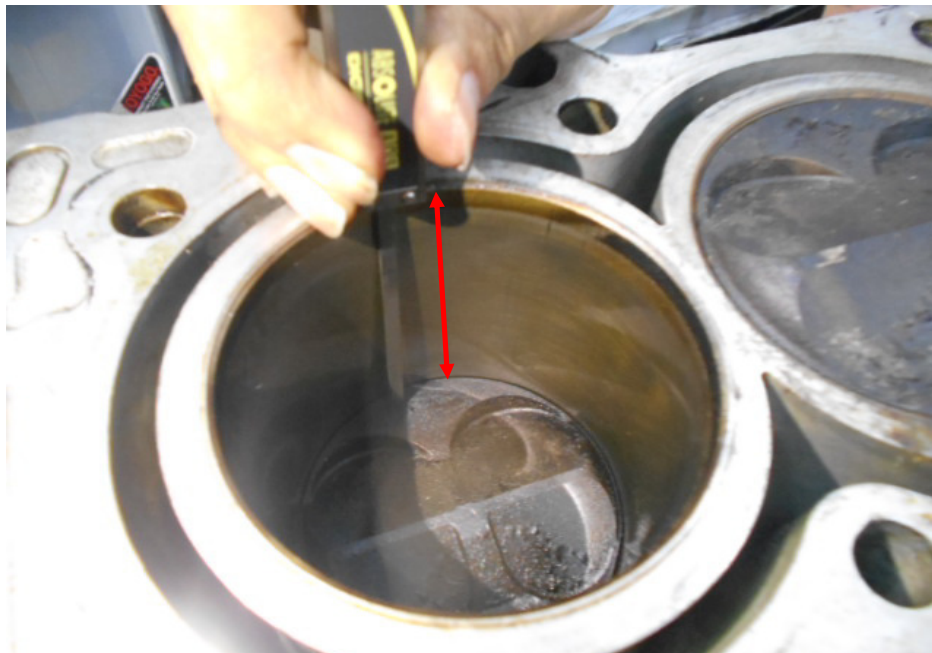
Photo 8 shows measurement being carried out to the stroke of cylinder 1 of the Honda engine. The bore and stroke measurements of the Honda engine were carried out using a digital Vernier Caliper.

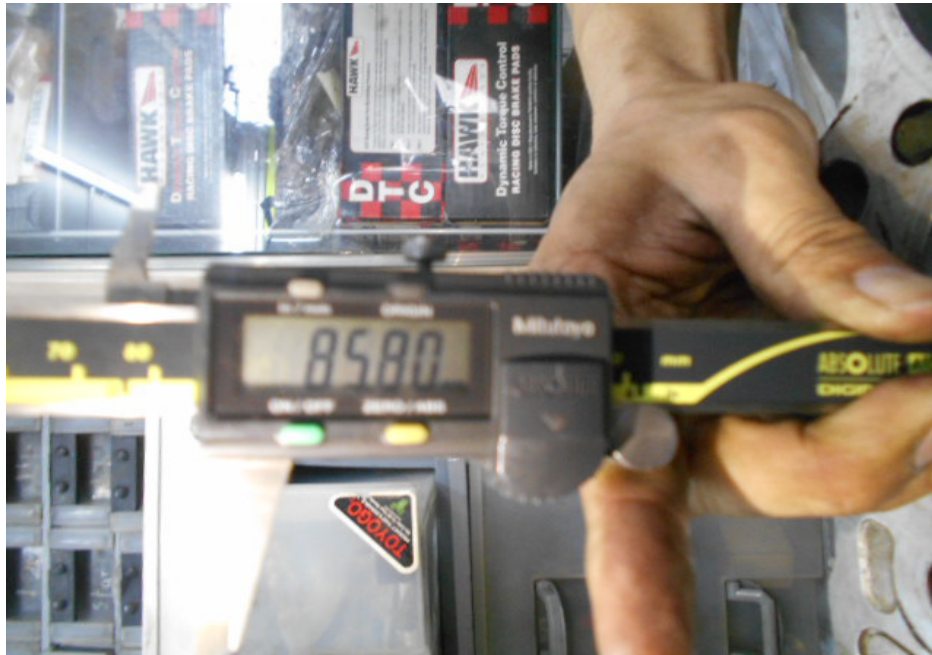
Photo 9 shows the stroke measurement of cylinder 1, which was recorded to be 85.80mm.

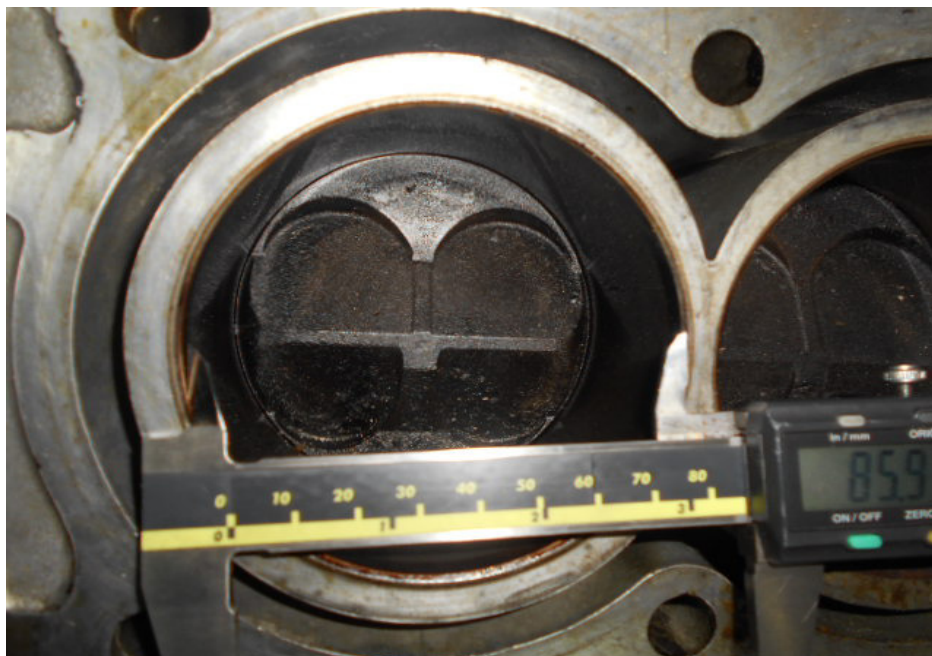
Photo 10 shows measurement being carried out to the bore of cylinder 2 of the Honda engine. The bore and stroke measurements of the Honda engine were carried out using a digital Vernier Caliper, which was calibrated prior to the start of measurements.

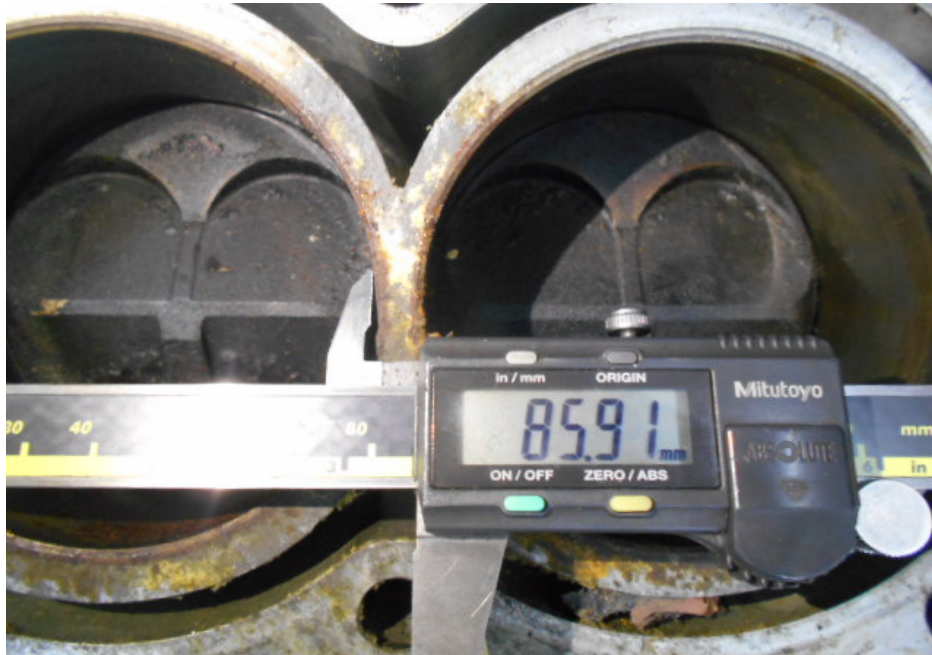
Photo 11 shows the bore measurement of cylinder 2, which was recorded to be 85.91mm.

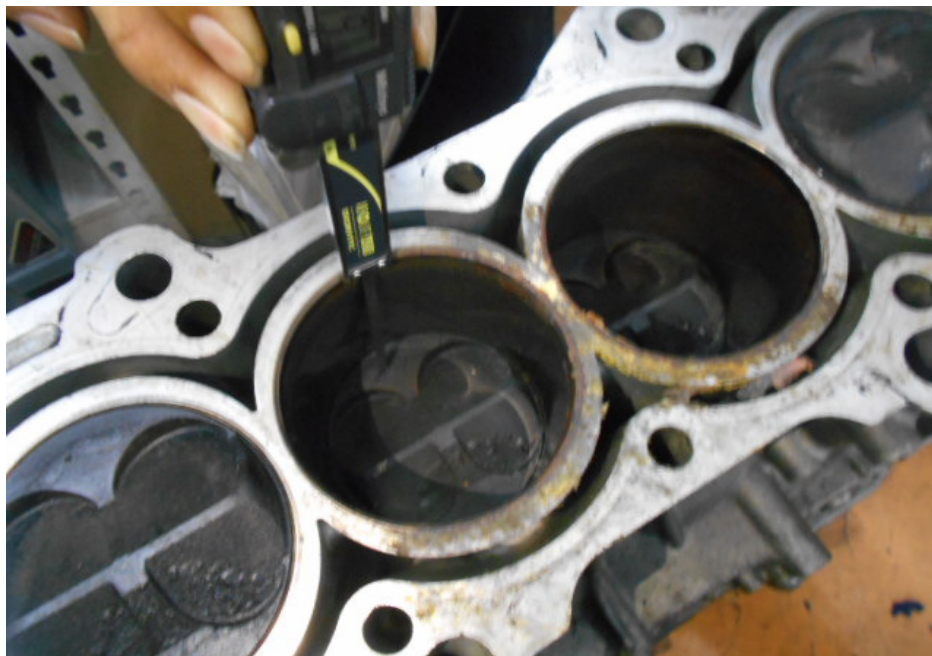
Photo 12 shows measurement of the stroke for cylinder 2 of the Honda engine that I had inspected.

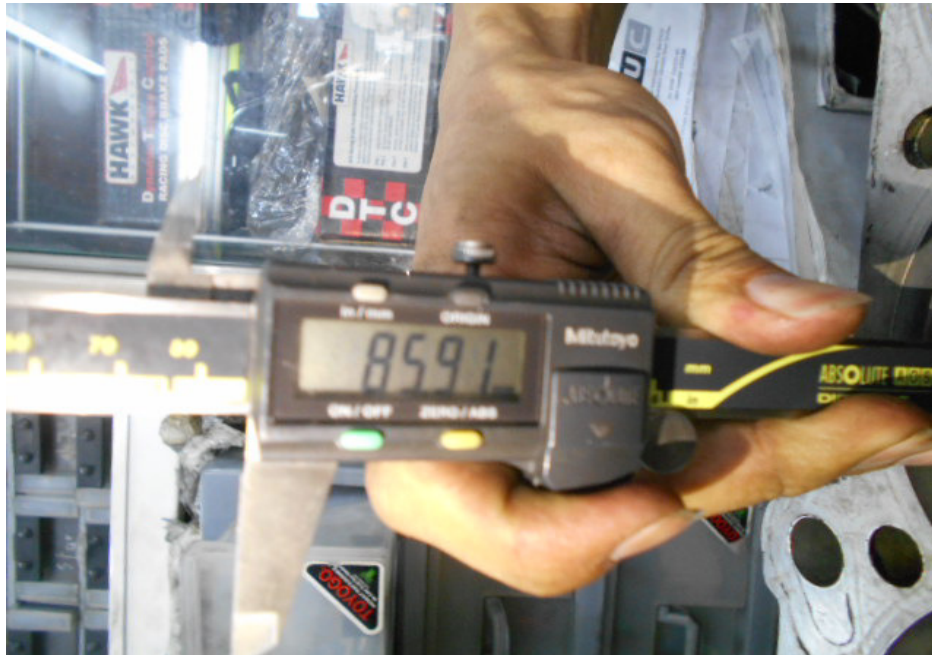
Photo 13 shows the stroke measurement of cylinder 2, which was recorded to be 85.91mm.

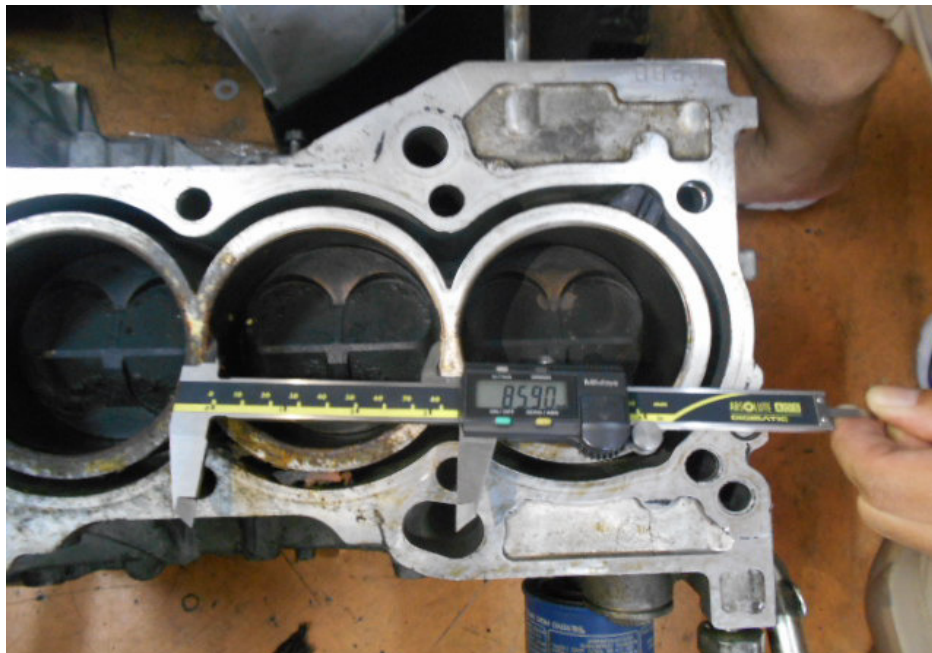
Photo 14 shows measurement being carried out to the bore of cylinder 3 of the Honda engine. The bore and stroke measurements of the Honda engine were carried out using a digital Vernier Caliper. The bore measurement of cylinder 3 was recorded to be 85.90mm.

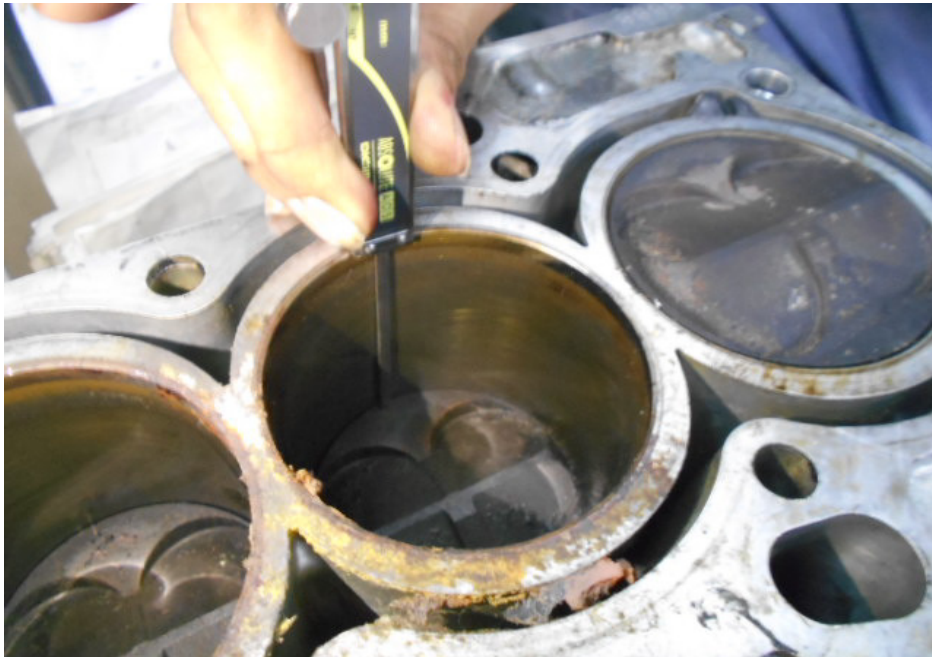
Photo 15 shows measurement of the stroke for cylinder 3 of the Honda engine that I had inspected.

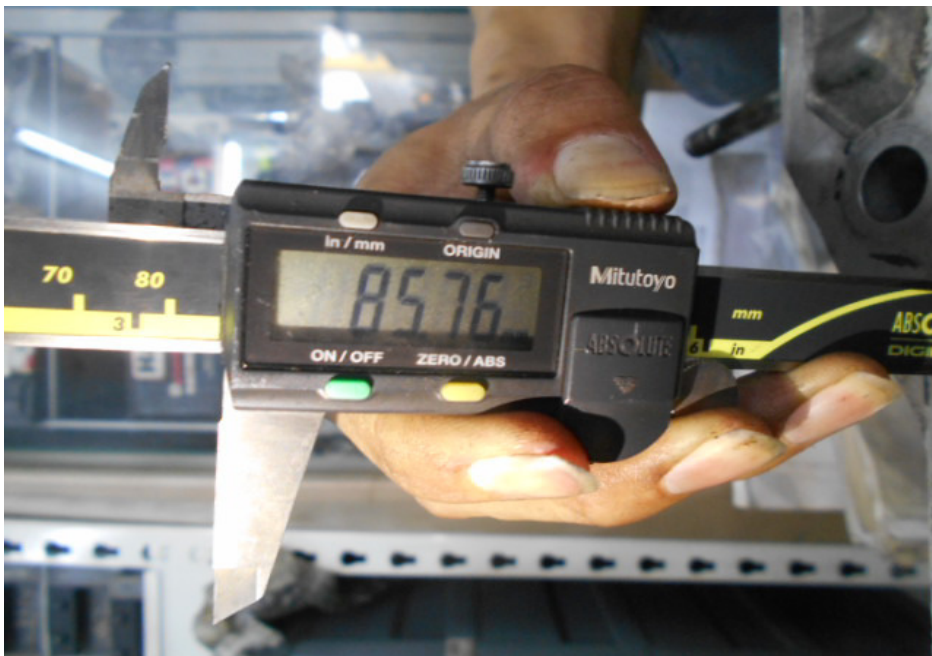
Photo 16 shows the stroke measurement of cylinder 3, which was recorded to be 85.76mm.

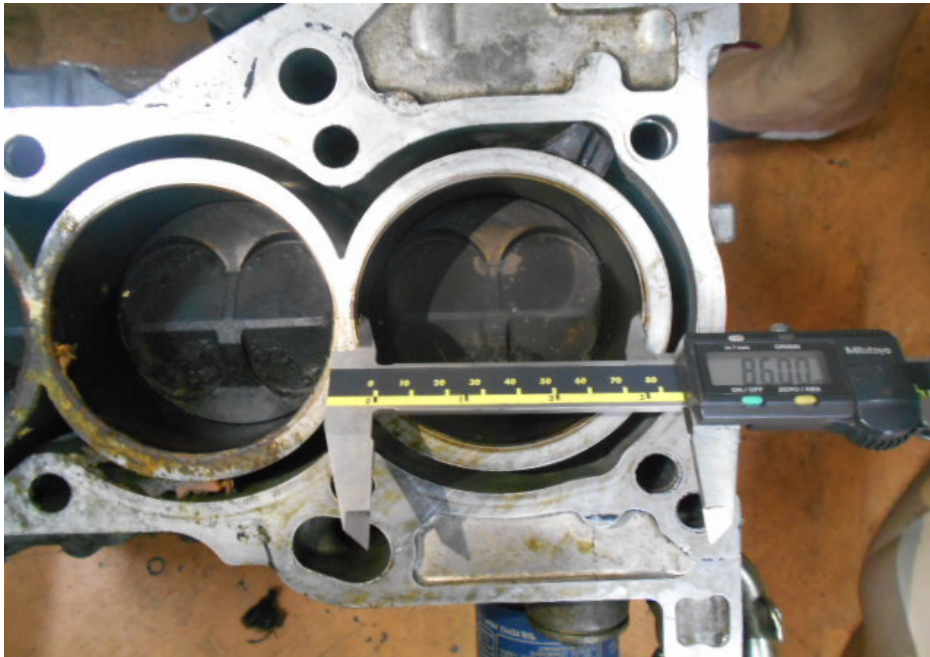
Photo 17 shows measurement being carried out to the bore of cylinder 4 of the Honda engine. The bore and stroke measurements of the Honda engine were carried out using a digital Vernier Caliper. The bore measurement of cylinder 4 was recorded to be 86.00mm.

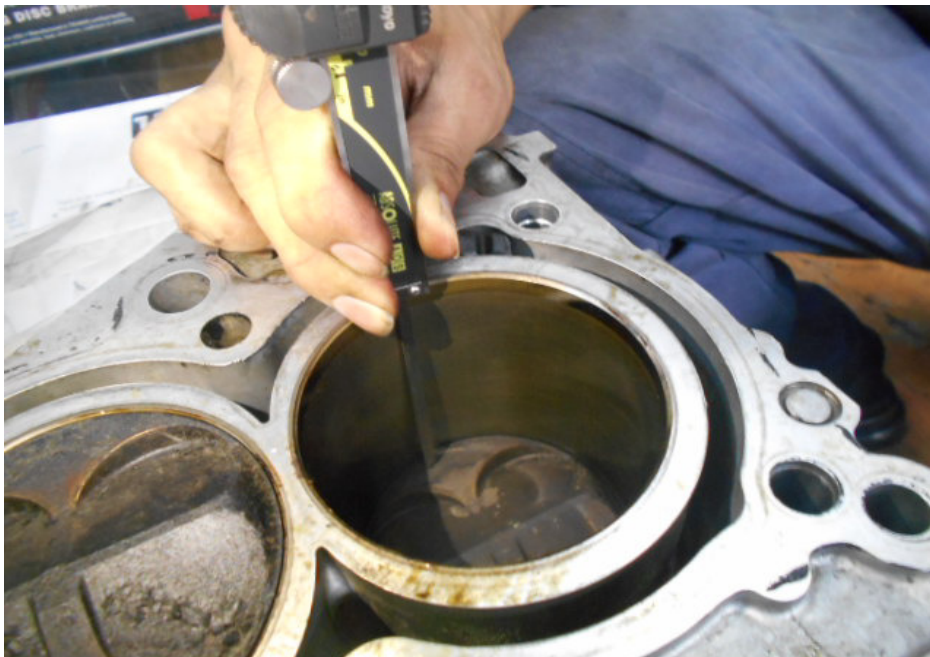
Photo 18 shows measurement being carried out to the stroke of cylinder 4 of the Honda engine. The bore and stroke measurements of the Honda engine were carried out using a digital Vernier Caliper, which was calibrated prior to the start of measurements.

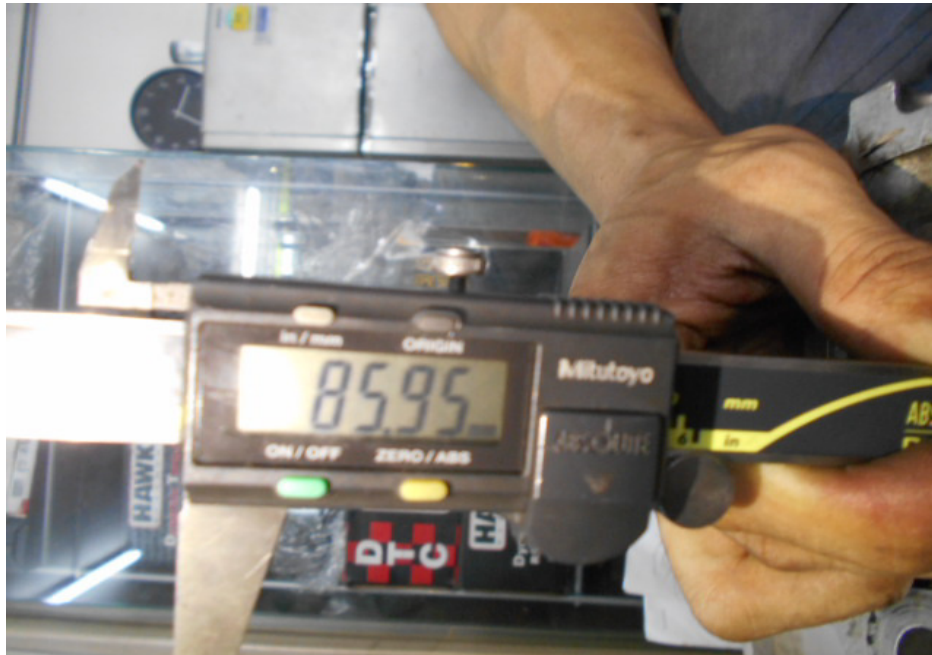
Photo 19 shows the stroke measurement of cylinder 4, which was recorded to be 85.95mm.
