Your Ref : D17/9983M/jy  
Our Ref : CI/FCI18009314/D

19 May 2018

**AUTOMOBILE TECHNICAL INVESTIGATION REPORT OF ACCIDENT  
INVOLVING SHC 8317Z AND SLM 10K ON 22 OCTOBER 2017**

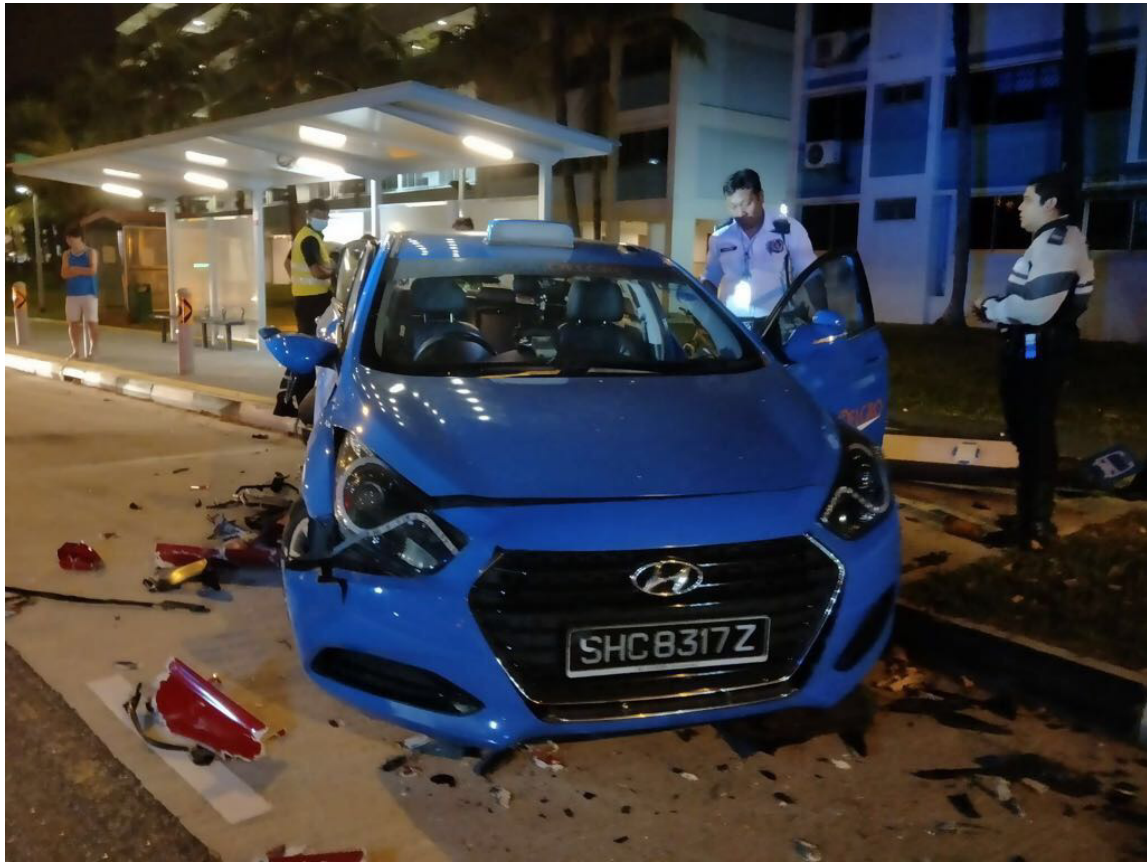
7. Firstly, the final rest positions of the involved vehicles were clearly depicted. SHC 8317Z was observed to have come to a rest with its left rear wheel mounted onto the pedestrian pavement adjacent to the bus bay. It was in a slanted position, approximately 40° towards the right of the direction of traffic flow. It was stopped entirely within the bus bay of the bus stop. None of its body had protruded into the extreme left lane of the roadway. The location where it had stopped was also observed to be towards the end of the bus bay.

**Photo 1** shows a general view of the frontal portion of SHC 8317Z after the accident. It was observed to have come to a complete rest with its entire body within the bus bay. It was stopped in a slanted position approximately 40° towards the right of the direction of traffic flow.

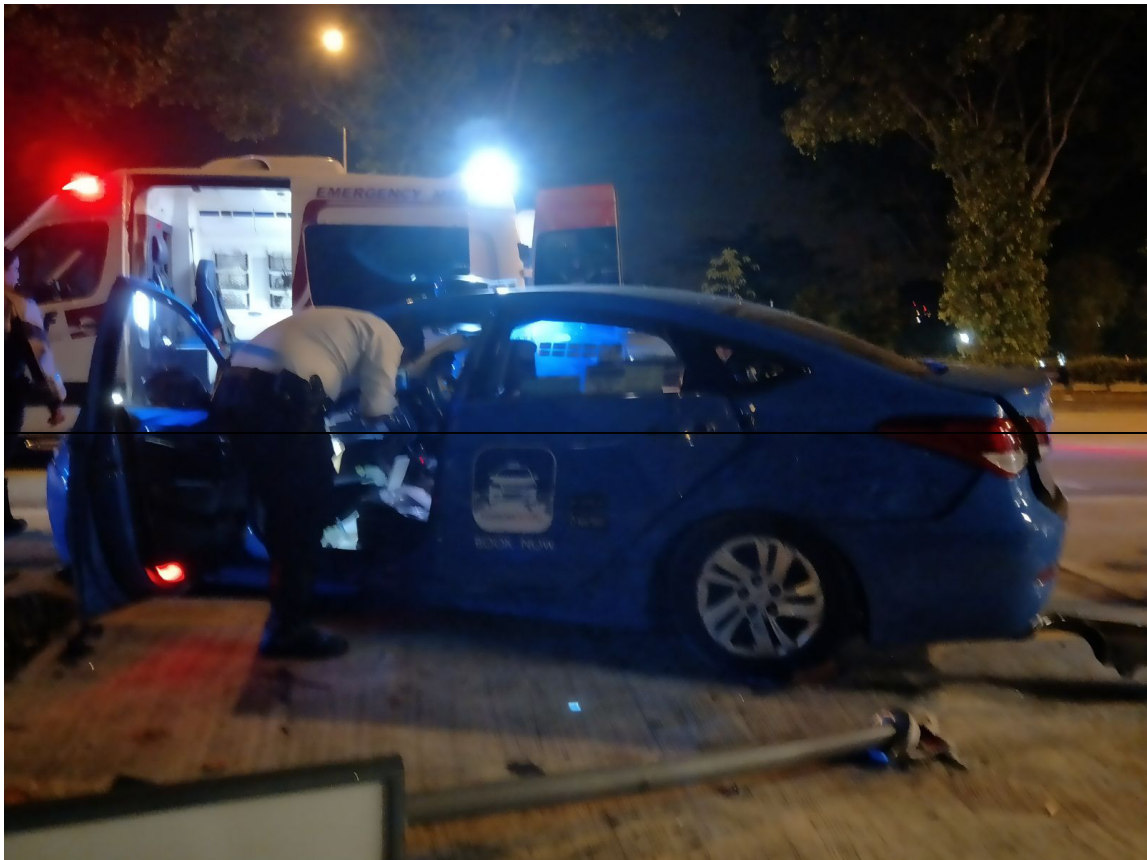
**Photo 2** shows a general view of the left side of SHC 8317Z after the accident. It was observed to have come to a complete rest with its entire body within the bus bay. Its left rear wheel was also observed to have mounted onto the pedestrian pavement adjacent to the bus bay.

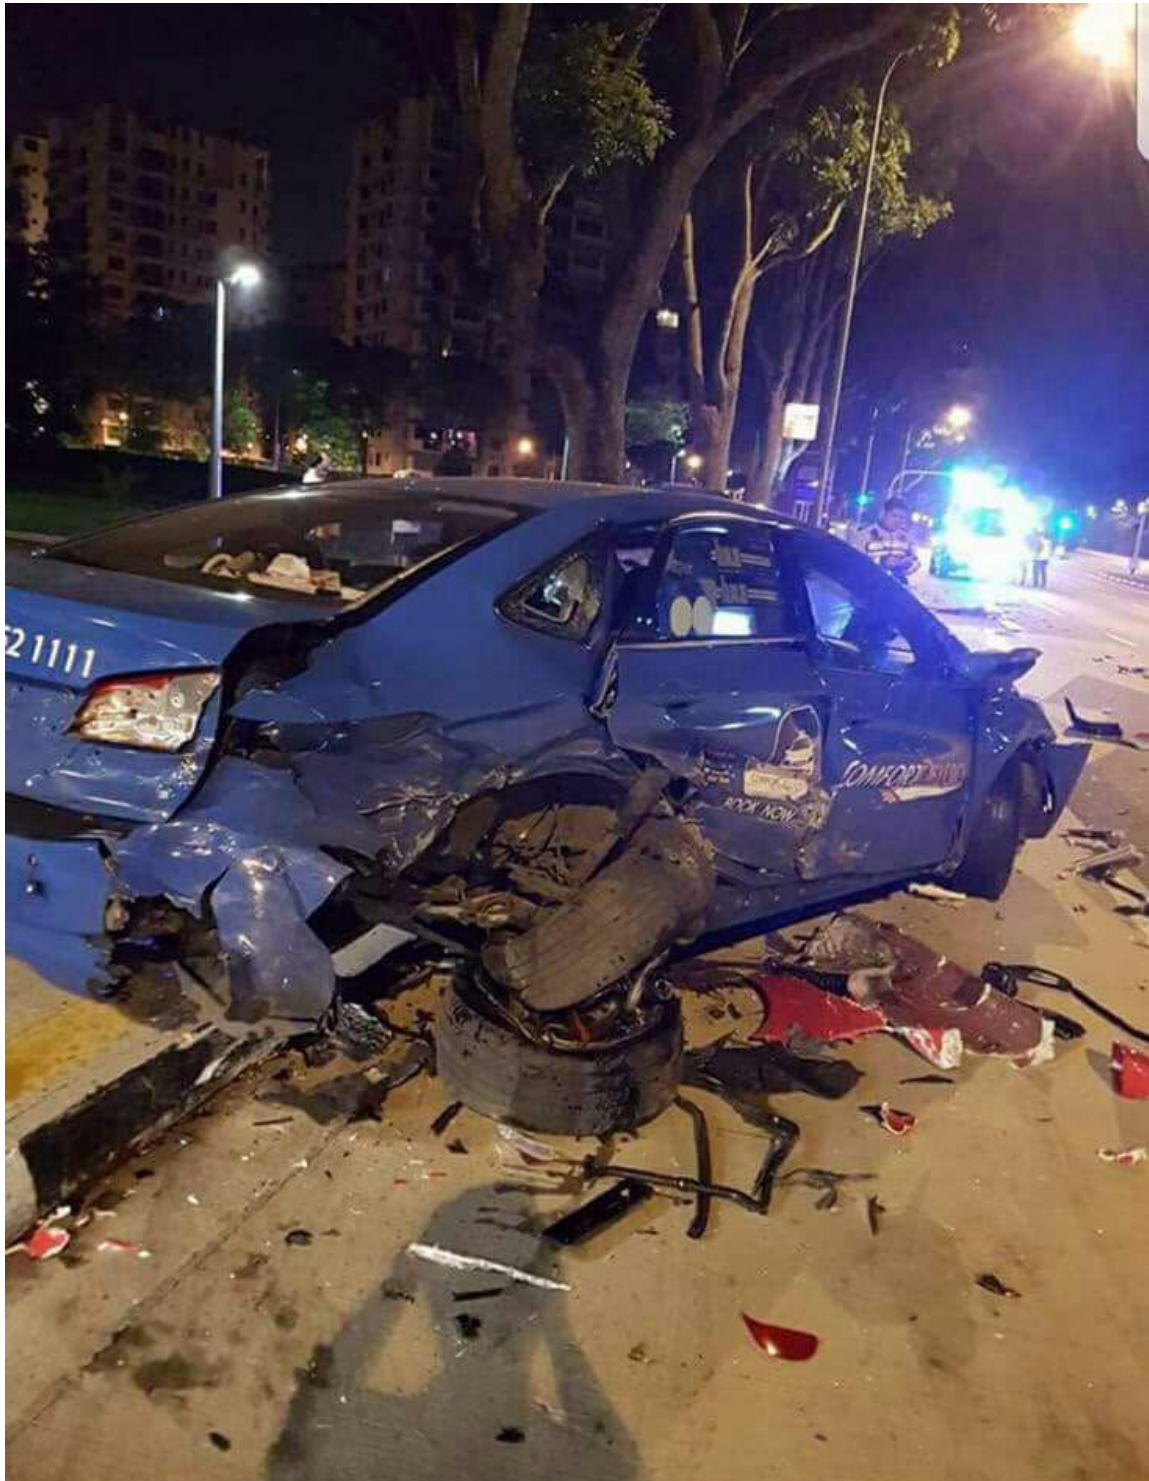
**Photo 3** shows a general view of SHC 8317Z after the accident. It was observed to have come to a complete rest with its entire body within the bus bay. It was stopped in a slanted position approximately 40° towards the right of the direction of traffic flow. None of its body had protruded into the extreme left lane of the roadway. The location where it had stopped was also observed to be towards the end of the bus bay.

14. The accident circumstance described by the driver of SHC 8317Z occurring is further supported by the location of its final rest. The accident scene photographs had showed SHC 8317Z stopped entirely within the bus bay with none of its body protruding into the extreme left lane of Yishun Avenue 1, which was the reported lane of travel of SLM 10K. This final rest location was slightly in front of its initial stop location prior to the accident, as seen from the video recording taken from the recording device that was mounted on the front windscreen of SHC 8317Z.

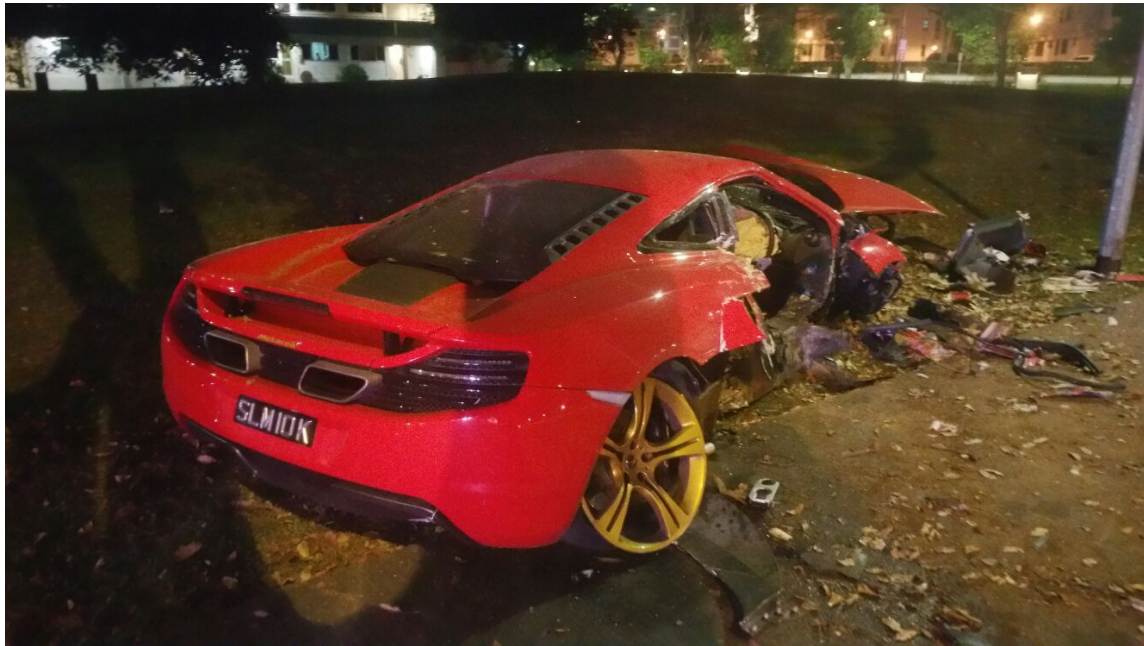
8. SLM 10K was observed to have mounted onto the pedestrian pavement and stopped on the grass patch adjacent to the pedestrian pavement, away from the roadway. It was stopped approximately 30m in front of where SHC 8317Z had stopped. See photo 1 – 4 below.

**Photo 4** shows the final rest position of SLM 10K after the accident. The photographs taken at the accident scene had depicted SLM 10K stopped on the grass patch adjacent to the pedestrian pavement, away from the roadway. It was stopped approximately 30m in front of where SHC 8317Z had stopped.

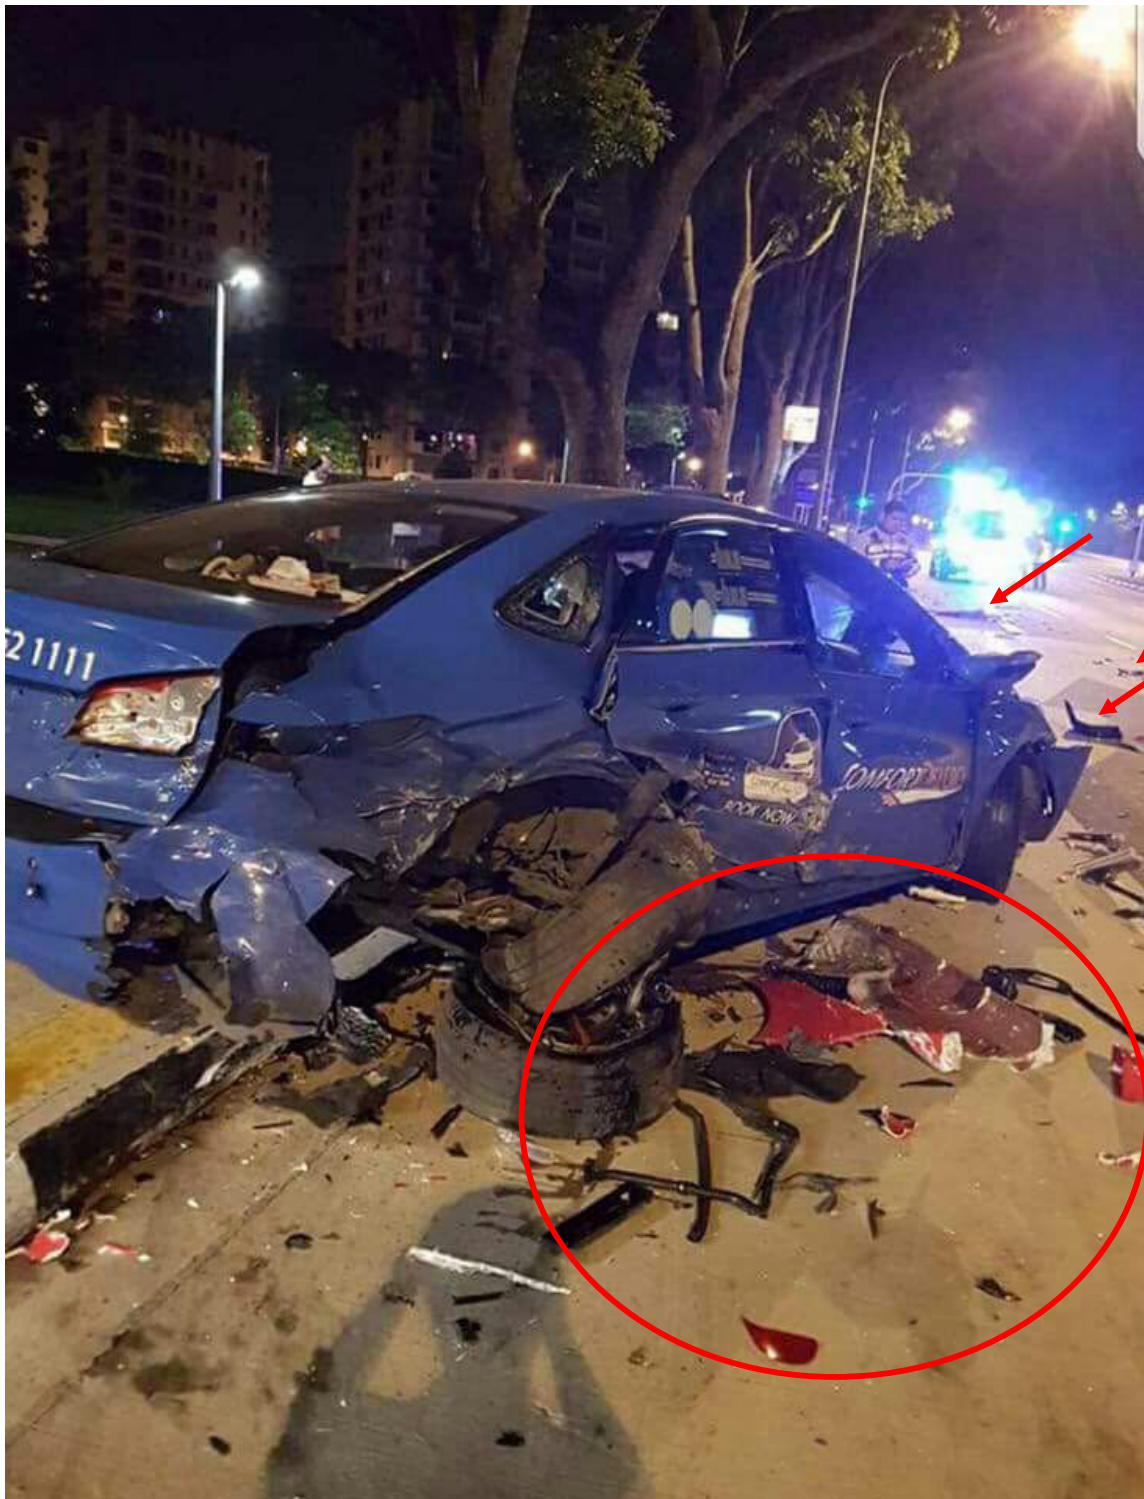
9. Vehicular debris from both the involved vehicles were all seen mainly within the bus bay. Broken body parts from SLM 10K can be seen lying within the bus bay on the right side of SHC 8317Z. Closer examination of the photographs and video recordings revealed what appears to be some debris on the extreme left lane at the stretch after the location where SHC 8317Z had stopped. There was however no debris found before the location where SHC 8317Z had stopped. See photo 5 & 6 below.

**Photo 5** shows the accident scene after the accident. Vehicular debris could be seen lying mainly within the bus bay, on the right side of SHC 8317Z. This had included broken body parts (circled) from SLM 10K. Upon closer examination of the photograph, I had also observed some vehicular debris (arrowed) lying on the extreme left lane after the location where SHC 8317Z had stopped.

12. Although there were also vehicular debris on the extreme left lane, these were found after the final rest location of SHC 8317Z. Since both the vehicles were facing in the same direction to vehicular traffic flow prior to the accident, the vehicular debris found on the extreme left lane after the final rest location of SHC 8317Z is then not the first location of where vehicular debris was found. These vehicular debris were left behind by SLM 10K as it was coming to a rest after collision with SHC 8317Z.

13. Given that there was no vehicular debris found before the final rest location of SHC 8317Z, the vehicular debris that was found within the bus bay, on the right side of SHC 8317Z would then be the first area where vehicular debris was found. Basing on this physical evidence at the accident scene, the location of the point of impact between SHC 8317Z and SLM 10K was within the bus bay. This corresponds to the accident circumstance described by the driver of SHC 8317Z rather than the circumstance that was described by the driver of SLM 10K.

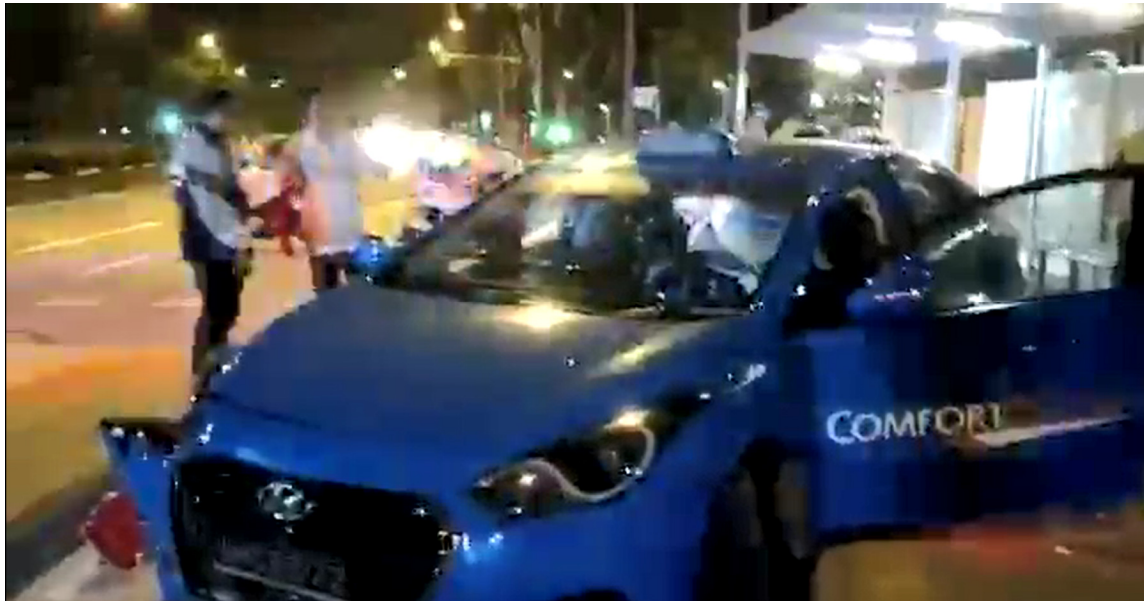
**Photo 6** shows a screenshot from one of the video recordings of the accident scene. Closer examination of the video recording appears to indicate that there was no vehicular debris on the roadway before the location where SHC 8317Z had stopped.

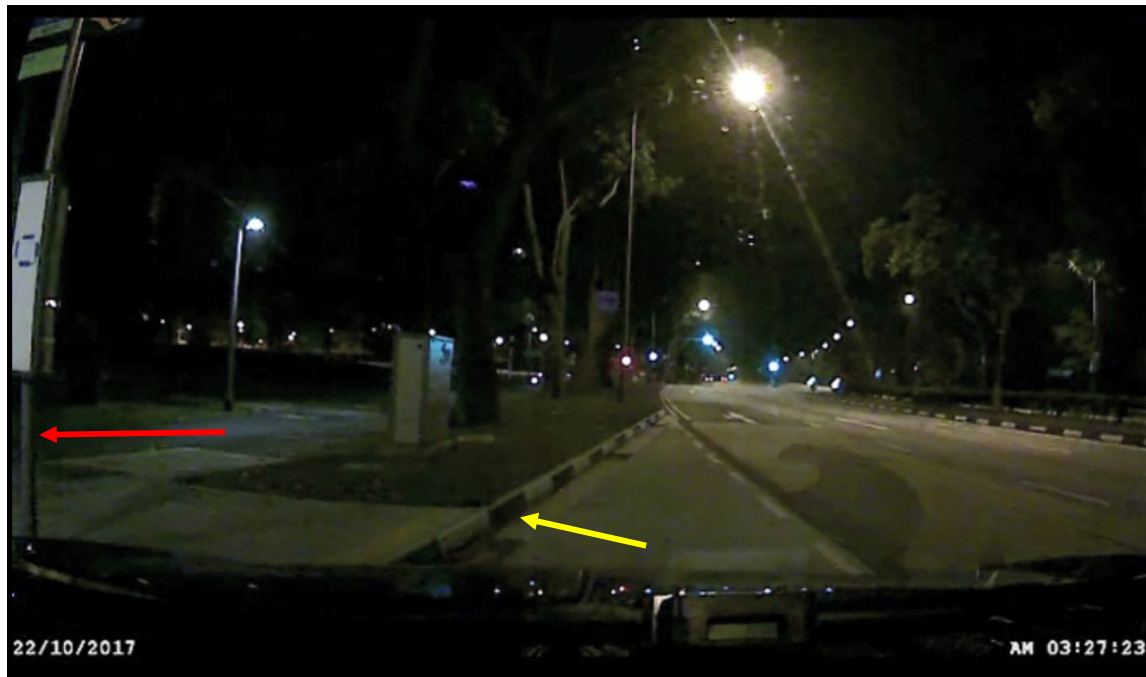
15. The last seen image from the recording device had showed SHC 8317Z stopped towards the end of the bus bay. The bus stop stand that had toppled after the accident could be seen towards the left and slightly ahead of SHC 8317Z. This initial stopped location to the final rest location was approximately less than 5m, taking reference from the fixed road features, in particular the start of the grass patch and black and white paint of the road kerb. See photo 7 below.

**Photo 7** shows a screenshot of the video recording taken from the recording device that was mounted on the front windscreen of SHC 8317Z. The last seen image from the recording device had showed SHC 8317Z stopped towards the end of the bus bay as seen from the screenshot. Taking reference from the fixed road features like the bus stop stand (red arrow) that was toppled after the accident, start of grass patch, and black and white paint of the road kerb (yellow arrow), the initial stopped location of SHC 8317Z to its final rest location was approximately less than 5m. Refer to photograph 1 above for comparison.

18. The evidence that SHC 8317Z had stopped slightly ahead from its initial stopped position indicates that the point of impact between the vehicles had occurred close to or at its initial stopped position within the bus bay. The impact force arising from the collision had shifted/pushed SHC 8317Z slightly forward before it came to a final rest as seen in the accident scene photographs.
