Your Ref : D17/9983M/jy
Our Ref : CI/FCI18009314/D

19 May 2018

**AUTOMOBILE TECHNICAL INVESTIGATION REPORT OF ACCIDENT
INVOLVING SHC 8317Z AND SLM 10K ON 22 OCTOBER 2017**

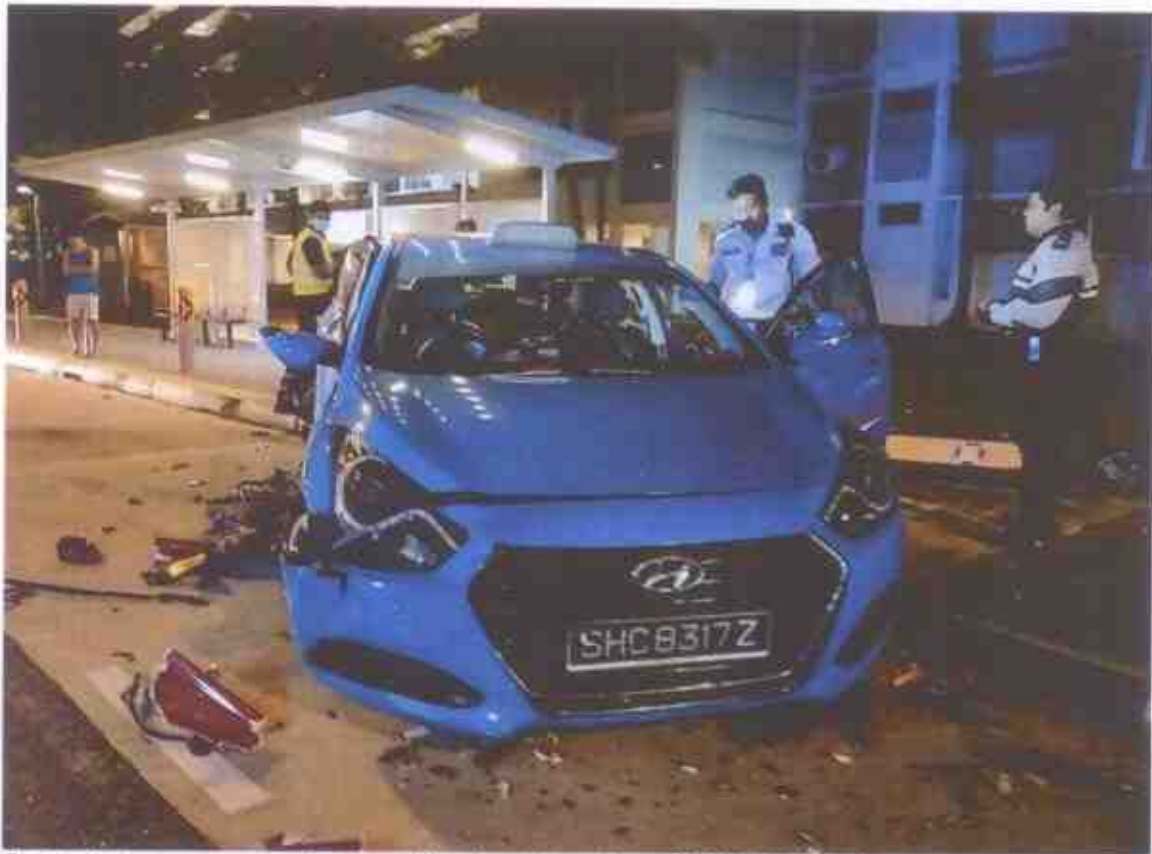
7. Firstly, the final rest positions of the involved vehicles were clearly depicted. SHC 8317Z was observed to have come to a rest with its left rear wheel mounted onto the pedestrian pavement adjacent to the bus bay. It was in a slanted position, approximately 40° towards the right of the direction of traffic flow. It was stopped entirely within the bus bay of the bus stop. None of its body had protruded into the extreme left lane of the roadway. The location where it had stopped was also observed to be towards the end of the bus bay.

Photo 1 shows a general view of the frontal portion of SHC 8317Z after the accident. It was observed to have come to a complete rest with its entire body within the bus bay. It was stopped in a slanted position approximately 40° towards the right of the direction of traffic flow.

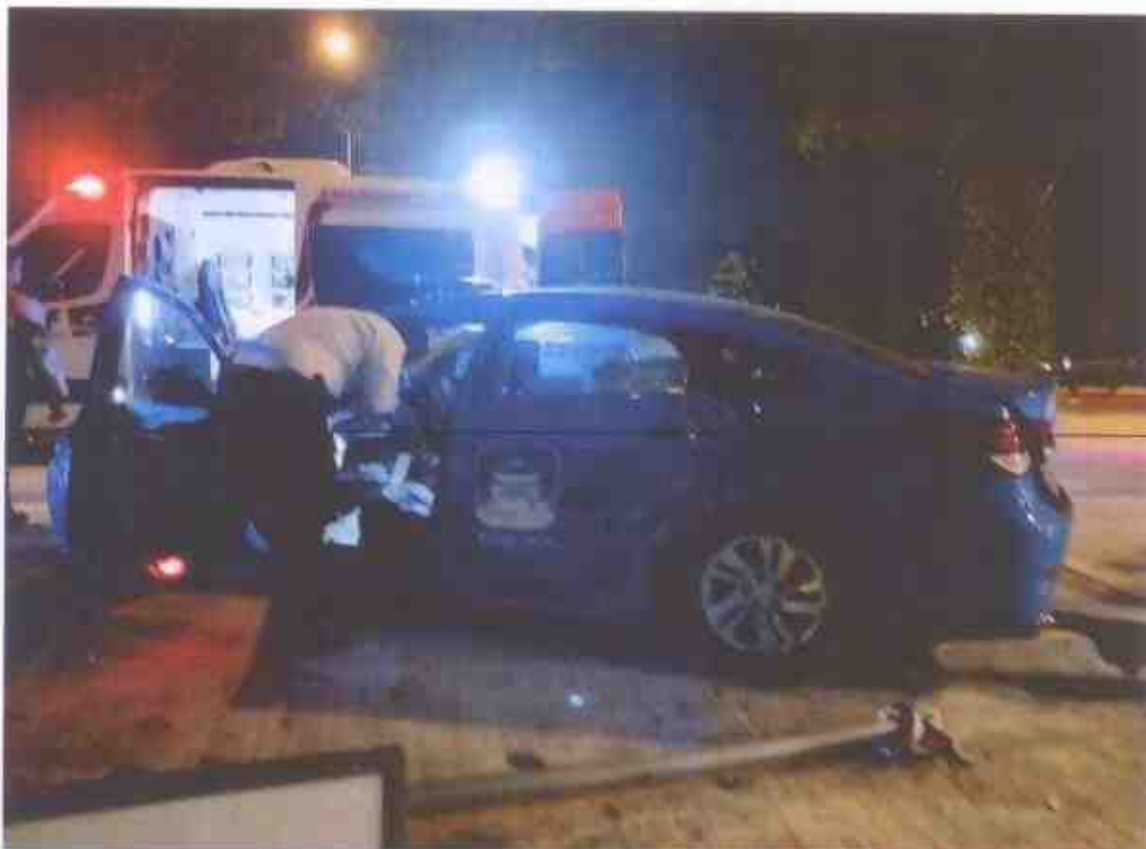
Photo 2 shows a general view of the left side of SHC 8317Z after the accident. It was observed to have come to a complete rest with its entire body within the bus bay. Its left rear wheel was also observed to have mounted onto the pedestrian pavement adjacent to the bus bay.

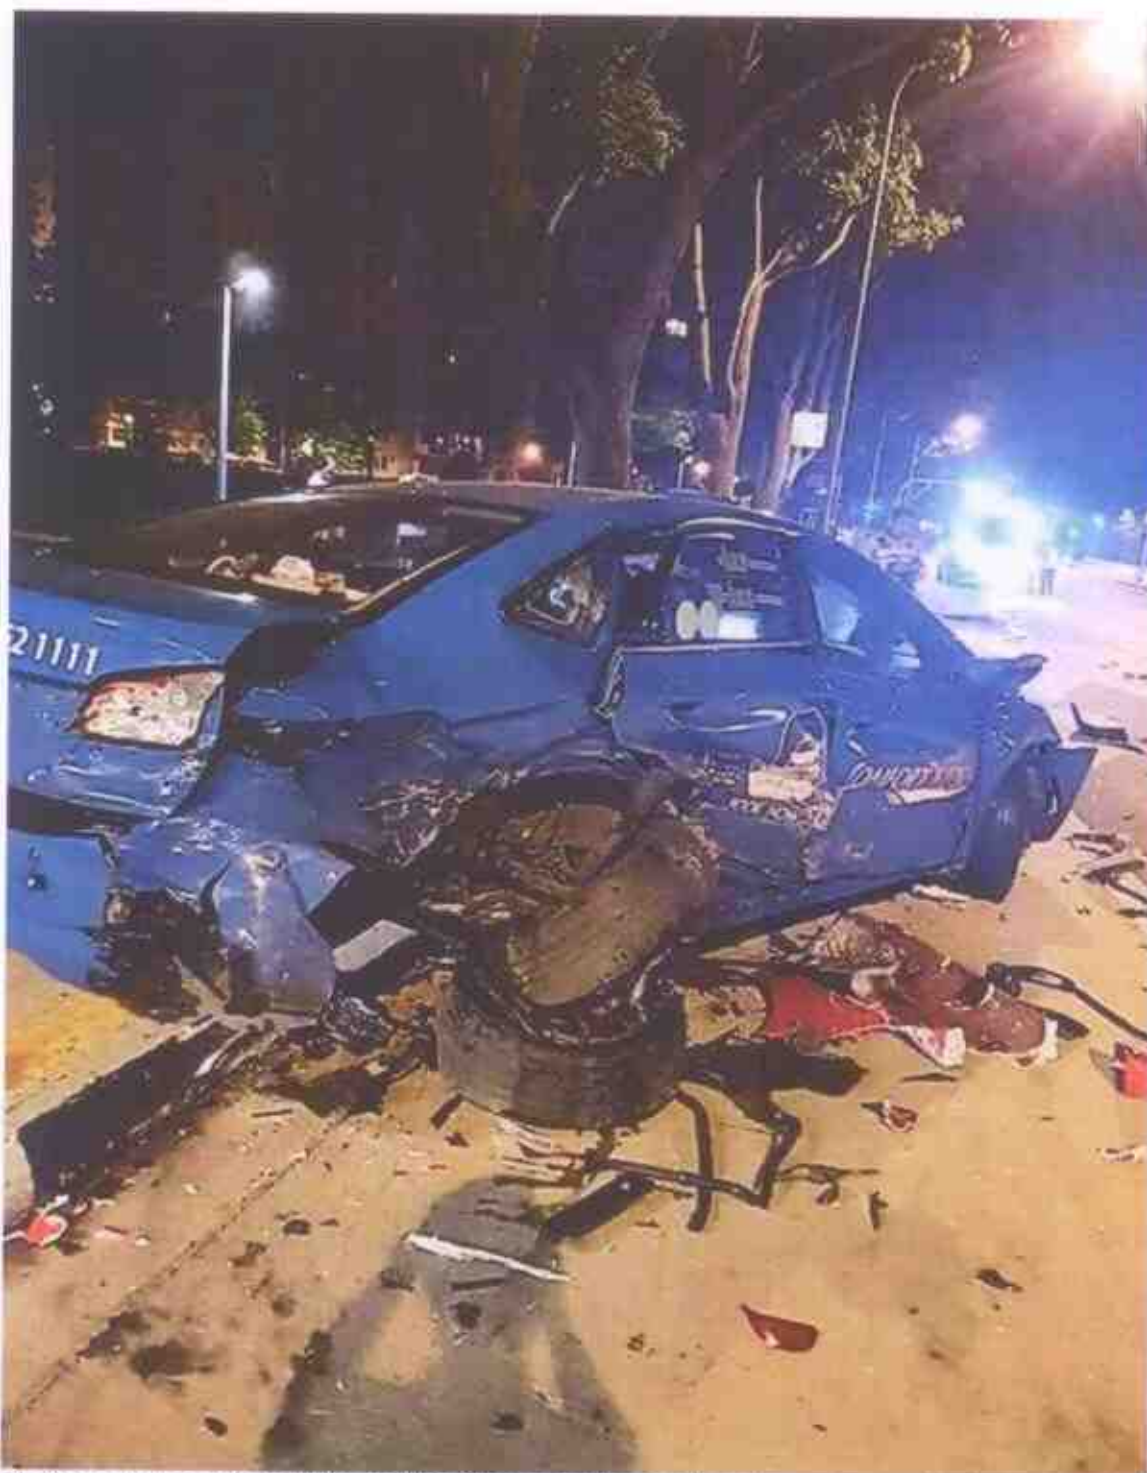
Photo 3 shows a general view of SHC 8317Z after the accident. It was observed to have come to a complete rest with its entire body within the bus bay. It was stopped in a slanted position approximately 40° towards the right of the direction of traffic flow. None of its body had protruded into the extreme left lane of the roadway. The location where it had stopped was also observed to be towards the end of the bus bay.

14. The accident circumstance described by the driver of SHC 8317Z occurring is further supported by the location of its final rest. The accident scene photographs had showed SHC 8317Z stopped entirely within the bus bay with none of its body protruding into the extreme left lane of Yishun Avenue 1, which was the reported lane of travel of SLM 10K. This final rest location was slightly in front of its initial stop location prior to the accident, as seen from the video recording taken from the recording device that was mounted on the front windscreen of SHC 8317Z.

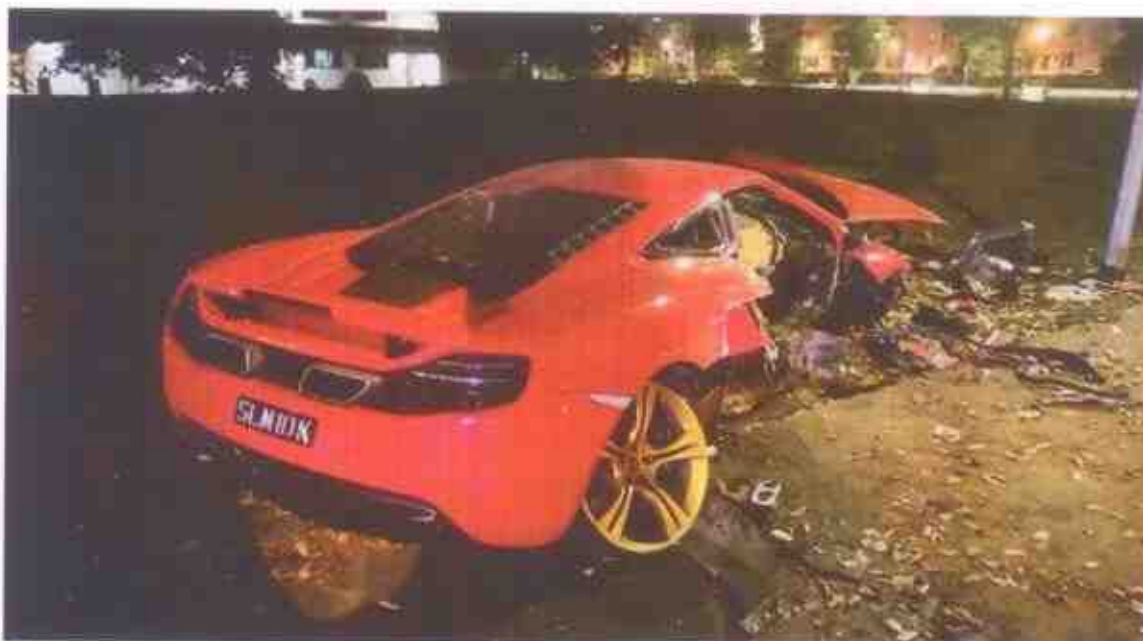
8. SLM 10K was observed to have mounted onto the pedestrian pavement and stopped on the grass patch adjacent to the pedestrian pavement, away from the roadway. It was stopped approximately 30m in front of where SHC 8317Z had stopped. See photo 1 – 4 below.

Photo 4 shows the final rest position of SLM 10K after the accident. The photographs taken at the accident scene had depicted SLM 10K stopped on the grass patch adjacent to the pedestrian pavement, away from the roadway. It was stopped approximately 30m in front of where SHC 8317Z had stopped.

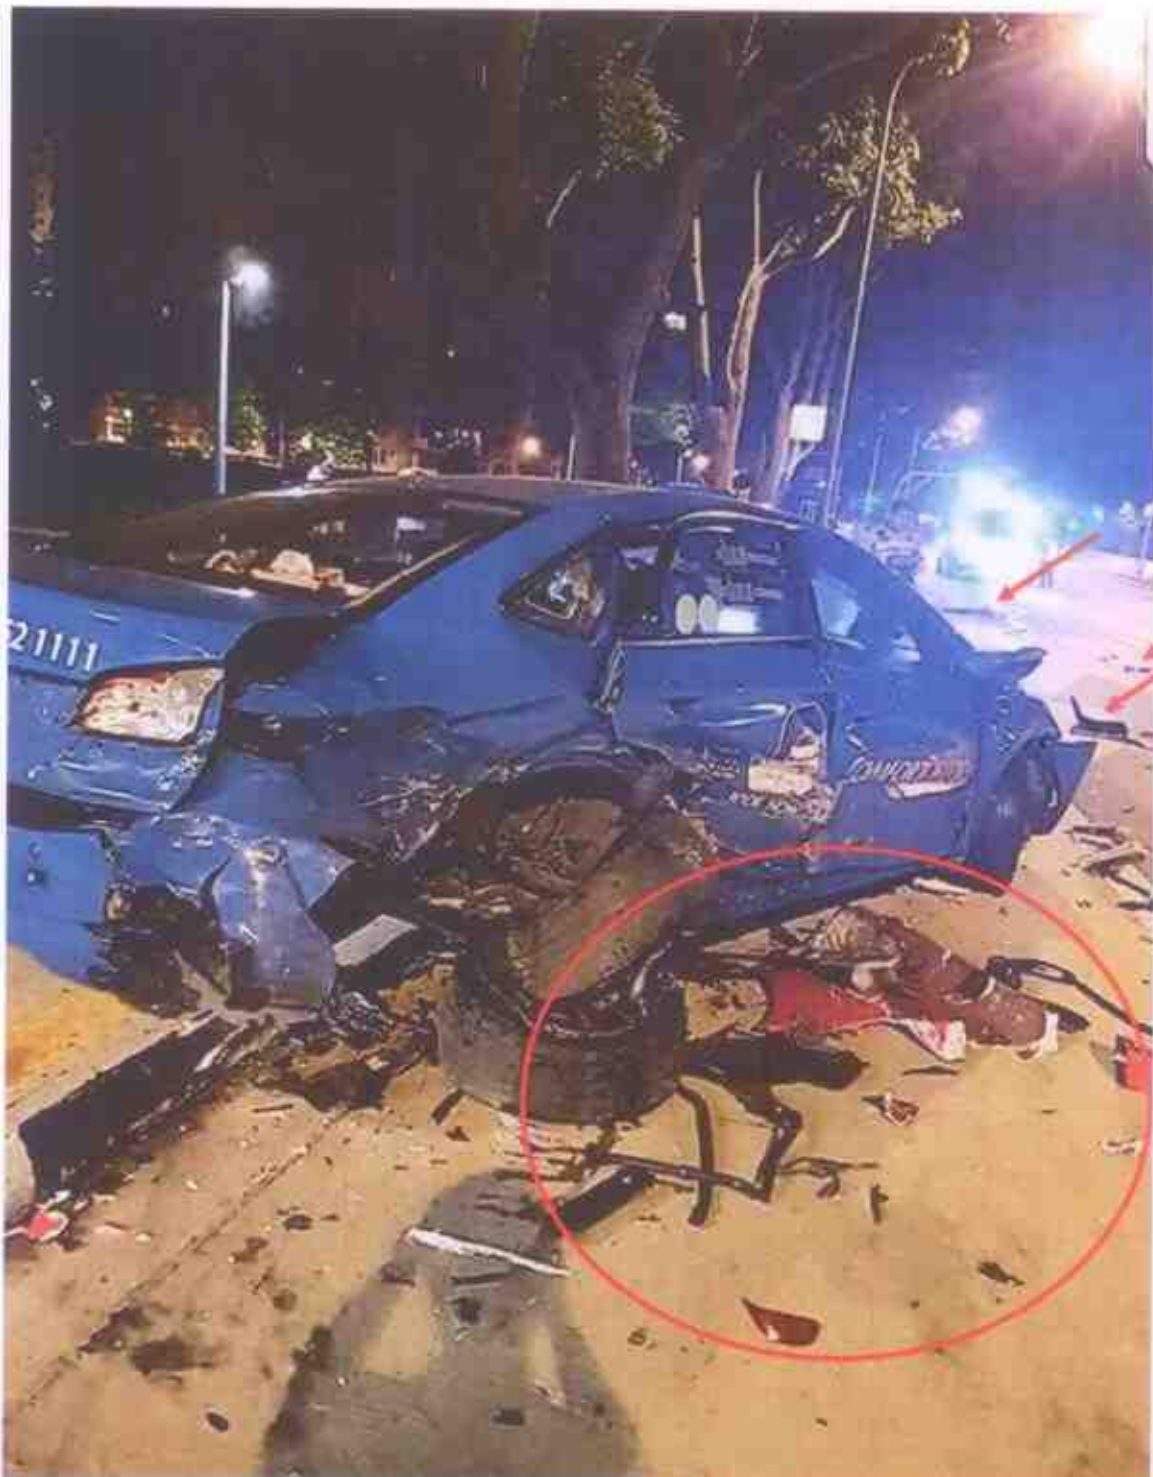
9. Vehicular debris from both the involved vehicles were all seen mainly within the bus bay. Broken body parts from SLM 10K can be seen lying within the bus bay on the right side of SHC 8317Z. Closer examination of the photographs and video recordings revealed what appears to be some debris on the extreme left lane at the stretch after the location where SHC 8317Z had stopped. There was however no debris found before the location where SHC 8317Z had stopped. See photo 5 & 6 below.

Photo 5 shows the accident scene after the accident. Vehicular debris could be seen lying mainly within the bus bay, on the right side of SHC 8317Z. This had included broken body parts (circled) from SLM 10K. Upon closer examination of the photograph, I had also observed some vehicular debris (arrowed) lying on the extreme left lane after the location where SHC 8317Z had stopped.

12. Although there were also vehicular debris on the extreme left lane, these were found after the final rest location of SHC 8317Z. Since both the vehicles were facing in the same direction to vehicular traffic flow prior to the accident, the vehicular debris found on the extreme left lane after the final rest location of SHC 8317Z is then not the first location of where vehicular debris was found. These vehicular debris were left behind by SLM 10K as it was coming to a rest after collision with SHC 8317Z.

13. Given that there was no vehicular debris found before the final rest location of SHC 8317Z, the vehicular debris that was found within the bus bay, on the right side of SHC 8317Z would then be the first area where vehicular debris was found. Basing on this physical evidence at the accident scene, the location of the point of impact between SHC 8317Z and SLM 10K was within the bus bay. This corresponds to the accident circumstance described by the driver of SHC 8317Z rather than the circumstance that was described by the driver of SLM 10K.

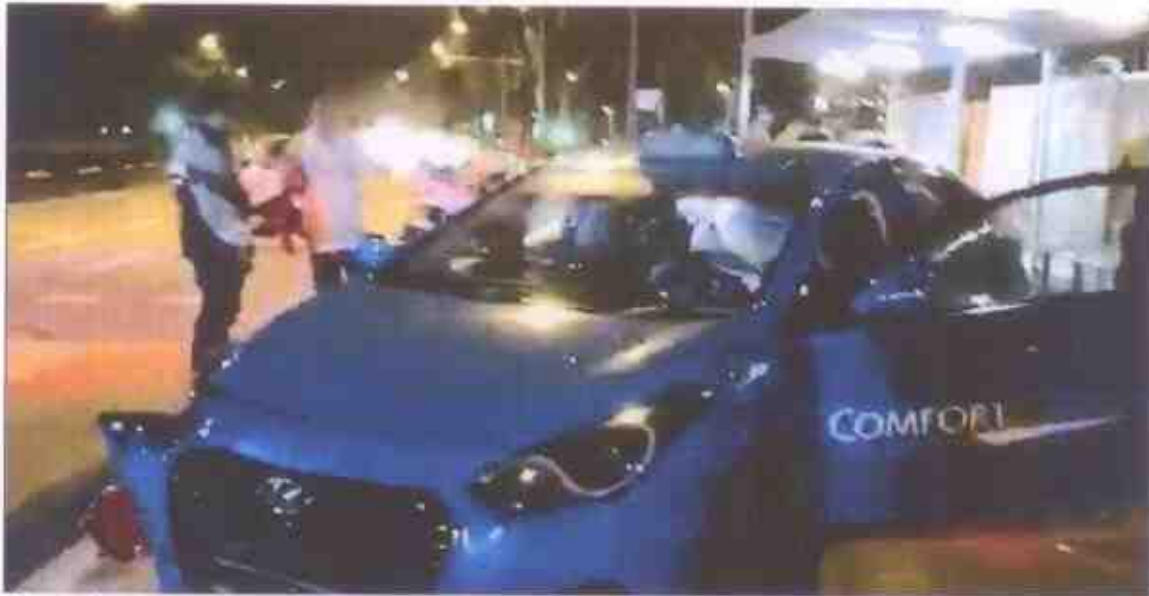
Photo 6 shows a screenshot from one of the video recordings of the accident scene. Closer examination of the video recording appears to indicate that there was no vehicular debris on the roadway before the location where SHC 8317Z had stopped.

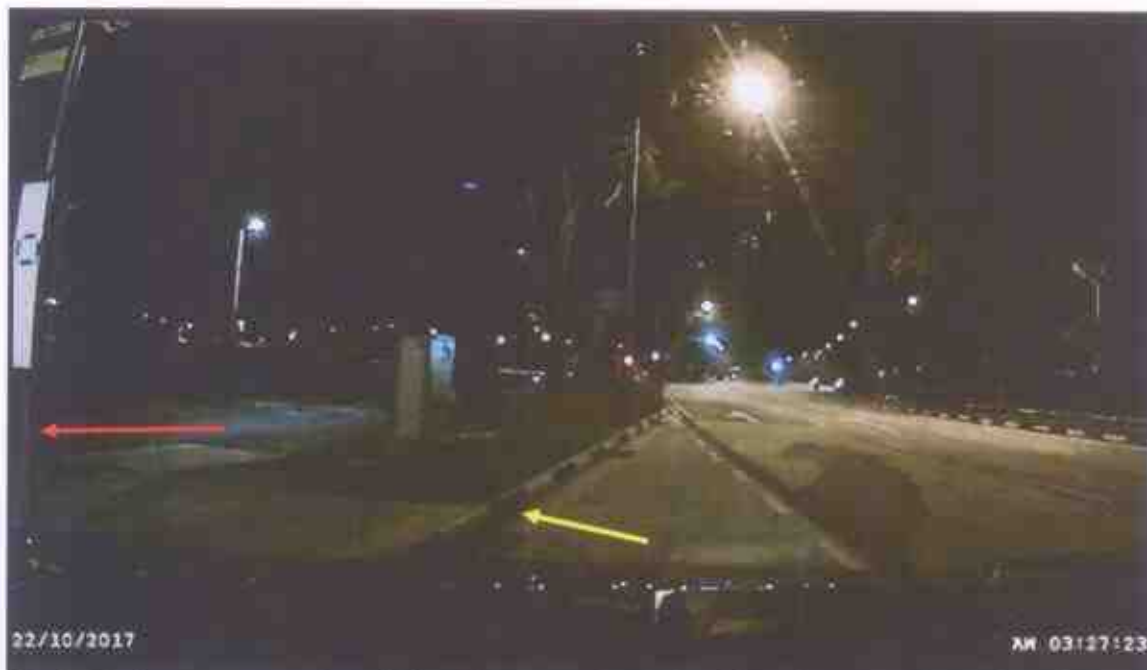
15. The last seen image from the recording device had showed SHC 8317Z stopped towards the end of the bus bay. The bus stop stand that had toppled after the accident could be seen towards the left and slightly ahead of SHC 8317Z. This initial stopped location to the final rest location was approximately less than 5m, taking reference from the fixed road features, in particular the start of the grass patch and black and white paint of the road kerb. See photo 7 below.

Photo 7 shows a screenshot of the video recording taken from the recording device that was mounted on the front windscreen of SHC 8317Z. The last seen image from the recording device had showed SHC 8317Z stopped towards the end of the bus bay as seen from the screenshot. Taking reference from the fixed road features like the bus stop stand (red arrow) that was toppled after the accident, start of grass patch, and black and white paint of the road kerb (yellow arrow), the initial stopped location of SHC 8317Z to its final rest location was approximately less than 5m. Refer to photograph 1 above for comparison.

18. The evidence that SHC 8317Z had stopped slightly ahead from its initial stopped position indicates that the point of impact between the vehicles had occurred close to or at its initial stopped position within the bus bay. The impact force arising from the collision had shifted/pushed SHC 8317Z slightly forward before it came to a final rest as seen in the accident scene photographs.
