PREMIER  
USER SERVICES

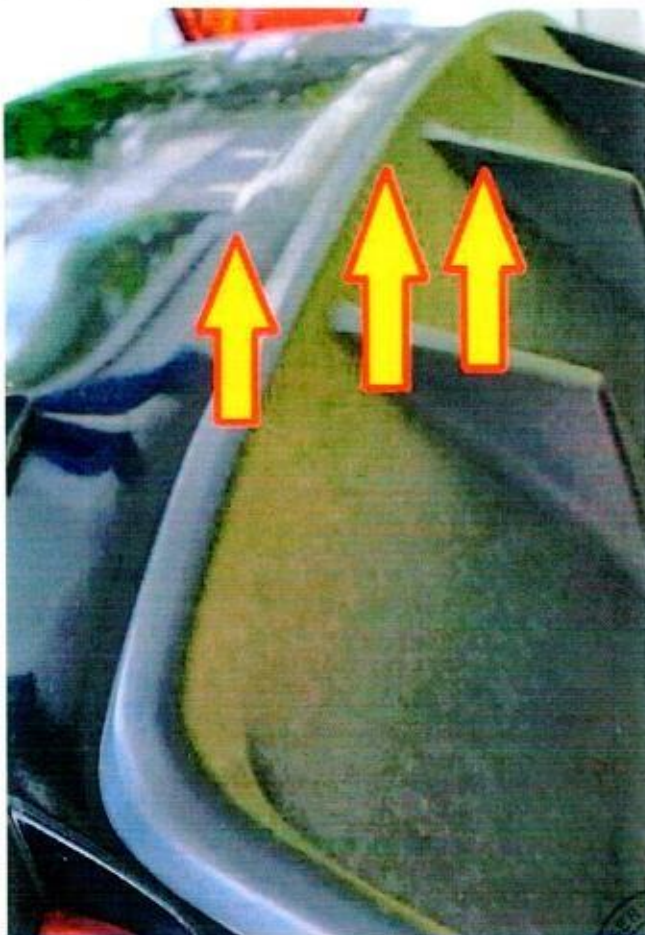
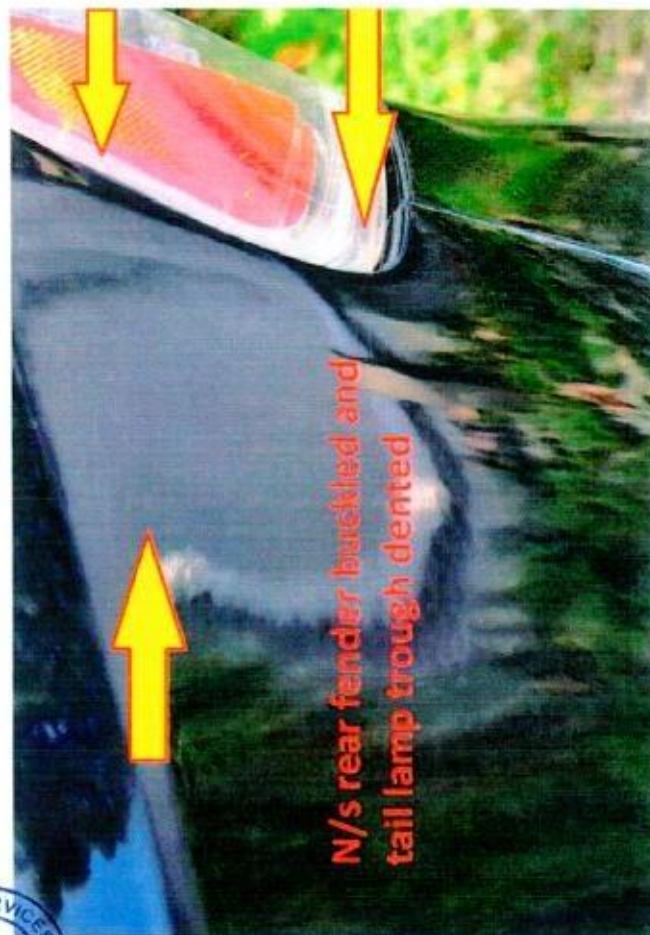
N/s rear fender buckled and  
tail lamp trough dented
