Report no: 181M0518.SSH

Vehicle no: SJK8204A

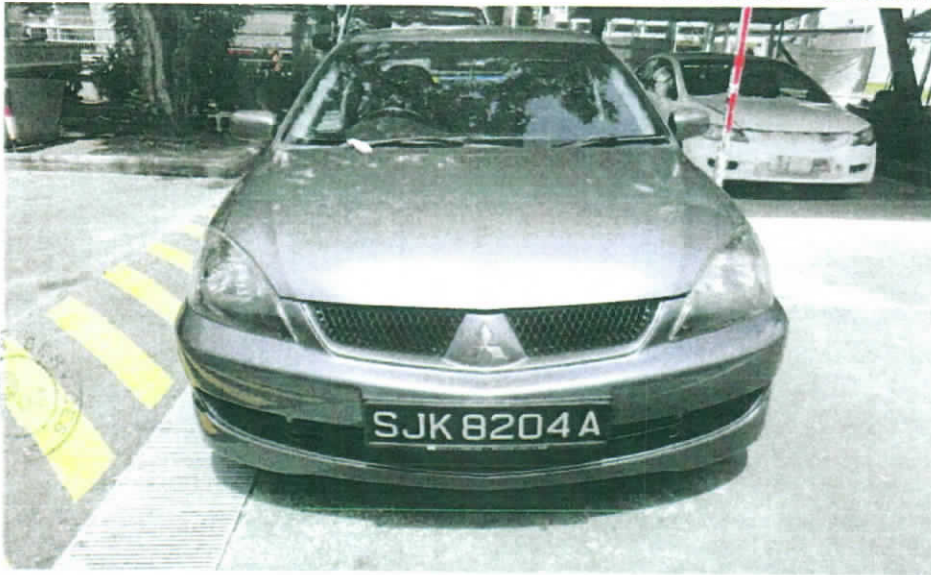
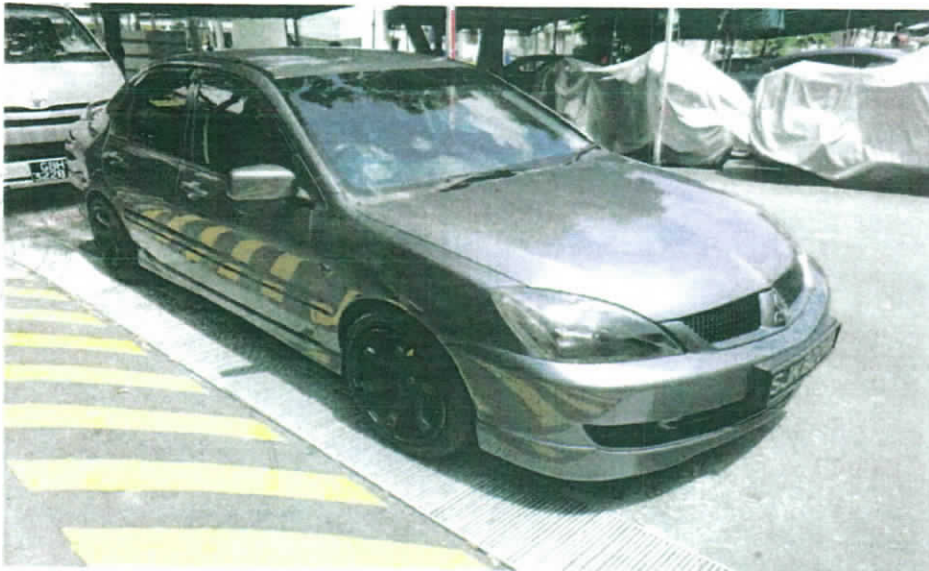
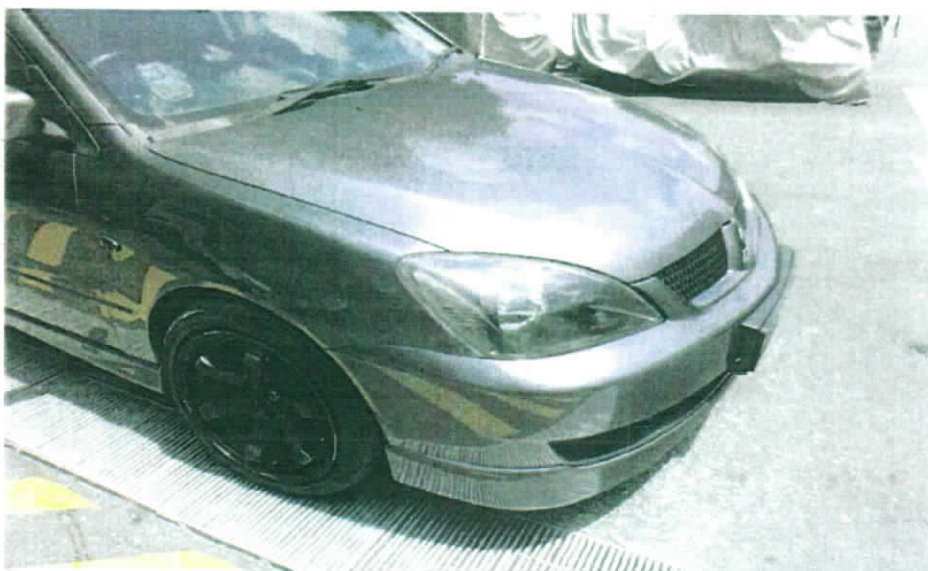
**POST REPAIR**

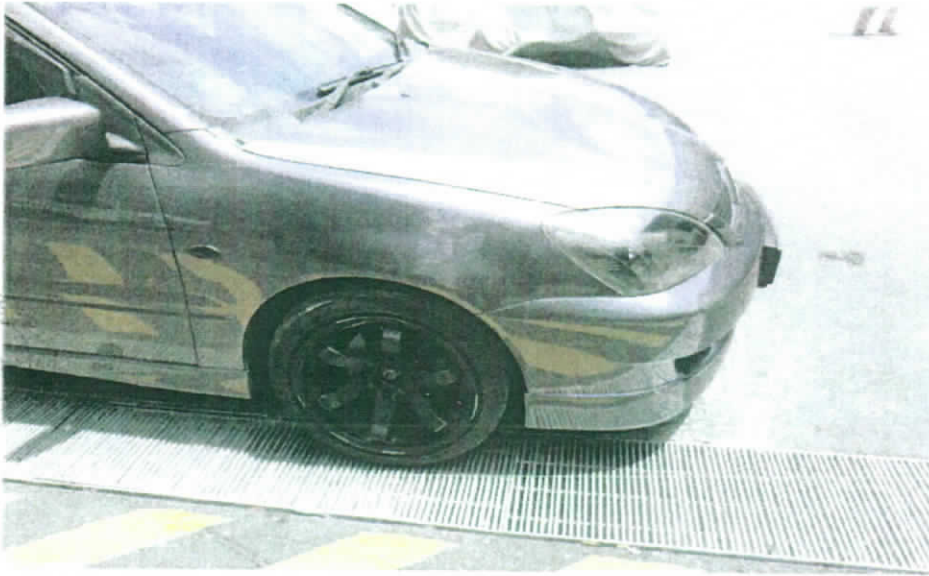
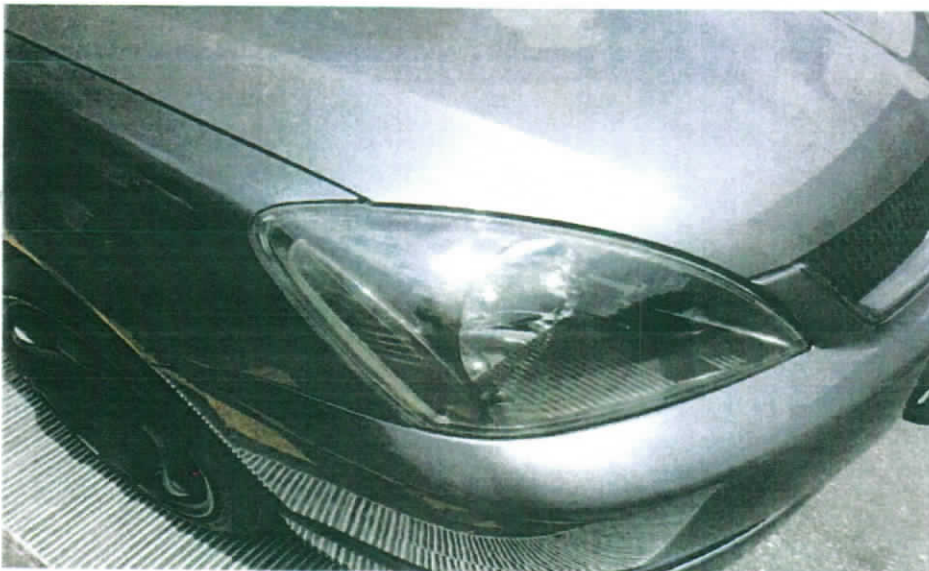
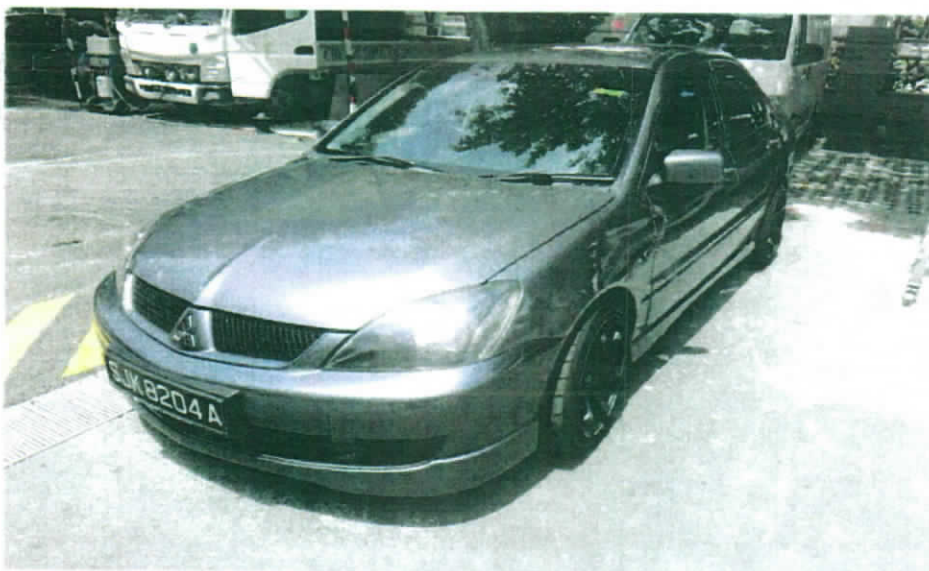
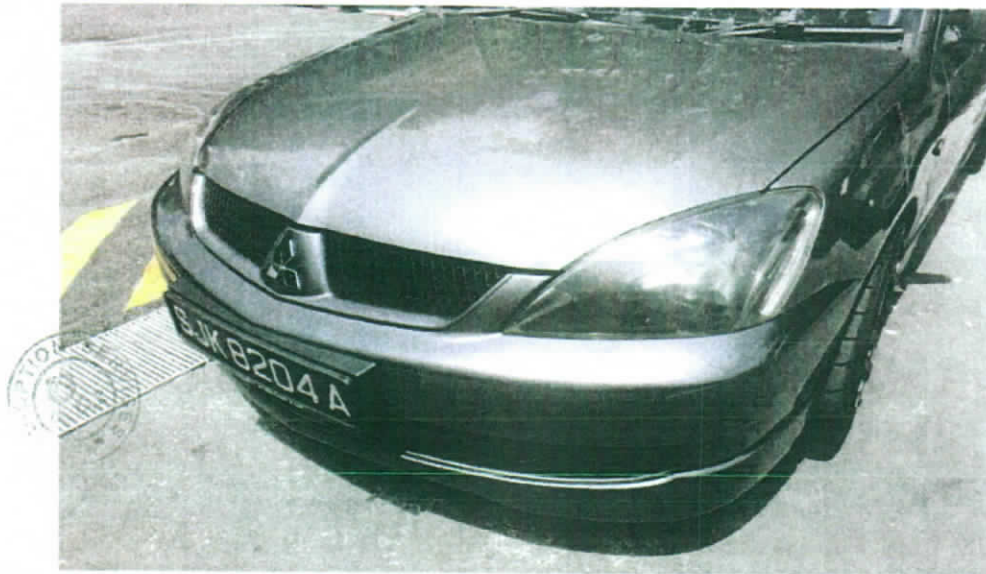
POST REPAIR
