Your Ref: VA1/GA134082  
Our Ref :CS/ASM18009602/Z

11<sup>th</sup> June 2018

**TECHNICAL INVESTIGATION REPORT OF FIRE INCIDENT INVOLVING THE  
INSURED VEHICLE SB4D ON 21<sup>st</sup> May 2018**

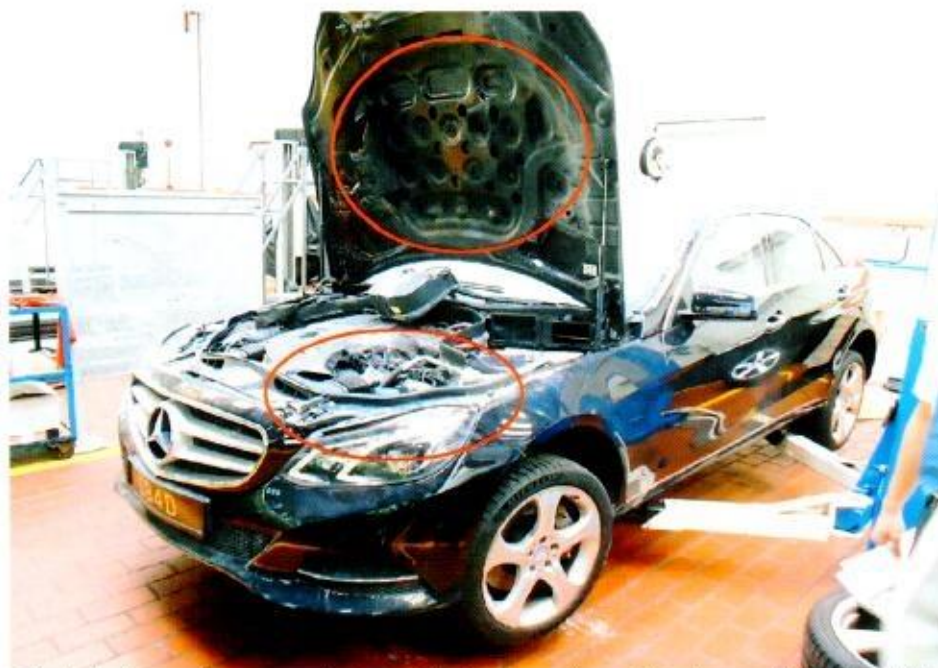
5. The Insured Vehicle was noted to have sustained fire damages that were confined to its front portion. The effected burnt area was observed to be on the middle slightly towards the left section of the engine compartment.
6. The fire had resulted in the body parts at the front portion of the Insured Vehicle to be burnt. This had included its front bonnet, at the centre area internal portion and several parts of the engine components especially at the centre of the engine. See photo 1 – 4 below.

**Photo 1** shows the general view of the front portion of the Insured Vehicle at the time of our inspection. The fire damage to the Insured Vehicle was confined to its front bonnet, at the centre area; engine parts were amongst the body parts that were found to have been affected as a result of the fire.

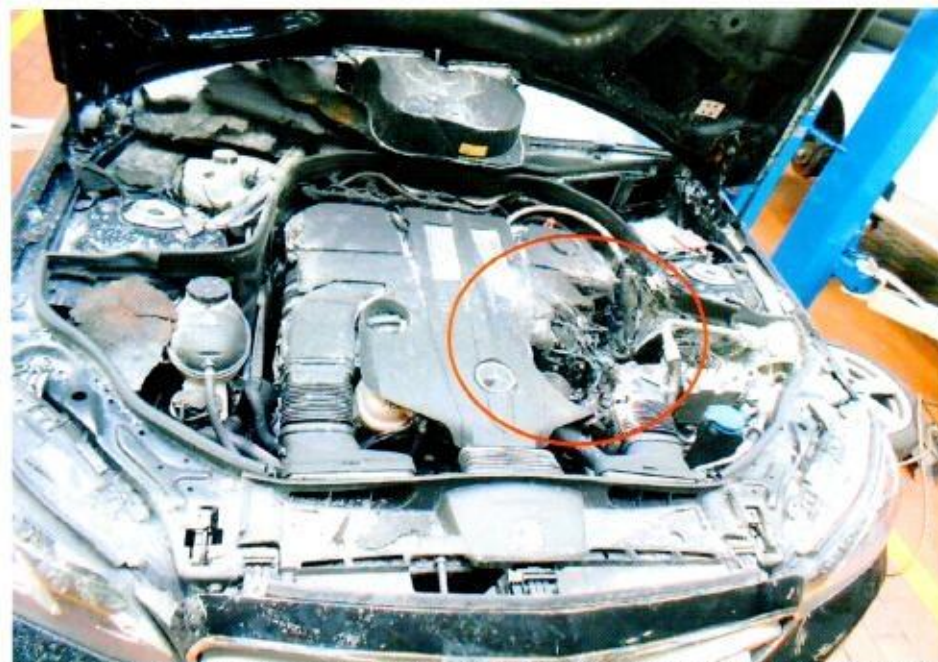
**Photo 2** shows the general view of the front centre portion of the Insured Vehicle at the time of our inspection. The fire damage to the Insured Vehicle was confined to its front bonnet, at the centre area; engine parts were amongst the body parts that were found to have been affected as a result of the fire.

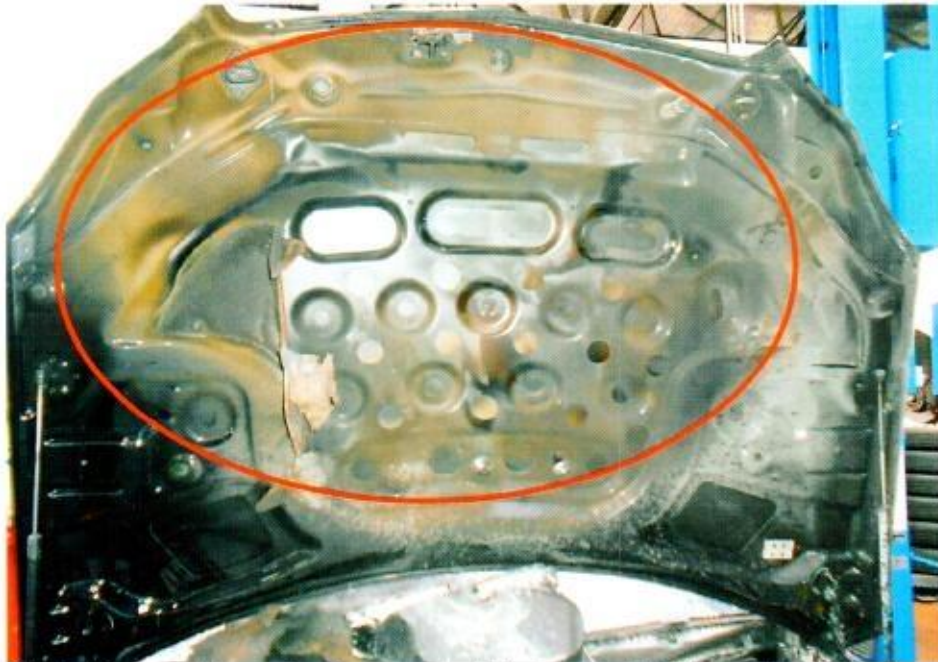
**Photo 3** shows the underside bonnet of the Insured Vehicle at the time of our inspection. It was observed to sustained with burnt marks.

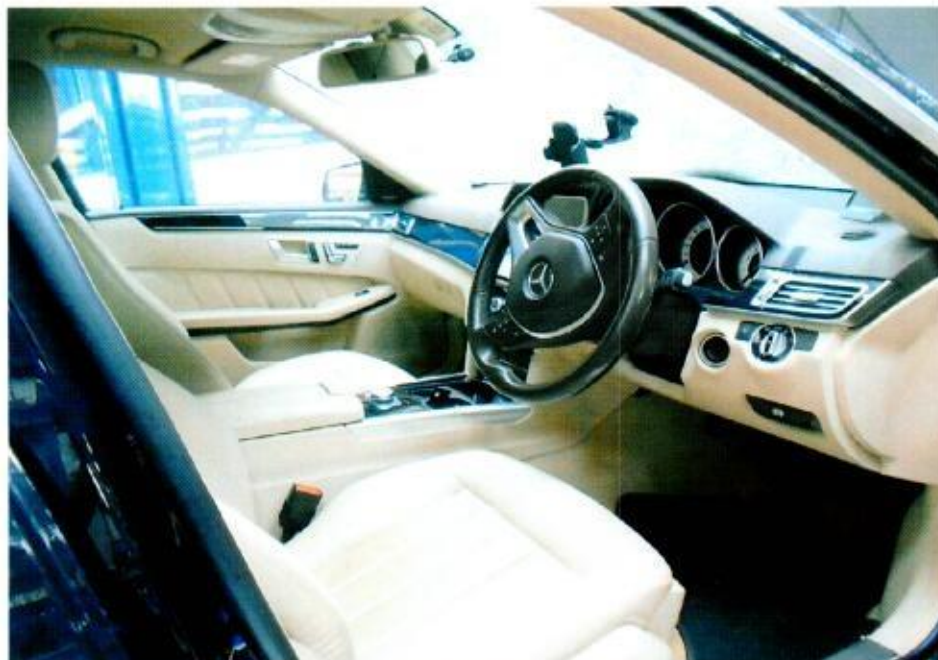
**Photo 4** shows the interior compartment of the Insured Vehicle, which was observed to be unaffected by the fire incident.

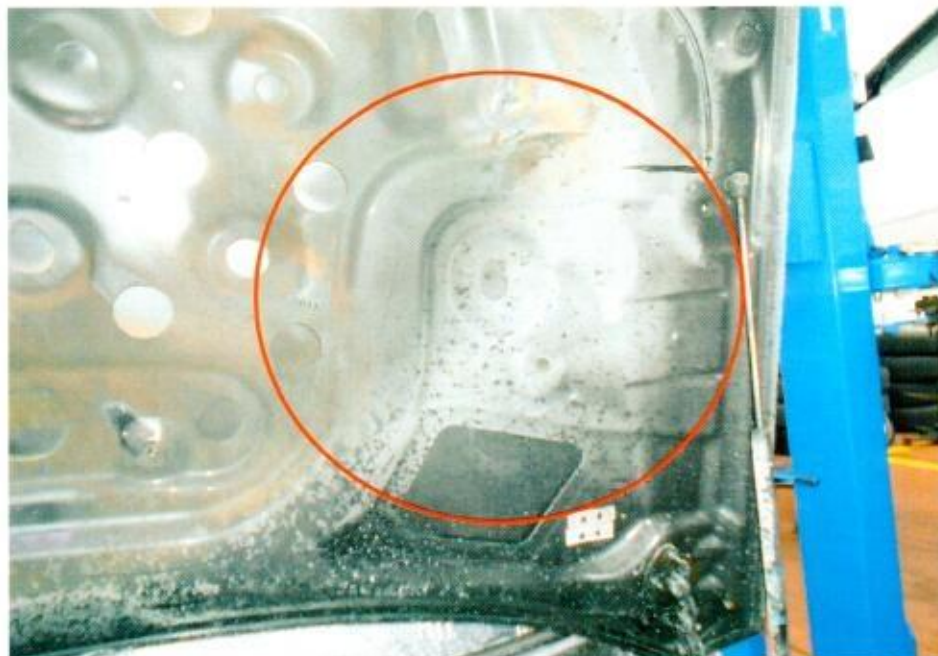
8. For this particular case, the fire appears to have originated within the engine compartment of the Insured Vehicle, somewhere around its centre portion at the engine compartment. This can be determined from the burn pattern and the high heat intensity burn marks found on the underside of the front bonnet of the Insured Vehicle; at the engine centre portion and also given that there was no other area of the Insured Vehicle that were found with damage of burnt nature.
9. These (whitish) burn marks are a result of exposure to prolong heat intensity. Rust would normally start to develop around these areas soon after a fire as prolonged exposure to high heat intensity usually causes steel/metal material body parts to be exposed to natural environmental condition. See photo 5 & 6 below.

**Photo 5** shows the burn pattern and whitish burn marks (circled) that were found on the underside of the front bonnet of the Insured Vehicle. Such whitish burn marks are a result of exposure to prolong heat intensity, which may indicate where the fire had started. Rust would also begin to develop on these areas soon after the fire.

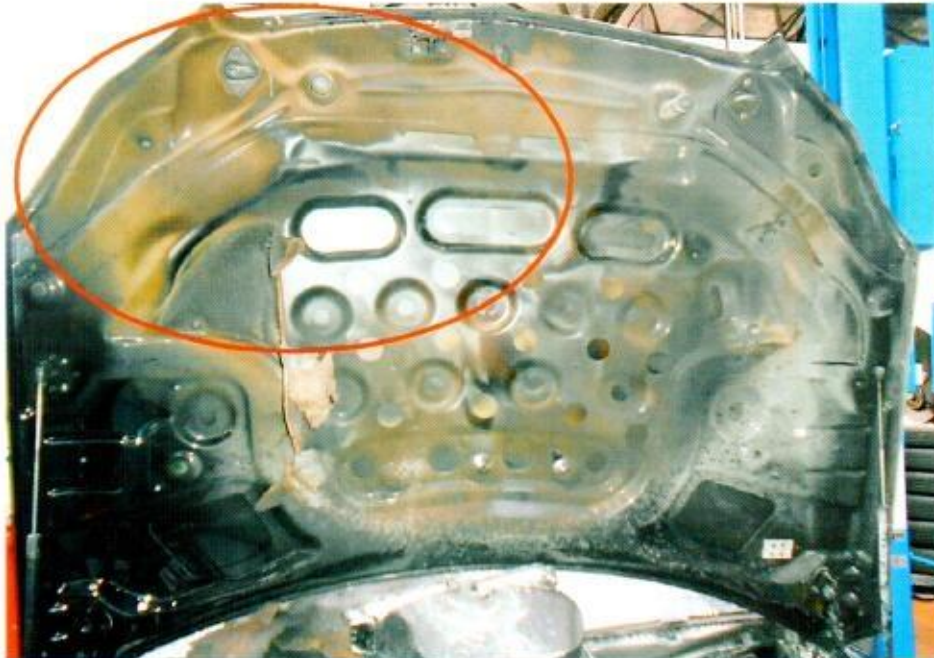
**Photo 6** shows the whitish burn marks that were found on the underside of the front bonnet, directly under the area where the same whitish burn marks were found on the top side of the front bonnet. The rust (circled) that had developed around this area was a result of prolong exposure to high heat intensity, which had caused the steel/metal material of the front bonnet to be exposed to natural environmental condition.

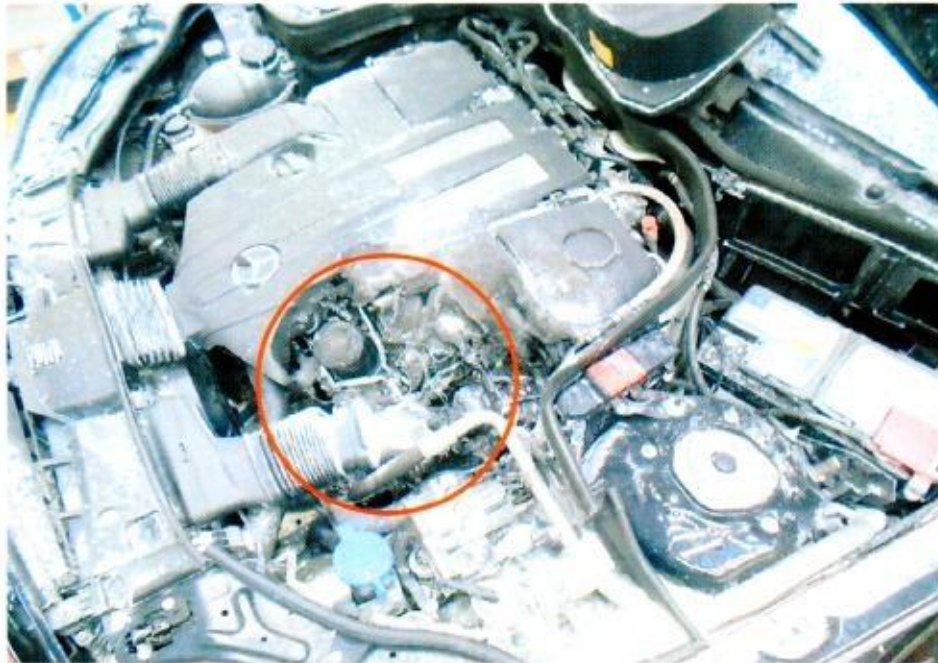
10. Upon closer examination of the area around the centre of the engine compartment, which was in the immediate vicinity of where the fire to the Insured Vehicle had likely started, we had found several stretches of wiring burnt internally to its bare copper state. The wirings were likely to be the original engine wire harness. Such condition normally indicate internal heating of copper wires which is a sign of an electrical short circuit occurring. This would then appear to suggest that the cause of fire to the Insured Vehicle could have possibly been due to electrical in nature. See photo 7 & 8 below.

**Photo 7** shows a closer view of the wirings around the left rear of the engine compartment, which was in the immediate vicinity where the fire to the Insured Vehicle had likely started.

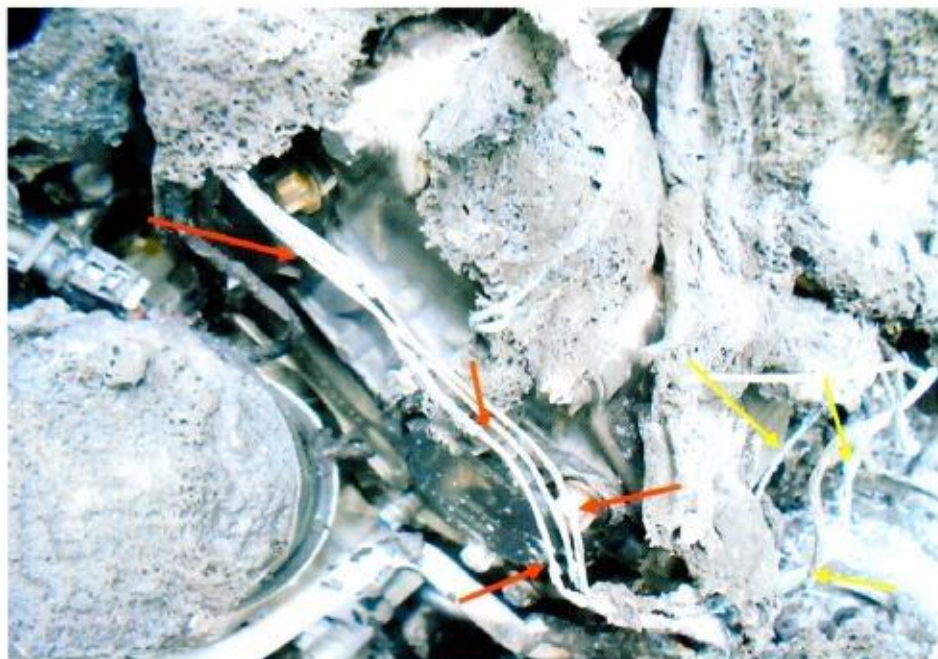
**Photo 8** shows a closer view of the wirings (red arrow) which were found to have been burnt internally to its bare copper state, suggesting occurrence of an electrical short circuit. These wirings were observed to be greenish (yellow arrow) believe to be the focal point of the fire ignition.

30. The possibility of the fire being due to electrical in nature would then seem more likely given that engine overheating and external factor would both seem unlikely. The fire being due to electrical nature is also supported by the condition of the wirings of the Insured Vehicle. The sparked from the short circuit wires might cause ignition to start a fire which was earlier discussed in paragraph 10 above.

32. Having investigated and technically analysed the damages of burnt nature to the Insured Vehicle, We are of the view that the cause of fire to the Insured Vehicle was of electrical in nature. For this particular case, the fire had originated along the wiring inside the engine compartment, somewhere around its front portion in the middle section of the engine. The wirings were likely to be the original engine wire harness.

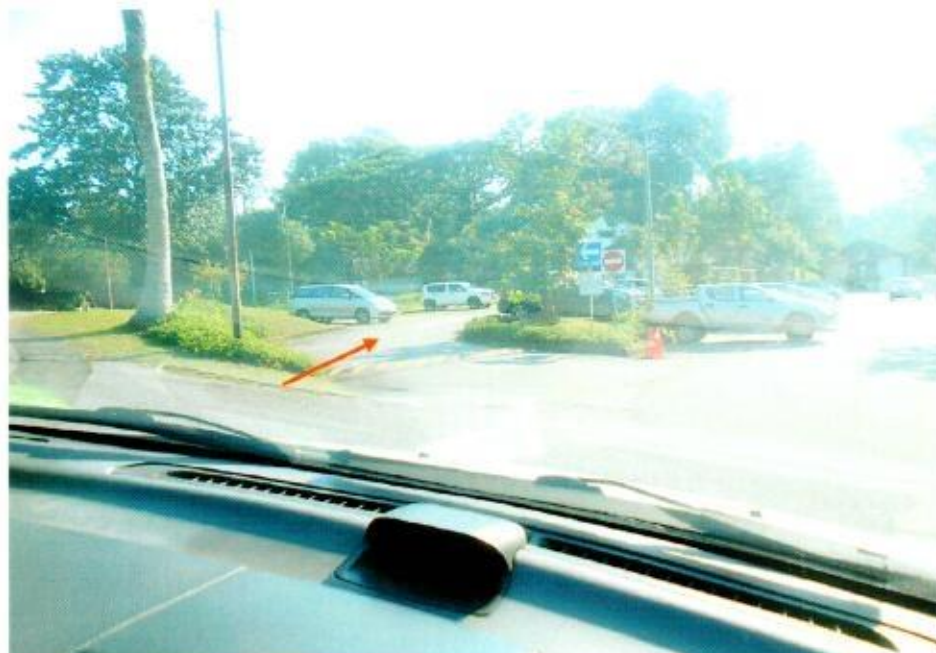
**Photo 12** shows the general view of the open car-park entrance. The said non-numbered parking lot was on the left side upon entering the vicinity.

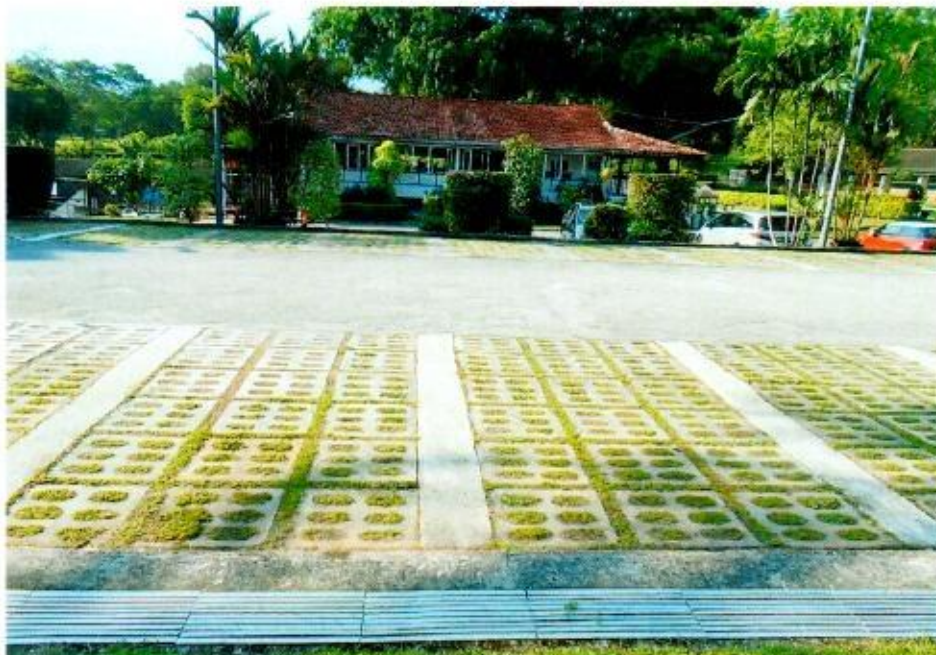
**Photo 13** shows the general view of the non-numbered parking lot that was said to be the where the fire incident had happened.

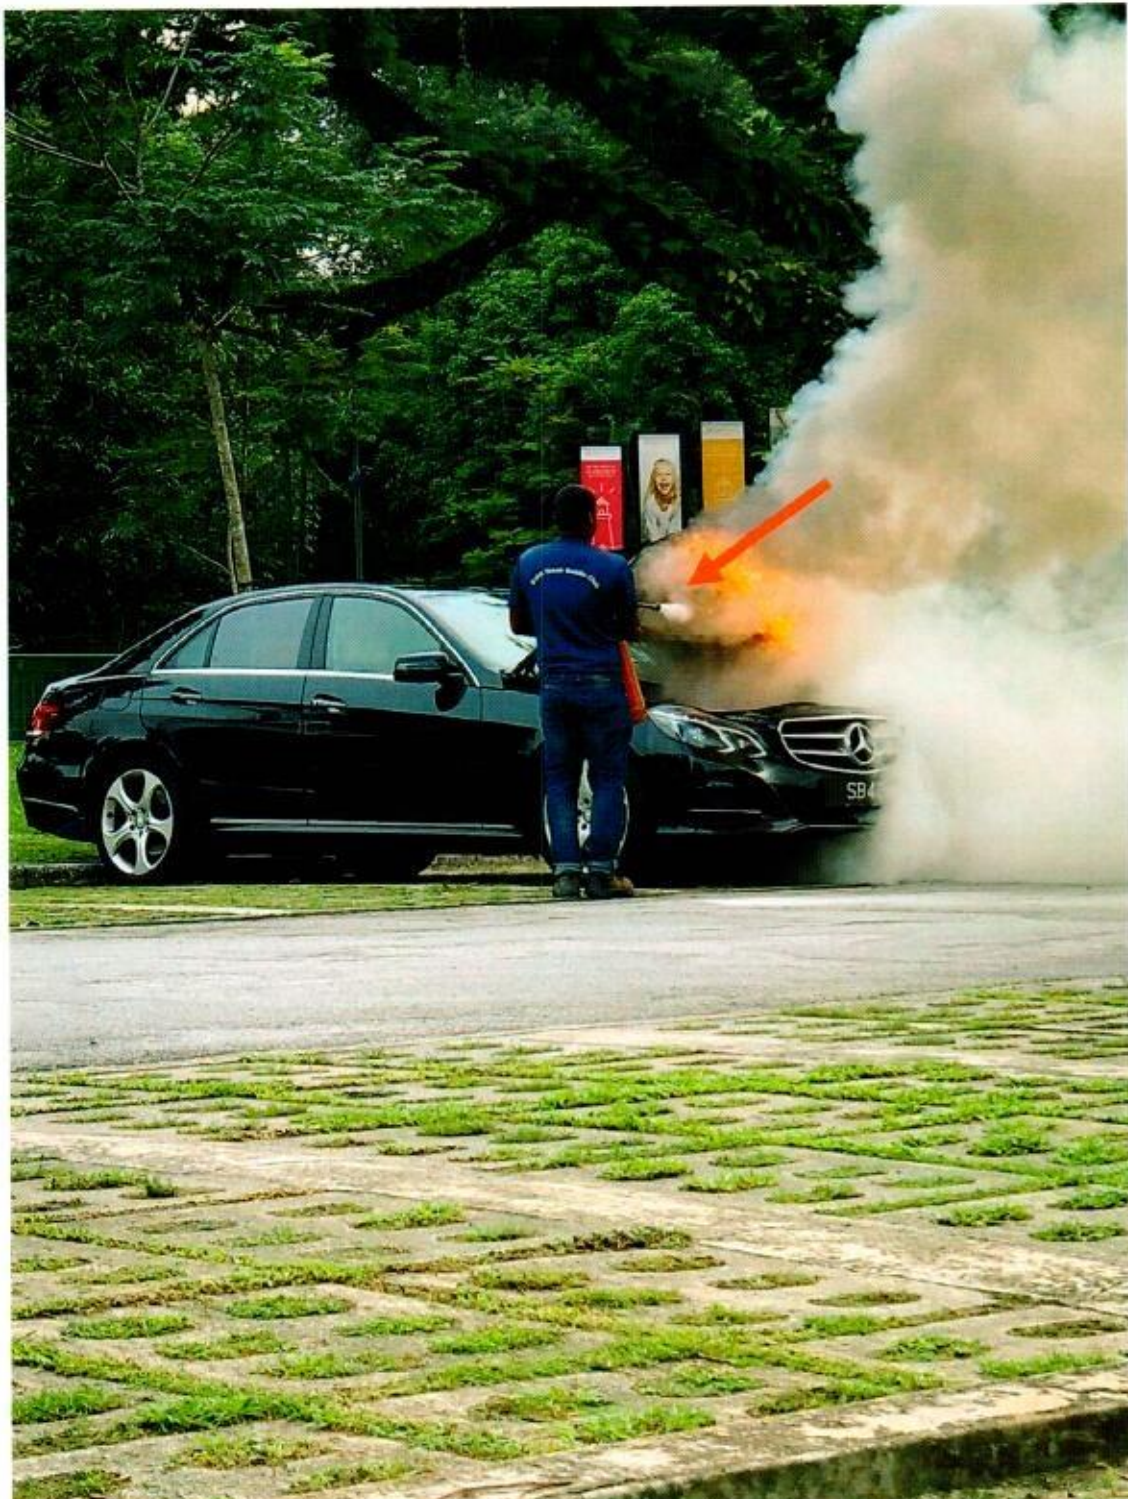
**Photo 14** shows the Insured Vehicle at the incident scene while the club staff extinguishing the fire (arrowed). There appears to be no abnormal foreign material(s) and/or object(s) found on the ground in the immediate area where the Insured Vehicle was parked. In general, the information that could be gathered from these photographs had corresponded to the events that were related to us by Mr Mark Shaw & Ms Tiara.

28. The possibility of the fire being due to external factor (foreign material(s) stuck on hot surfaces, arson and sabotage amongst others) would also seem unlikely given that our examination of the available incident scene photographs did not reveal any unusual material(s)/object(s) found on the ground near where the Insured Vehicle was parked.

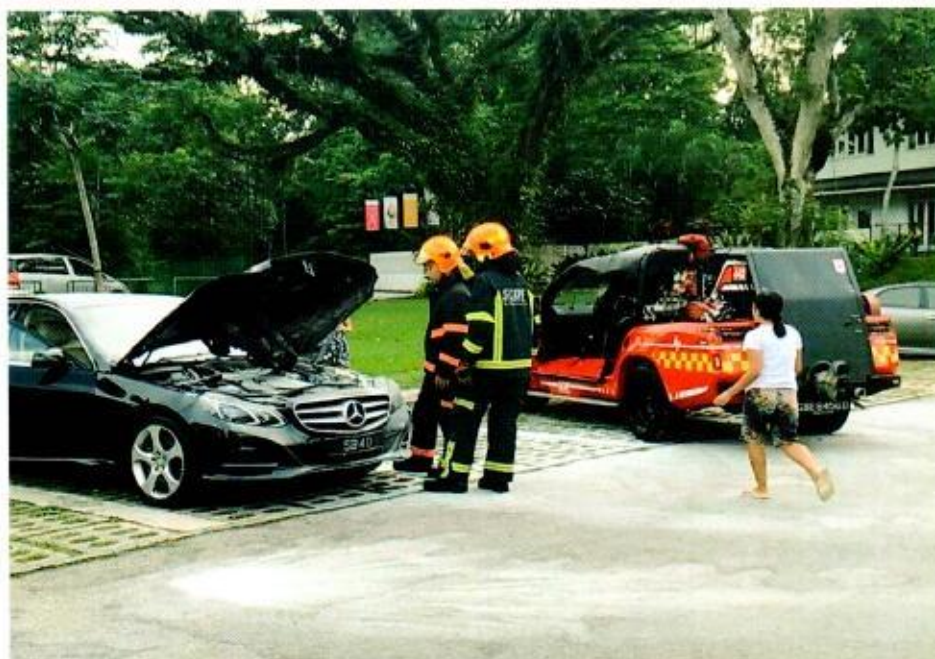
**Photo 15** shows the Insured Vehicle at the incident scene after the fire was extinguished. SCDF officers were seen investigating the Insured Vehicle.

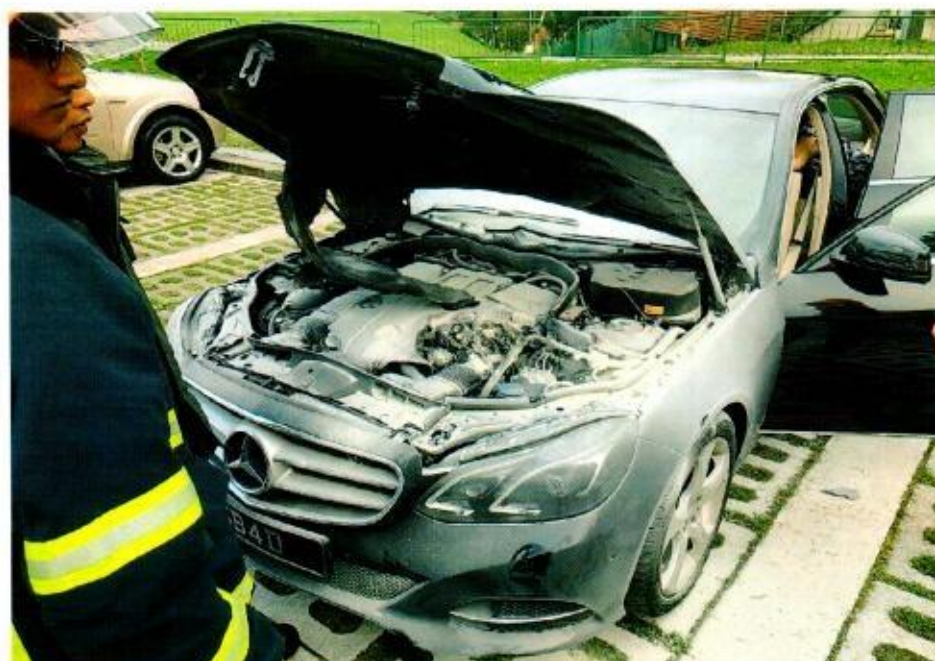
**Photo 16** shows the Insured Vehicle at the incident scene after the fire was extinguished. SCDF officers were seen investigating the Insured Vehicle.
