# LKK Auto Consultants Pte Ltd

**Preliminary Advice**

Vehicle No	: SKU3889S	Accident Date	: 05/05/2018
Make	: HONDA MOBILIO SV	Policy No.	: P4022801DMV
Assignment Date	: 28/05/2018	Excess	: S\$500.00
Date of Inspection	: 30/05/2018	Est. Duration of Repair	: 3.00
Inspection At	: SHU FATT AUTO WORKS (HQ) BLOCK 1009 BUKIT MERAH LANE 3, #01-90 SINGAPORE 159723

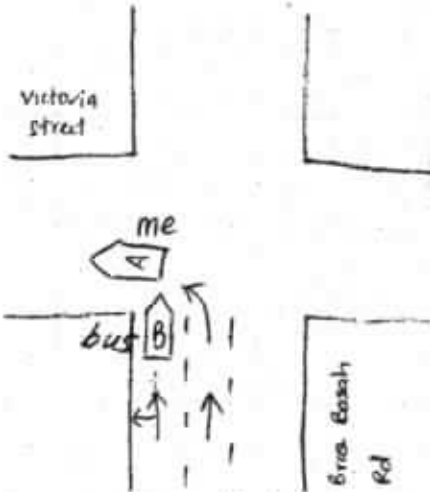
## SKETCH PLAN

A : SKU 3829 S

B : 3MB HTB

Type Of Accident	COLLISION - CHANGE/CROSS LANE
Weather Conditions	CLEAR
Road Surface	DRY
