<REQUEST FOR SURVEY REPORT> TCS REF: AAD1311-267--Accident involving

SHC1825U & SHB9857E on 24.11.13

Affiliated to Federation Internation	onale Des Experts En Automo	bile
TRAI	NS-CAB AUTO SE	RVICES PTE LTD	Ref : CS/TP18009941/	Krbe2
NO.2	ANG MO KIO ST	REET 63SINGAPORE 56911	Date: 16-07-2018	
١.	real transfer	Policy Particulars	:- THIRD PARTY CLAIM	
	Insured Veh.		Veh. Inspected	SHB 9857E
	Policy No.		Coverage (\$)	0.00
	Claim No.		Excess (\$)	0.00
	Assign From		Assign Date	26/11/2013

# ADJUSTMENT ON REPAIR COST FOR VEHICLE NO. SHB 9857E

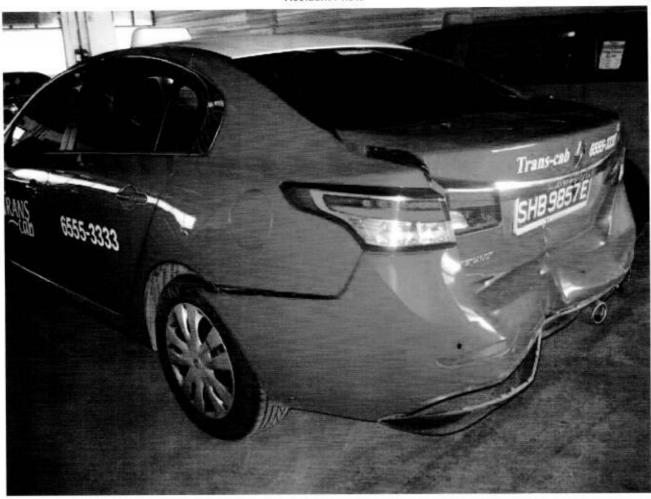
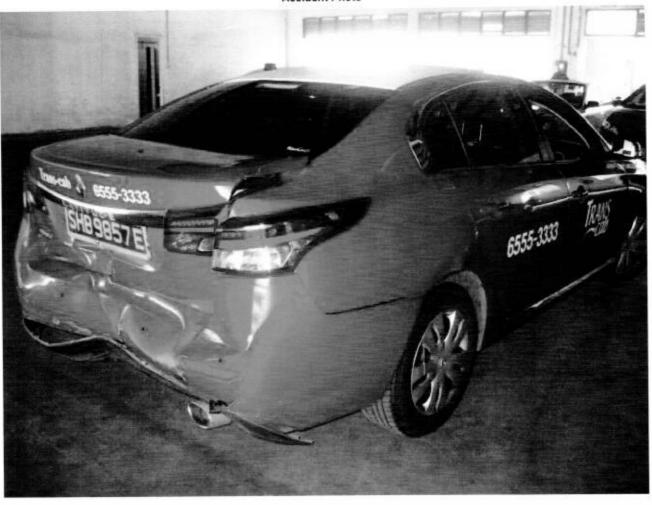
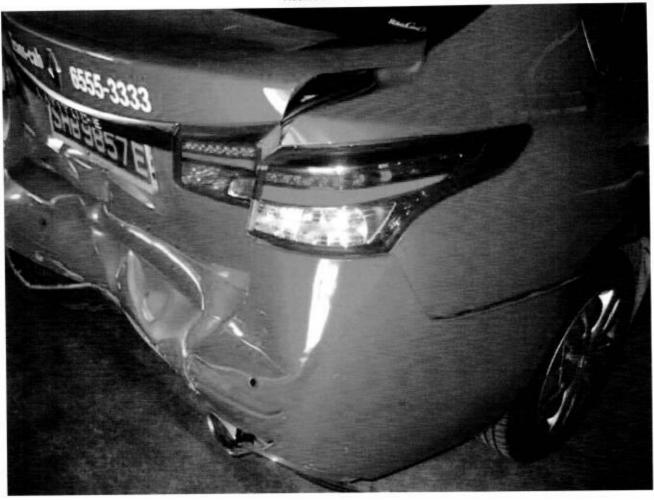
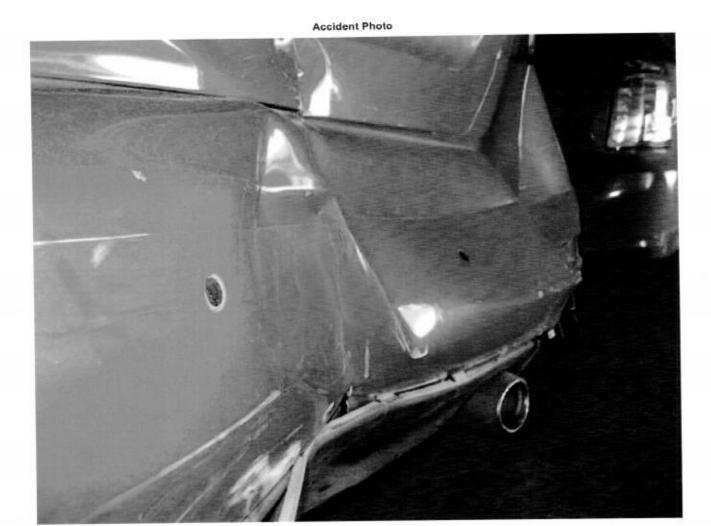
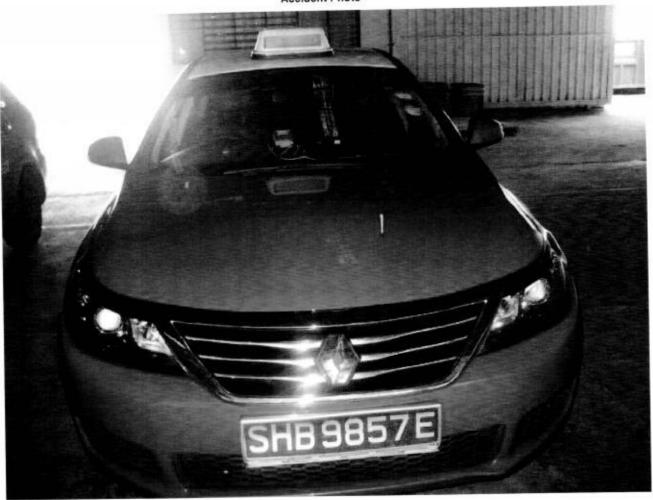
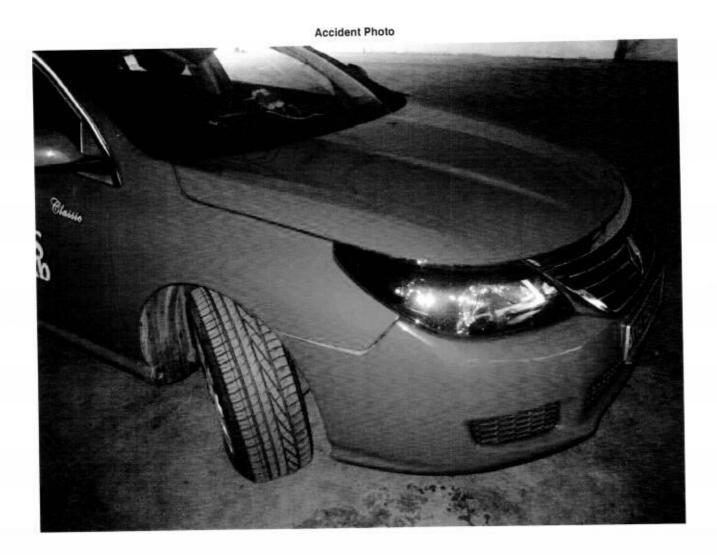
### **Accident Photo**

4.			tion of Damages	
	THE VEHICLE SU	STAINED DAMAGES AT THE R	EAR AND FRONT PORTION	N.
	DAMAGES SEE D	ETAILS.		
5.		Gener	al Information	
	Accident Date	24/11/2013	Inspection Date	26/11/2013
	Survey held at	TRANS-CAB AUTO SERVICES	S PTE LTD	
		NO.2 ANG MO KIO ST 63 SINGAPORE 569111		
5a.			Remarks	
	A)THE INSPECTION B)IN ACCORDAN	ON WAS CONDUCTED ON A'W CE TO YOUR INSTRUCTIONS,	WE HAVE NOT AUTHORIS	S. ED REPAIRS.
5b.			e Days of Repair	
1/4-7	ESTIMATED NORMAL PERIOD FOR REPAIR: 14 Working Days
