ACCIDENT INVOLVING VEHICLES SLU 384P AND SJS 9881X ON 25/05/2018

VEHICLE DAMAGE INSPECTION REPORT

Our File No: CC6/AIG18010070/AHB3Q2
Date: 25/10/2018

Handling Insurer: AIG Asia Pacific Insurance Pte. Ltd. Policy No: 1700079401
Claimant Vehicle No: SJS9881X Insured Vehicle No: SLU384P
Date of Loss: 25/05/2018 Nature of Claim: TP Claim No: 4841899582SG

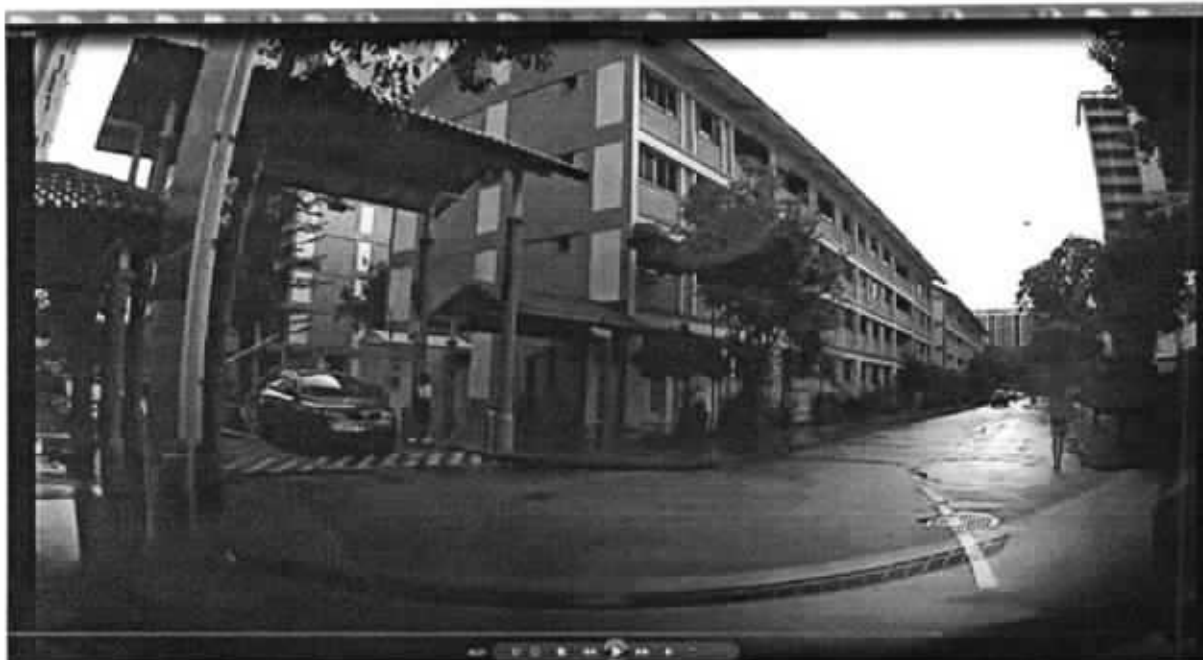
We also refer to the Insured's video footage uploaded in merimen which shows that Insured's vehicle had already completed the turn and was on the main road when hit by TP vehicle (red circle) that did not even slowed down after exiting the car park. Please see below video screenshot.

As such, we would like to reject the TP claim.

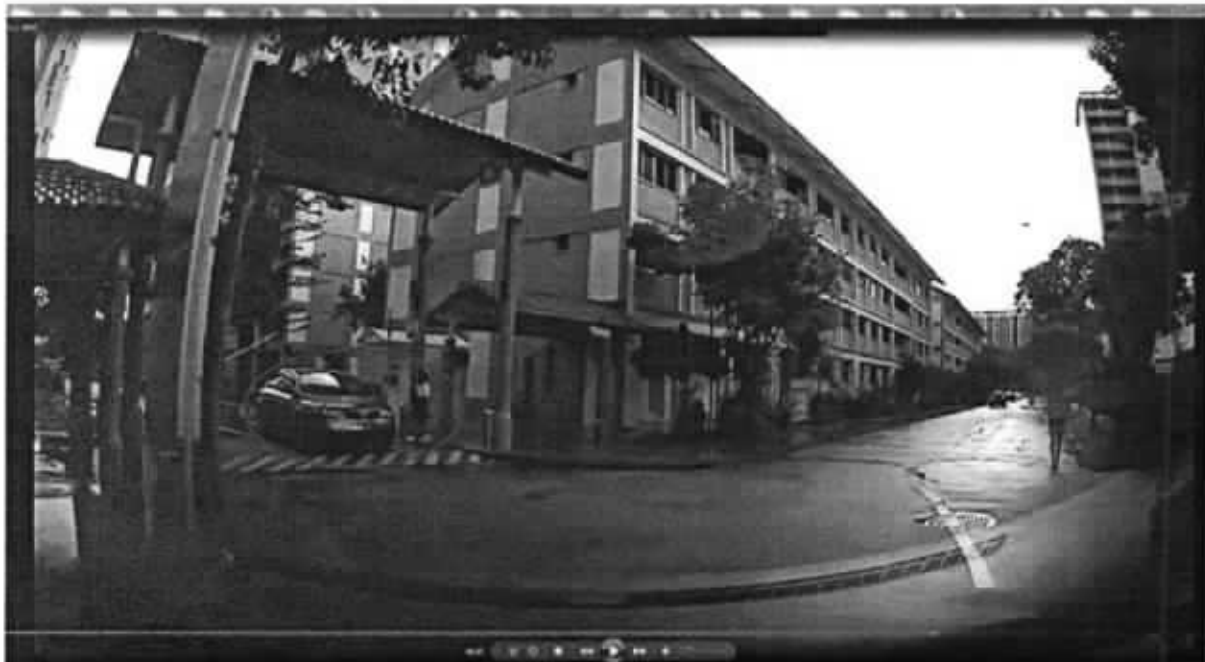
Our Insured had already completed the turn and was on the main road when your client did not slowed down and stopped to give way to the vehicles on the main road.

As such, we have our principal's instruction to deny your client's claim in view that your client should have gave way to our Insured when turning.

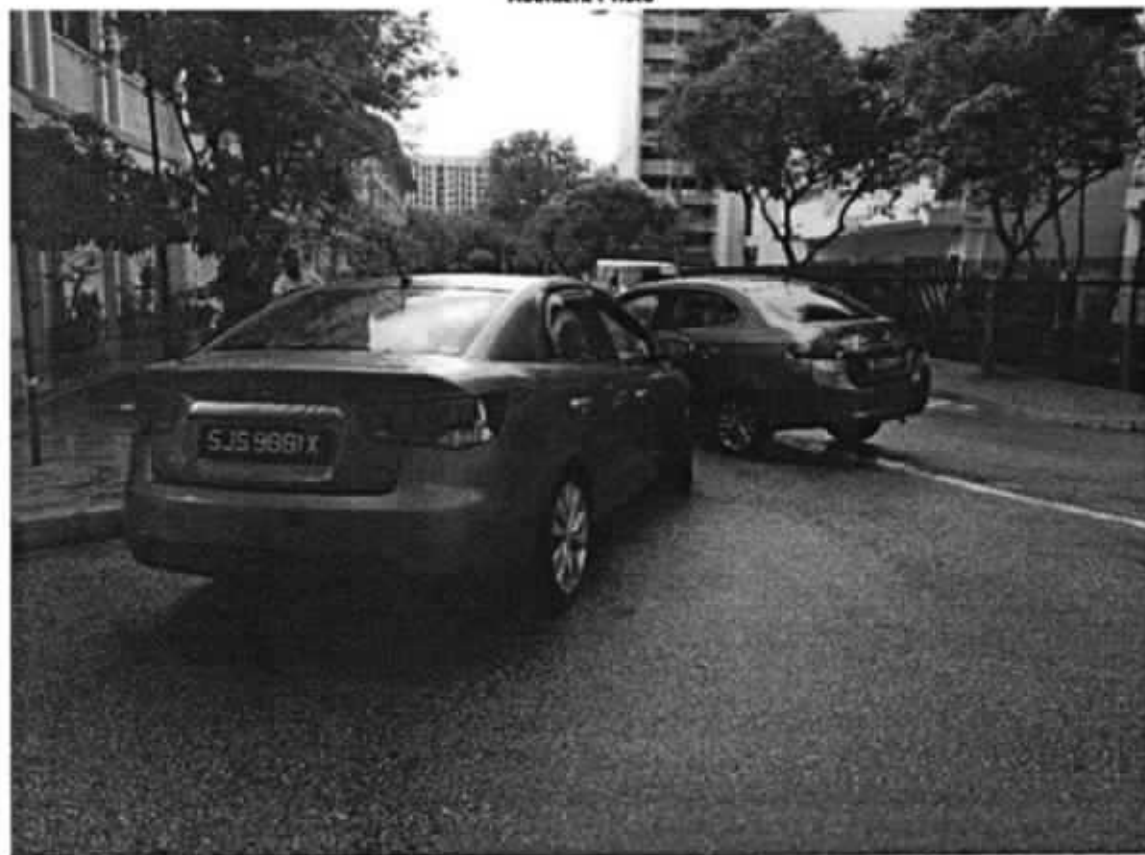
Accident Photo

I drove out of James Cook University Campus.
It was a right turn out of the campus onto Sims Drive.
I saw a grey car coming out of the carpark on my left. It was moving slowly and I didn't have any indication that the driver wouldn't stop to let me pass.
I drove past the car and felt the impact when the other car hit my side passenger doors.
