Your Ref: TP/IP/14693/2017  
Our Ref : CI/TPD18010135/Z

30<sup>th</sup> April 2018

**Fatal Accident Investigation Team**  
Traffic Police Department  
Singapore Police Force  
10 Ubi Avenue 3  
Singapore 408865

### **MECHANICAL INSPECTION REPORT OF MOTOR CAR SLN 9029T**

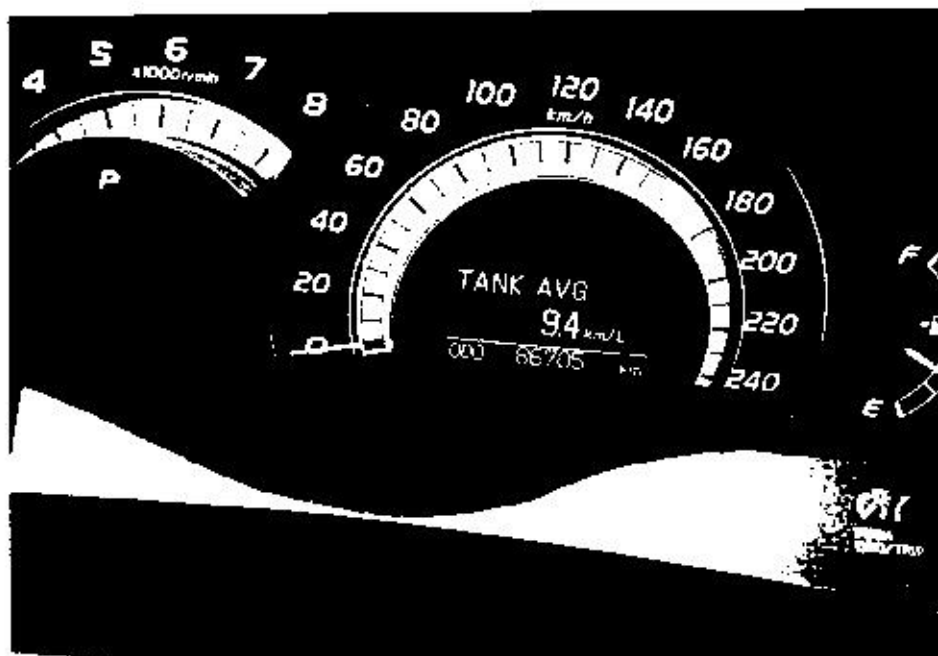
4. The mileage of the Motor Car recorded at the time of our inspection was 86705 km.
5. The Motor Car had sustained a relatively minor impact damages that was confined to its frontal left portion. Its bonnet was observed to have been dented and its front windshield was observed to be cracked amongst others.
6. This was likely due to the consistency of the accidents case facts that the Motor Car was travelling along Yishun Ring Road towards Yishun Avenue 11 on the left of a 2 lane road. He claimed A1 who was travelling in front of his vehicle made a sudden brake & stop. As such, he made a lane change to the right to overtake A1. In the midst of overtaking, suddenly a pedestrian crossed the road in front of A1 and appeared on his left to right. The Motor Car could not avoid and collided onto the pedestrian. See photo 1 to 7 below.

Photo 1 shows the mileage of the Motor Car was 86705 km.

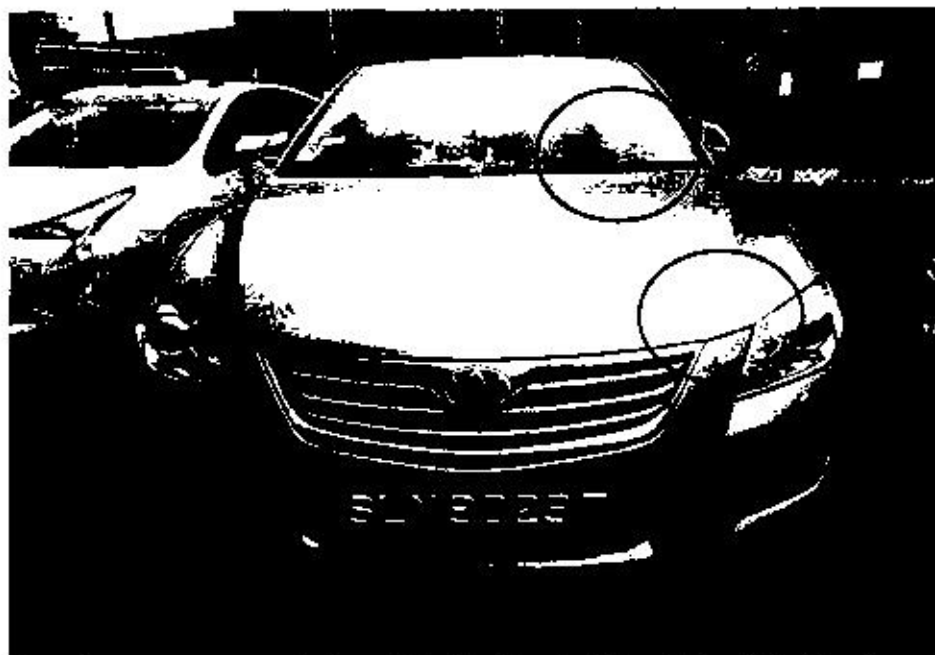
Photo 2 shows a general view of the front body of the Motor Car at the time of our inspection. The Motor Car was observed to be in good general condition except for minor damages at the frontal portion.

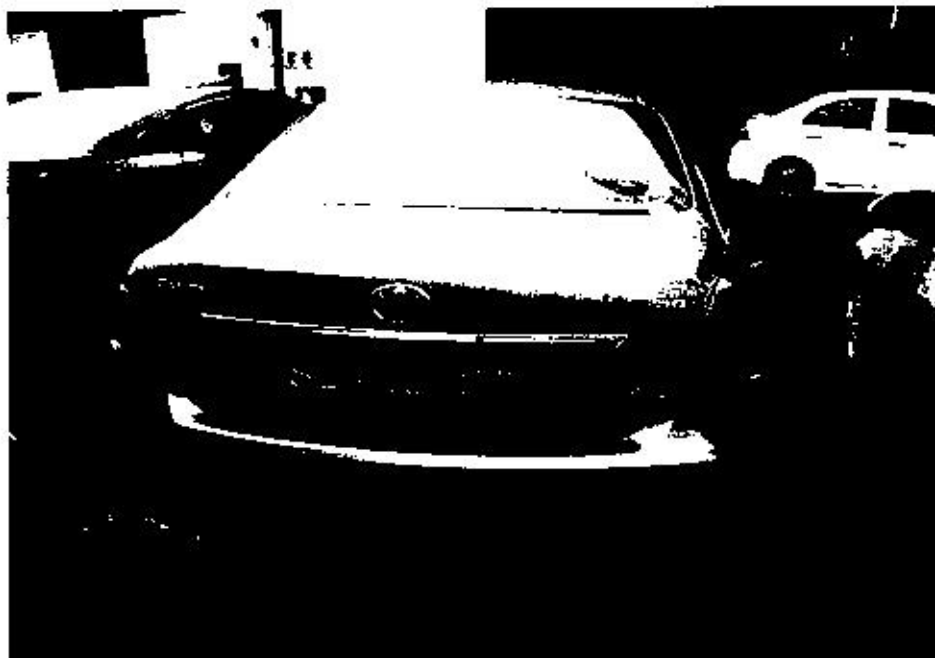
Photo 3 shows a general view of the rear body of the Motor Car at the time of our inspection. The Motor Car was observed to be in good general condition.

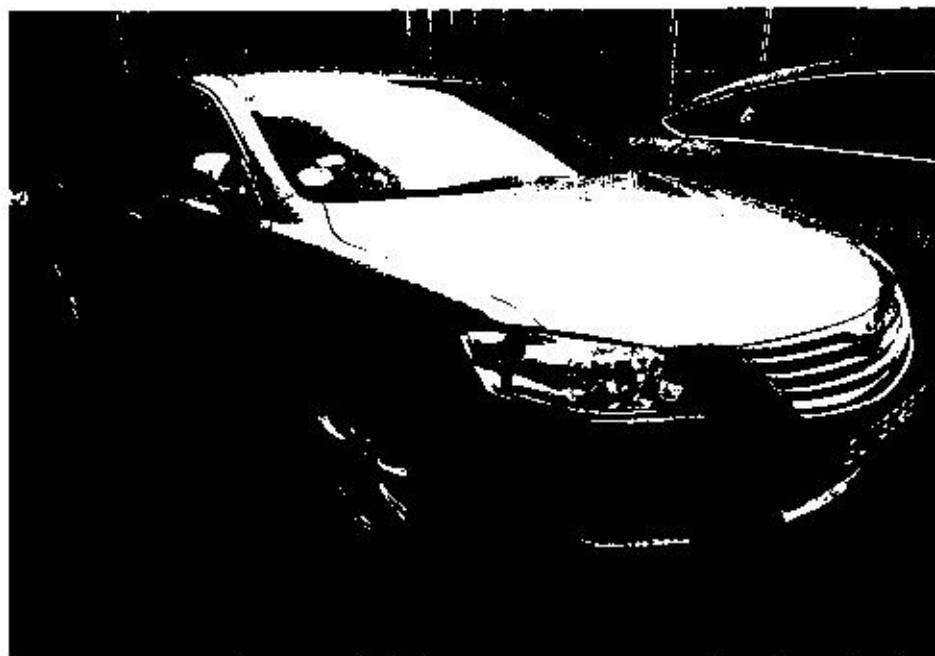
Photo 4 shows a general view of the front right body of the Motor Car at the time of our inspection. The Motor Car was observed to be in good general condition.

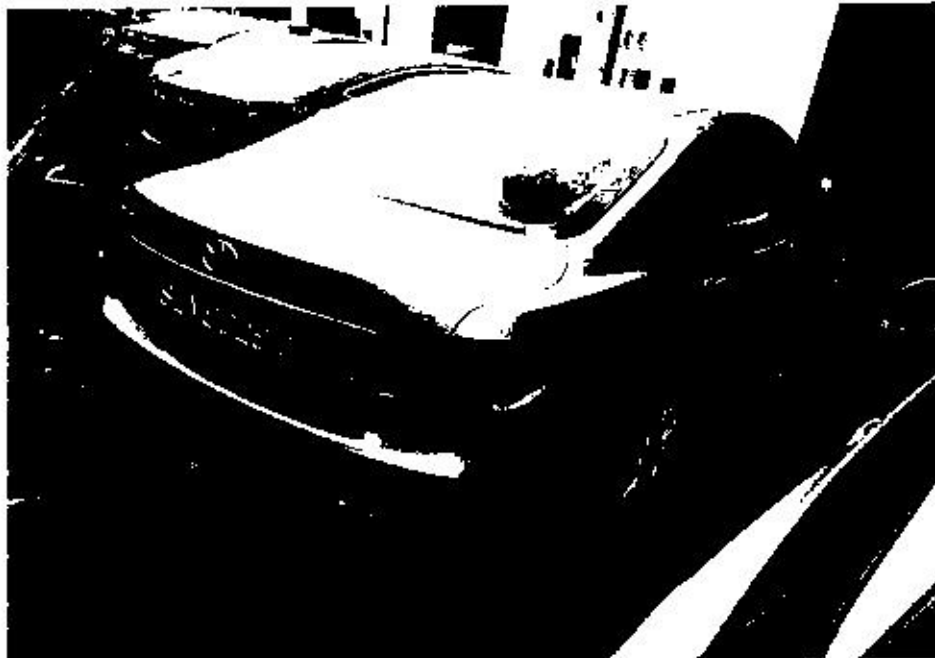
Photo 5 shows a general view of the rear right body of the Motor Car at the time of our inspection. The Motor Car was observed to be in good general condition.

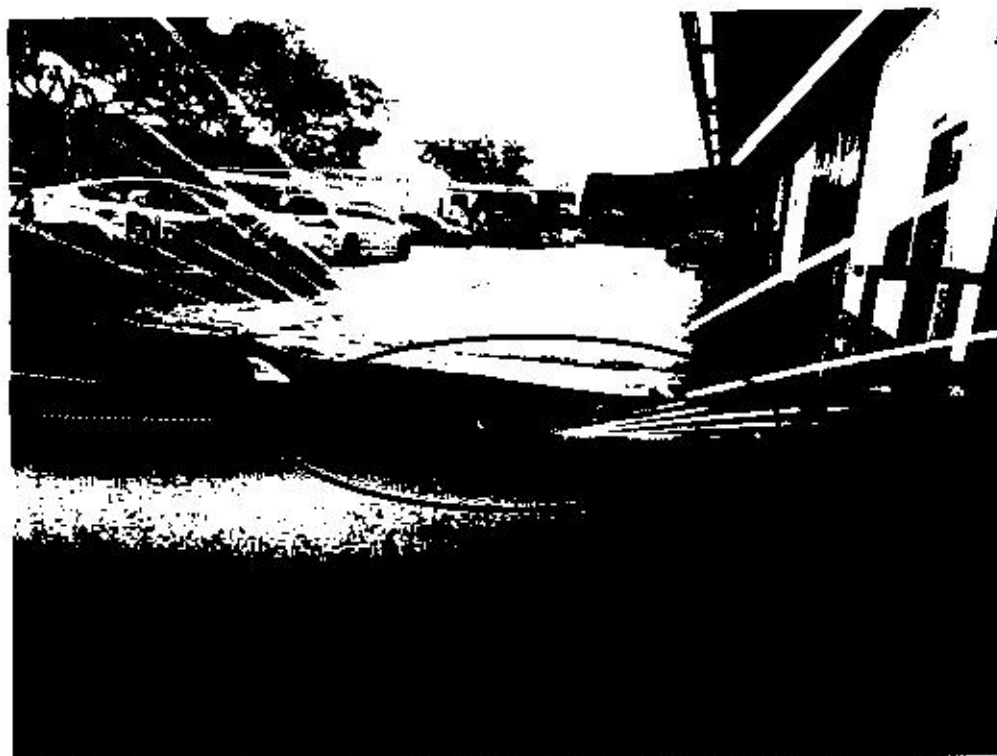
Photo 7 shows a close up view of the front windshield of the Motor Car at the time of our inspection. It was observed to be cracked likely due to the accident's impact.

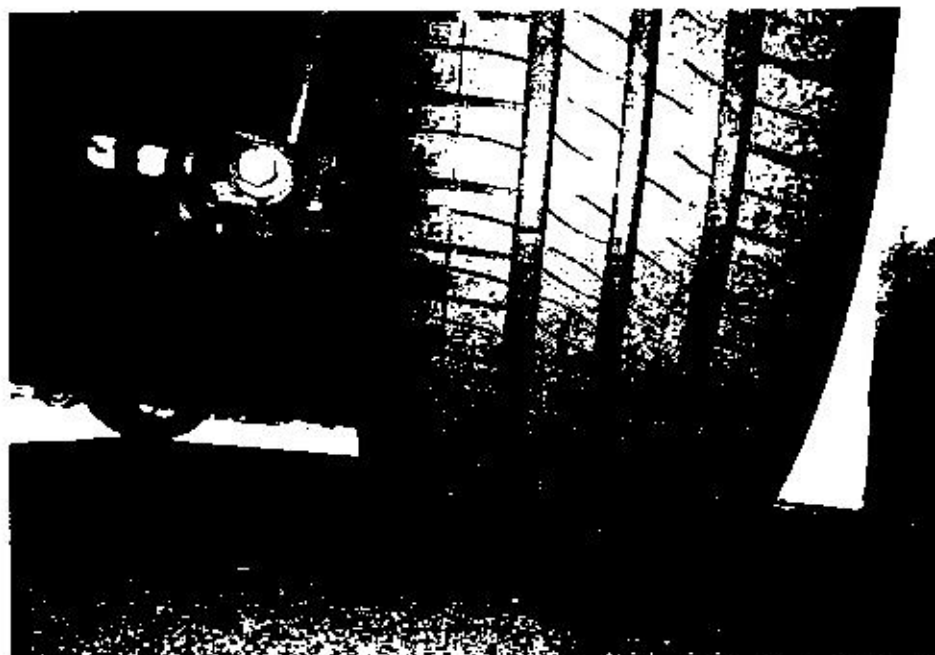
Photo 11 shows the condition of the rear right tyre of the Motor Car, which was observed to be in serviceable condition with remaining tread depth of approximately 7mm. There was also no tear, cut or burst mark(s) on the outer and the inner sidewalls as well as across the tread of the 4 tyres.

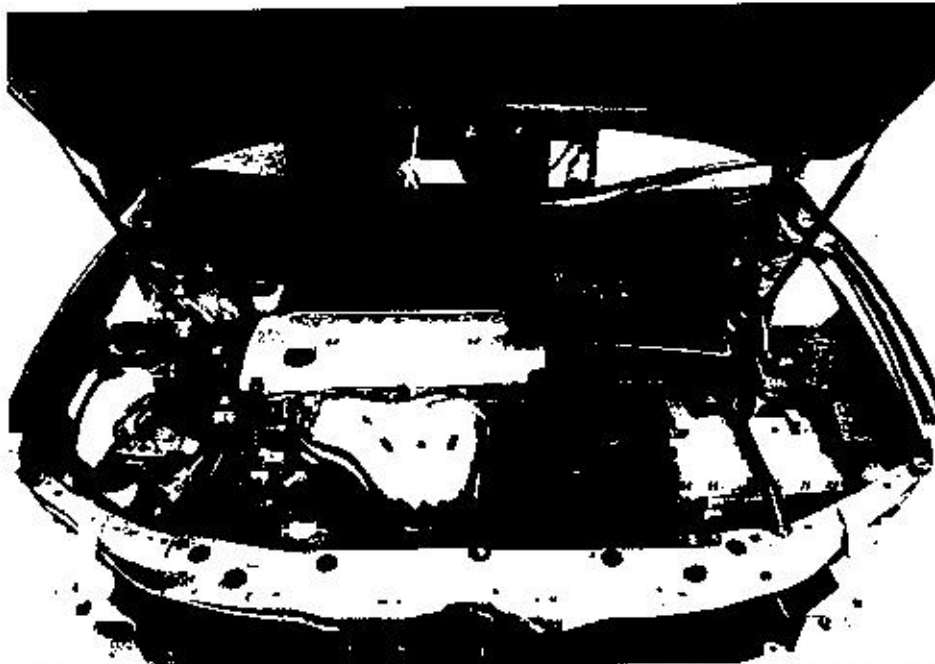
9. Upon examination of the engine compartment of the Motor Car, we had observed all the parts and components inside the engine compartment to be intact and unaffected by the accident. The brake fluid, engine oil and engine coolant were all found to be of sufficient level for operating purposes. Visually, there was also no contamination found to these fluids.
10. Further examination of the engine compartment revealed no sign(s) or indication(s) of fluid leakage and/or fluid stain within the engine compartment of the Motor Car.
11. Our subsequent checks on the underside of the Motor Car also revealed no fluid stain. Visually, the various undercarriage components of the Motor Car were all observed to be intact and without any visible damage. See photo 12 – 16 below.

Photo 12 shows a general view of the Motor Car's engine compartment. The various parts and components inside the engine compartment were unaffected by the accident. There was also no sign(s) or indication(s) of fluid leakage and/or fluid stain within the engine compartment.

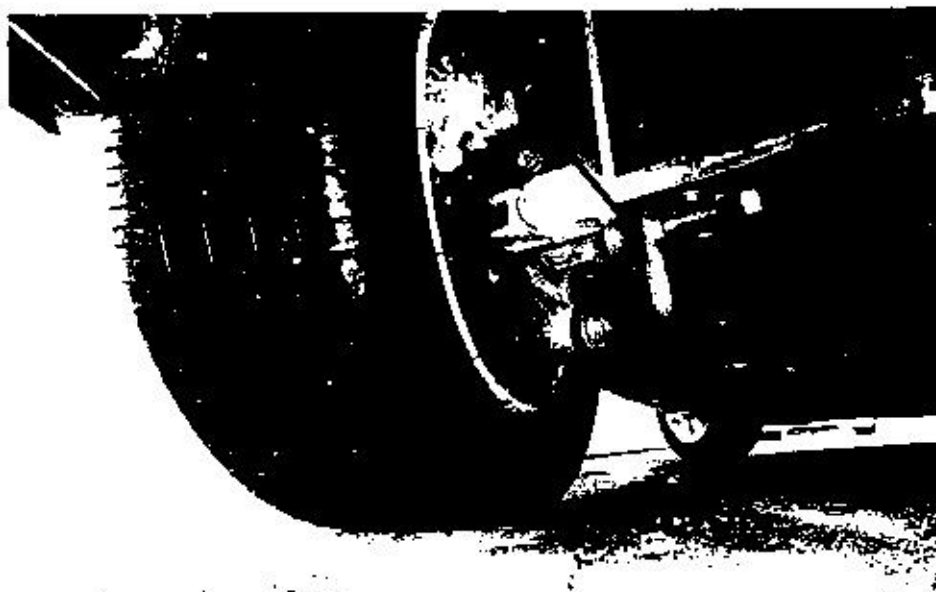
Photo 17 shows the brake hose (arrowed) at the rear left wheel of the Motor Car. We did not observe any leakage of brake fluid at the time of our inspection of the Motor Car. Our visual inspection of the various mechanical components of the Motor Car's braking system revealed all to be intact and without visible damage.

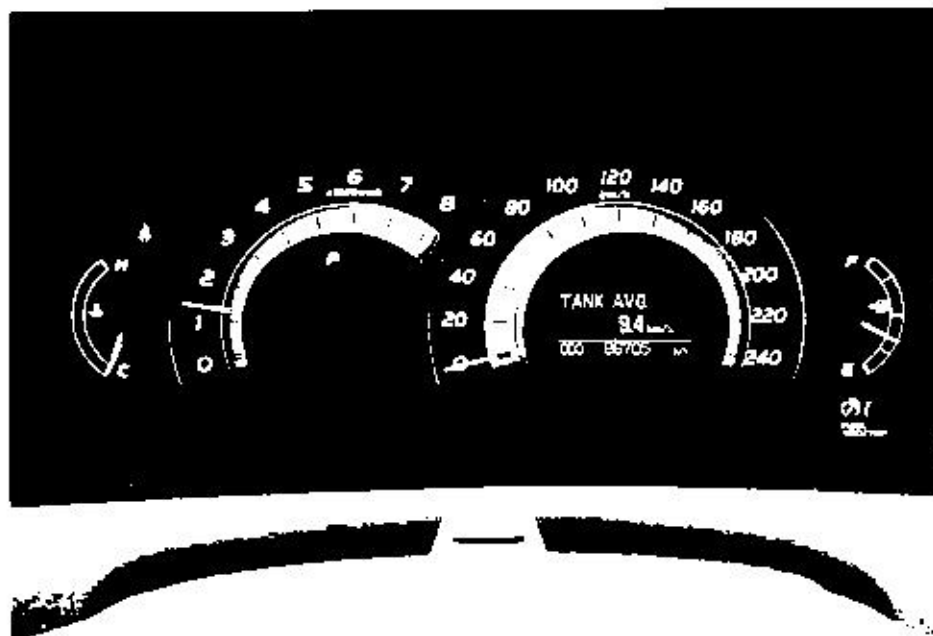
Photo 22 shows no warning lights illuminated on the instrument panel of the Motor Car after the engine was cranked. This would suggest that there was no abnormality to the various electronic operating systems of the Motor Car, like the ABS and SRS.
