Your Ref: TP/IP/09577/2018
Our Ref : CI/TPD18010143/Z

20th March 2018

MECHANICAL INSPECTION REPORT OF MOTOR VAN GBA 2132K.

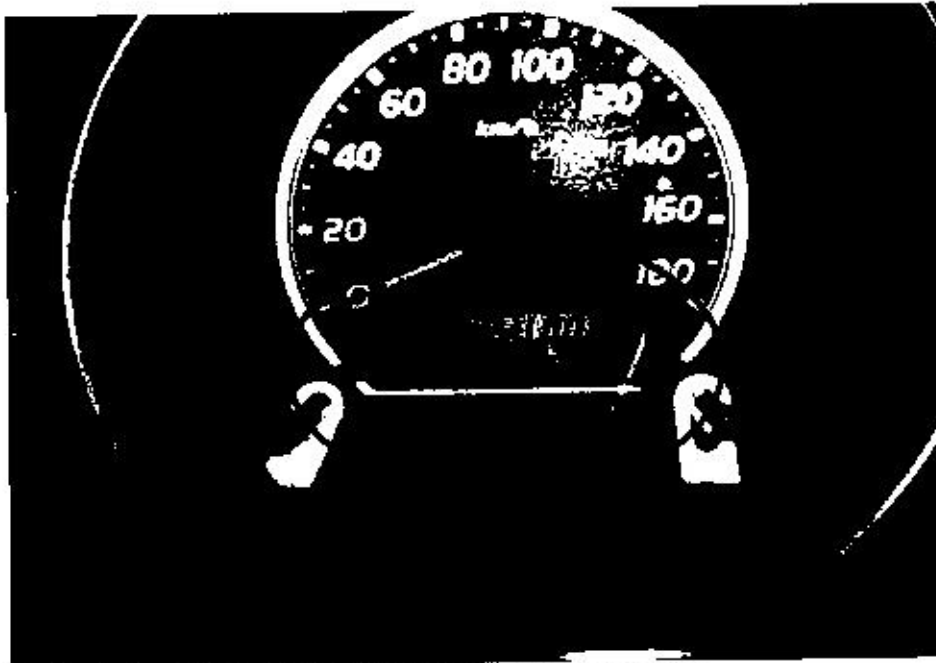
Photo 1 shows the mileage of the Motor Van was 405636km.

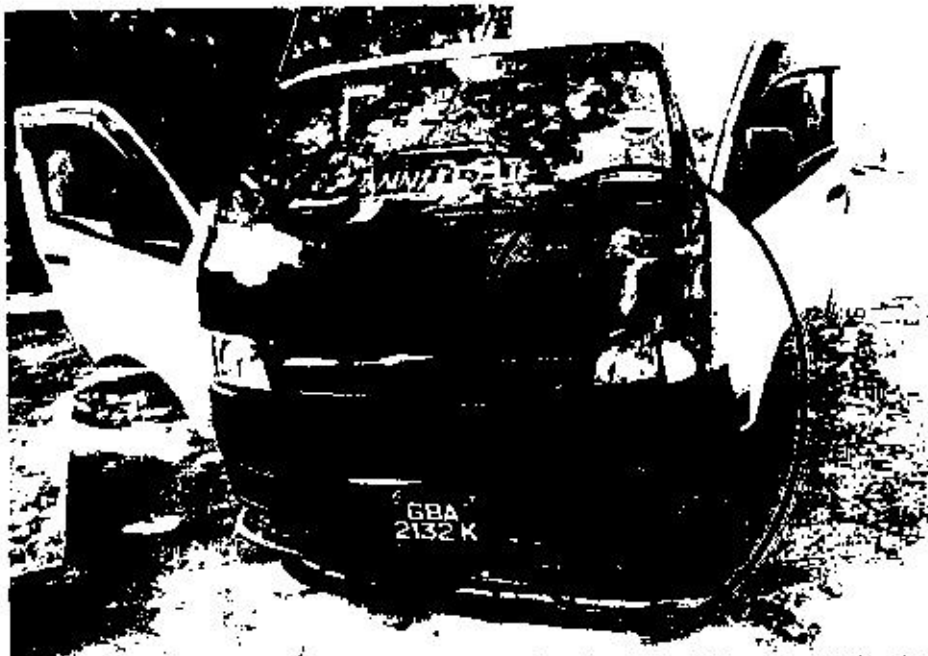
4. The mileage of the Motor Van at the time of our inspection was 405636km.
5. The Motor Van was observed to have sustained damages at its front bonnet; front left headlamp and front left lower bumper were amongst the body parts that were damaged as a result of the accident.
6. This was likely due to the consistency of the accident's case facts that the Motor Van was traveling along CTE (AYE) on lane 3 of 5 lane road near 7km mark. A motor cyclist was riding on lane 4. The Motor Van driver then switched to lane 4 and in the midst of changing lane, the front left portion of the Motor Van collided onto the Motorcycle. See photo 1 to 7 below.

Photo 2 shows a general view of the front left body of the Motor Van at the time of our inspection. The Motor Van was observed to sustained damages that were confined to front left side of the body.

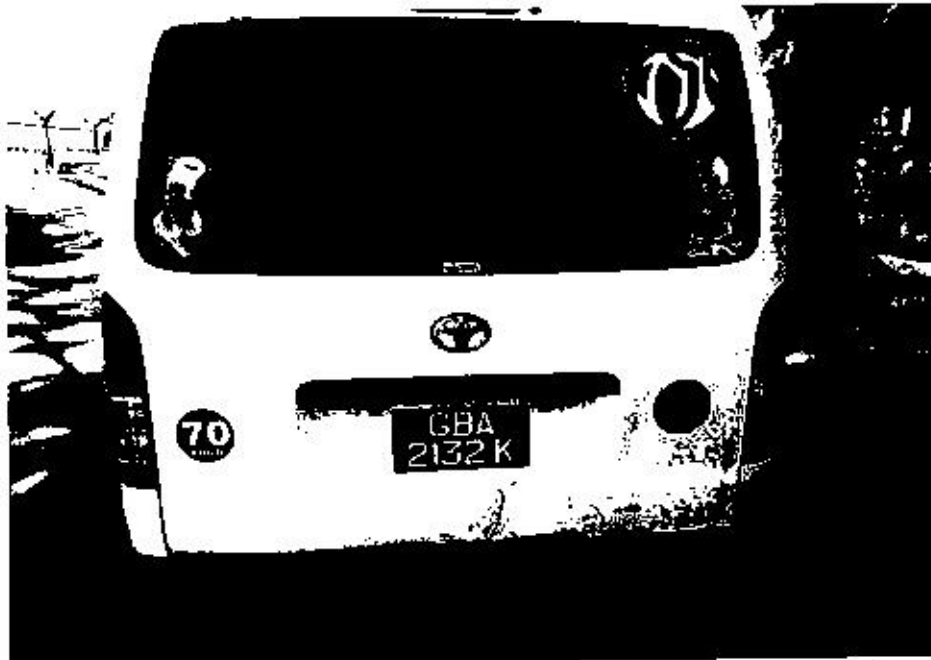
Photo 5 shows a general view of the rear body of the Motor Van at the time of our inspection. The Motor Van was observed to be in good general condition at time of inspection.

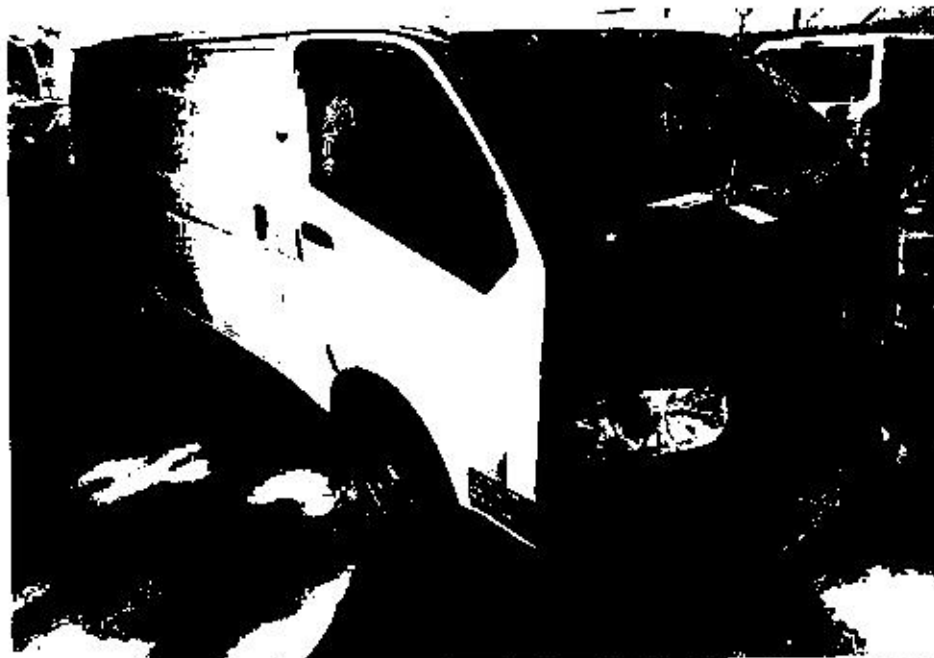
Photo 6 shows a general view of the front right body of the Motor Van at the time of our inspection. The Motor Van was observed to be in good general condition at time of inspection.

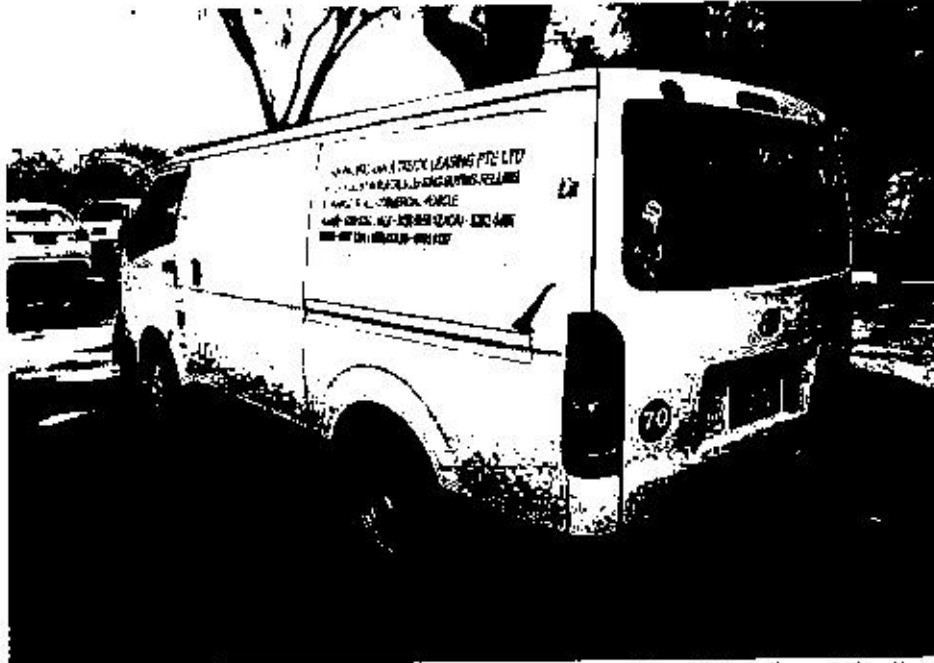
Photo 7 shows a general view of the rear left body of the Motor Van at the time of our inspection. The Motor Van was observed to be in good general condition at time of inspection.

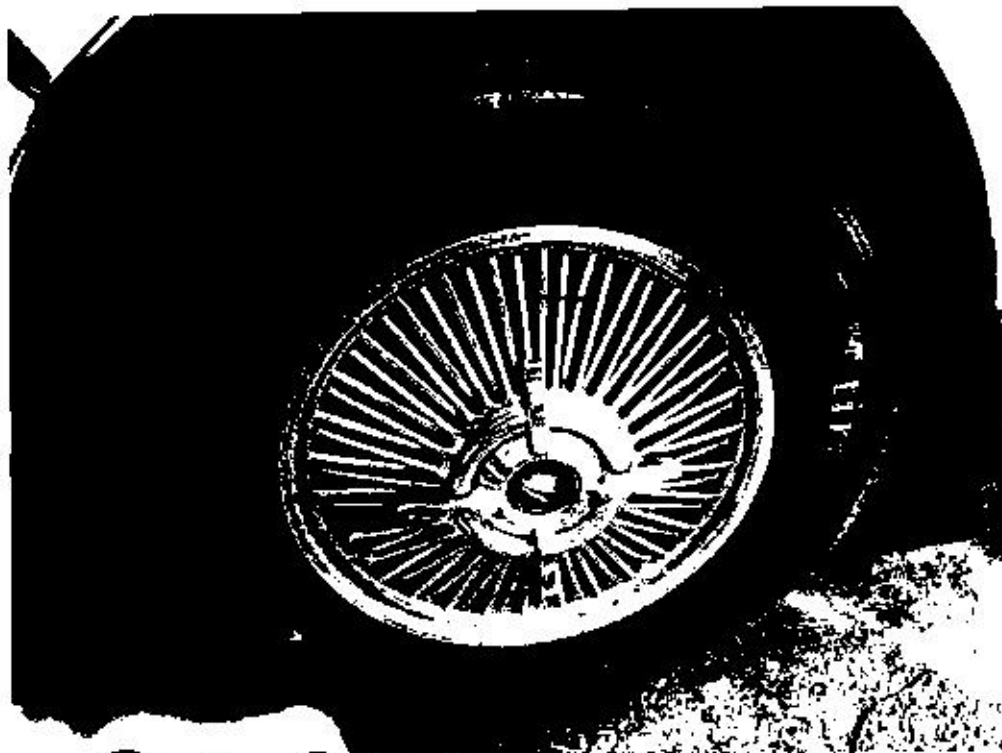
Photo 8 shows the condition of the front left tyre of the Motor Van, which was observed to be in serviceable condition without any damage found at time of our inspection.

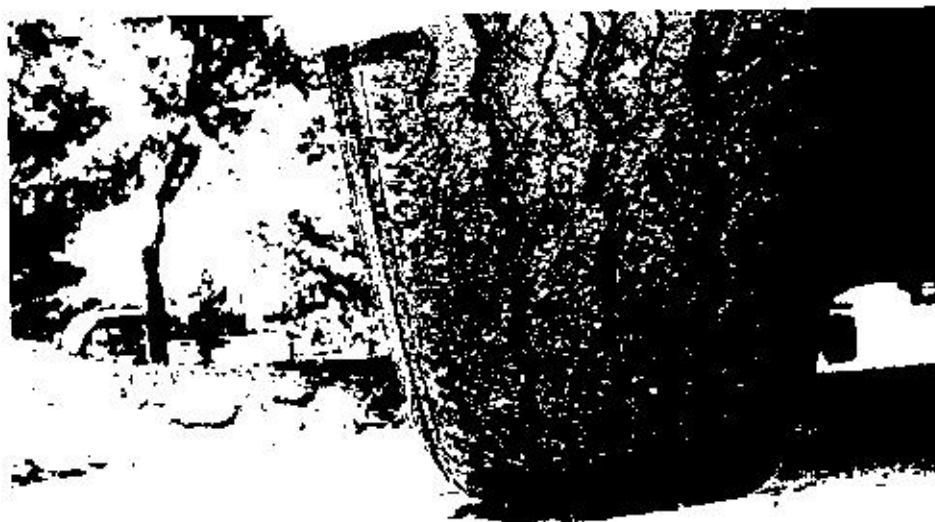
Photo 9 shows the condition of the front right tyre of the Motor Van, which was observed to be in serviceable condition with remaining tread depth of approximately 5mm. The tyres were all observed to be sufficiently inflated for vehicular operation with no tear, cut or burst mark(s) on the outer and the inner sidewalls as well as across the tread.

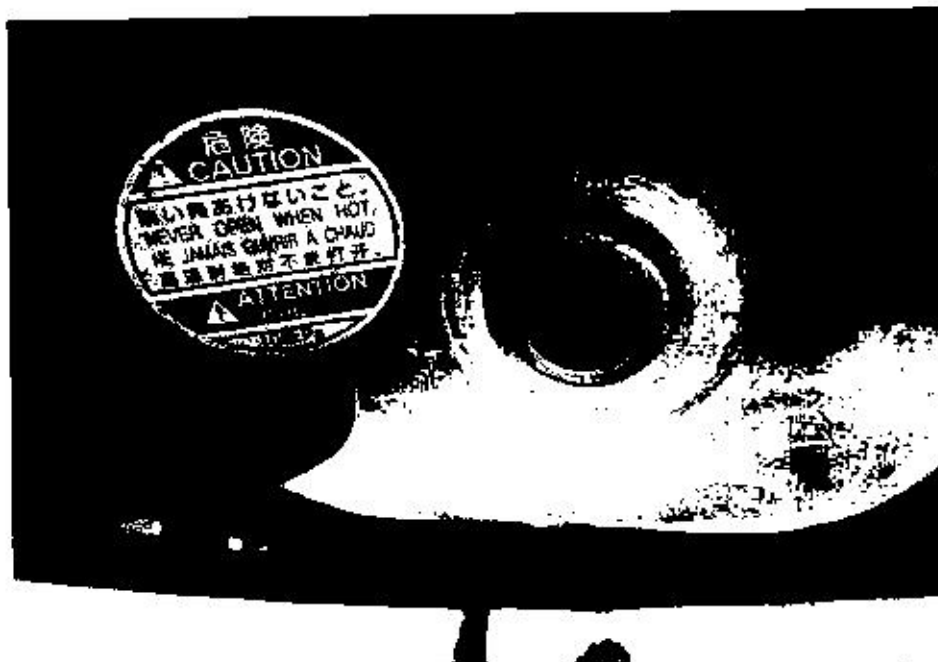
Photo 16 shows the engine coolant reservoir of the Motor Van at the time of our inspection. The engine coolant was observed to be of sufficient level and without any visible contamination.
