Your Ref: TP/IP/09701/2018
Our Ref : CI/TPD18010144/Z

20th March 2018

MECHANICAL INSPECTION REPORT OF MOTOR VAN GBC 9458P.

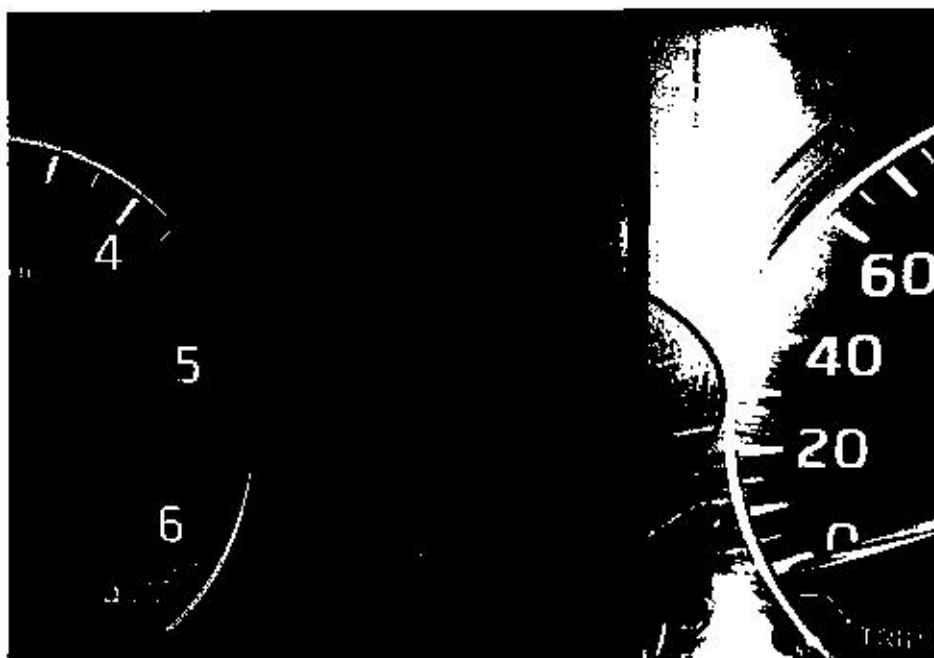
Photo 1 shows the mileage of the Motor Van was 45567km.

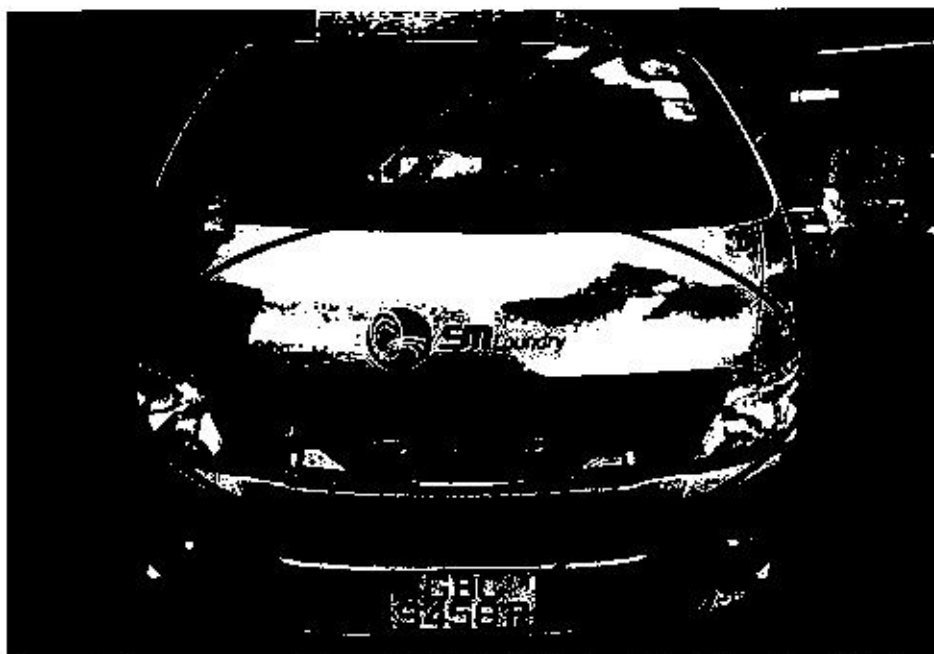
4. The mileage of the Motor Van at the time of our inspection was 45567km.
5. The Motor Van was observed to have sustained damages at its front left panel, front left grille and front left lower bumper were amongst the body parts that were damaged as a result of the accident.
6. This was likely due to the consistency of the accident's case facts that the Motor Van was traveling along PIE towards Tuas and exited Bedok North Avenue 3. He then drive straight approaching a signalized pedestrian crossing when a PAB rider cycled across the road from the right to left of a Motor Van's direction. The driver was unable to brake in time and collided onto the cyclist. See photo 1 to 7 below.

Photo 2 shows a general view of the front right body of the Motor Van at the time of our inspection. The Motor Van was observed to sustained damages that were confined to front left side of the body.

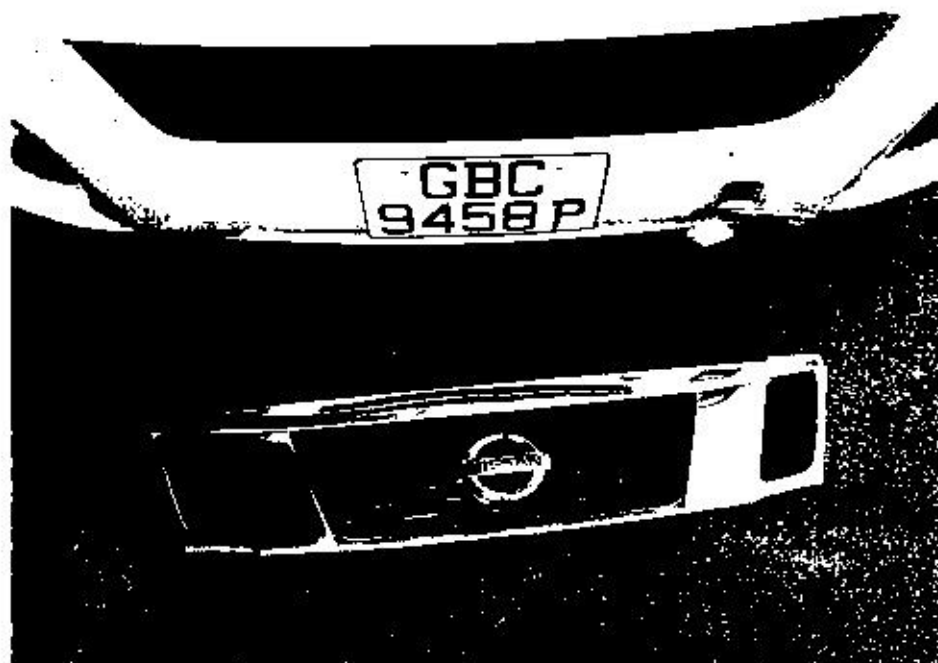
Photo 3 shows a broken emblem & front grille.

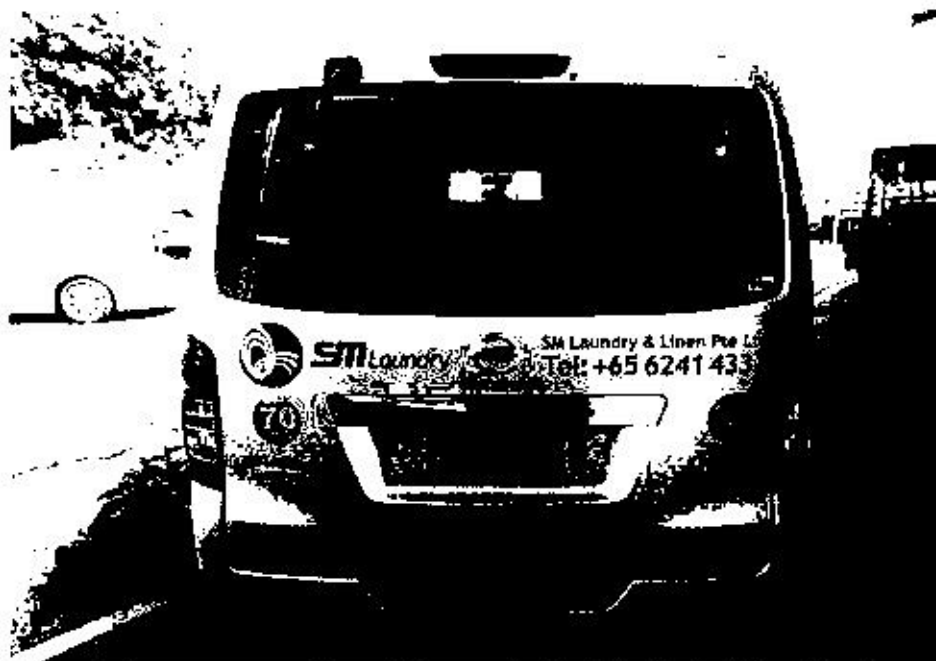
Photo 5 shows a general view of the rear body of the Motor Van at the time of our inspection. The Motor Van was observed to be in good general condition at time of inspection.

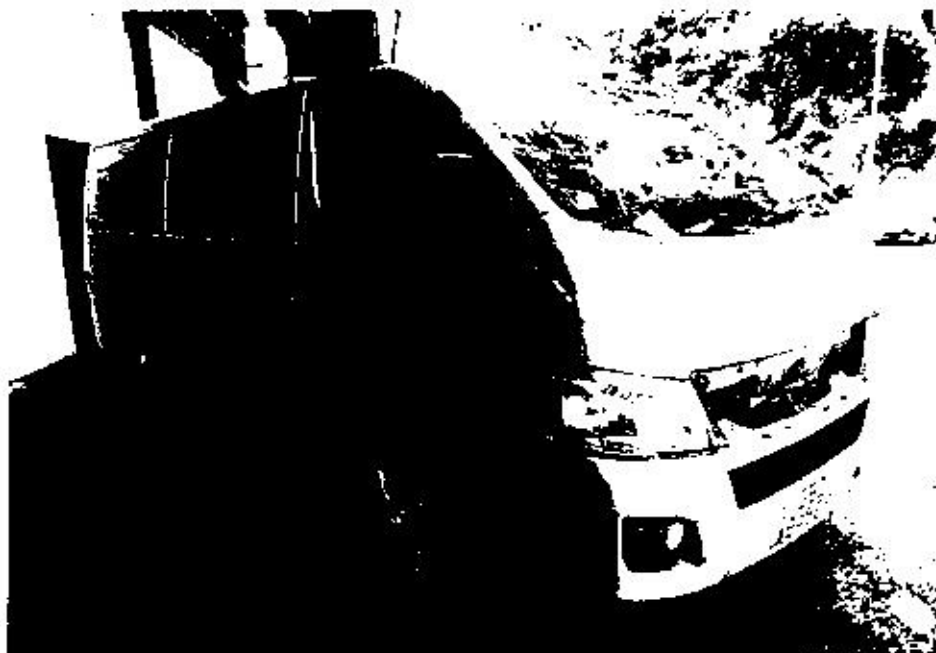
Photo 6 shows a general view of the front right body of the Motor Van at the time of our inspection. The Motor Van was observed to be in good general condition at time of inspection.

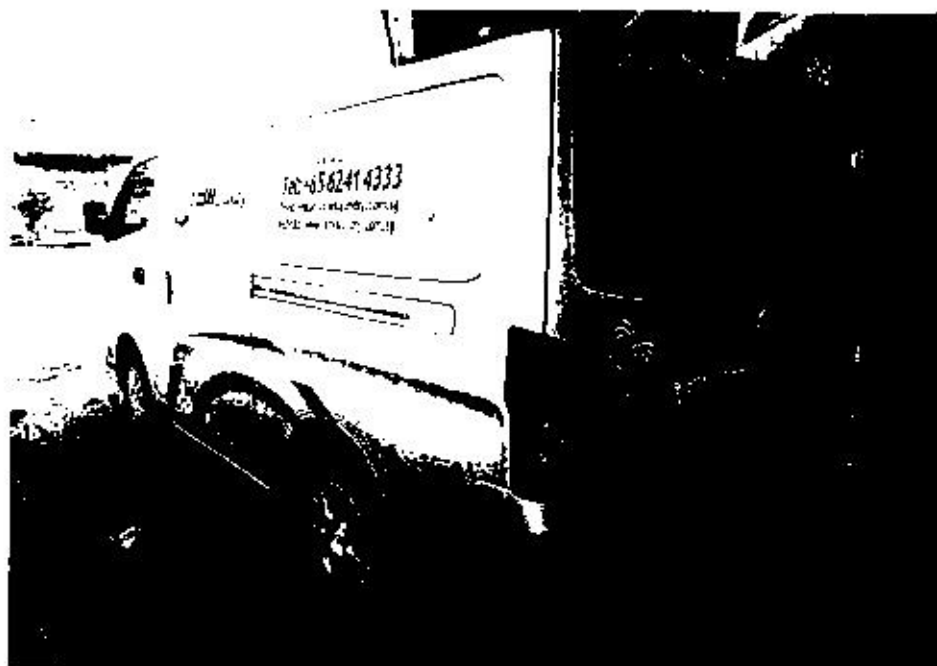
Photo 7 shows a general view of the rear left body of the Motor Van at the time of our inspection. The Motor Van was observed to be in good general condition at time of inspection.

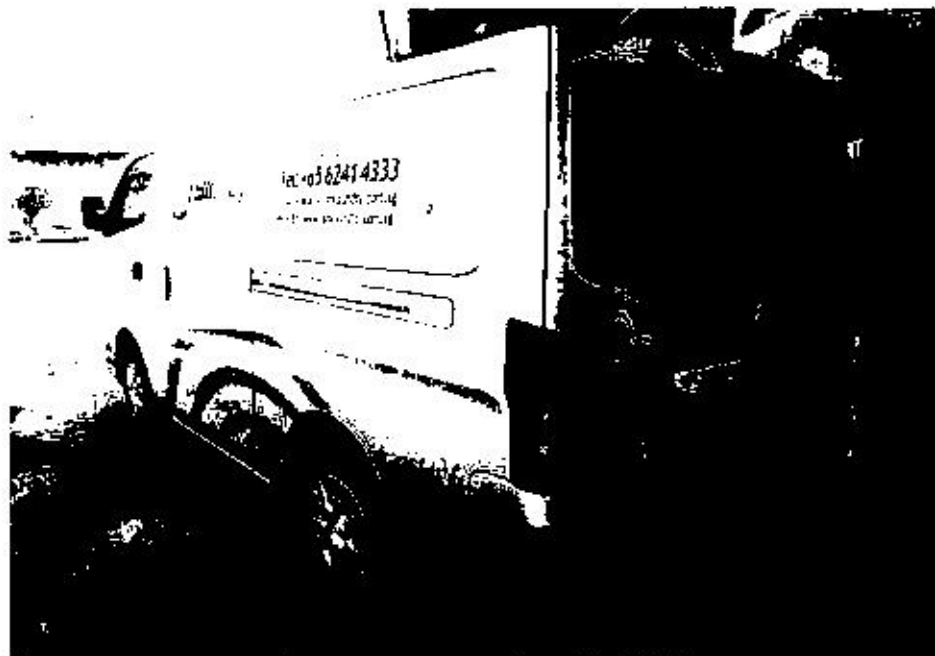
Photo 7 shows a general view of the rear left body of the Motor Van at the time of our inspection. The Motor Van was observed to be in good general condition at time of inspection.

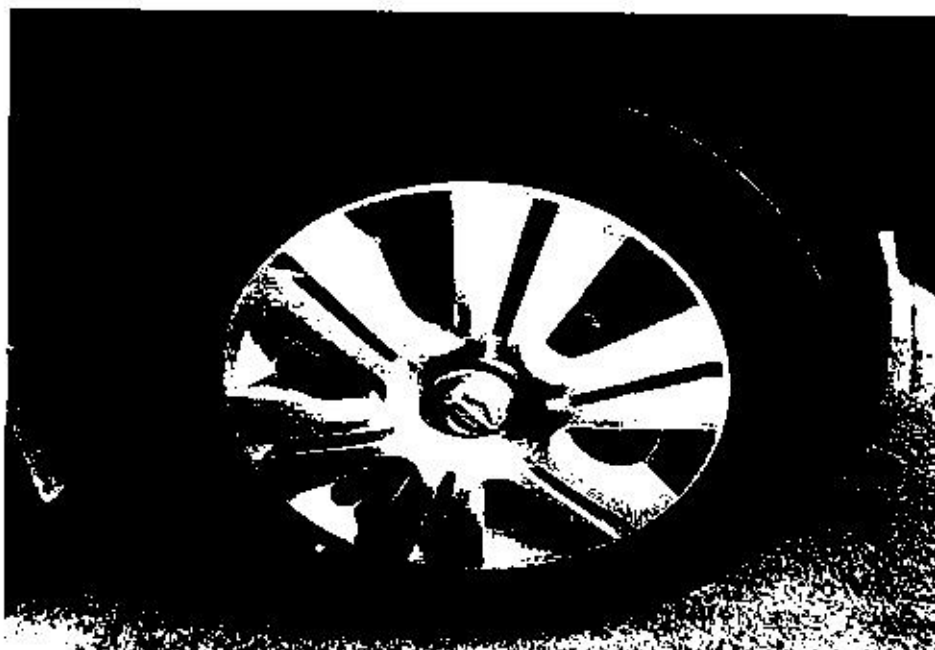
Photo 8 shows the condition of the front left tyre of the Motor Van, which was observed to be in serviceable condition without any damage found at time of our inspection.

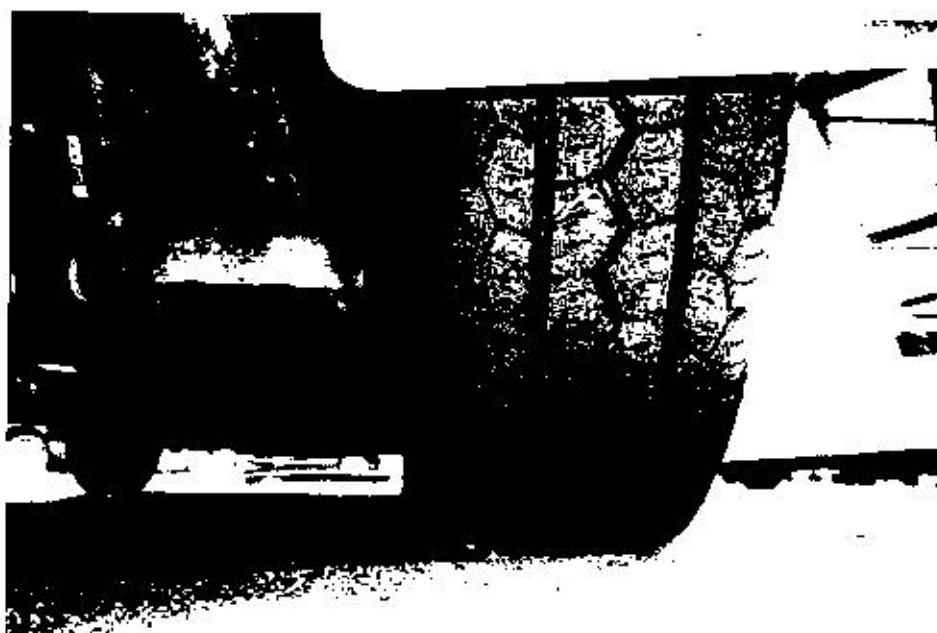
Photo 12 shows the condition of the rear right tyre of the Motor Van, which was observed to be in serviceable condition with remaining tread depth of approximately 6mm. There was also no tear, cut or burst mark(s) on the outer and the inner sidewalls as well as across the tread of the tyre, which was also sufficiently inflated for vehicular operation.

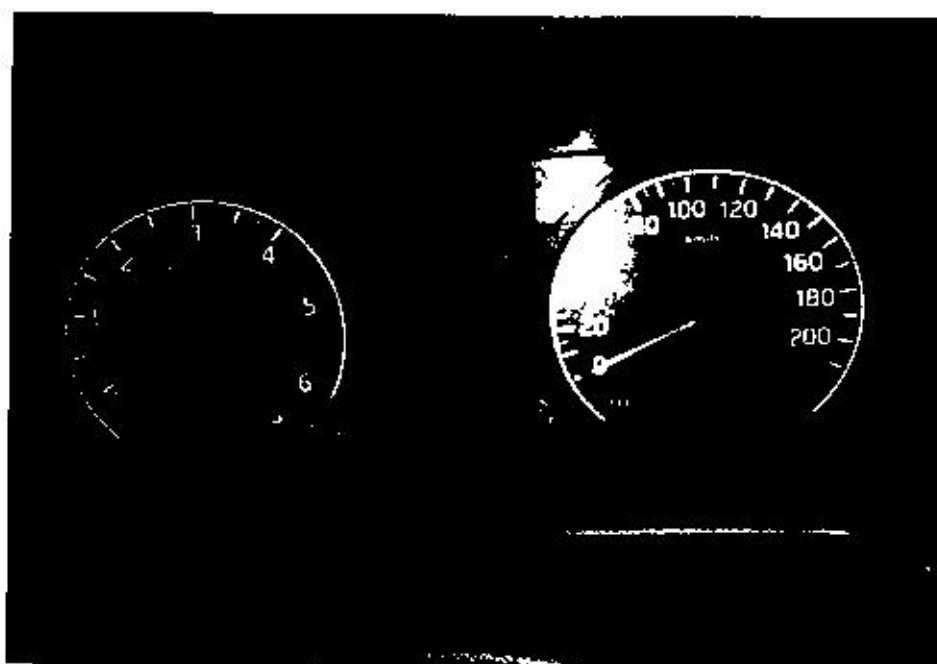
Photo 21 shows the warning lights for the various electronic operating systems of the Motor Car appearing on its instrument panel during the self-test when the engine was cranked.

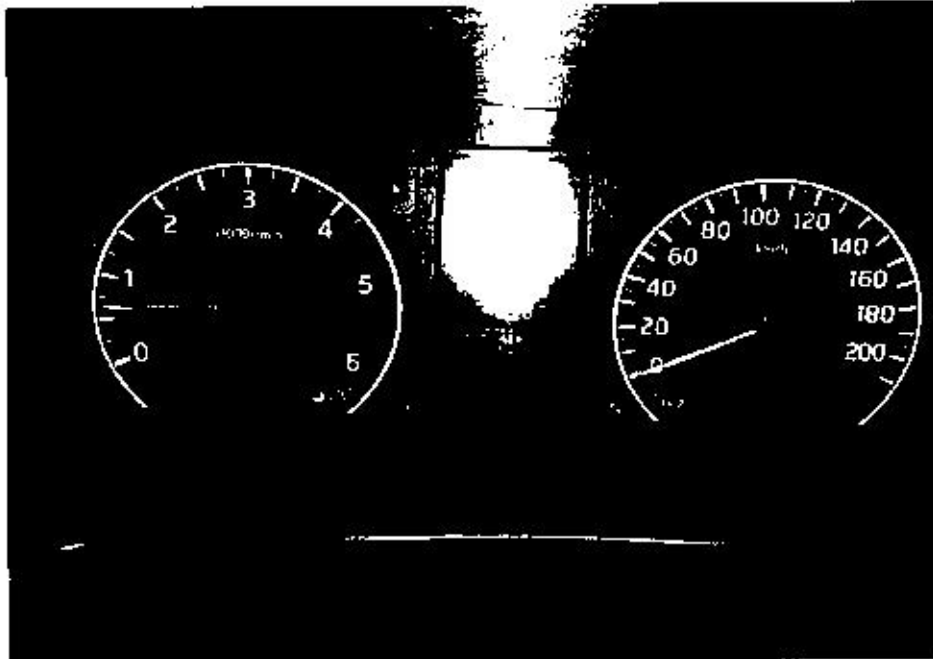
Photo 22 shows no warning lights illuminated on the instrument panel of the Motor Van after the engine was cranked. This would suggest that there was no abnormality to the various electronic operating systems of the Motor Car.
