Auto
Consultants
Pte Ltd

Your Ref: TP/IP/09701/2018
Our Ref :CI/TPD18010145/Z

16th March 2018

**MECHANICAL INSPECTION REPORT OF ELECTRIC BICYCLE - PAB (RED) -
TRAFFIC POLICE POUND REPORT NO. 0641/18**

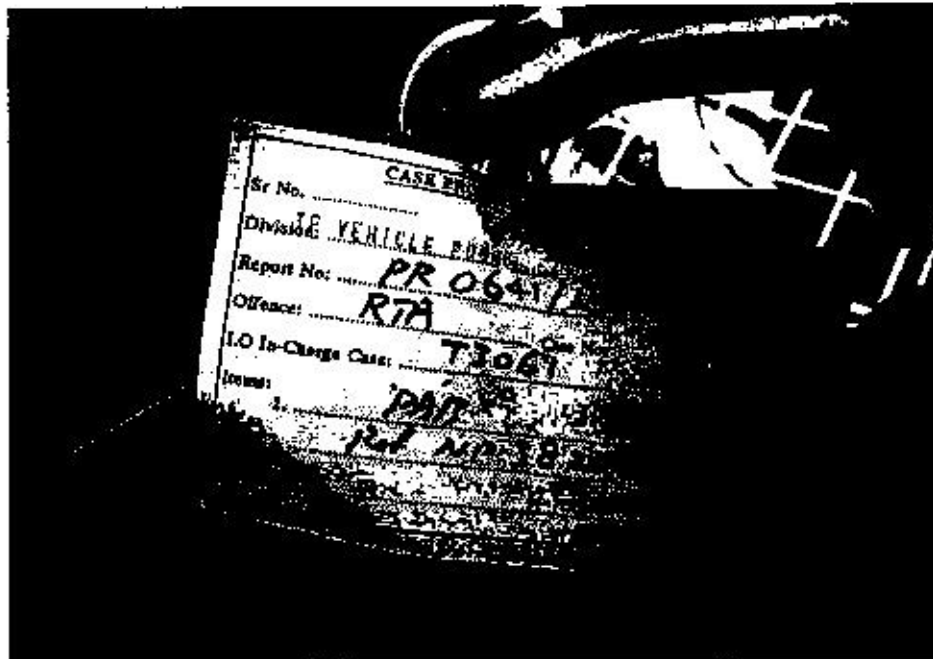
Photo 1 shows the identification of the Electric Bicycle with reference to Traffic Police Pound Report No. 0641/18.

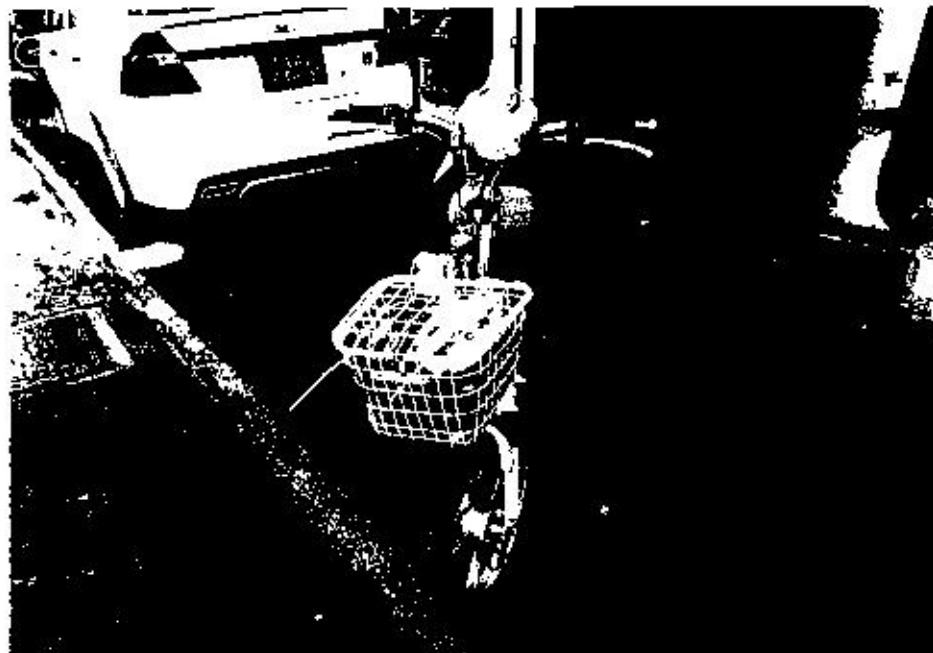
Photo 2 shows the frontal portion of the Electric Bicycle at time of inspection. Damage on the steering system was observed likely due to the accident.

10. Our checks on the steering components of the Electric Bicycle had revealed that its steering system was not in serviceable condition; its front fork was found to be misaligned likely due to the accident's impact.

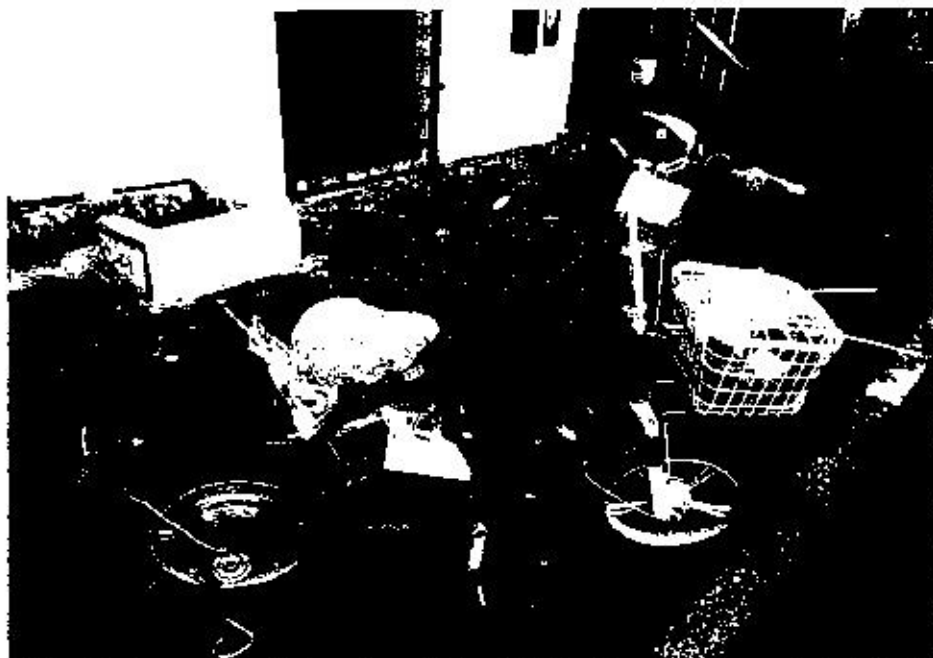
Photo 3 shows the right portion of the Electric Bicycle at time of inspection. Damage on the battery compartment & the foot pedal was observed likely due to the accident.

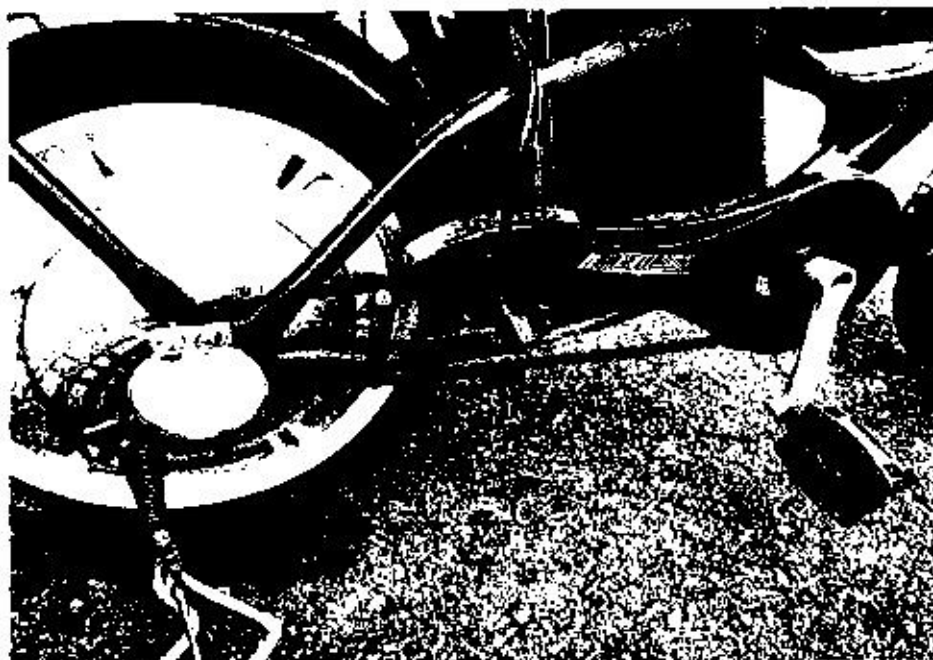
9. The gear chain of the Electric Bicycle was found to be intact but found misaligned. It was observed to be dented inwards likely due to the accident. Free play tension test was conducted but found that the tension was very tight. There was no free play on the gear chain to say that it was in operational condition. See photo 9 to 11 below.

Photo 9 shows the general view of the gear train (arrowed) of the Electric Bicycle, which was found to be intact. However, it was observed to be dented inwards likely due to the accident's impact.

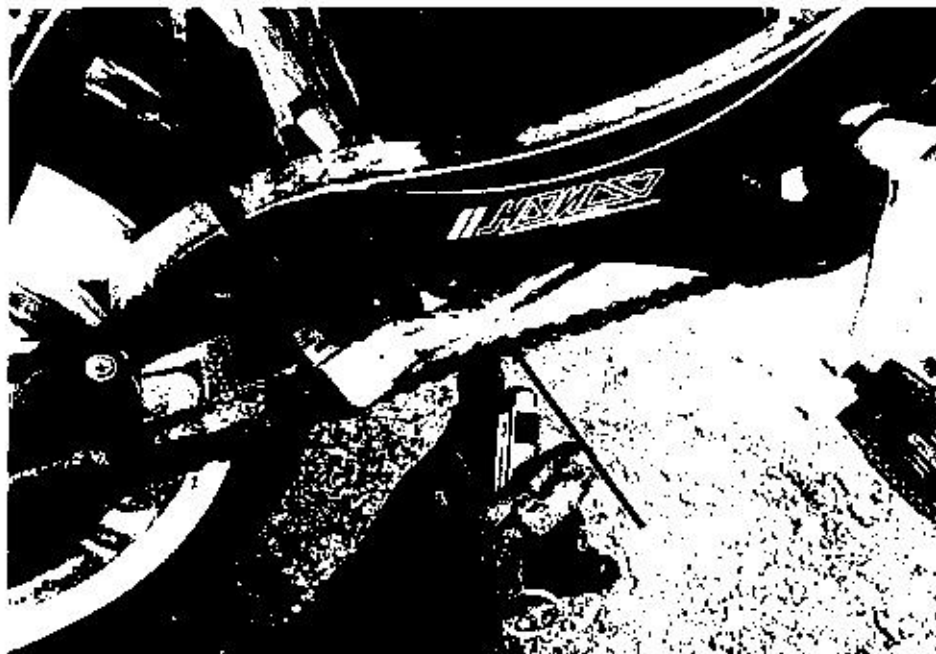
Photo 10 shows a close-up view of the rear chain of the Bicycle at the time of our inspection. Free play tension test was also conducted & found adequately acceptable. It was also observed to be in operational condition.
