Your Ref: 77212 /EG
Our Ref :CS/DAI18010248/D

12 June 2018

TECHNICAL INVESTIGATION REPORT OF FIRE INCIDENT INVOLVING THE INSURED VEHICLE SJU 409B ON 03 JUNE 2018

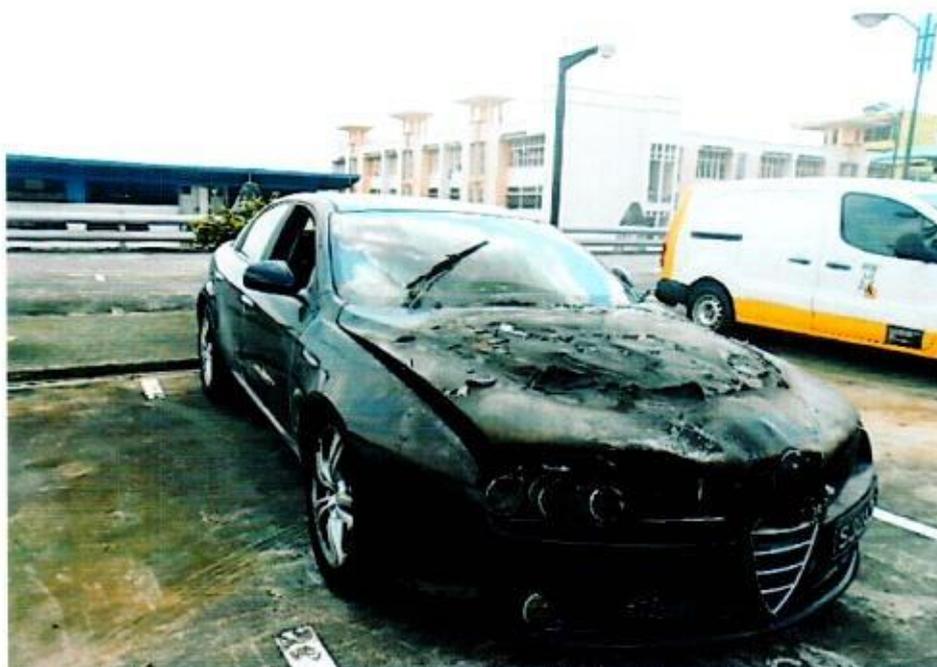
Photo 1 shows a general view of the front right body of the Insured Vehicle at the time of inspection. The Insured Vehicle was observed to be severely burnt at its frontal body. Its front bumper, front bonnet, front grille, front right headlamp and front right fender were amongst the body parts that were found to have been burnt as a result of the fire.

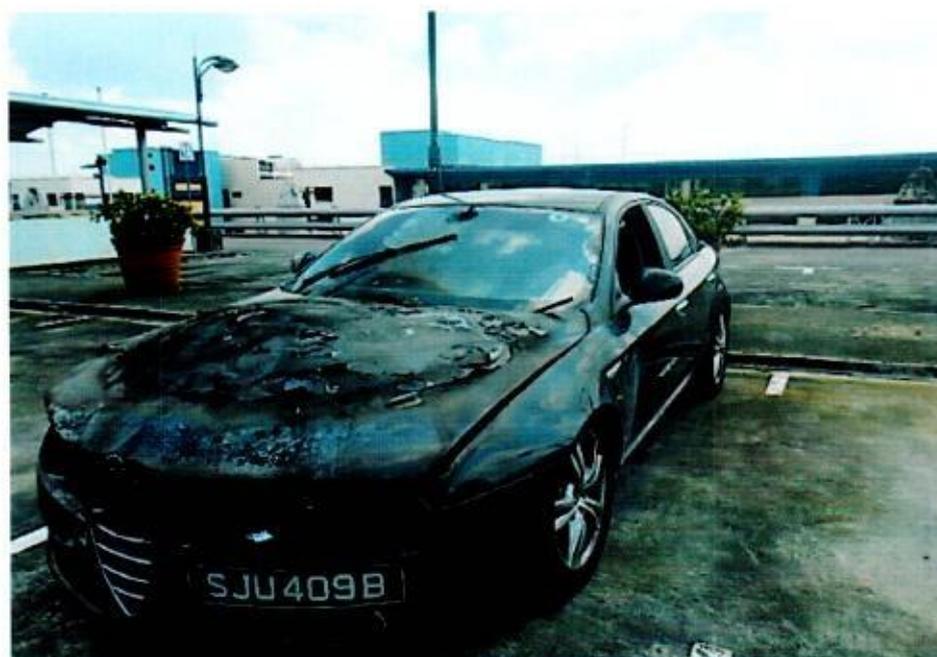
Photo 2 shows a general view of the front left body of the Insured Vehicle at the time of inspection. The Insured Vehicle was observed to be severely burnt at its frontal body. Its front bumper, front left fender, front left headlamp, front bonnet and front windscreen were amongst the body parts that were found to have been burnt as a result of the fire.

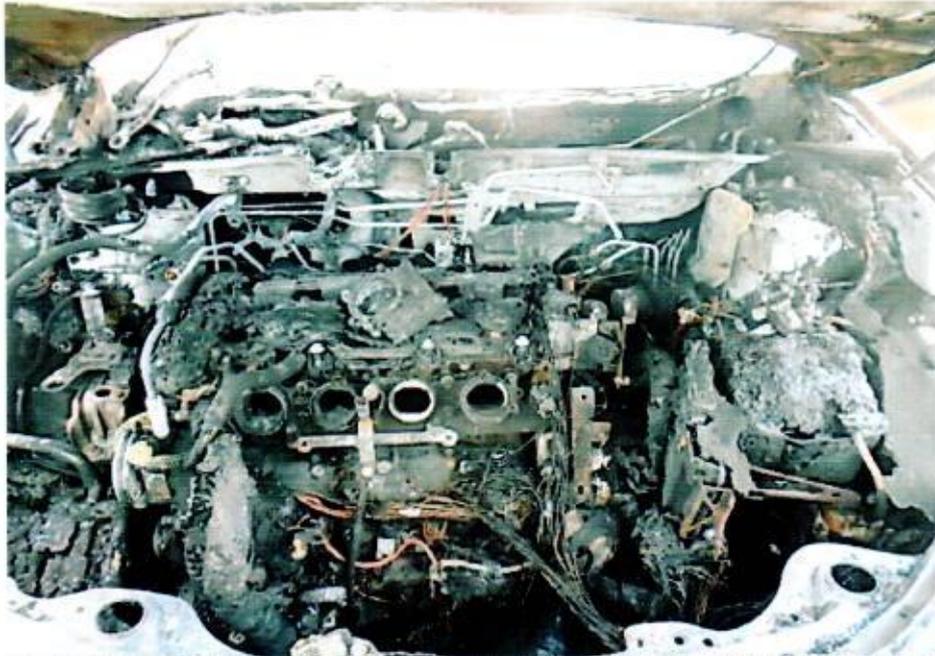
Photo 3 shows the engine compartment of the Insured Vehicle at the time of inspection. Almost all the parts inside the engine compartment were observed to be burnt and/or melted as a result of the fire. These parts had included its radiator, air condenser, cooling fan, intake manifold, fuse box, battery, air duct, hoses and pipes amongst others.

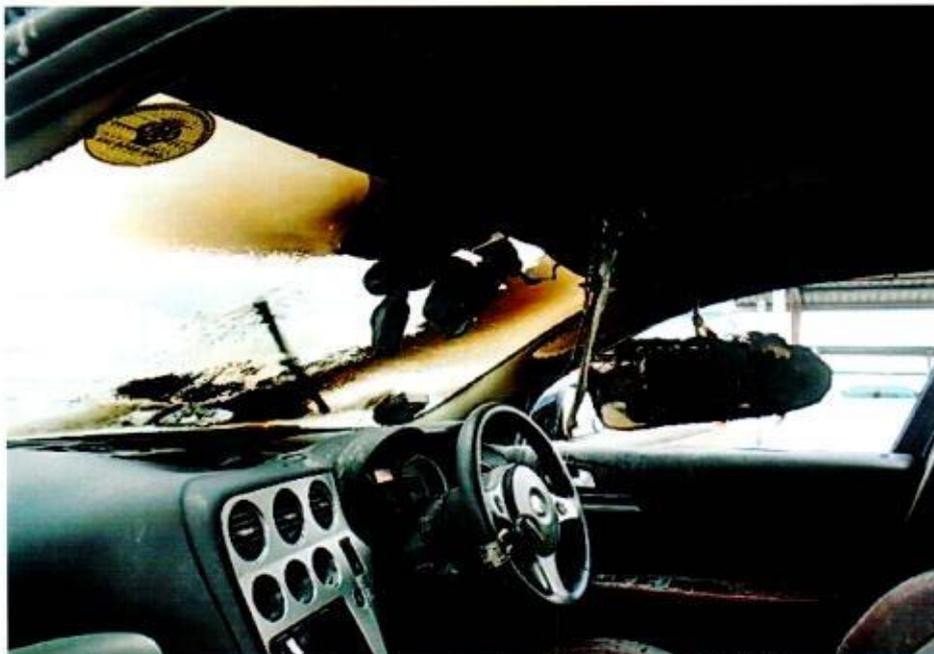
Photo 4 shows the interior compartment of the Insured Vehicle, which was affected at the front area. The dashboard and upholstery were amongst the parts in the interior compartment that were observed to be partially melted/burnt.

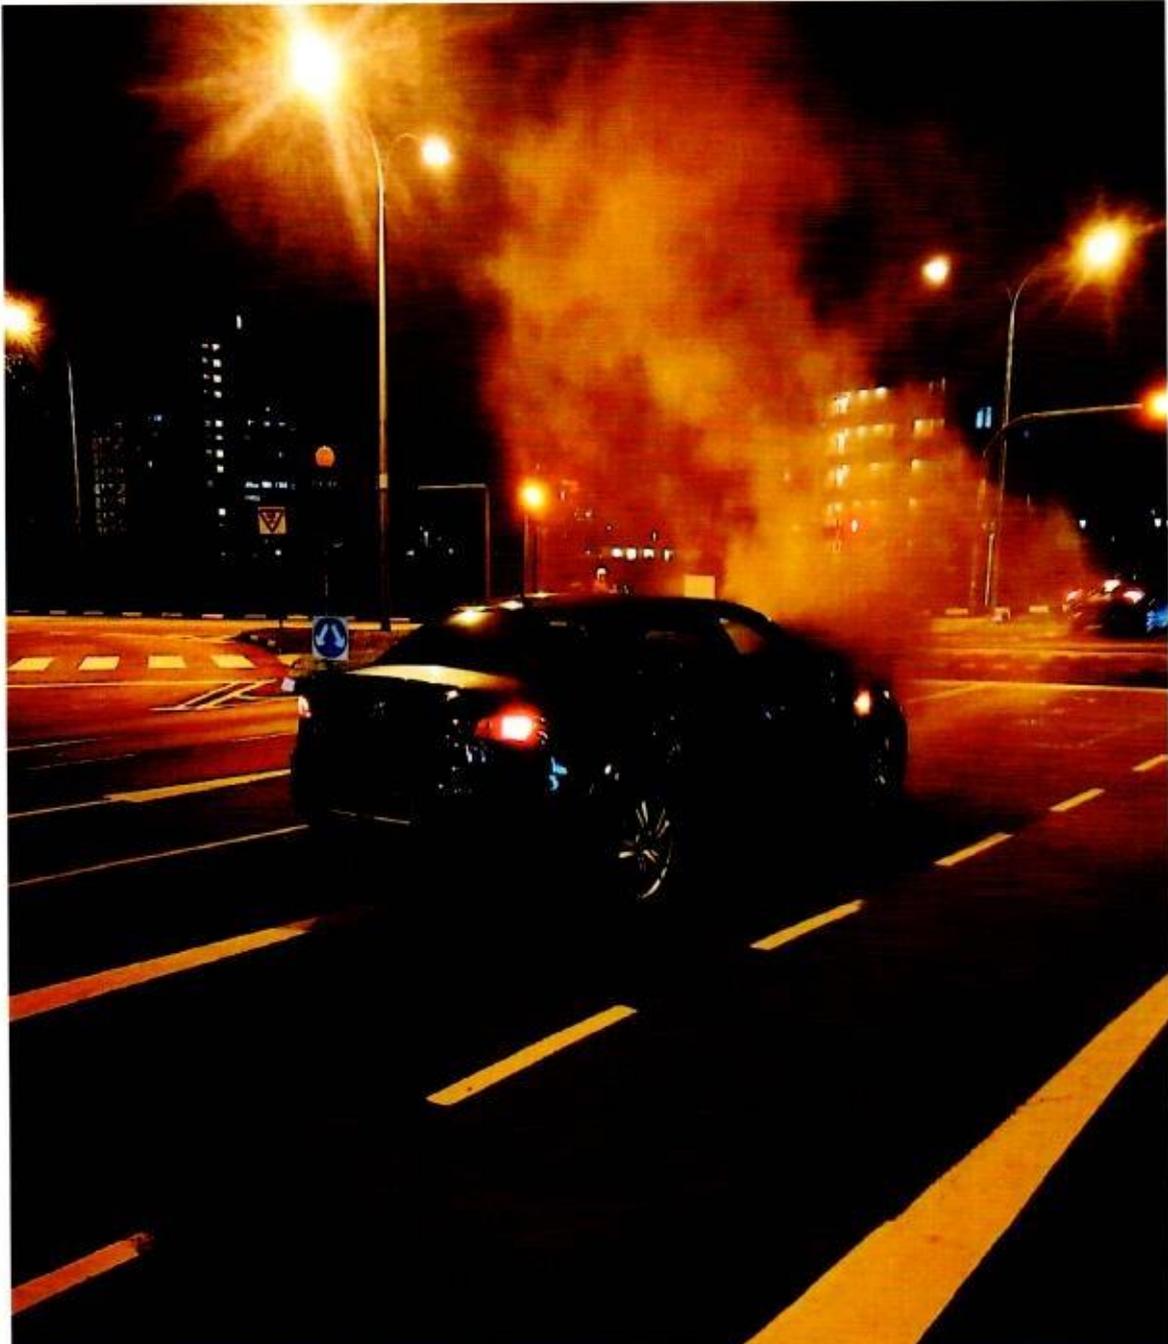
Photo 5 shows the Insured Vehicle at the incident location with smoke emitting out from its frontal portion. There was no unusual foreign material(s) and/or object(s) on the ground in the immediate area of where the Insured Vehicle had stopped.

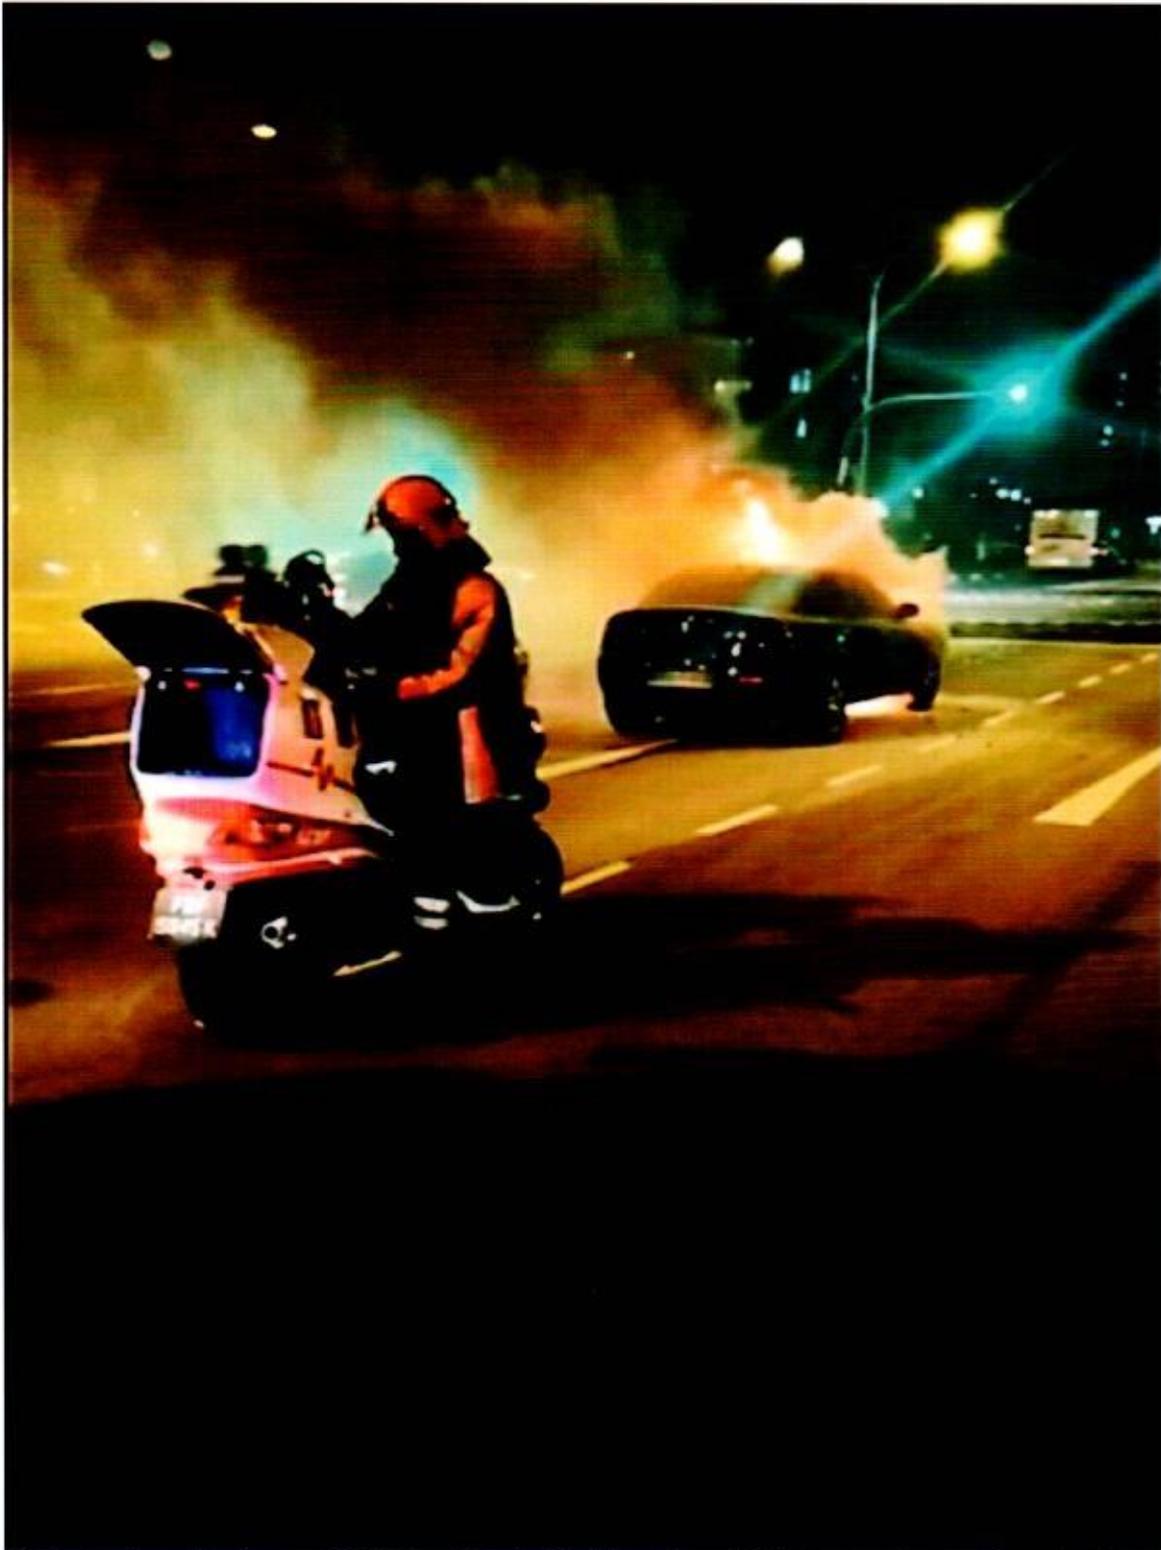
Photo 6 shows the Insured Vehicle at the incident location with flames coming out from its frontal portion. In general, the observations gathered from my review of the incident scene photographs and videos had corresponded to the information gathered from Mr Tan when I spoke to him.

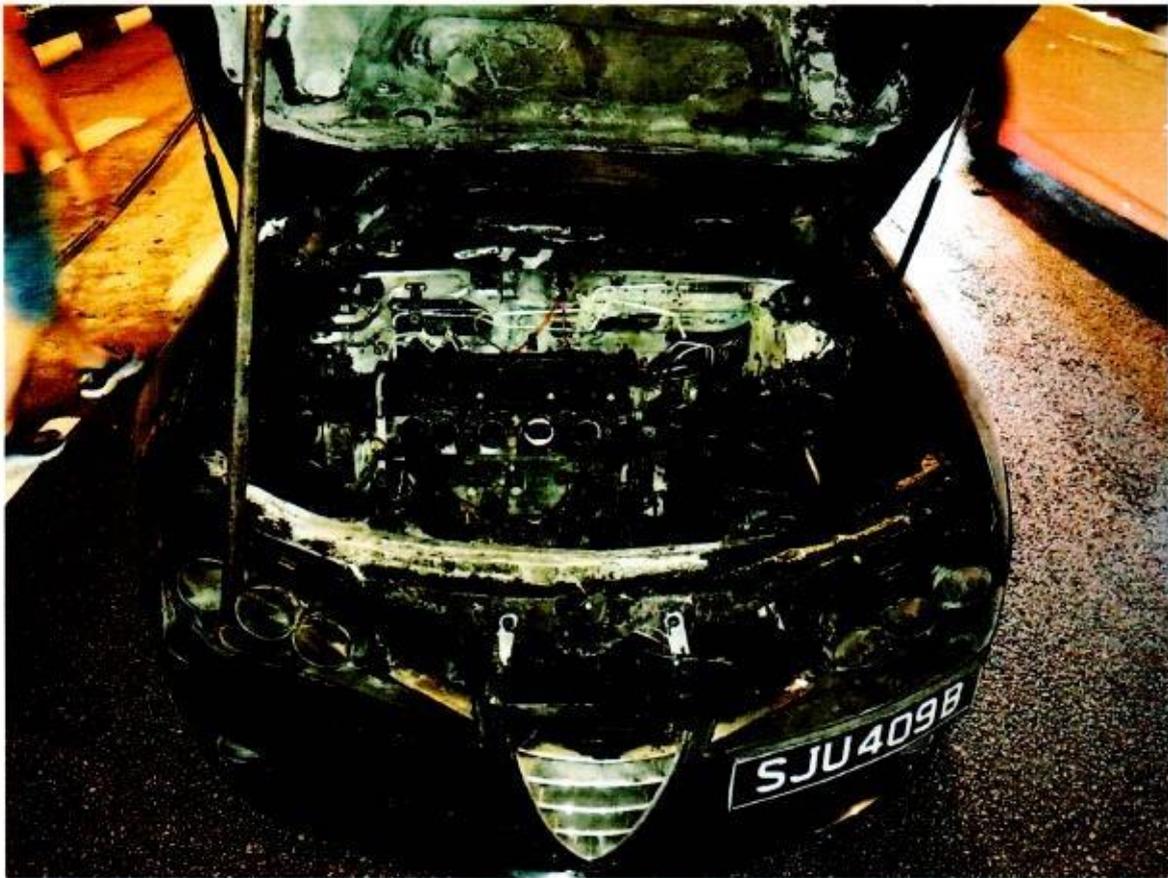
Photo 7 shows the Insured Vehicle at the incident location after the fire was extinguished by SCDF personnel. The damage of burnt nature to the Insured Vehicle had corresponded to the damages as seen by me during my inspection of the Insured Vehicle.

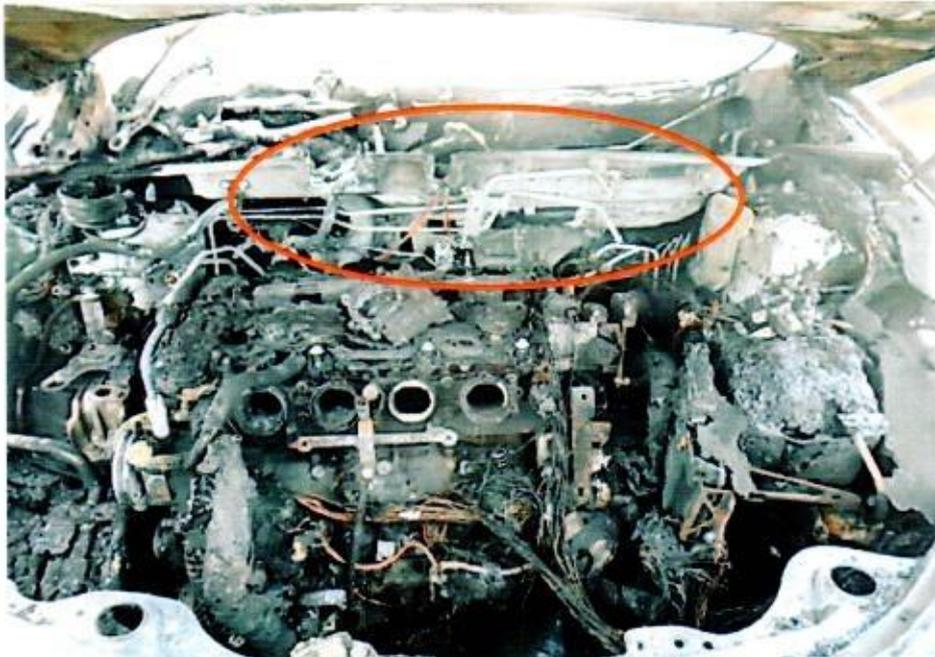
24. Firstly, high heat intensity burn marks (whitish burn marks) were found on the firewall panel, towards the rear of the engine compartment. These whitish burn marks are a result of exposure to prolong heat intensity. Rust would normally start to develop around these areas soon after a fire as prolonged exposure to high heat intensity usually causes steel/metal material body parts to be exposed to natural environmental condition. Given this burn pattern, the origin of fire can then be determined to be at the rear centre area of the engine compartment. See photo 8 below.

Photo 8 shows the whitish burn marks (circled) that were found on the firewall panel, towards the rear of the Insured Vehicle's engine compartment. Such whitish burn marks are a result of exposure to prolong heat intensity. The fire to the Insured Vehicle can then be established to have originated around the rear centre of the engine compartment.

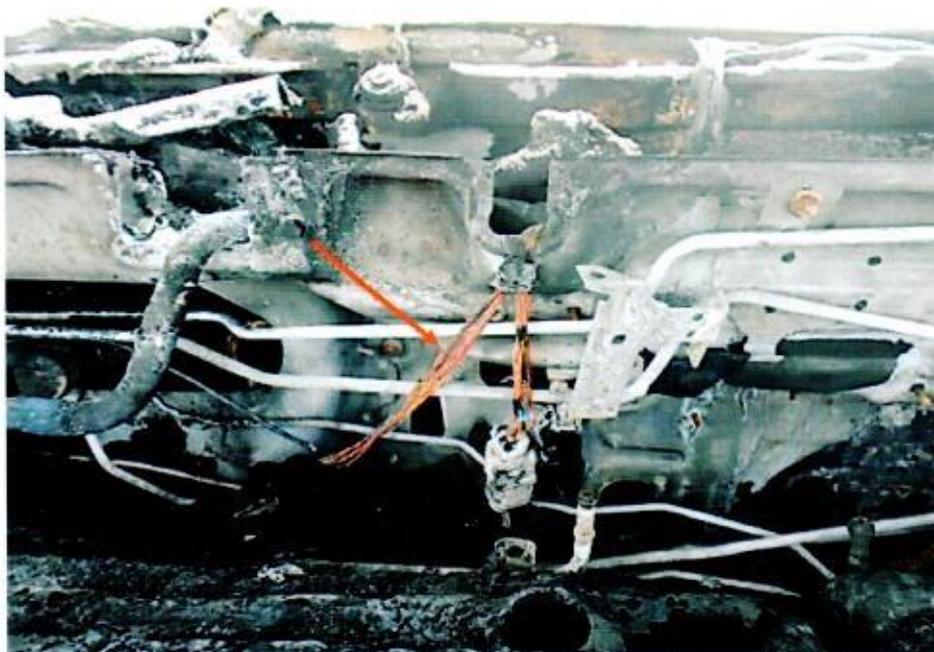
25. My examination of the rear centre area of the engine compartment, during my inspection of the Insured Vehicle, revealed wirings that were completely burned to its bare copper state. The bright reddish colour of the copper wires suggest that the wirings were exposed to high heat. Such condition normally indicates internal heating of copper wires which is a sign of an electrical short circuit occurring. The same wirings were also noted to be bright reddish in colour immediately after the fire was extinguished as seen from the incident scene photographs taken by Mr Tan. Hence the physical condition of the wirings at the area where the fire had originated indicates that the cause of fire to the Insured Vehicle was due to electrical in nature. See photo 9 & 10 below.

Photo 9 shows the wirings at the rear centre area of the Insured Vehicle's engine compartment. The wirings (arrowed) were found to be completely burned to its bare copper state. The bright reddish colour of the copper wires suggest that the wirings were exposed to high heat. Such condition normally indicates internal heating of copper wires which is a sign of an electrical short circuit occurring.

27. Having investigated and technically analysed the damages of burnt nature to the Insured Vehicle, I am of the view that the cause of fire to the Insured Vehicle was of electrical in nature. For this particular case, the fire had originated along the wiring inside the engine compartment, at the rear centre area of the engine compartment. The wiring was an original factory wiring harness.
28. I did not find any evidence which had suggested that the cause of fire to the Insured Vehicle was due to poor maintenance and/or recurring electrical problem.
29. There was no modification(s) and/or additional electronic and/or electrical component(s) fitted on the Insured Vehicle at the time of my inspection of the Insured Vehicle.
30. My investigations also revealed that at the time of writing this report, there is no manufacturer recall of similar make and model vehicle as the Insured Vehicle.

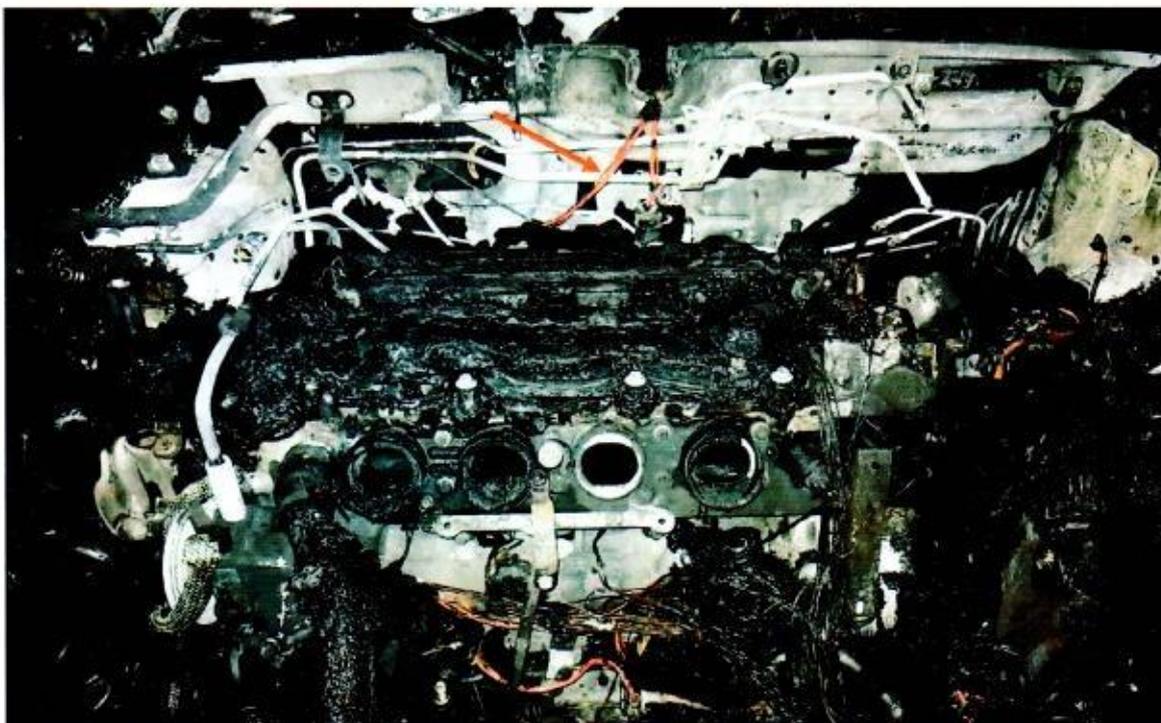
Photo 10 shows the engine compartment of the Insured Vehicle immediately after the fire was extinguished. This was from photographs taken by Mr Tan at the incident location. The same wirings (arrowed) as photograph 9 were noted to be bright reddish in colour immediately after the fire. Such condition suggest that the wirings were exposed to high heat, indicating internal heating of copper wires. This is a sign of an electrical short circuit occurring.
