Your Ref: 77212 /EG
Our Ref :CS/DAI18010248/D

12 June 2018

TECHNICAL INVESTIGATION REPORT OF FIRE INCIDENT INVOLVING THE INSURED VEHICLE SJU 409B ON 03 JUNE 2018

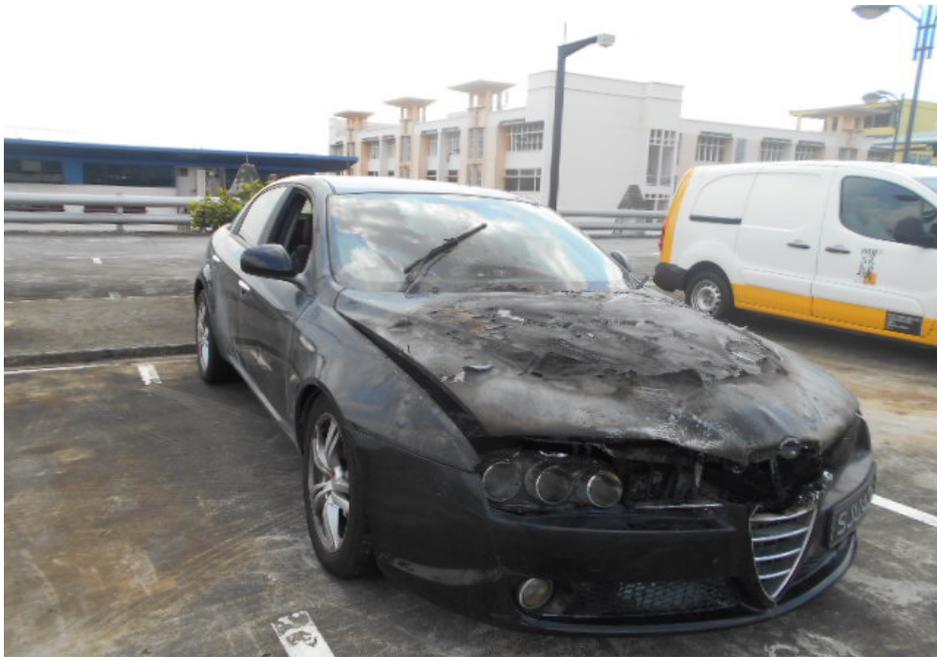
Photo 1 shows a general view of the front right body of the Insured Vehicle at the time of inspection. The Insured Vehicle was observed to be severely burnt at its frontal body. Its front bumper, front bonnet, front grille, front right headlamp and front right fender were amongst the body parts that were found to have been burnt as a result of the fire.

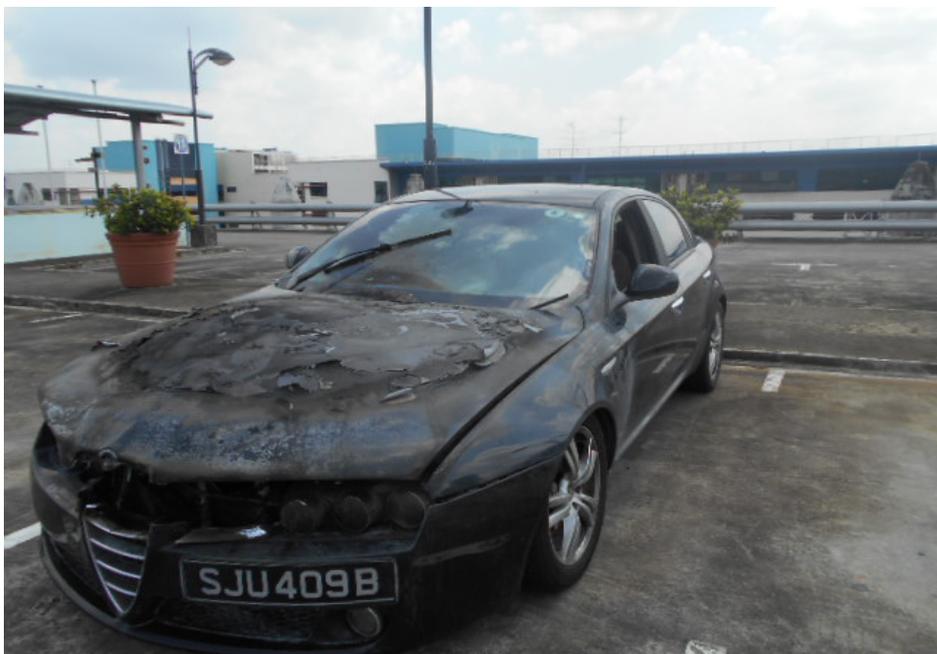
Photo 2 shows a general view of the front left body of the Insured Vehicle at the time of inspection. The Insured Vehicle was observed to be severely burnt at its frontal body. Its front bumper, front left fender, front left headlamp, front bonnet and front windscreen were amongst the body parts that were found to have been burnt as a result of the fire.

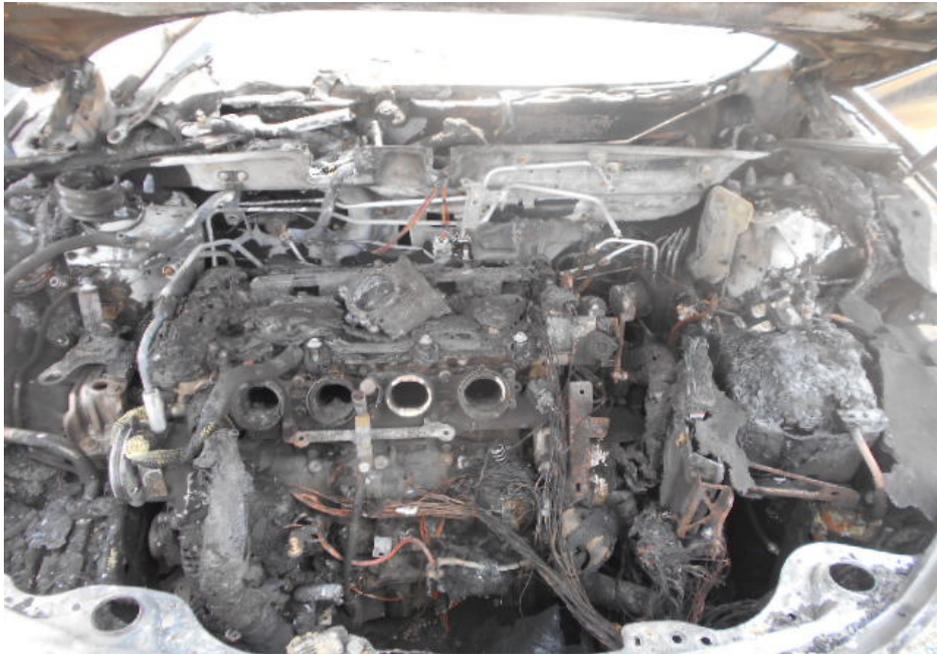
Photo 3 shows the engine compartment of the Insured Vehicle at the time of inspection. Almost all the parts inside the engine compartment were observed to be burnt and/or melted as a result of the fire. These parts had included its radiator, air condenser, cooling fan, intake manifold, fuse box, battery, air duct, hoses and pipes amongst others.

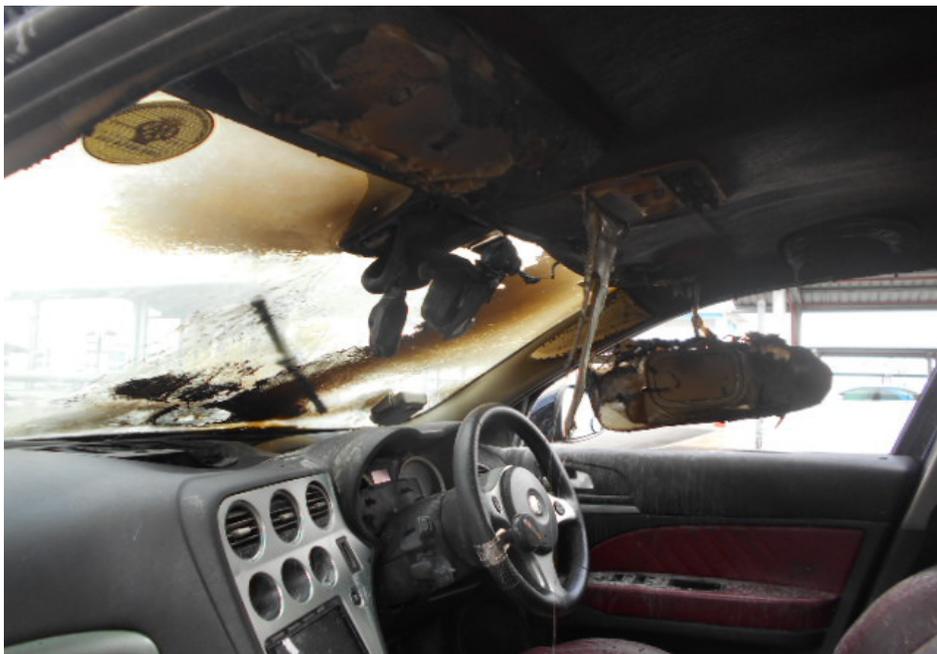
Photo 4 shows the interior compartment of the Insured Vehicle, which was affected at the front area. The dashboard and upholstery were amongst the parts in the interior compartment that were observed to be partially melted/burnt.

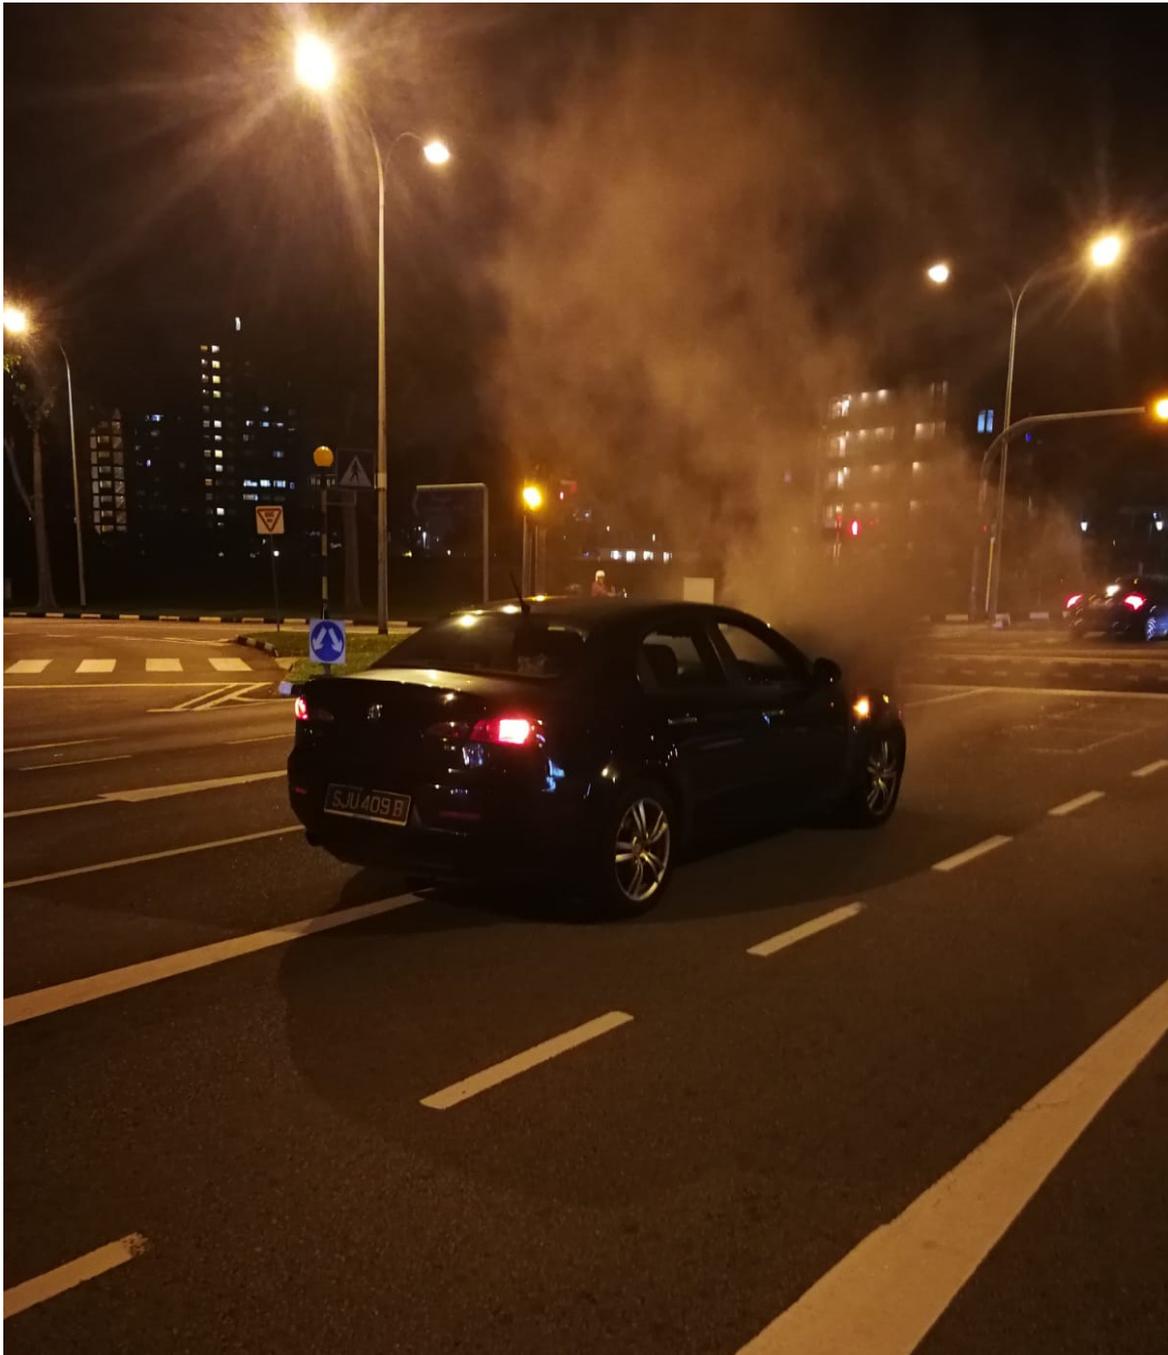
Photo 5 shows the Insured Vehicle at the incident location with smoke emitting out from its frontal portion. There was no unusual foreign material(s) and/or object(s) on the ground in the immediate area of where the Insured Vehicle had stopped.

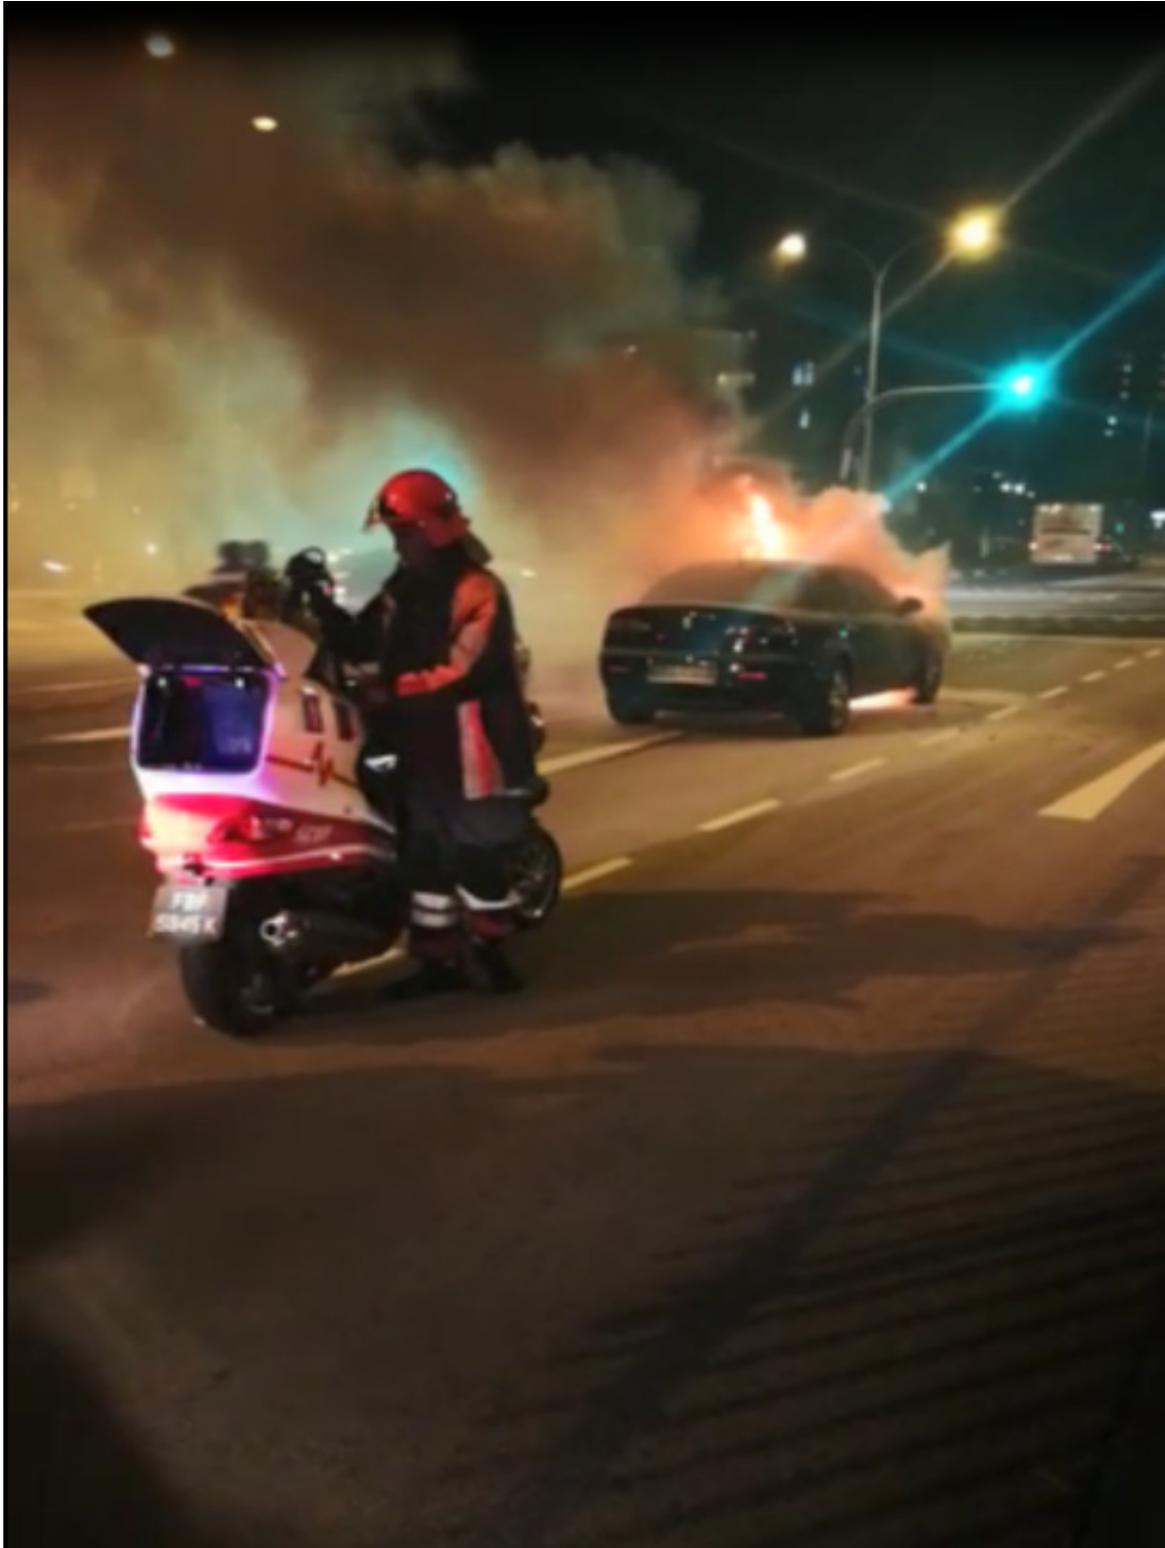
Photo 6 shows the Insured Vehicle at the incident location with flames coming out from its frontal portion. In general, the observations gathered from my review of the incident scene photographs and videos had corresponded to the information gathered from Mr Tan when I spoke to him.

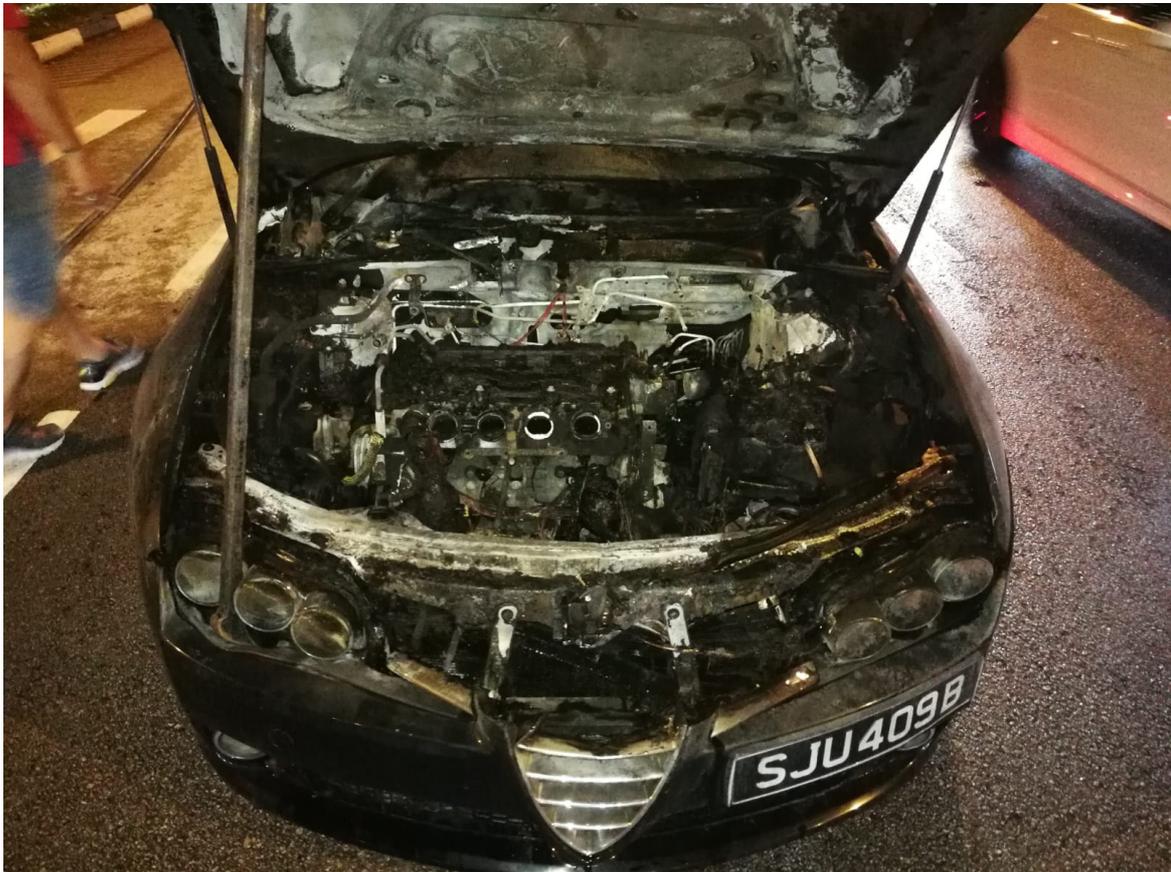
Photo 7 shows the Insured Vehicle at the incident location after the fire was extinguished by SCDF personnel. The damage of burnt nature to the Insured Vehicle had corresponded to the damages as seen by me during my inspection of the Insured Vehicle.

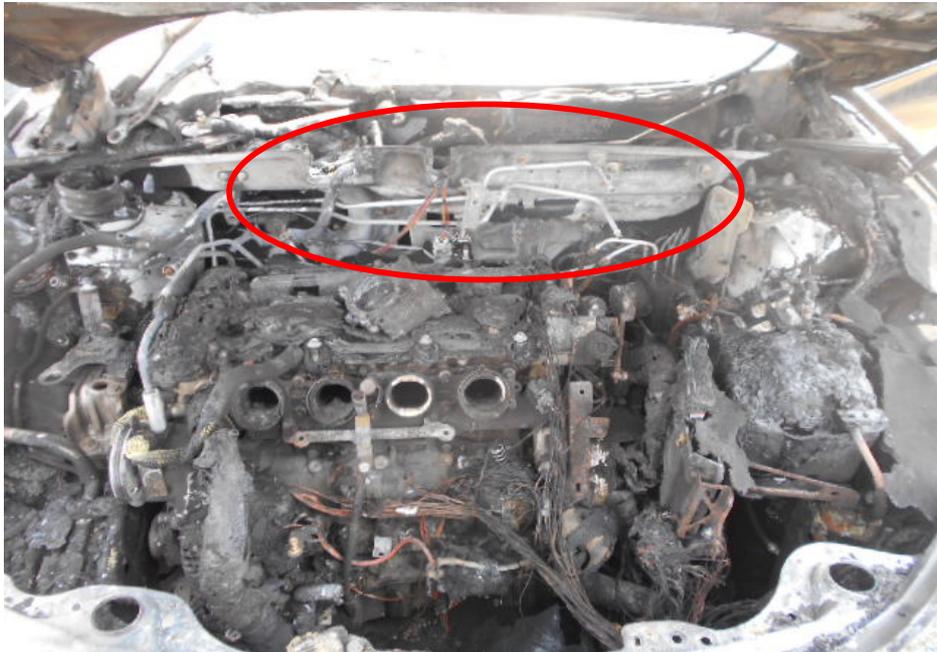
24. Firstly, high heat intensity burn marks (whitish burn marks) were found on the firewall panel, towards the rear of the engine compartment. These whitish burn marks are a result of exposure to prolong heat intensity. Rust would normally start to develop around these areas soon after a fire as prolonged exposure to high heat intensity usually causes steel/metal material body parts to be exposed to natural environmental condition. Given this burn pattern, the origin of fire can then be determined to be at the rear centre area of the engine compartment. See photo 8 below.

Photo 8 shows the whitish burn marks (circled) that were found on the firewall panel, towards the rear of the Insured Vehicle's engine compartment. Such whitish burn marks are a result of exposure to prolong heat intensity. The fire to the Insured Vehicle can then be established to have originated around the rear centre of the engine compartment.

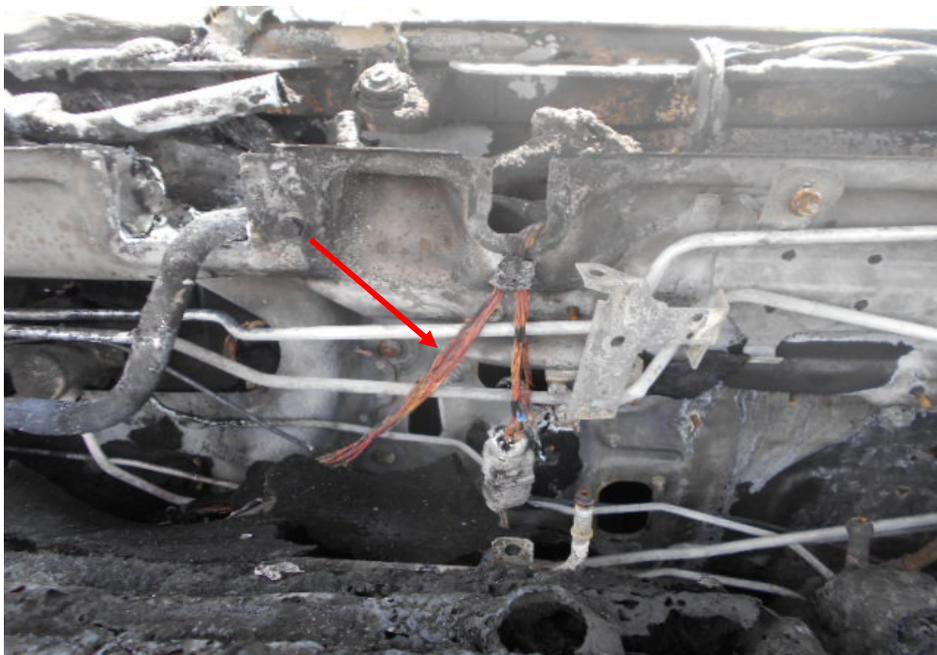
25. My examination of the rear centre area of the engine compartment, during my inspection of the Insured Vehicle, revealed wirings that were completely burned to its bare copper state. The bright reddish colour of the copper wires suggest that the wirings were exposed to high heat. Such condition normally indicates internal heating of copper wires which is a sign of an electrical short circuit occurring. The same wirings were also noted to be bright reddish in colour immediately after the fire was extinguished as seen from the incident scene photographs taken by Mr Tan. Hence the physical condition of the wirings at the area where the fire had originated indicates that the cause of fire to the Insured Vehicle was due to electrical in nature. See photo 9 & 10 below.

Photo 9 shows the wirings at the rear centre area of the Insured Vehicle's engine compartment. The wirings (arrowed) were found to be completely burned to its bare copper state. The bright reddish colour of the copper wires suggest that the wirings were exposed to high heat. Such condition normally indicates internal heating of copper wires which is a sign of an electrical short circuit occurring.

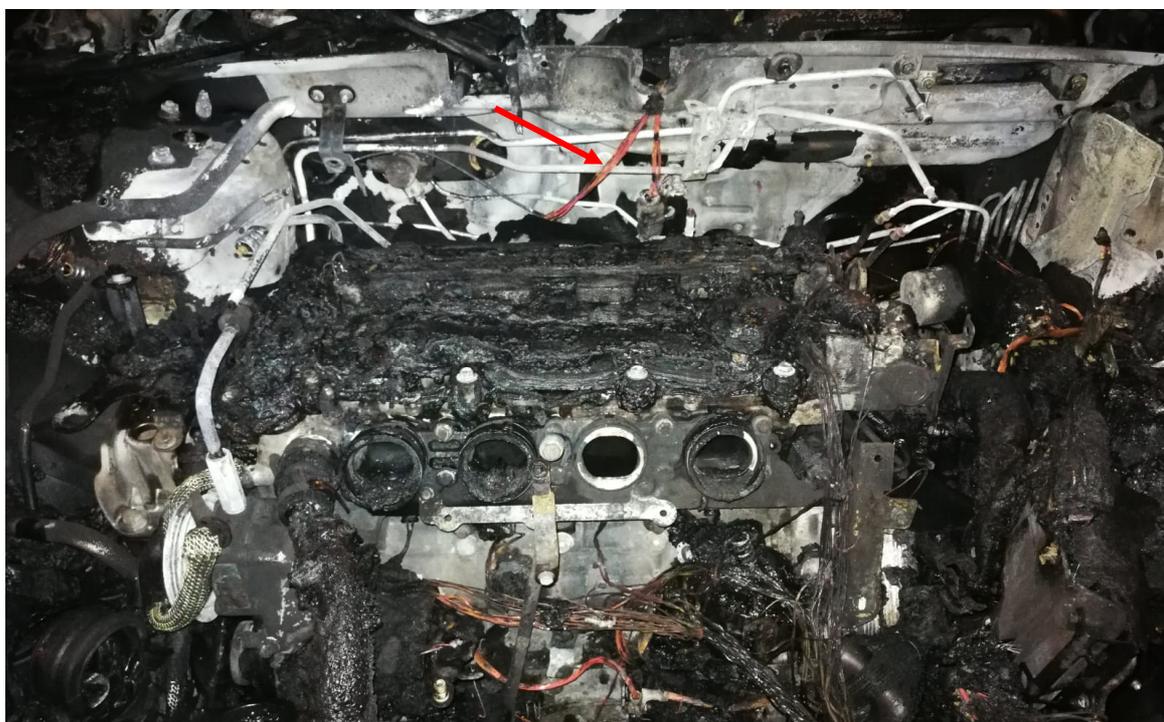
Photo 10 shows the engine compartment of the Insured Vehicle immediately after the fire was extinguished. This was from photographs taken by Mr Tan at the incident location. The same wirings (arrowed) as photograph 9 were noted to be bright reddish in colour immediately after the fire. Such condition suggest that the wirings were exposed to high heat, indicating internal heating of copper wires. This is a sign of an electrical short circuit occurring.
