Your Ref : EFA/China0575/dh
Our Ref : CI/LAW18010324/N

8 May 2018

**AUTOMOBILE TECHNICAL INVESTIGATION REPORT OF ACCIDENT
INVOLVING SHD 899H AND SJC 1685H ON 29 MARCH 2017**

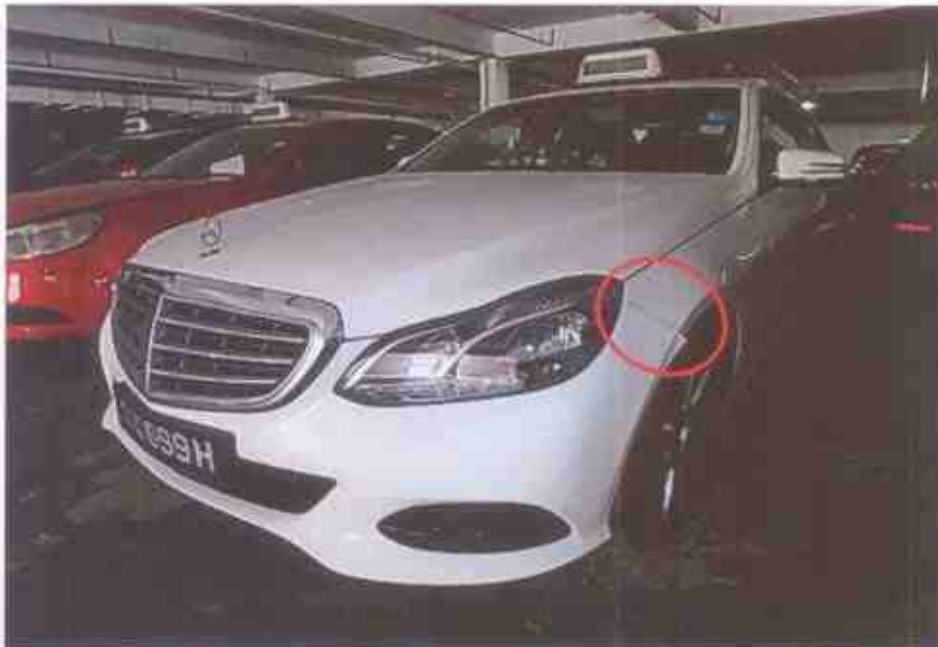
Photo 1 shows the general left view of the front portion of the Taxi at the time of the Pre- Repair Survey conducted by LKK Auto Consultants Pte. Ltd. which was taken 2 days after the accident. The damages to the Taxi were observed to be confined to the left front portion, particularly to its front bumper and left front tyre fender (circled).

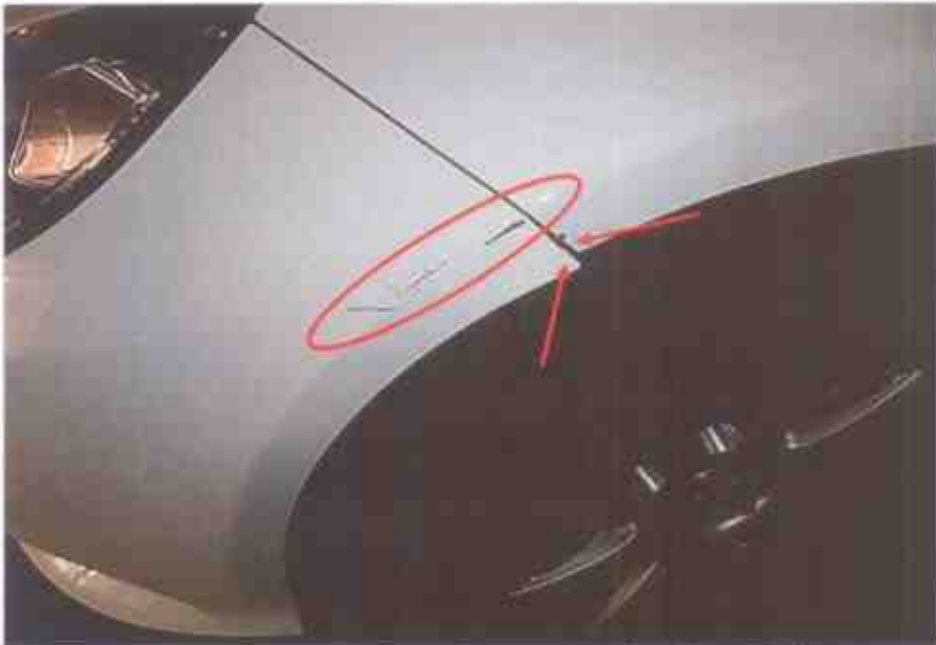
Photo 2 shows a closer view of the left front portion of the Taxi. The front bumper was dislodged at the left corner edge (arrowed). Paint graze marks were also found on the left portion of the front bumper as well as on the left front tyre fender (circled).

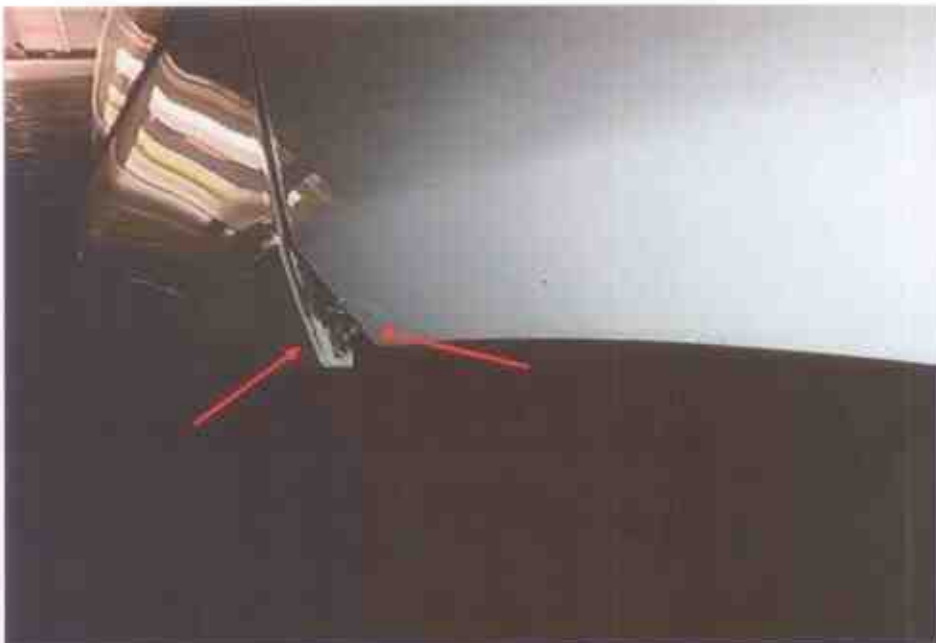
Photo 3 shows a close up view of the dislodgement of the Taxi's front bumper at the left corner edge (arrowed).

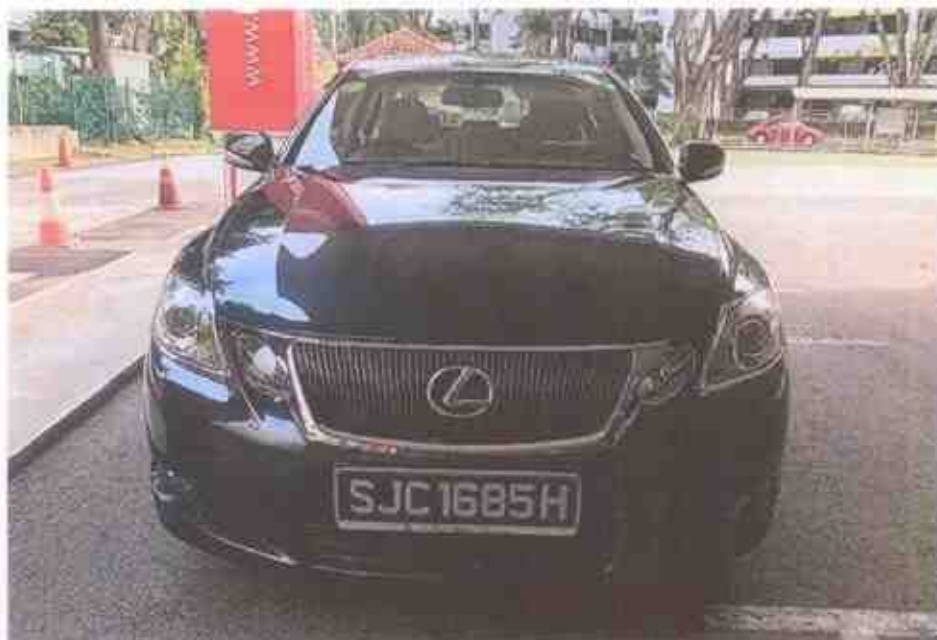
Photo 4 shows the general view of the front portion of the Lexus taken by Ms Lim after receiving the letter from her insurance company. Our review of this photograph did not produce any significant information as the photograph was taken from afar, without any close up photograph of the body parts at the front portion of the Lexus.

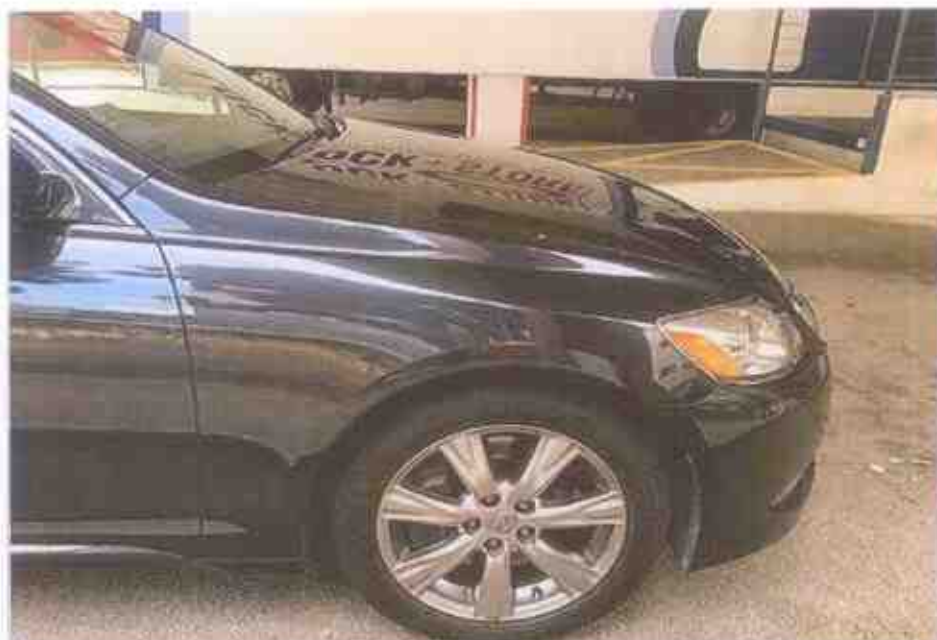
Photo 5 shows the general view of the right front portion of the Lexus taken by Ms Lim after receiving the letter from her insurance company. Our review of this photograph did not produce any significant information as the photograph was taken from afar, without any close up photograph of the body parts at the right front portion of the Lexus.

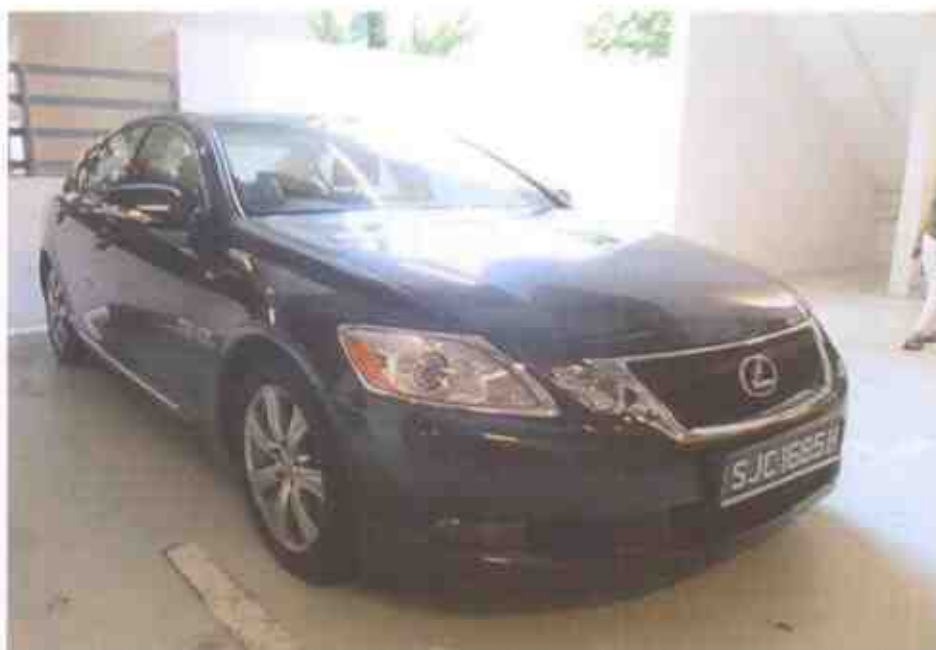
Photo 6 shows a general right view of the front portion of the Lexus at the time of our physical inspection.

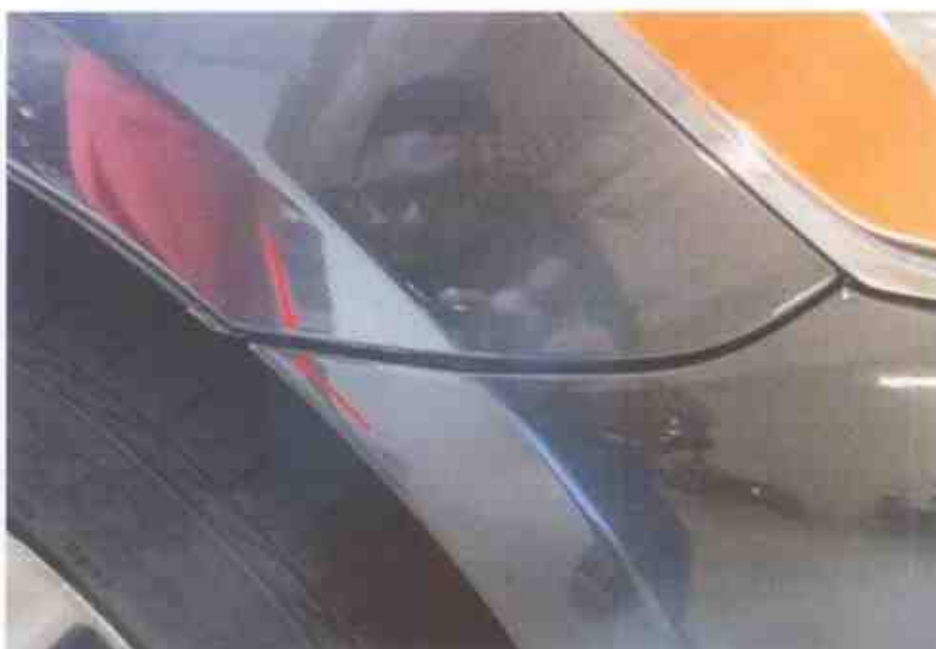
Photo 7 shows the misalignment of the Lexus's front bumper at the right corner edge (arrowed).

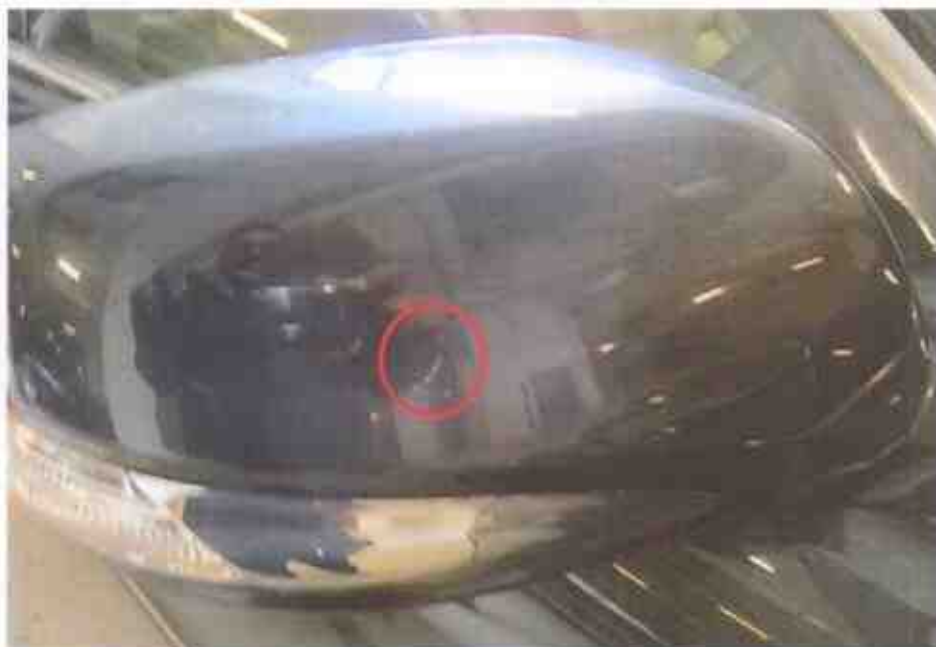
Photo 8 shows the whitish marks found on the right side mirror of the Lexus (circled).

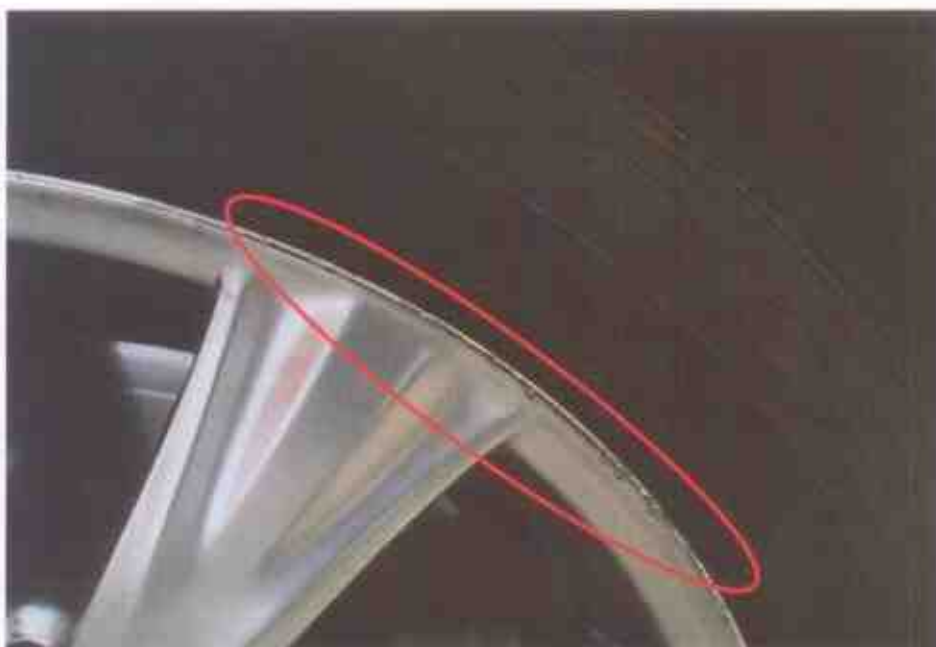
Photo 9 shows a close up view of the relatively minor marks of grazing nature observed around the edges of the right front wheel rim of the Lexus (circled).

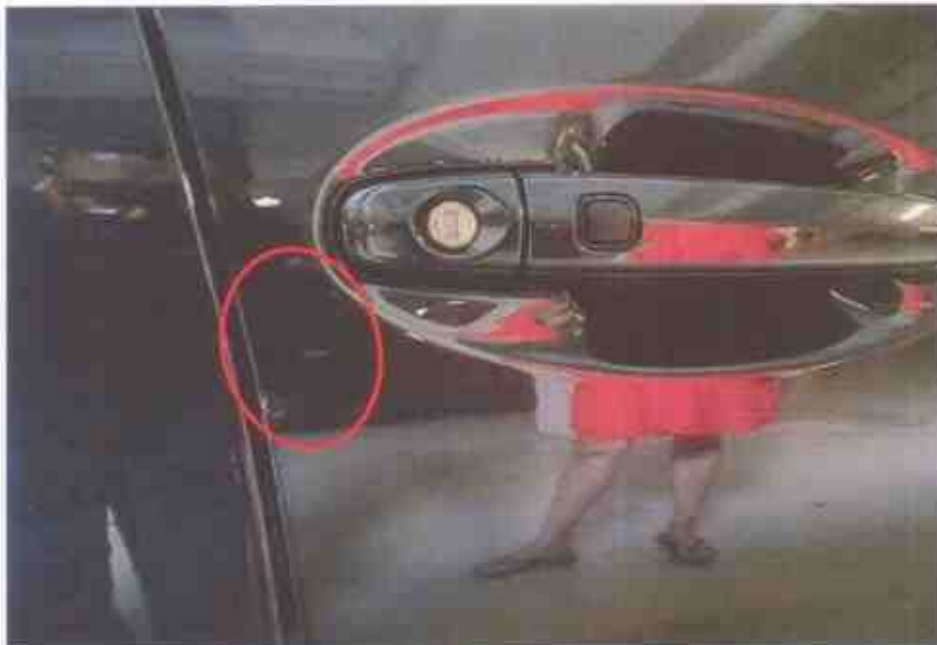
Photo 10 shows the paint graze marks found near the handle of the driver door of the Lexus (circled).

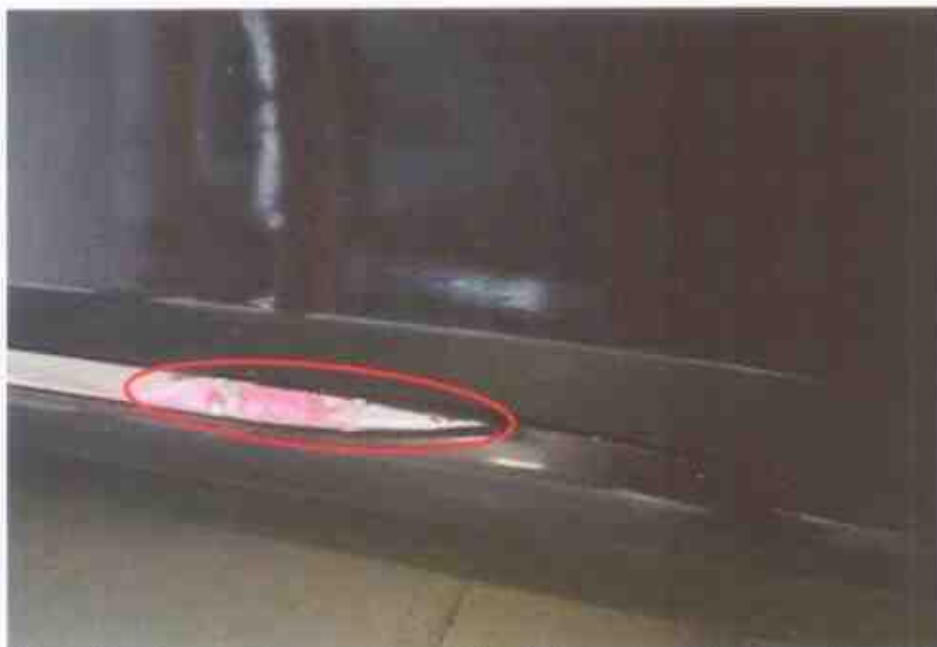
Photo 11 shows a close up view of the dent found on the driver door body chrome trim (circled).

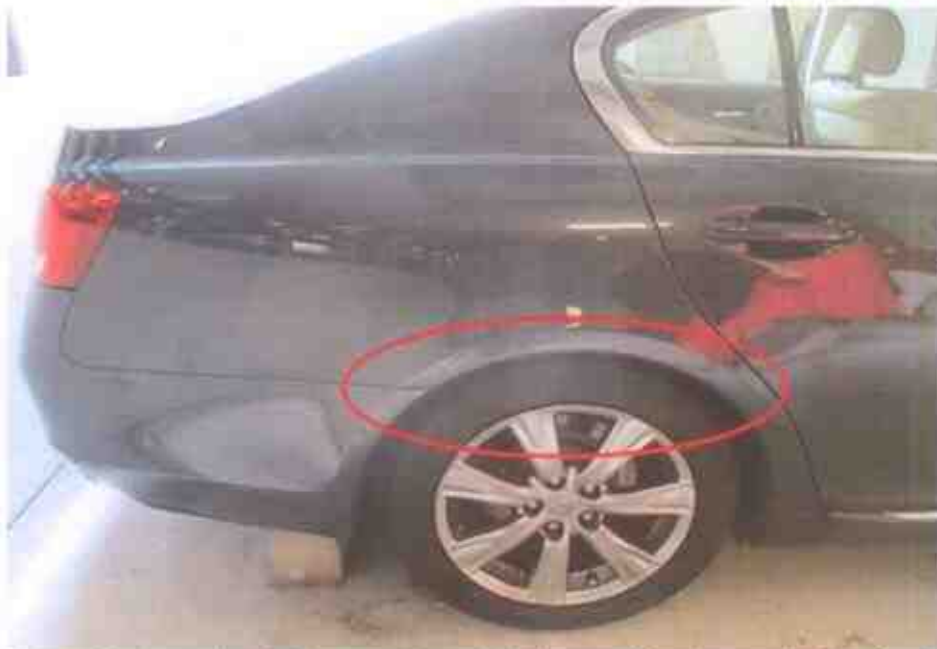
Photo 12 shows the right rear portion of the Lexus. We observed several paint graze marks on the right rear tyre fender as well as relatively minor marks of grazing nature around the edges of the right rear wheel rim (circled).

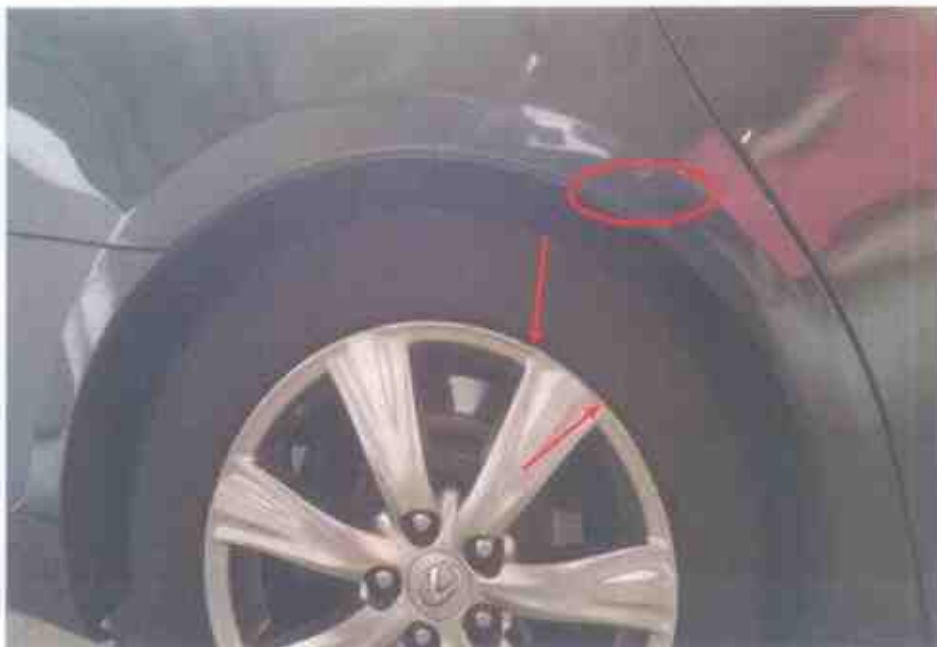
Photo 13 shows a close up view of the paint graze marks on the right rear tyre fender (circled) as well as relatively minor marks of grazing nature around the edges of the right rear wheel rim (red arrows).

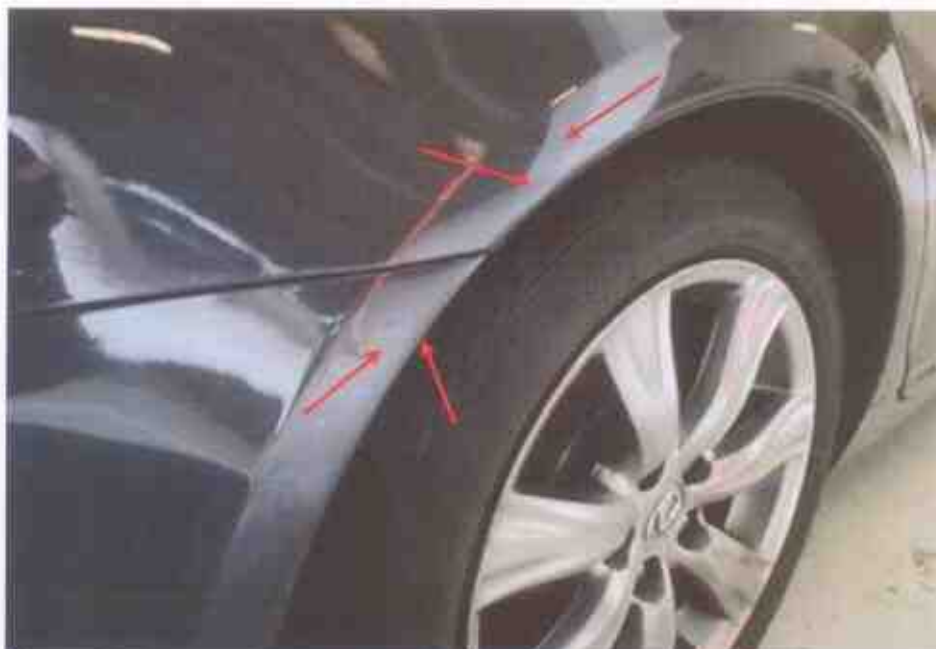
Photo 14 shows a close up view of the paint graze marks on the right rear tyre fender (red arrows).

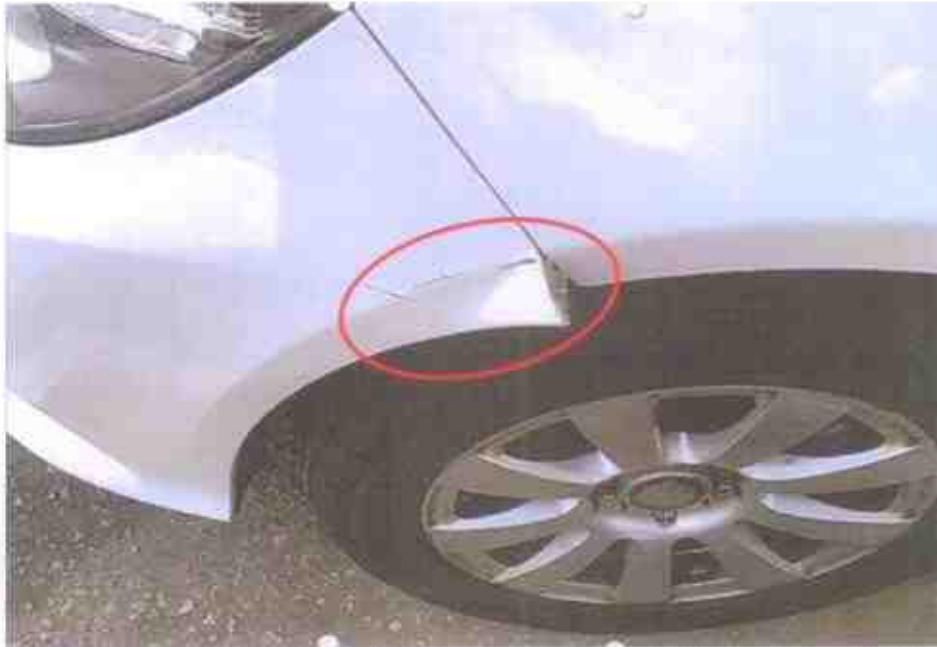
Photo 15 shows a close up view of the damages sustained to the left front portion of the Taxi post- accident (circled). Upon closer examination of these photos, the damages seem to be consistent with the photos taken during the accident reporting as well as the Pre- Repair Survey.

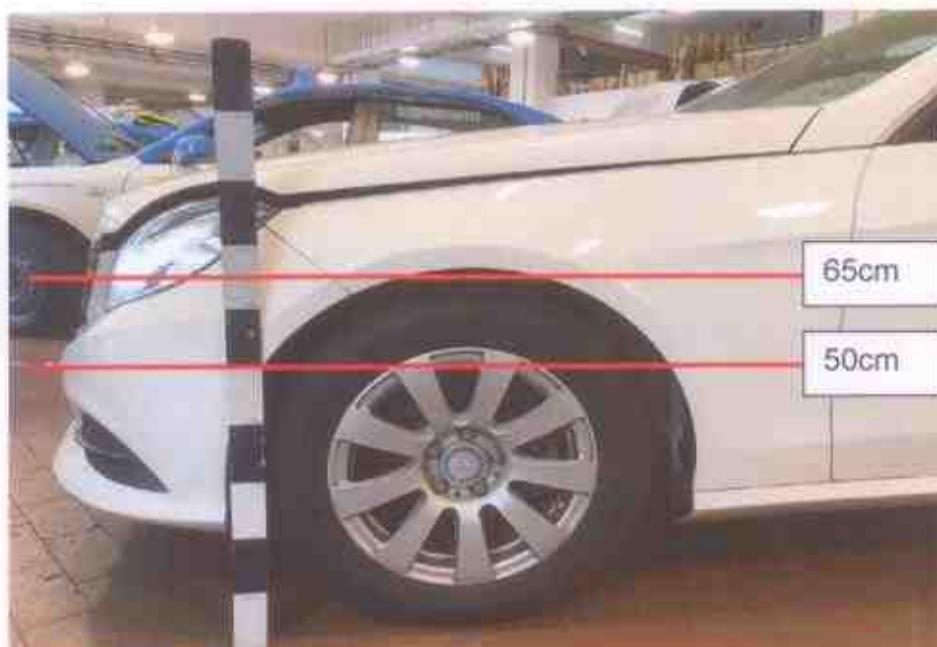
Photo 16 shows the height measurement being conducted on the left front portion of the Taxi (using a similar make and model). The paint graze marks and the dislodgement of the front bumper on the left front portion of the Taxi were measured to be between the height ranges of 50cm to 65cm above ground level.

- a) the paint graze marks and the dislodgement of the front bumper on the left front portion of the Taxi were measured to be between the height ranges of 50cm to 65cm above ground level;
- b) the body part within the height range of 50cm to 65cm above ground was the edges of the right front wheel rim of the Lexus where the graze marks were found;
- c) the body part within the height range of 50cm to 65cm above ground was the edges of the right rear wheel rim as well as the right rear tyre fender of the Lexus where the graze marks were found;
- d) the height measurements appear to support the findings of possible contact between the left front portion of the Taxi and the right portion of the Lexus. The damage observed on the left front portion of the Taxi was a result of this contact and corresponds to the damage observed on the right portion of the Lexus.

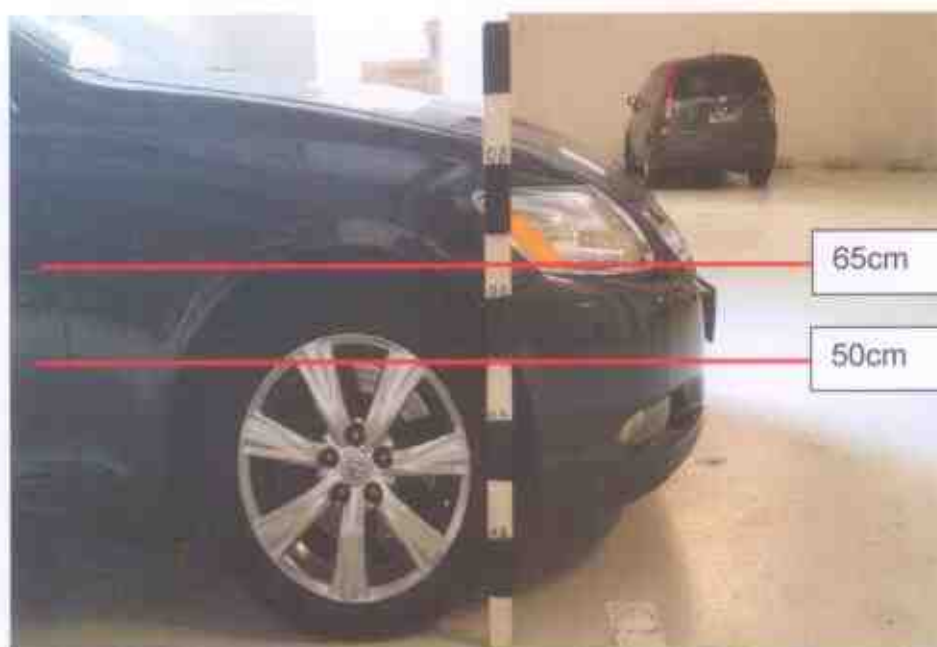
Photo 17 shows the height measurement being conducted on the right front portion of the Lexus. The body part within the height range of 50cm to 65cm above ground was the edges of the right front wheel rim where the graze marks were found.

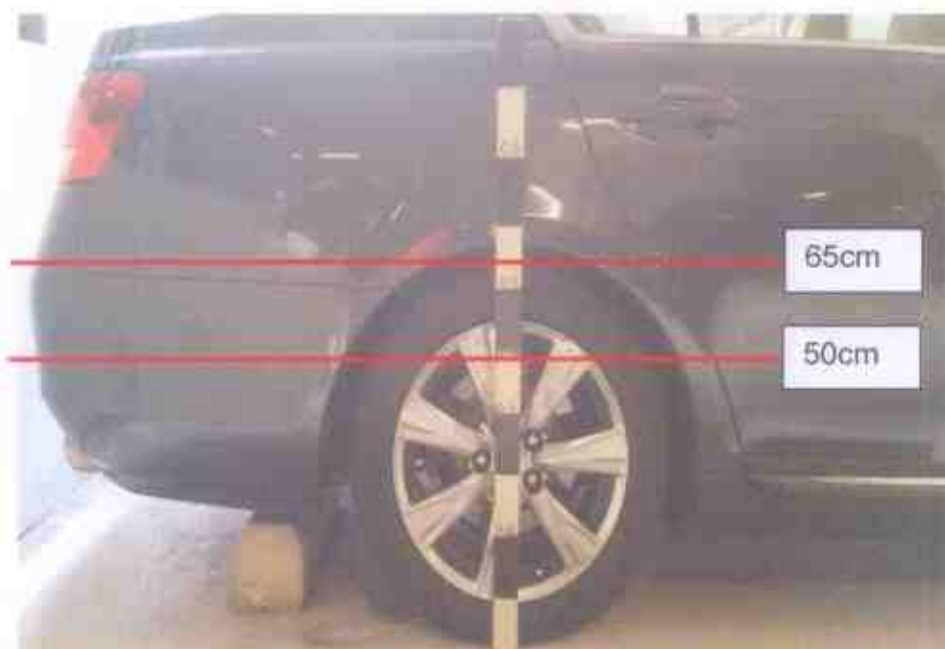
Photo 18 shows the height measurement being conducted on the right rear portion of the Lexus. The body part within the height range of 50cm to 65cm above ground was the edges of the right rear wheel rim as well as the right rear tyre fender where the graze marks were found.
