Your Ref: 4498380060SG
Our Ref : CI/AIG18010367/D

**TECHNICAL INVESTIGATION REPORT OF TRANSMISSION DAMAGE TO
THE INSURED VEHICLE SLP 2323D**

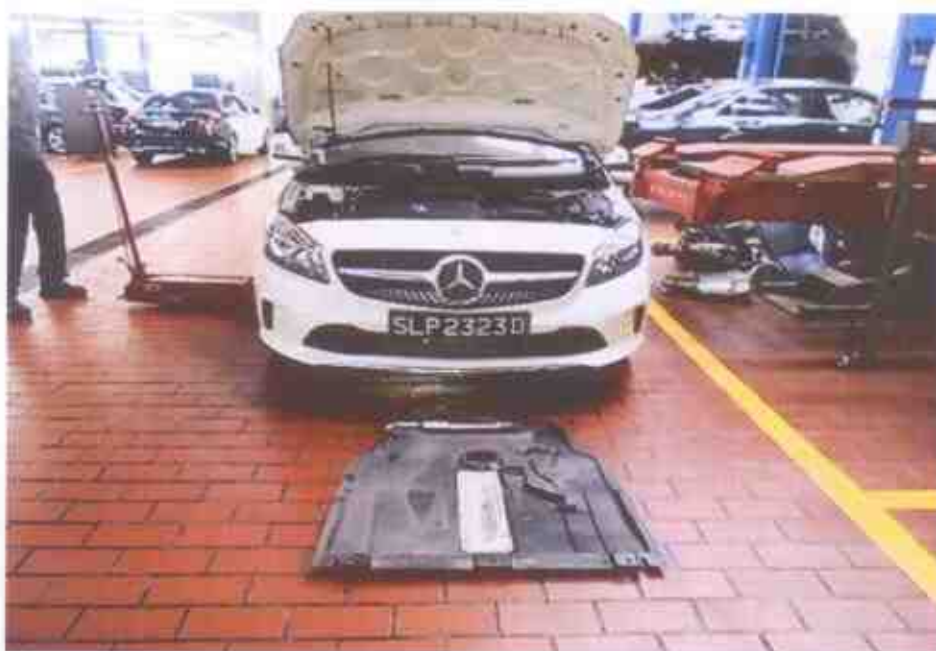
Photo 1 shows a general view of the Insured Vehicle at the time of my inspection.

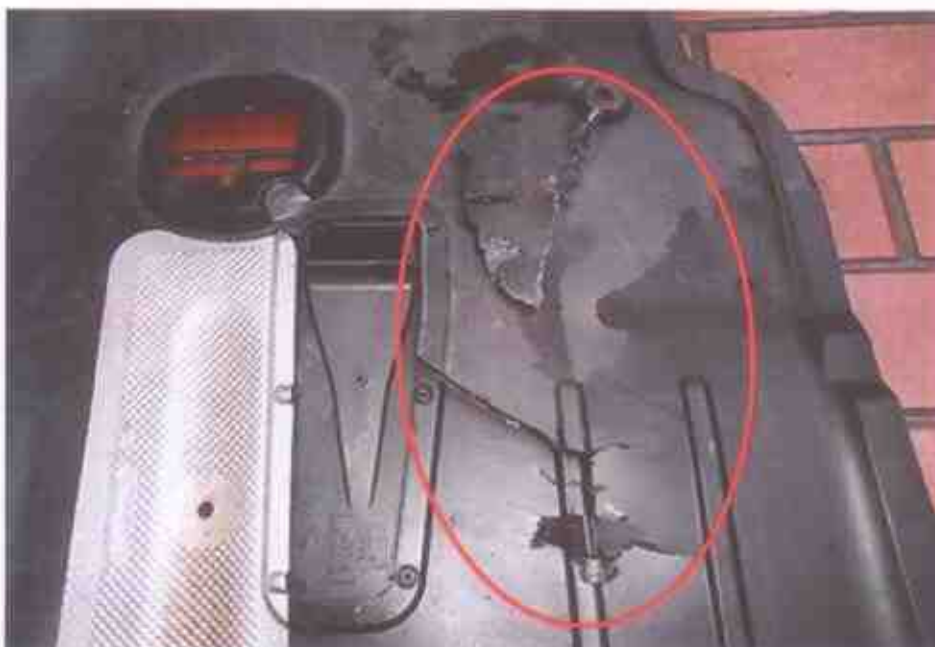
6. The underside of the front bumper and engine undercover at the front of the Insured Vehicle was found to be without any visible damage. The second engine undercover was however found to be torn at a single area. The nature of the tear corresponds to a cut that was caused by a sharp edge object.

Photo 2 shows the torn second engine undercover of the Insured Vehicle. The second engine undercover was found to be torn at a single area (circled). The nature of the tear corresponds to a cut that was caused by a sharp edge object.

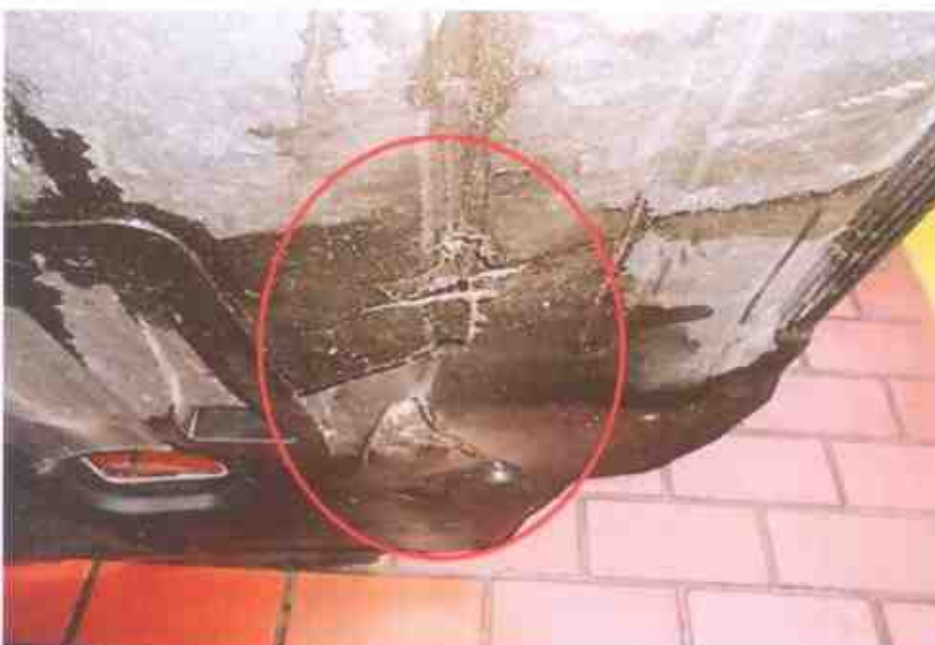
Photo 3 shows the torn second engine undercover of the Insured Vehicle. The second engine undercover was found to be torn at a single area (circled). The nature of the tear corresponds to a cut that was caused by a sharp edge object.

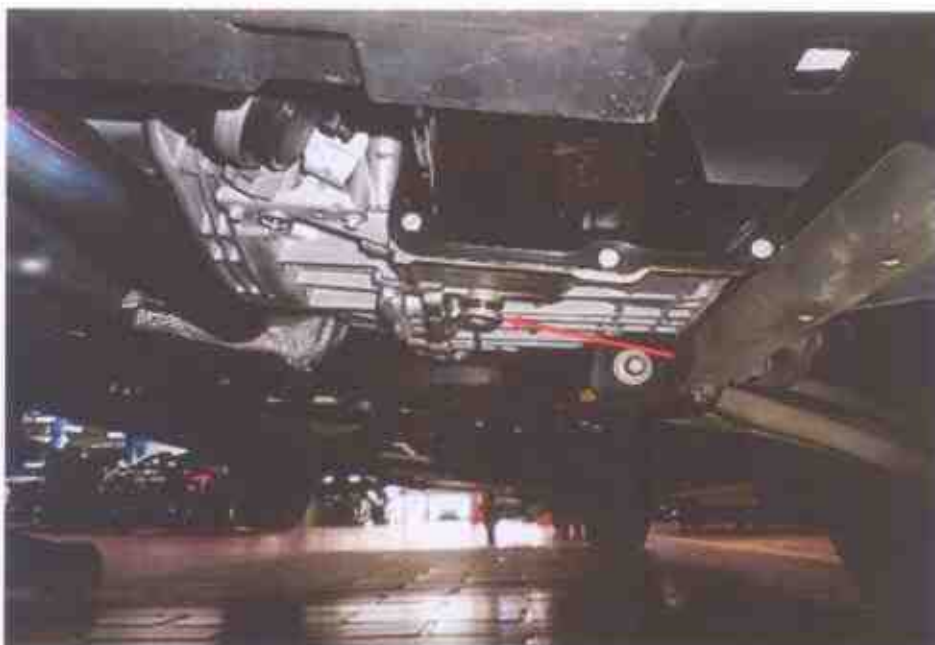
7. It was also observed that the drain plug for the transmission fluid was not fully secured/tightened. Droplets of fluid was seen on the drain plug. Upon closer examination, a single cut mark was observed, stretching across the underside of the drain plug. In general, the damage profile of the second engine undercover and cut on the underside of the drain plug correspond to the Insured Vehicle going over an object. See photo 1 – 6 below.

Photo 4 shows the drain plug (arrowed) for the transmission fluid of the Insured Vehicle. The drain plug was observed to be not fully secured/tightened.

10. For this case, the drain plug for the transmission fluid was found with cut mark that was caused by the Insured Vehicle going over the stone. It was also found to be not fully secured/tightened at the time of my inspection. The contact with the stone could have caused the drain plug to become slightly misaligned/shifted/loose from the tread groove that secures the drain plug, resulting in minor leakage of transmission fluid that was initially not detected by the driver of the Insured Vehicle.

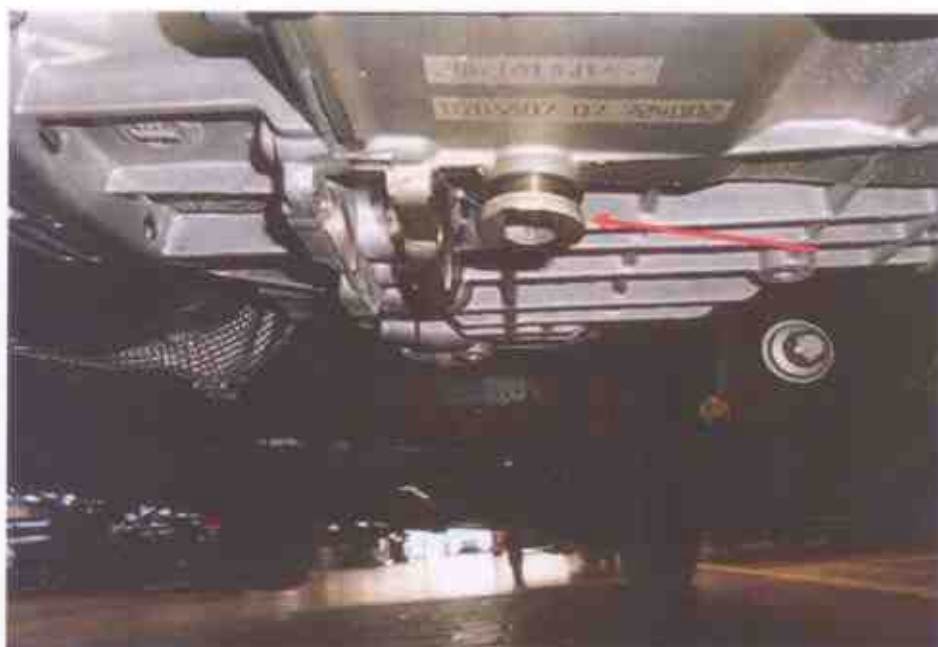
Photo 5 shows a closer view of the drain plug (arrowed) for the transmission fluid of the Insured Vehicle. The drain plug was observed to be not fully secured/tightened.

11. The leak however became more severe when the drain plug started to further misalign/shift/loosen progressively due to vibrations and oscillations of the Insured Vehicle during motion when it was continued to be driven for the next subsequent days after going over the stone, evident from the condition of the drain plug as seen at the time of my inspection and the eventual discovery of fluid leak by the driver of the Insured Vehicle, 8 days after the Insured Vehicle had gone over the stone.

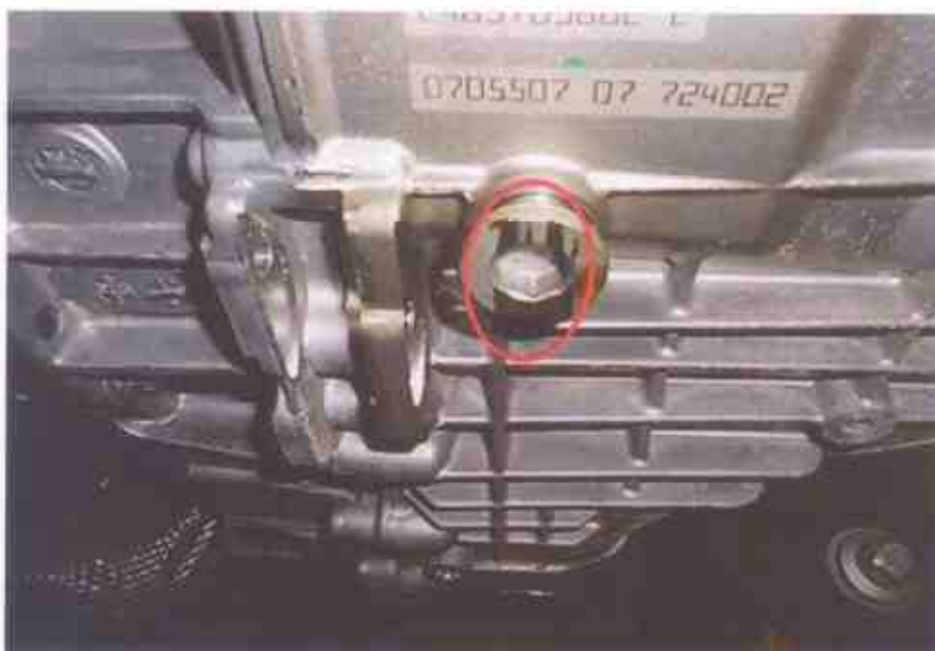
Photo 6 shows a closer view of the drain plug for the transmission fluid of the Insured Vehicle. Upon closer examination, a single cut mark (circled) was observed, stretching across the underside of the drain plug. The cut on the underside of the drain plug correspond to the Insured Vehicle going over an object.

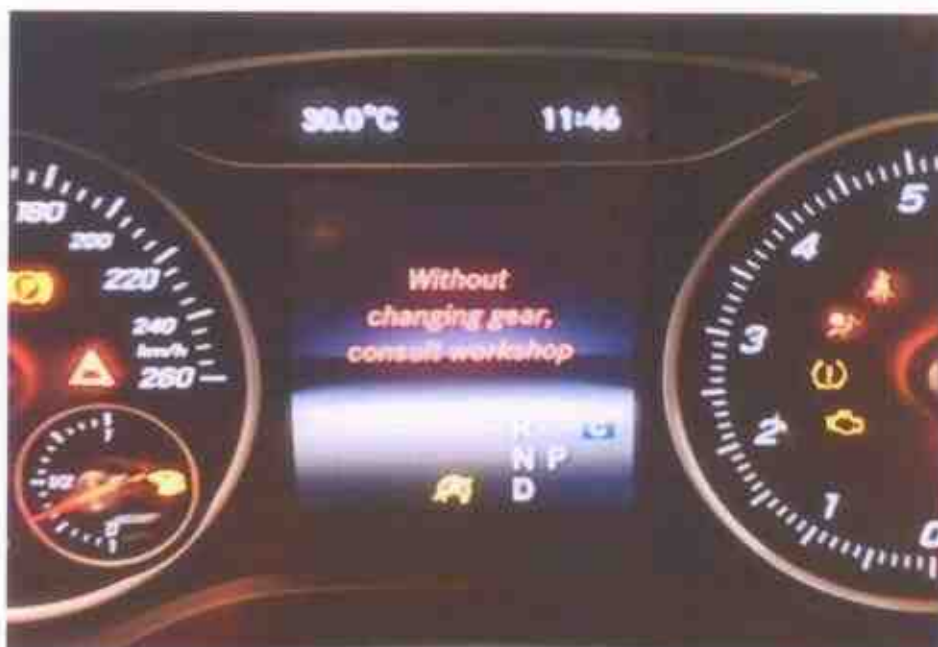
8. Upon turning the key to half crank position, a warning message had appeared on the instrument panel of the Insured Vehicle. The message "without changing gear, consult workshop" had appeared. This indicates a fault in the transmission of the Insured Vehicle. See photo 7 below.

Photo 7 shows the warning message "without changing gear, consult workshop" that appeared on the instrument panel of the Insured Vehicle after the key was turned to half crank position. This would indicate a fault to the transmission of the Insured Vehicle.

14. During my inspection of the Insured Vehicle at Cycle & Carriage Industries Pte Ltd, I had enquired with the technicians on whether there would be any warning message to alert drivers when the transmission fluid becomes of insufficient level for operating purposes. I was informed that for the transmission fluid, there will not be any warning message. Usually, if there is insufficient transmission fluid, the driver will feel the vehicle lose power, become sluggish as the transmission gears may become difficult or may not shift due to low hydraulic pressure from insufficient transmission fluid.
