Your Ref: TP/IP/06231/2018  
Our Ref :CI/TPD18010452/Z

**Fatal Accident Investigation Team**  
Traffic Police Department  
Singapore Police Force  
10 Ubi Avenue 3  
Singapore 408865

### **MECHANICAL INSPECTION REPORT OF MOTORCYCLE FBK 7228H**

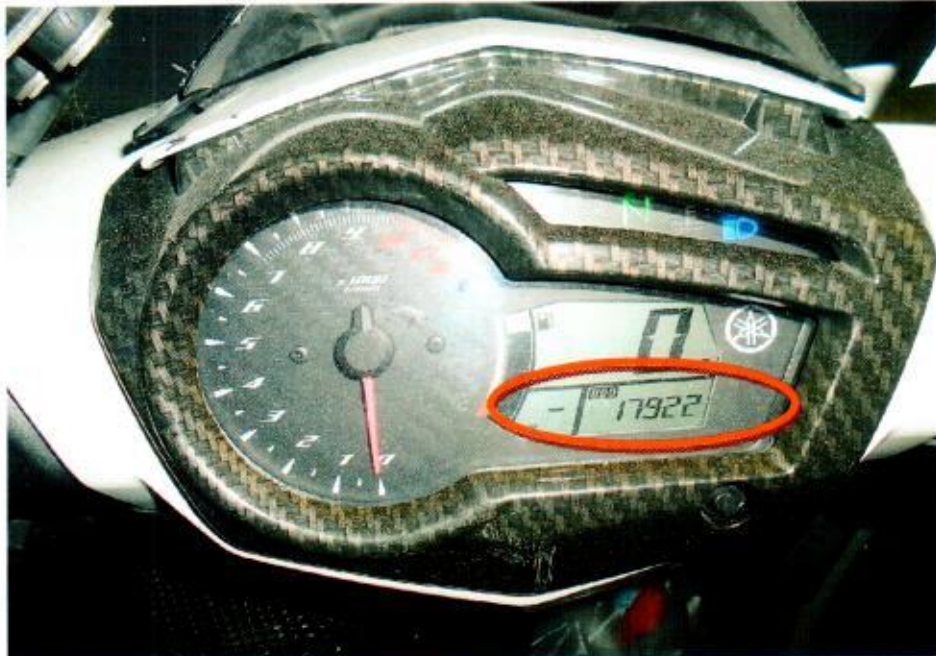
**Photo 1** shows the mileage at the time of inspection was recorded to be 179,22km.

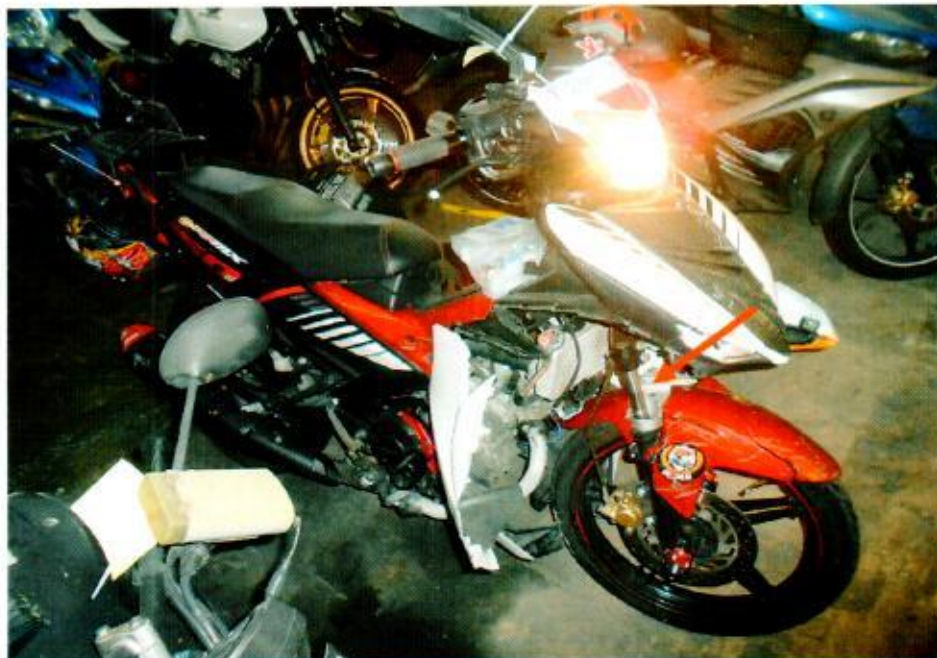
**Photo 2** shows a general view of the front right body of the Motorcycle at the time of our inspection. The Motorcycle was observed to be sustained with relatively extensive impact due to the accident collision. Amongst the body parts damaged was its front fork (arrowed), which was observed to be bent inwards.

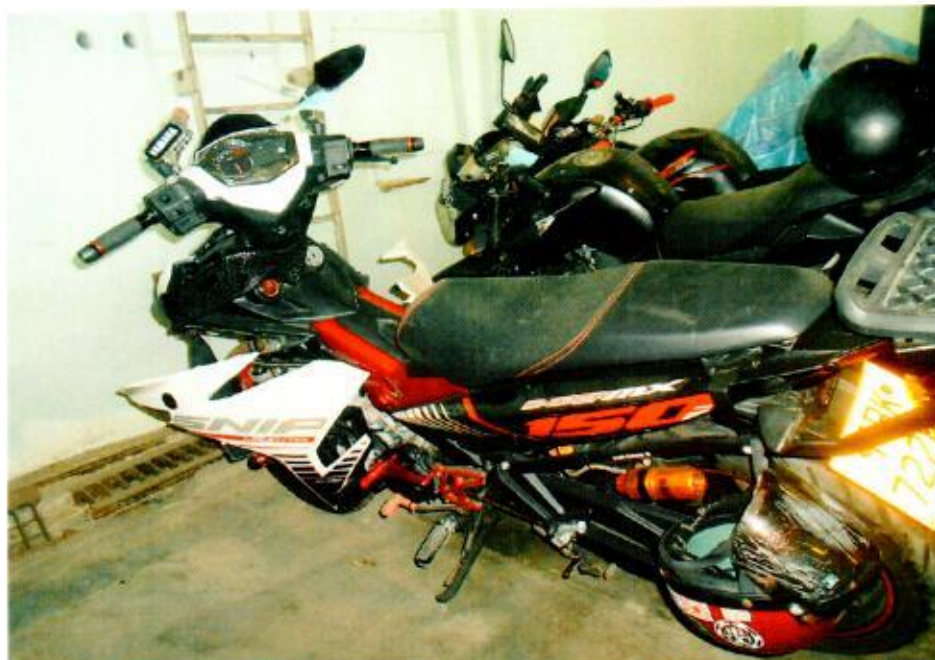
Photo 3 shows a general view of the rear left body of the Motorcycle at the time of our inspection. The Motorcycle was observed to have sustained damages at the frontal & rear portion, along both its left side and right side.

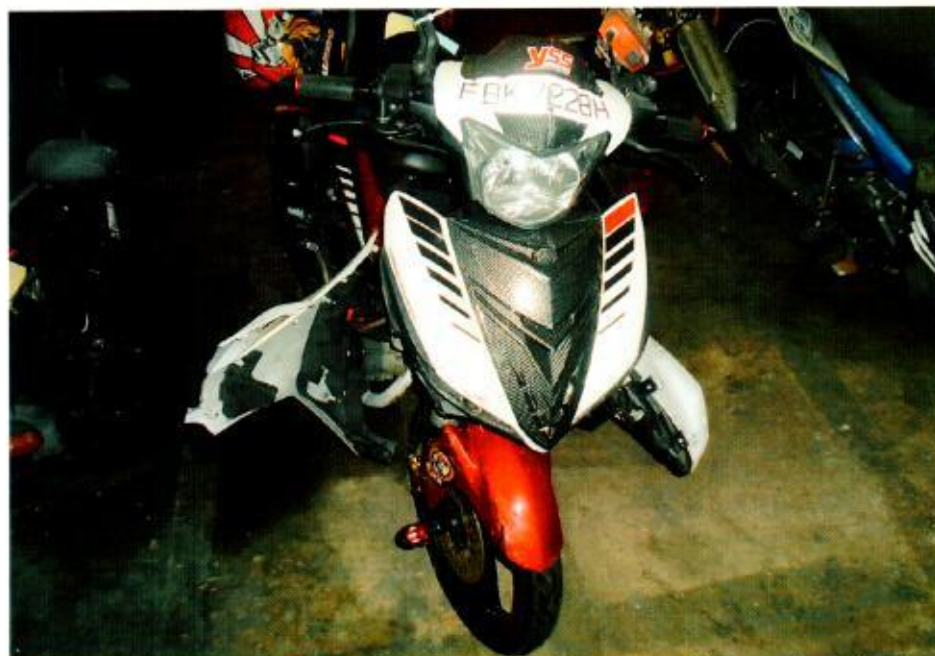
Photo 4 shows a general view of the frontal portion of the Motorcycle at the time of our inspection. The Motorcycle was observed to be sustained relatively extensive impact due to the accident collision.

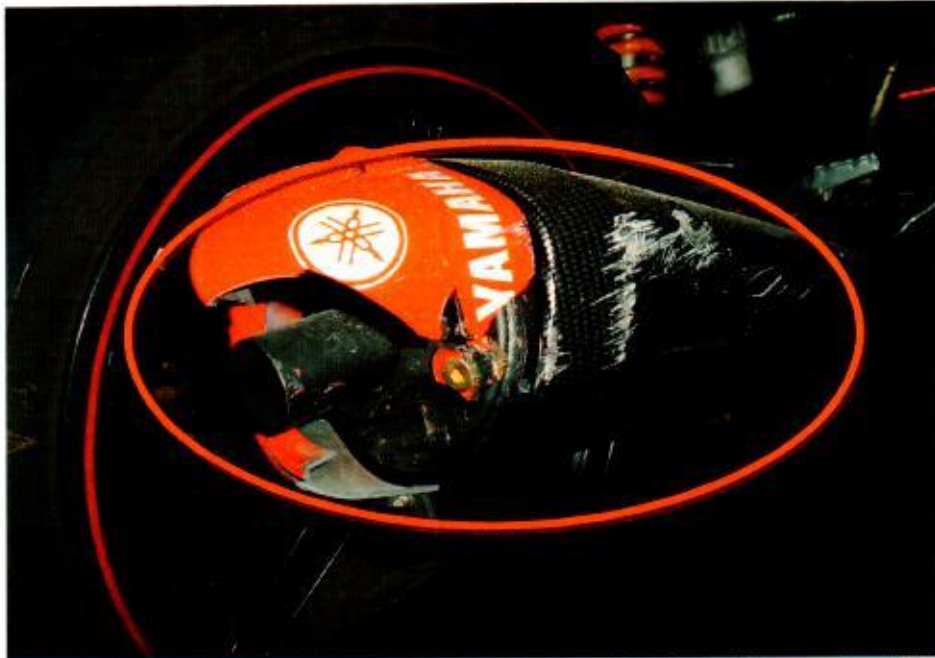
**Photo 5** shows a close-up view of the exhaust muffler of the Motorcycle at the time of our inspection. It was observed to have sustained with damages due to the accident collision.

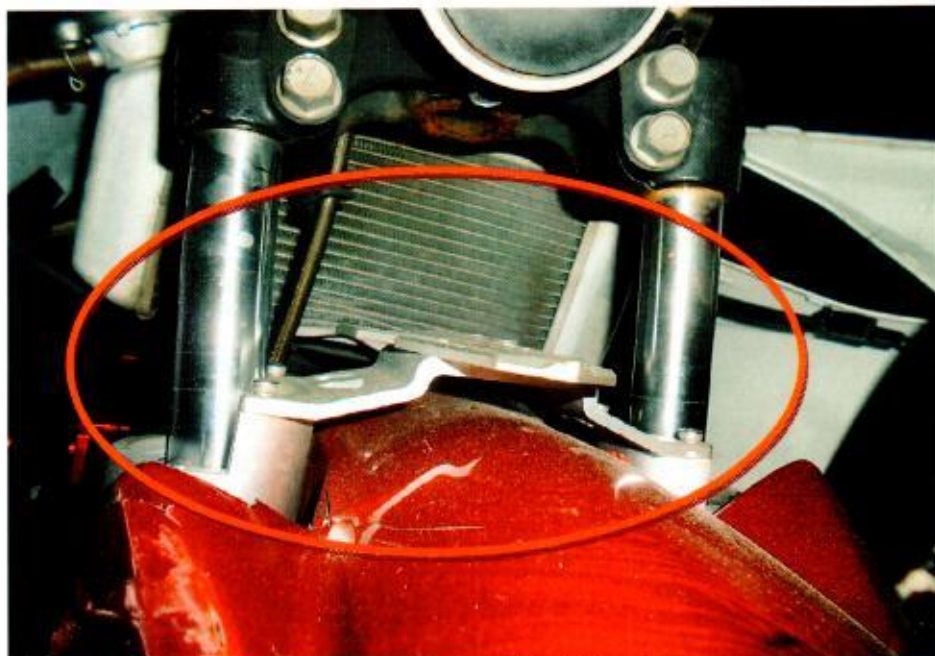
**Photo 6** shows a close-up view of the front fork & radiator of the Motorcycle at the time of our inspection. It was observed to have sustained with damages due to the accident collision.

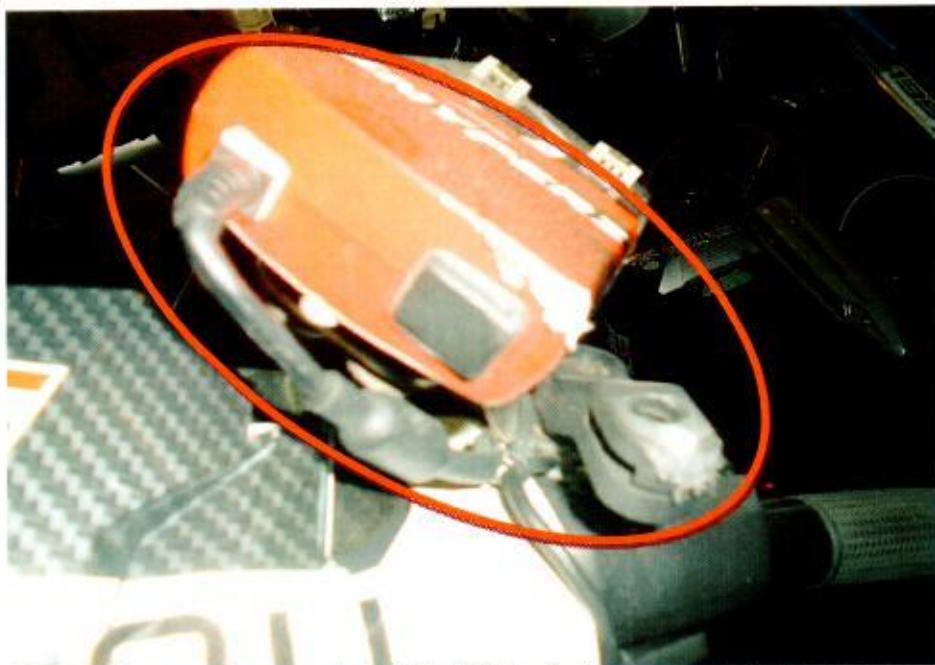
**Photo 7** shows a close-up view of the ERP unit c/w bracket of the Motorcycle at the time of our inspection. It was observed to have sustained with damages due to the accident collision.

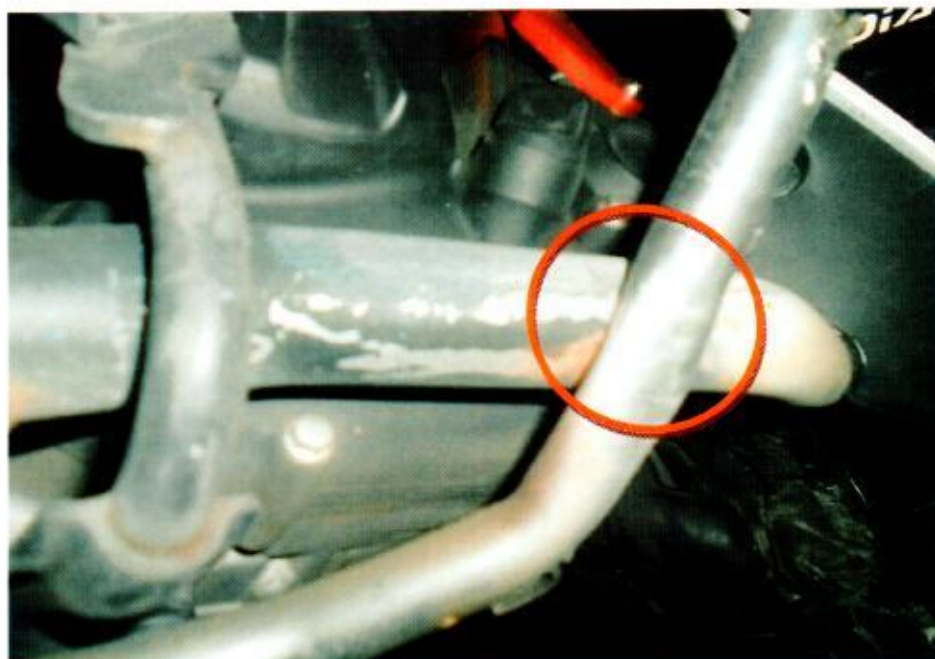
**Photo 8** shows a close-up view of the stuck exhaust muffler & foot brake pedal of the Motorcycle at the time of our inspection. It was observed to have sustained with damages due to the accident collision.

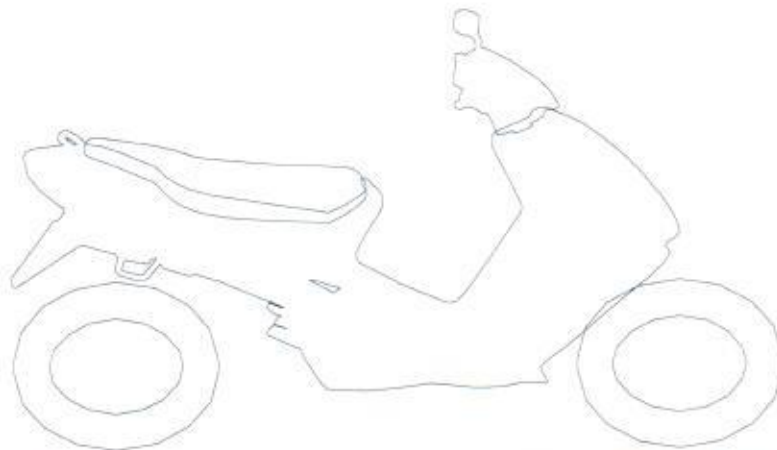
7. The condition of the Motorcycle's tyres was observed to be in serviceable condition. The tread pattern of the 2 tyres was clearly visible. We did not observe any tear, burst mark(s) and/or punctured hole(s) on the sidewalls as well as across the tread of the 2 tyres. Both tyres were observed to be sufficiently inflated for vehicular operation. The tyre brand, tyre size and remaining tread depth of the 2 tyres were recorded as follows:-

IRC NFG7 120/70-17 (3mm)

IRC NFG7 70/90-17 (3mm)

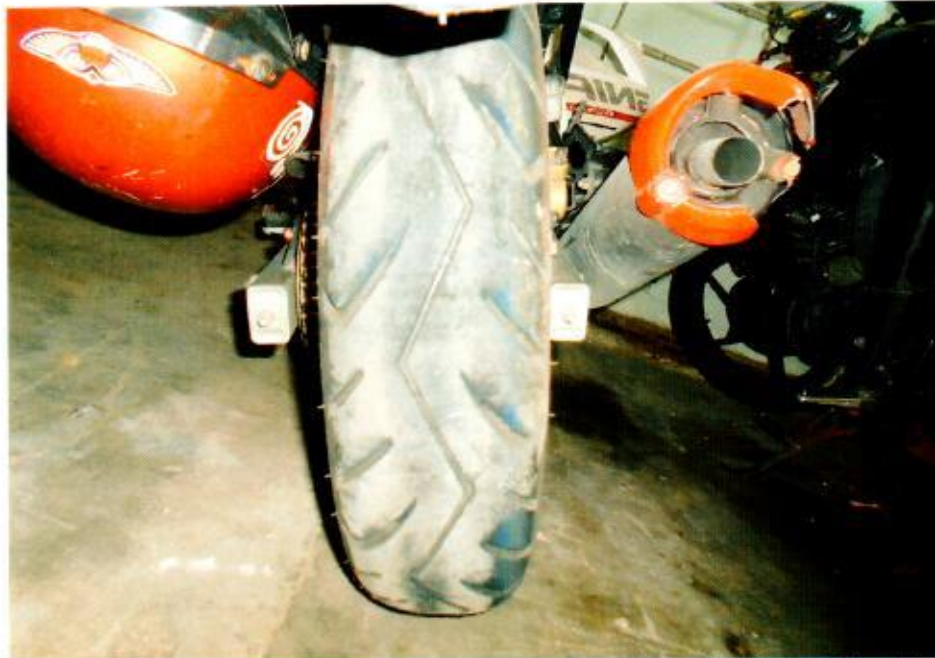
**Photo 9** shows the rear tyre of the Motorcycle at the time of our inspection. The rear tyre was observed to be in serviceable condition with remaining tread depth of approximately 3mm. The tyre was also observed to be sufficiently inflated for vehicular operation. There was no significant damage observed on the rear wheel rim & tyre.

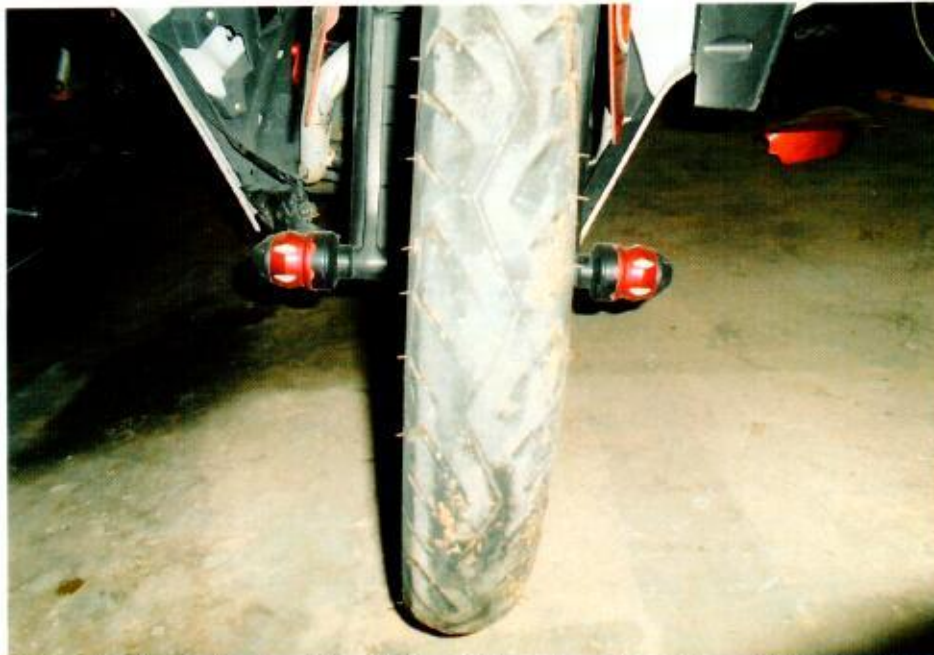
**Photo 10** shows the front tyre of the Motorcycle. The pattern of the tread was clearly visible. There was no tear, burst mark(s) and/or punctured hole(s) on the sidewalls as well as across the tread of the front tyre.

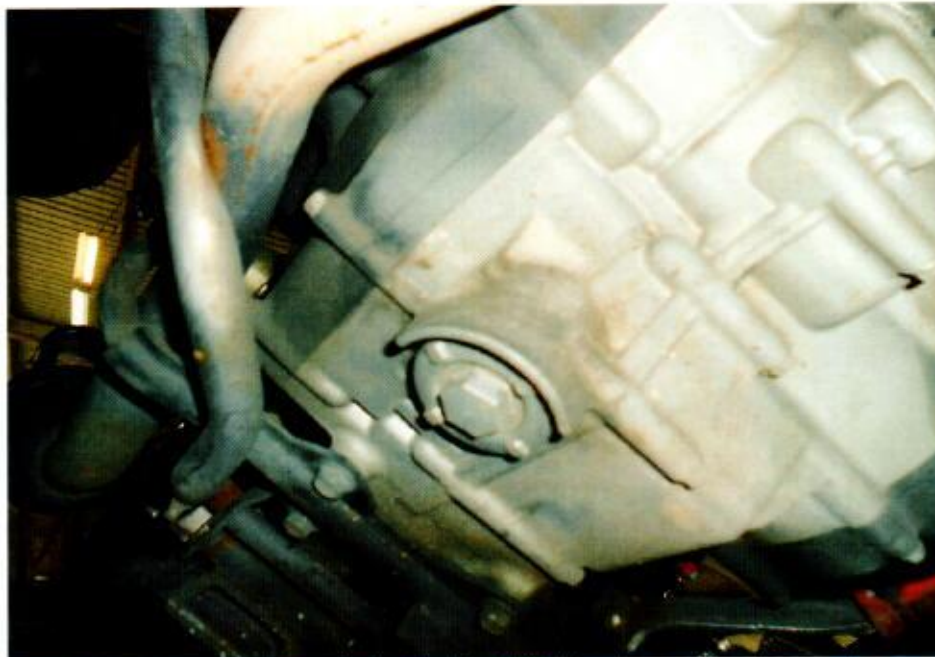
**Photo 11** shows sign(s) or indication(s) of fluid leakage stain observed around the engine undercarriage area of the Motorcycle.

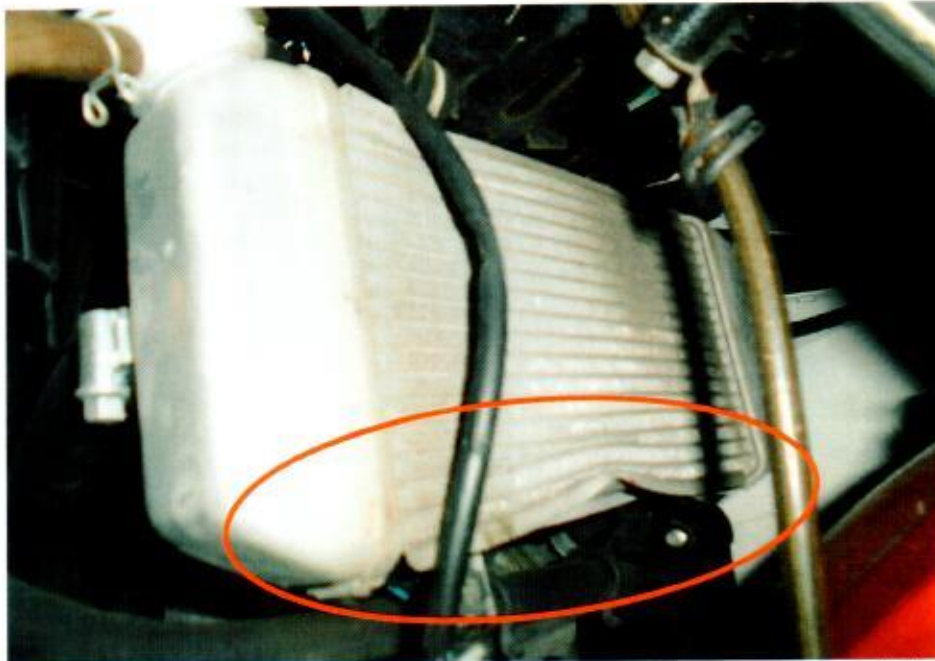
**Photo 12** shows the damaged radiator likely due to the accident's collision impact.

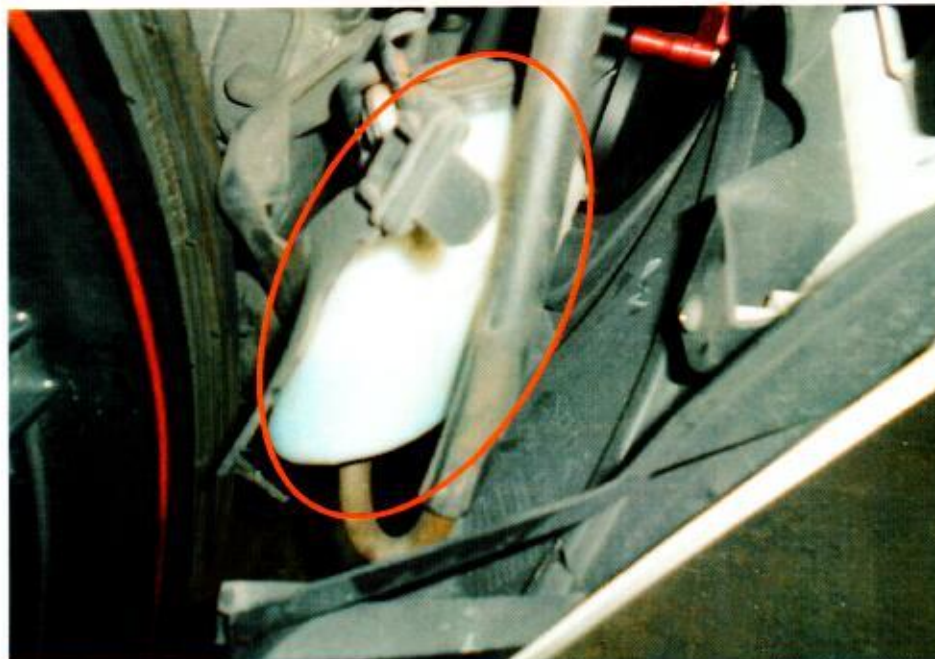
**Photo 13** shows the radiator reservoir was not affected by the accident's collision impact.

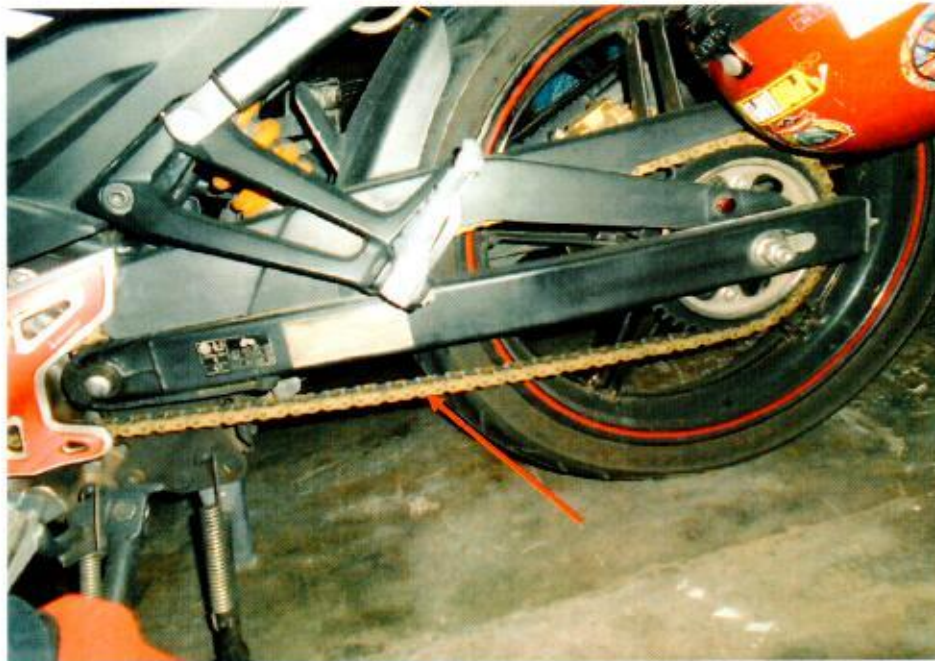
**Photo 14** shows the general view of the gear train (arrowed) of the Motorcycle, which was observed to be intact with no misalignment. It was also adequately lubricated for operating purposes.

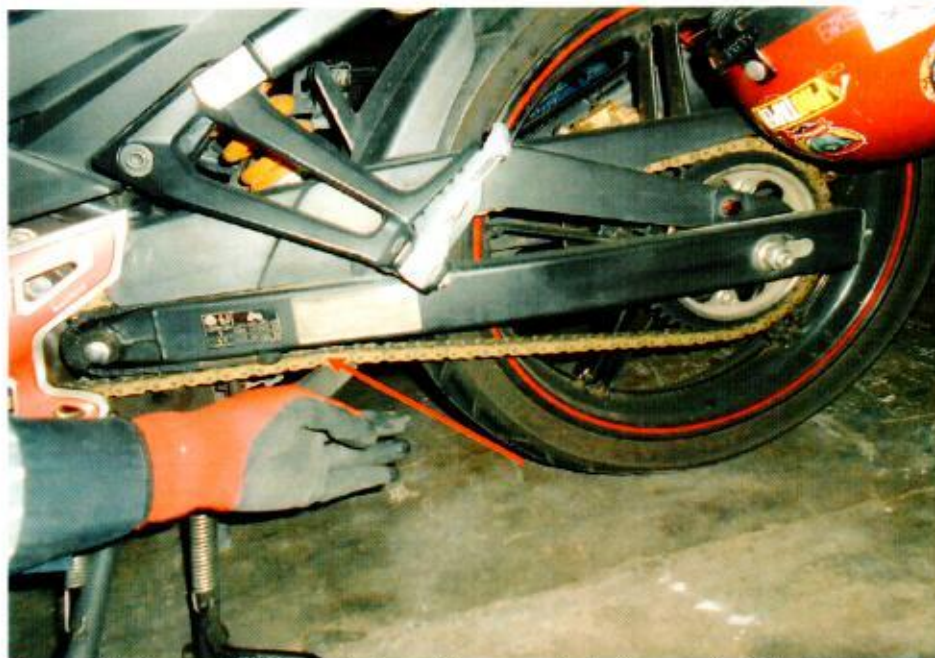
**Photo 15** shows the general view of the gear train (arrowed) of the Motorcycle, which was observed to be intact with no misalignment. It was also adequately lubricated for operating purposes. Free play tension was also observed & found adequately acceptable.

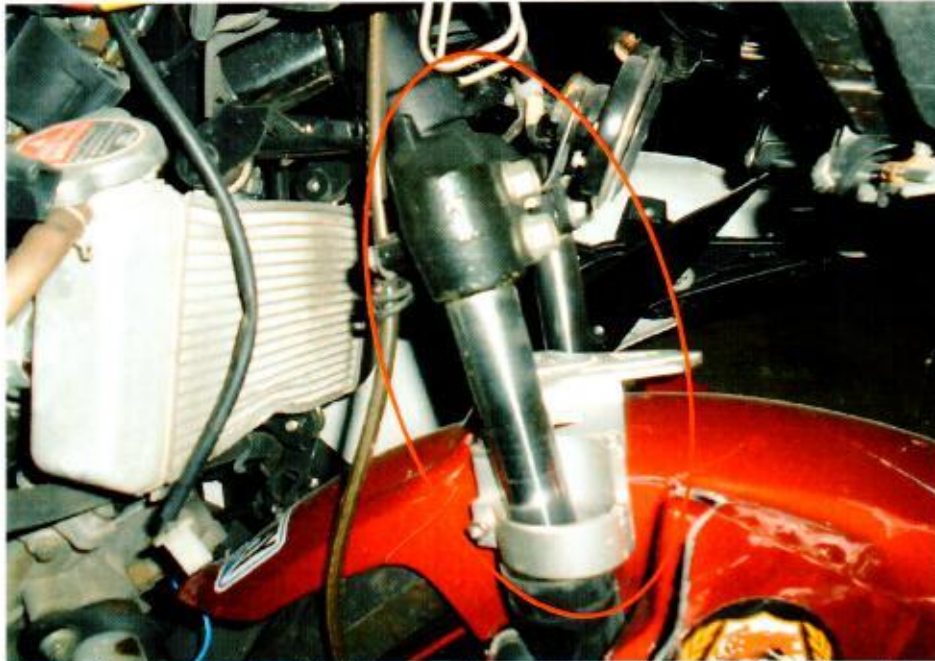
11. For this case, we were not able to conduct any test(s) on the steering system of the Motorcycle due to the damage on its front fork. The front fork was found to be buckled inwards as a result of the accident, hence causing the whole steering system to be in a state of immobility.

**Photo 16** shows the front fork (arrowed) was observed to be buckled inwards as a result of the accident. Hence, we are not able to conduct any tests on the steering system of the Motorcycle.

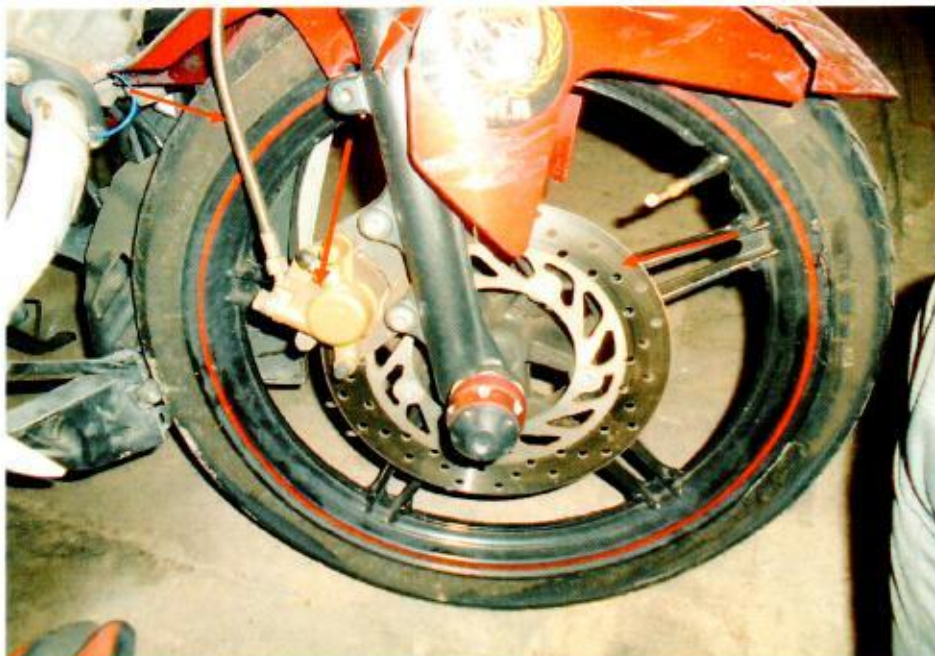
**Photo 17** shows the front brake calliper, front brake disc and front brake hose of the Motorcycle (arrowed), which are all part of the components in the front brake system of the Motorcycle. Our visual checks of these various components had revealed all to be intact with no visible damage. No leakage of brake fluid was also observed.

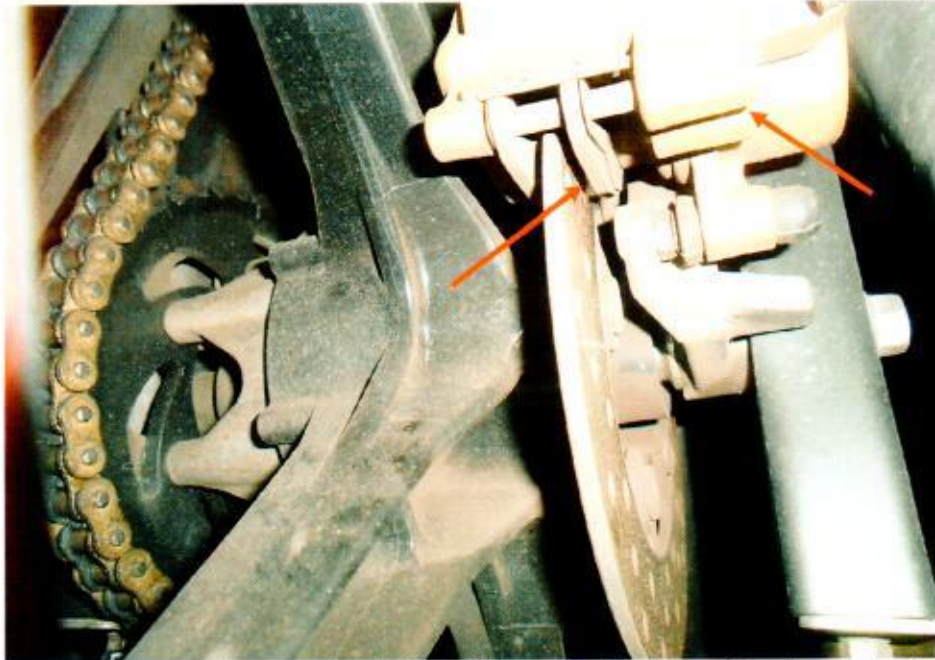
**Photo 18** shows the rear wheel of the Motorcycle. The type of brake system for the rear wheel was of hydraulic type, controlled by the brake foot pedal of the Motorcycle. Our checks of the calliper (arrowed) & brake pad which are all part of the components in the rear brake system of the Motorcycle reveal all to be intact and without damage.
