Report no: 422M0916.TB

Vehicle no: SJT330Z

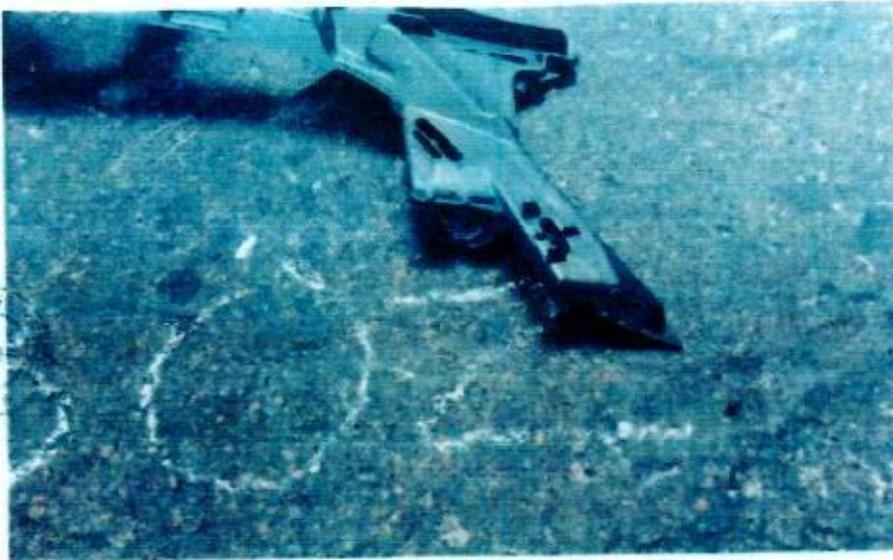
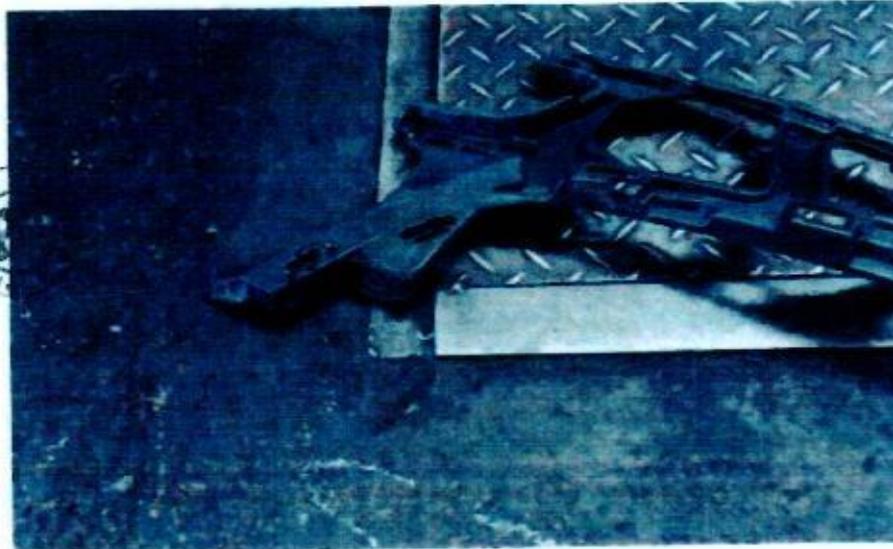
Before paint
