Your Ref: TP/IP/11235/2018  
Our Ref : CI/TPD18010464/Z

**Fatal Accident Investigation Team**

**MECHANICAL INSPECTION REPORT OF MOTOR CAR WYT 6311**

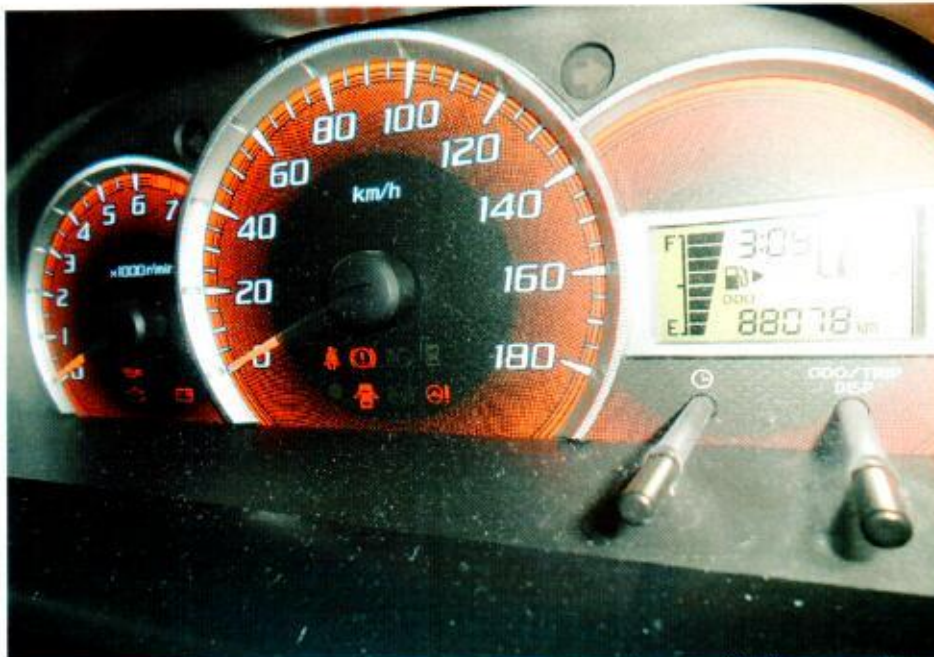
**Photo 1** shows a close-up view of the Motor Car's mileage digital meter at time of our inspection. It was recorded as 88078km.

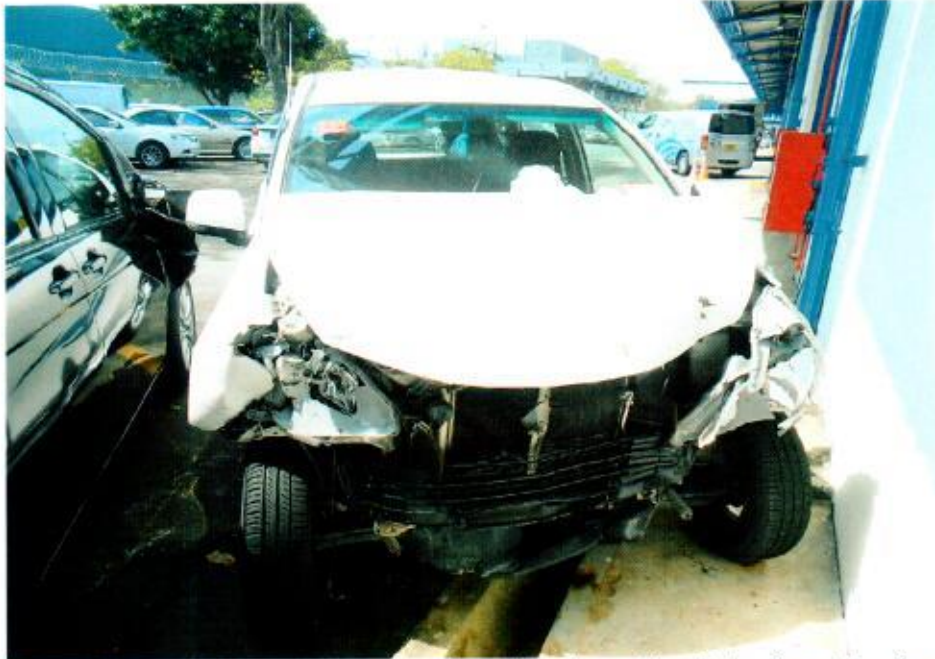
4. The mileage of the Motor Car at the time of our inspection was recorded as 88078km.
5. The Motor Car had sustained extensive impact damage at its frontal portion. The impact force was significant, causing the various parts and components inside the engine compartment to be damaged. This had included its engine assembly and transmission assembly, which were both amongst the multiple parts and components inside the engine compartment that were pushed inwards, towards the rear of the Motor Car.

**Photo 2** shows a general view of the frontal portion of the Motor Car at the time of our inspection. The Motor Car was observed to have sustained extensive impact damage at its frontal portion. The impact force was significant, causing the various parts and components inside the engine compartment to be damaged.

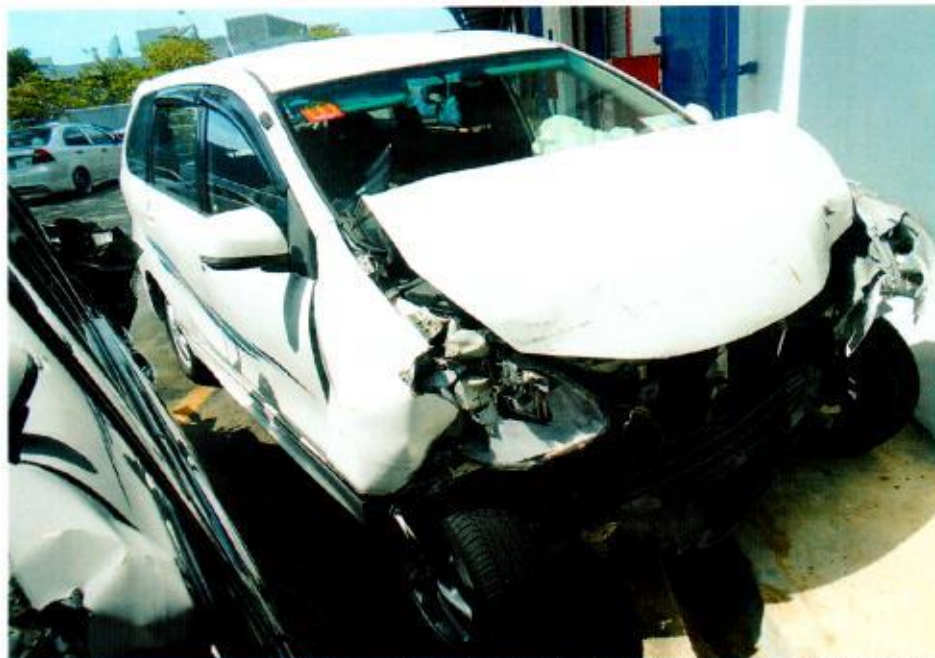
**Photo 3** shows a general view of the front right portion of the Motor Car at the time of our inspection. The Motor Car was observed to have sustained extensive impact damage at its frontal portion.

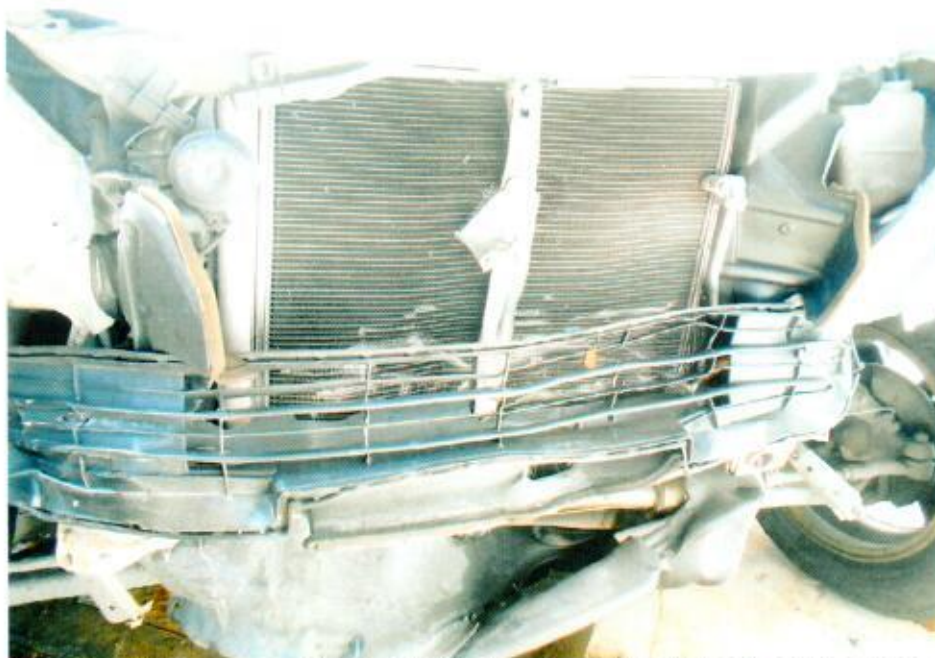
**Photo 4** shows a general view of the front portion of the Motor Car at the time of our inspection. Its radiator was observed to have sustained extensive impact damage due to the accident's impact.

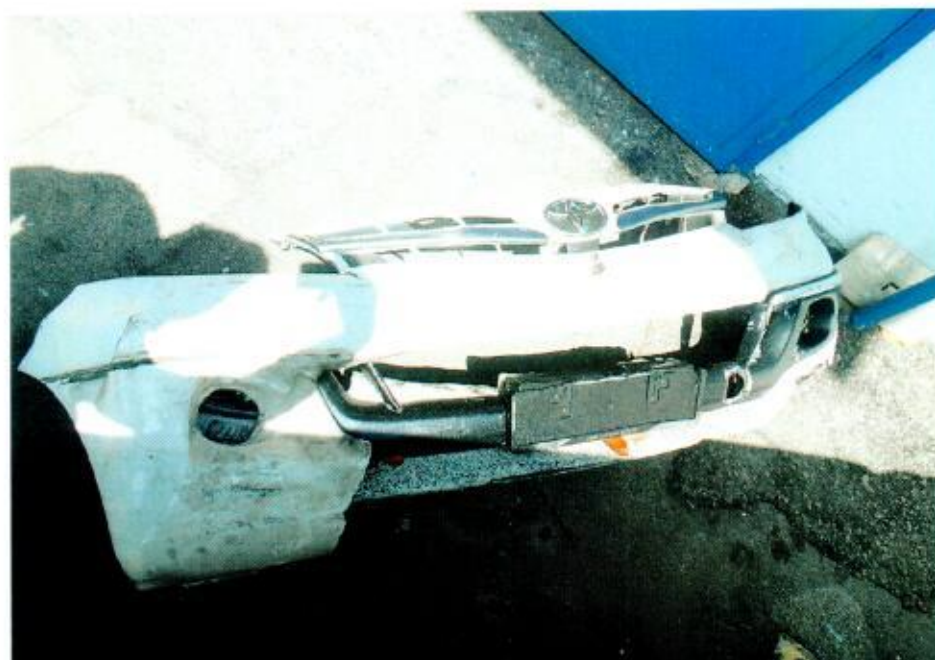
6. Other body parts that were damaged had included a dislodged front lower bumper, buckled front left & right side fenders amongst others. The interior compartment was not affected badly. The driver's airbag and front left passenger airbag however were observed to be activated.
7. This was likely due to the consistency of the accident's case facts that the Motor Car driver was travelling along AYE (MCE) on lane 1 of a 4 lane road near to 10.5km. He was seen veered to his left into lane 4 and collided onto the rear of Motor Bus who was traveling on the lane. See photo 1 to 10 below.

**Photo 5** shows a closer view of the dislodged lower bumper of the Motor Car. The impact force was significant, causing the various parts and components inside the engine compartment to be pushed inwards, towards the rear of the Motor Car.

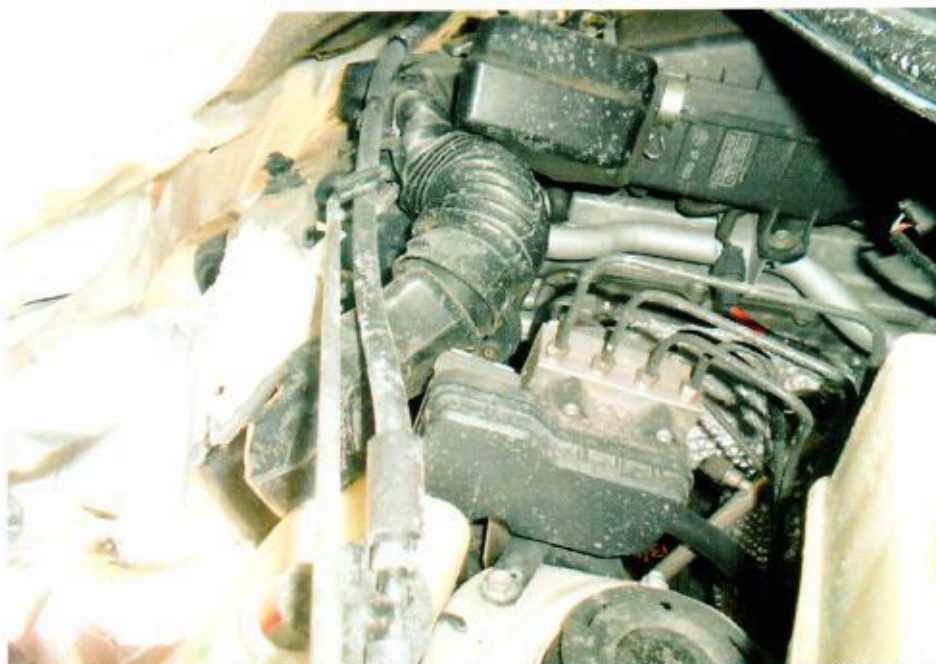
**Photo 6** shows a closer view of the engine compartment of the Motor Car from the left hand side of the bonnet opening. The impact force was significant, causing the various parts and components inside the engine compartment to be pushed inwards, towards the rear of the Motor Car.

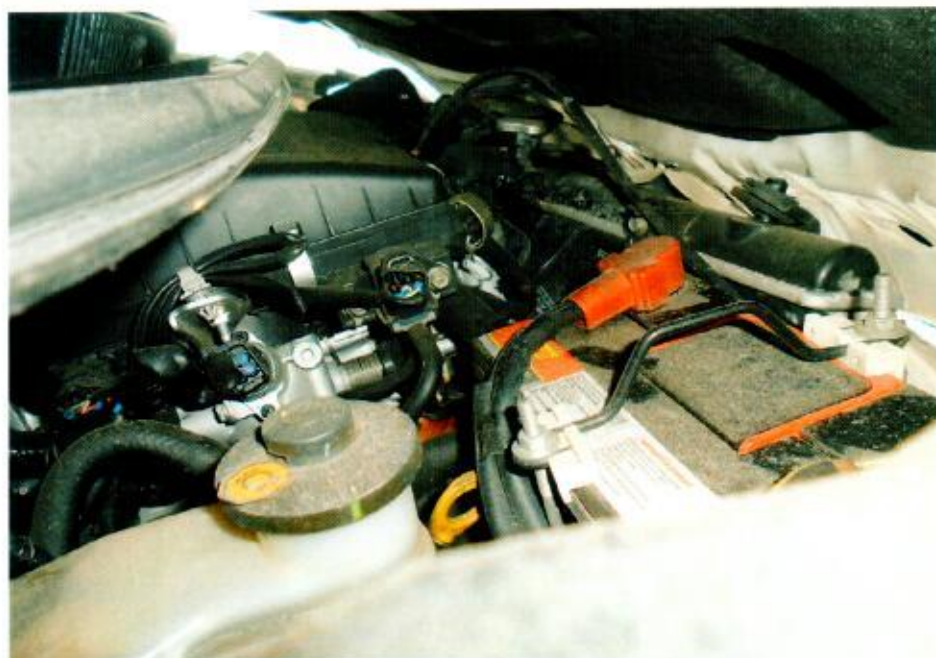
**Photo 7** shows a closer view of the engine compartment of the Motor Car from the right hand side of the bonnet opening. The impact force was significant, causing the various parts and components inside the engine compartment to be pushed inwards, towards the rear of the Motor Car.

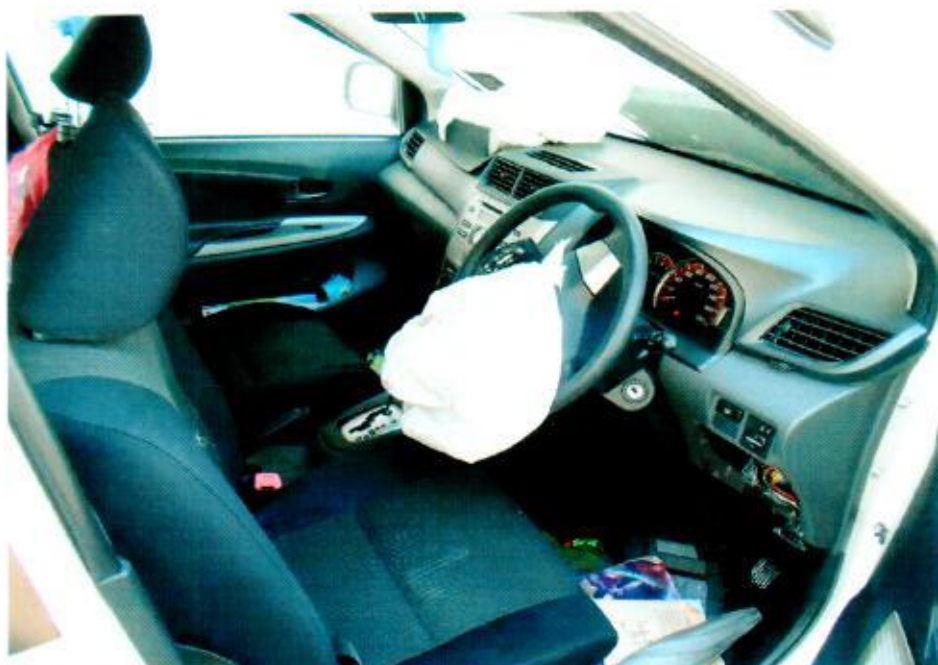
**Photo 8** shows the interior portion of the Motor Car. The impact force was significant causing the driver's airbag & front passenger's airbag to be dislodged.

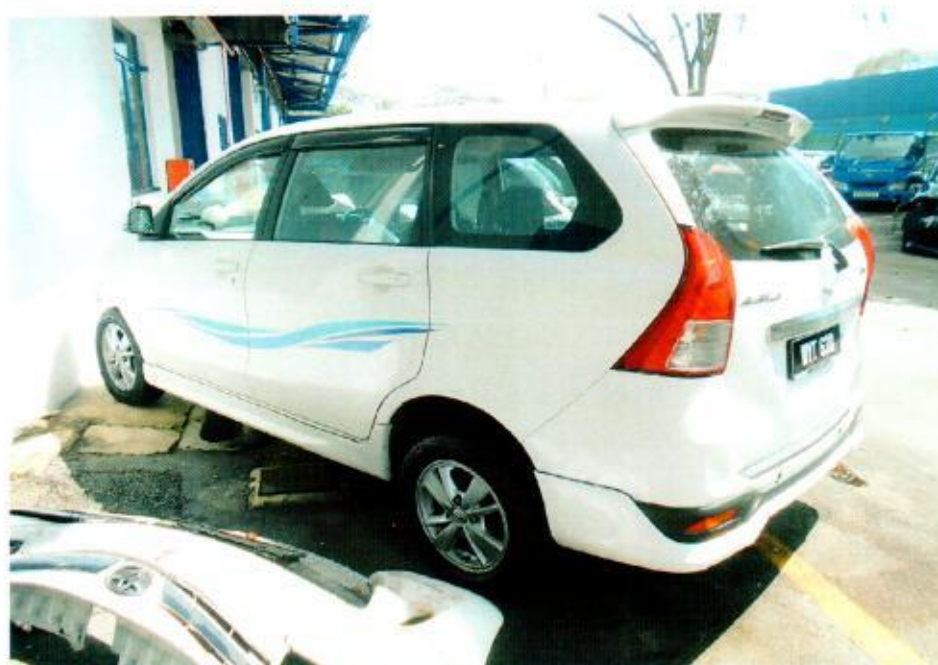
**Photo 9** shows a general view of the rear left portion of the Motor Car at the time of our inspection. The rear portion was observed to be relatively unaffected by the accident.

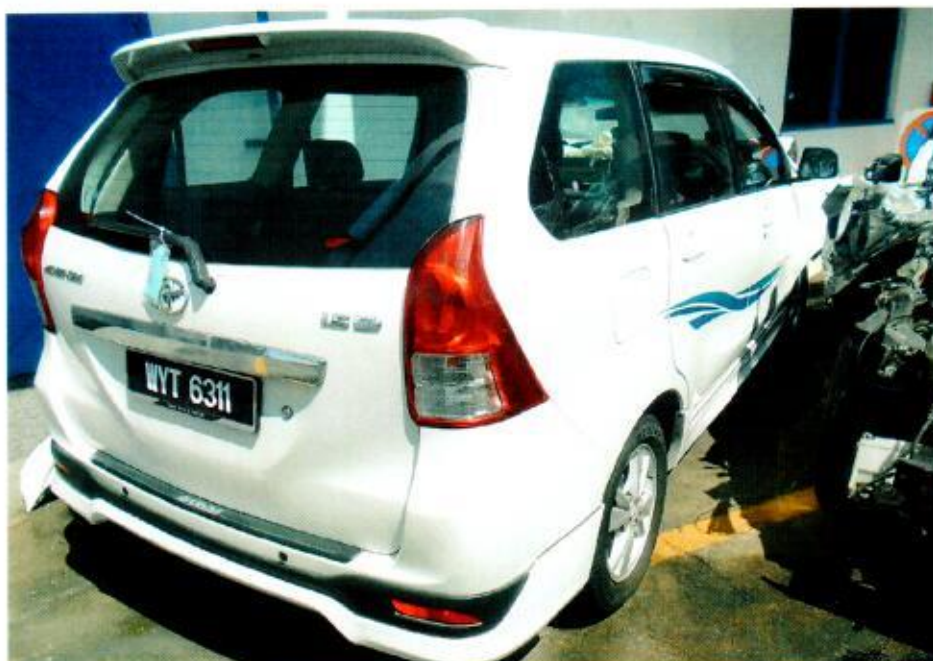
Photo 10 shows a general view of the rear right portion of the Motor Car at the time of our inspection. The rear portion was observed to be relatively unaffected by the accident.

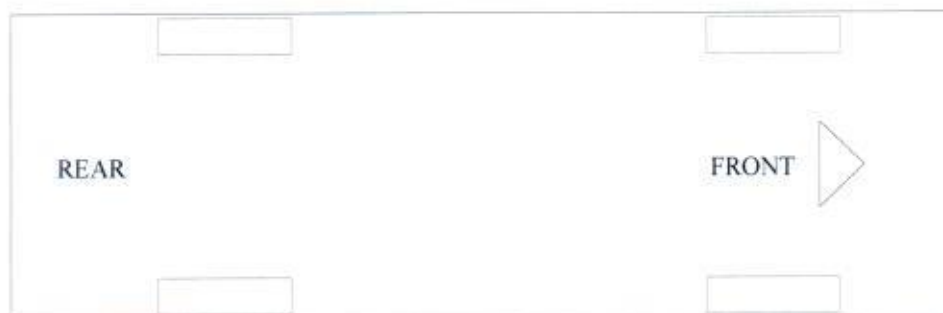
8. The condition of the Motor Car's 4 tyres was observed to be in serviceable condition. We did not find any tear, cut or burst mark(s) on the outer and the inner sidewalls as well as across the tread of the 4 tyres. The 4 tyres were also observed to be sufficiently inflated for vehicular operation. The tyre brand, tyre size and remaining tread depth of the 4 tyres were recorded as follows:-

Dunlop SP Sport J5  
185/65R15 (6mm)

Dunlop SP Sport J5  
185/65R15 (7mm)

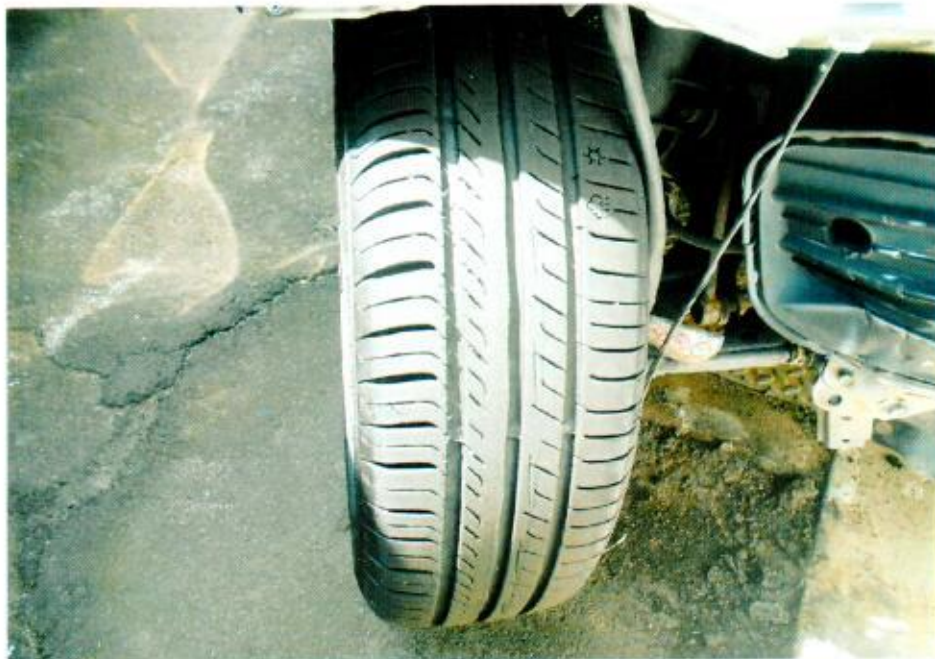
**Photo 11** shows the condition of the front right tyre of the Motor Car, which was observed to be in serviceable condition with remaining tread depth of approximately 7mm. There was no tear, cut or burst mark(s) on the outer and the inner sidewalls as well as across the tread of this tyre.

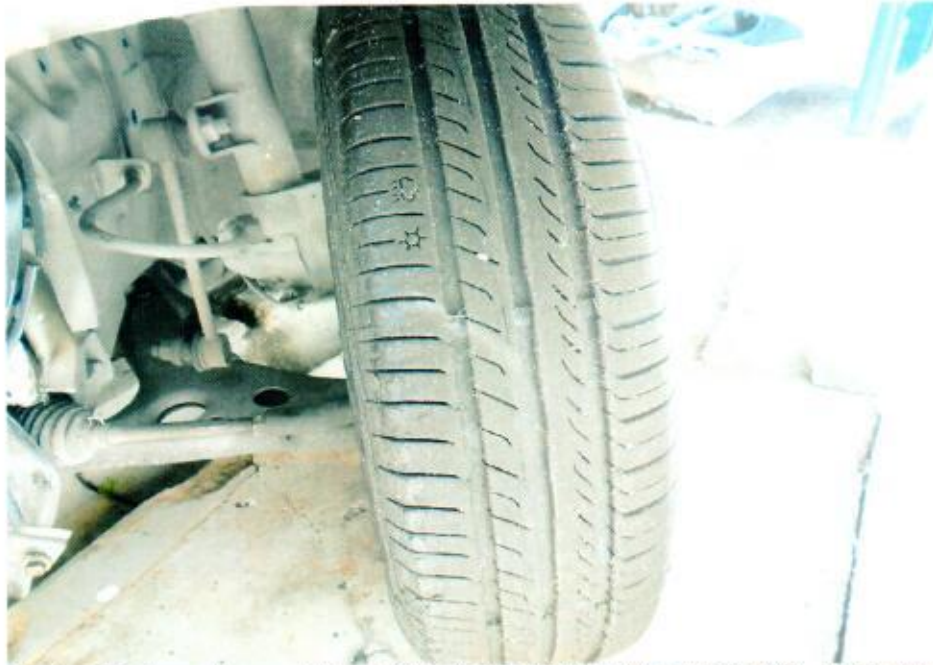
**Photo 12** shows the condition of the front left tyre of the Motor Car, which was observed to be in serviceable condition with remaining tread depth of approximately 7mm. There was no tear, cut or burst mark(s) on the outer and the inner sidewalls as well as across the tread of this tyre, which was also sufficiently inflated for vehicular operation.

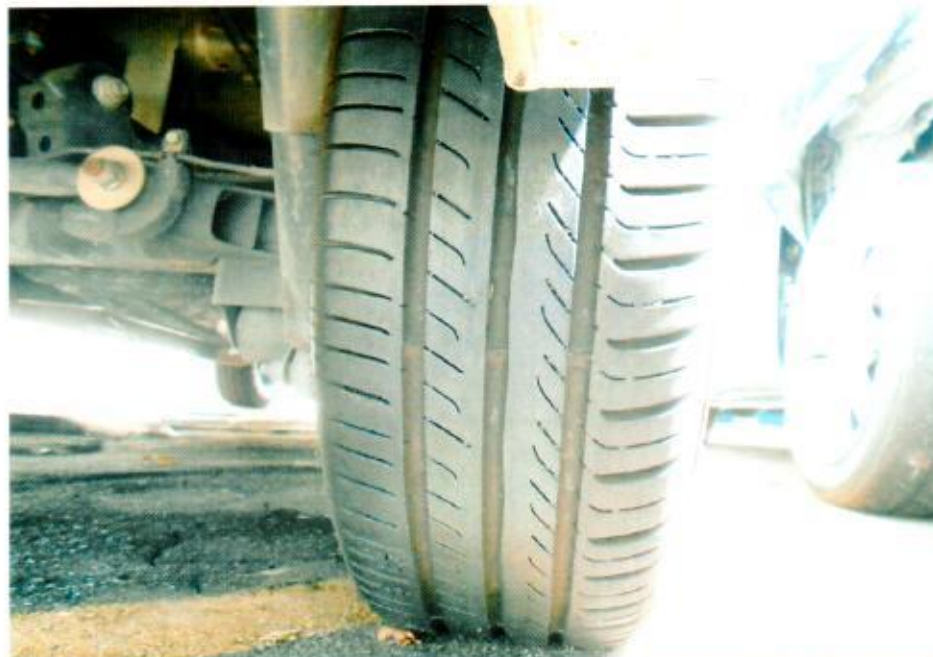
**Photo 13** shows the condition of the rear right tyre of the Motor Car, which was observed to be in serviceable condition with remaining tread depth of approximately 6mm. There was also no tear, cut or burst mark(s) on the outer and the inner sidewalls as well as across the tread of this tyre.

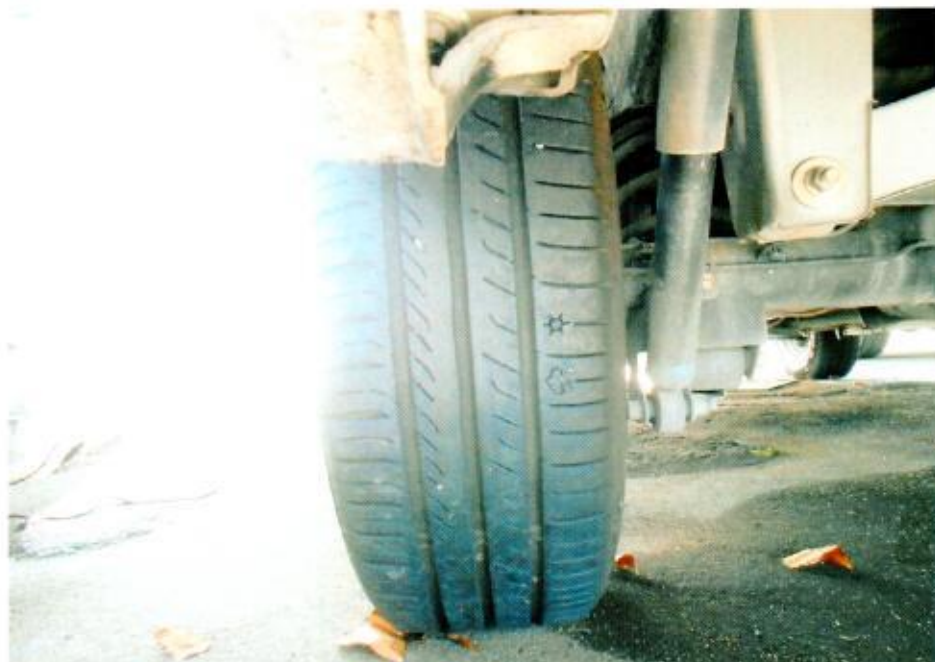
**Photo 14** shows the condition of the rear left tyre of the Motor Car, which was observed to be in serviceable condition with remaining tread depth of approximately 6mm. There was also no tear, cut or burst mark(s) on the outer and the inner sidewalls as well as across the tread of this tyre.

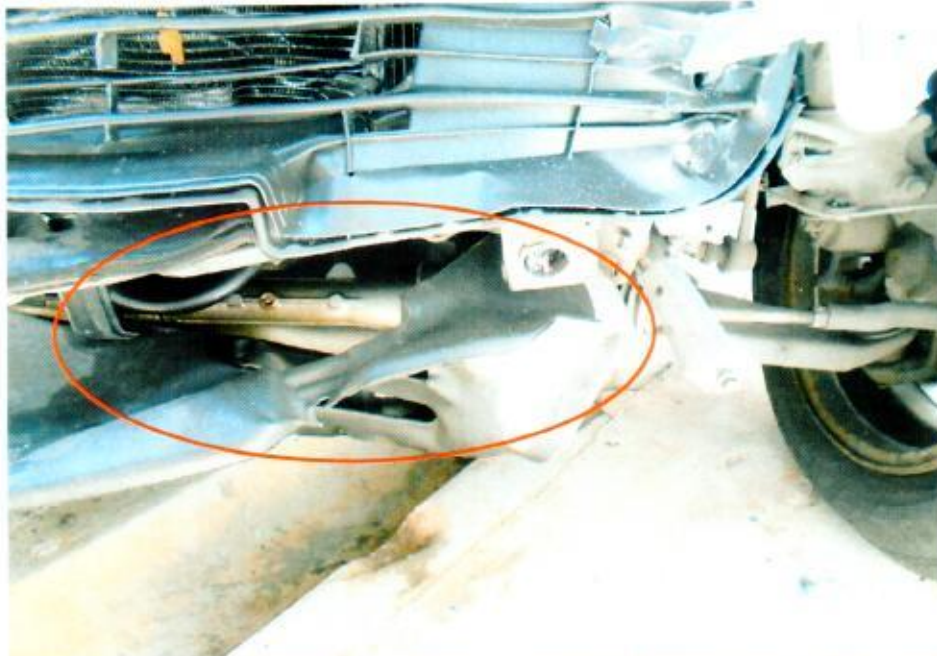
11. Leakage of the various operating fluids such as power steering fluid was noted. Given the extent of damages to the engine compartment, the leakages were likely due to the accident. The engine undercarriage was however observed to be covered with reddish fluid, suggesting leakage of fluid. There was no accumulation of dust and/or dirt particles on the engine housing where the fluid stains had formed. This would indicate that the fluid leakage was a fresh leak and likely to be a result of the accident. We were therefore unable to comment whether these operating fluids were of sufficient level and without contamination for vehicular operation prior to the accident.

**Photo 15** shows the close up view of the steering rack of the Motor Car. Leakage of the various operating fluids like the power steering fluid was seen.

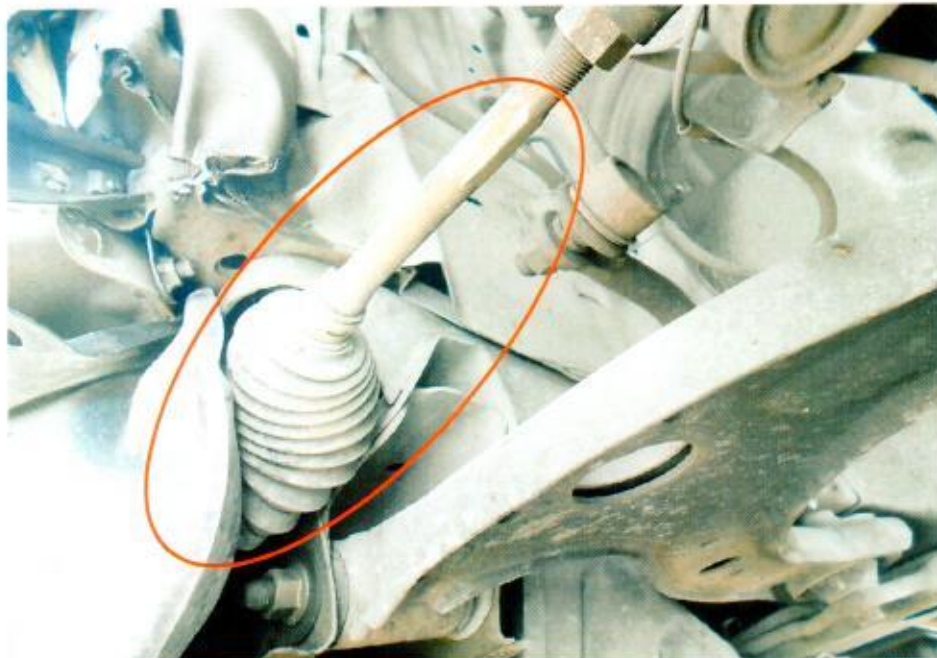
**Photo 16** shows the close up view of the damage drive shaft due to the accident impact.

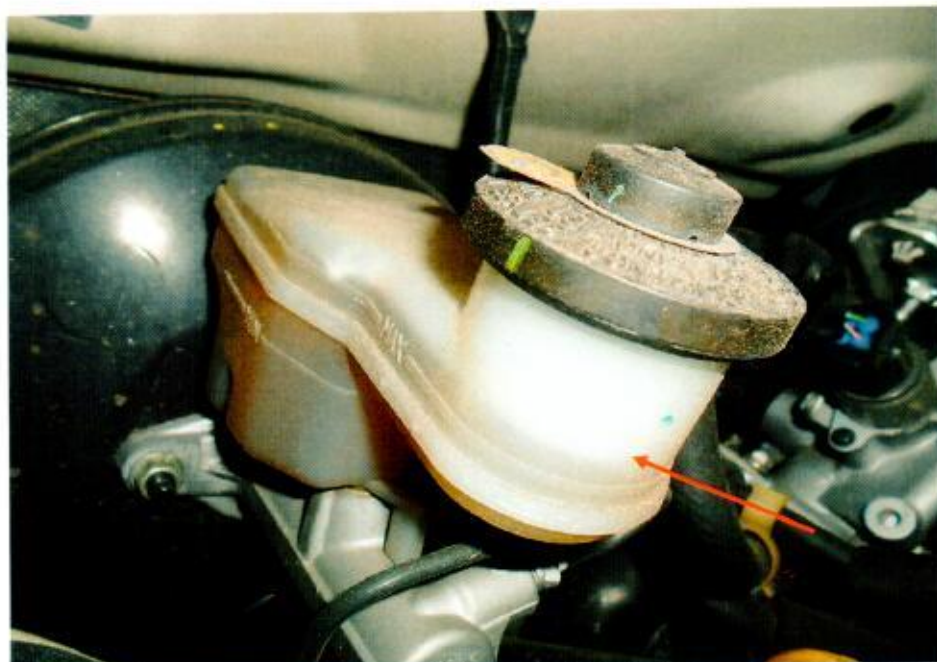
**Photo 17** shows the close up view of the brake fluid that was seen with sufficient level not affected by the accident's impact.

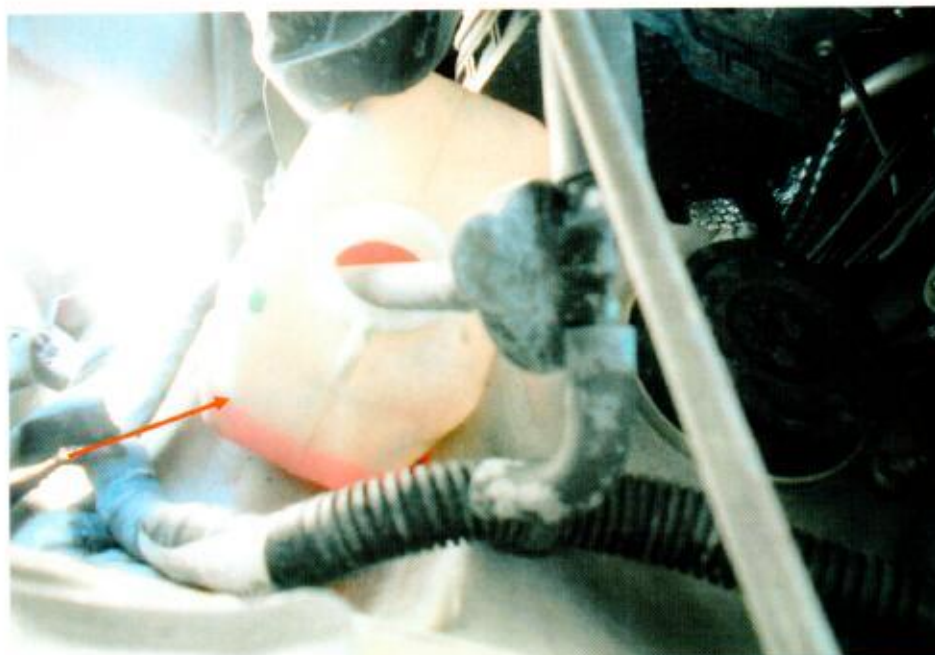
**Photo 18** shows the close up view (top elevation) of the engine coolant fluid which was with sufficient level un affected by the accident's impact.

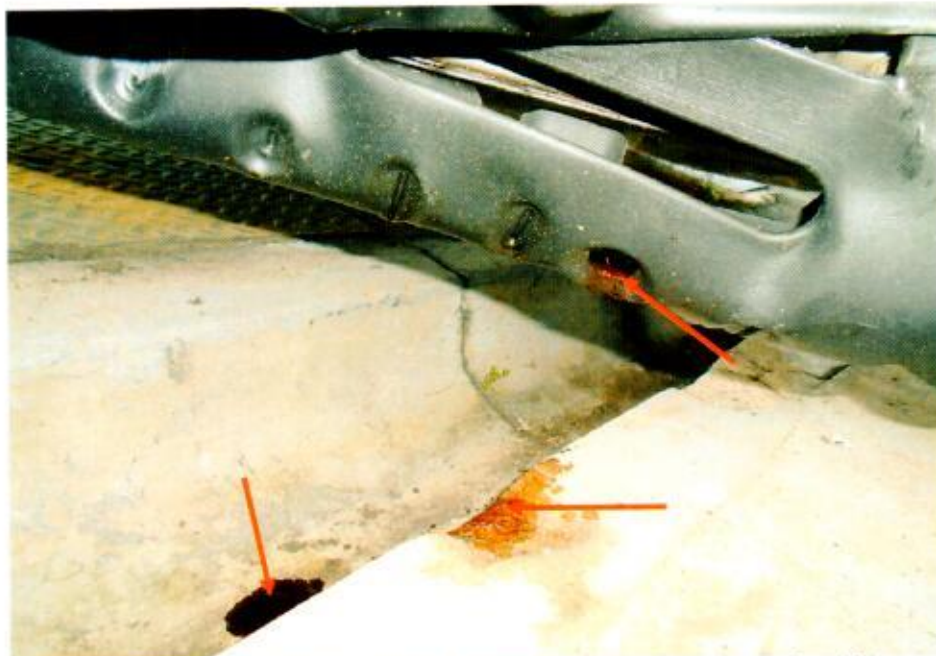
13. We were not able to conduct any tests on the steering system of the Motor Car. This was due to leakage of power steering fluid, as a result of the accident, as well as damage to several mechanical components of the steering system & engine system.

**Photo 19** shows the damaged on the steering rack of the Motor Car. We were not able to conduct any tests on the steering system of the Motor Car due to the damage to this components, as well as leakage of power steering fluid.

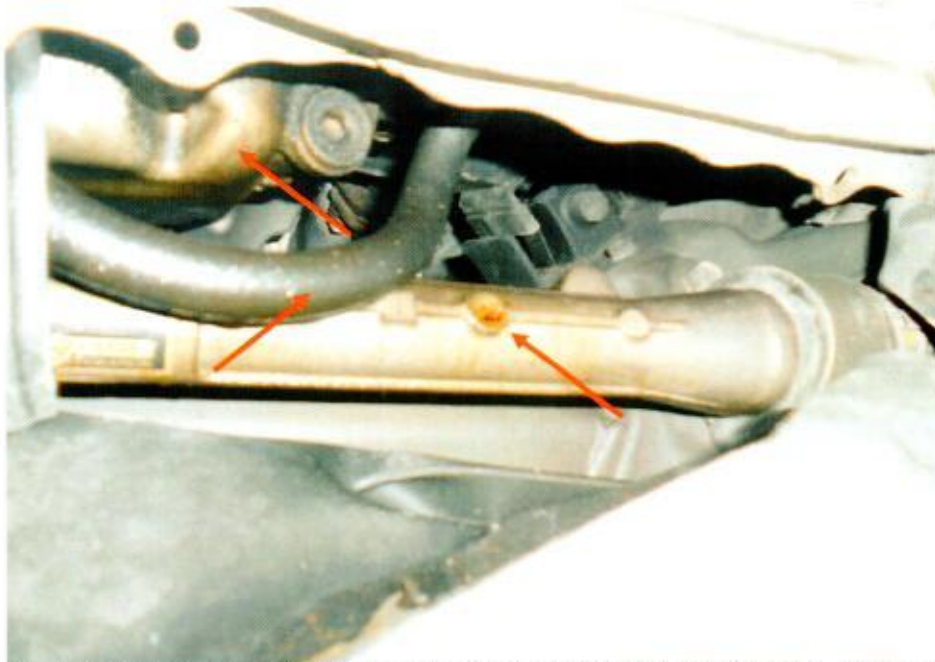
**Photo 20** shows the damaged on the steering rack of the Motor Car. We were not able to conduct any tests on the steering system of the Motor Car due to the damage to this components, as well as leakage of power steering fluid.

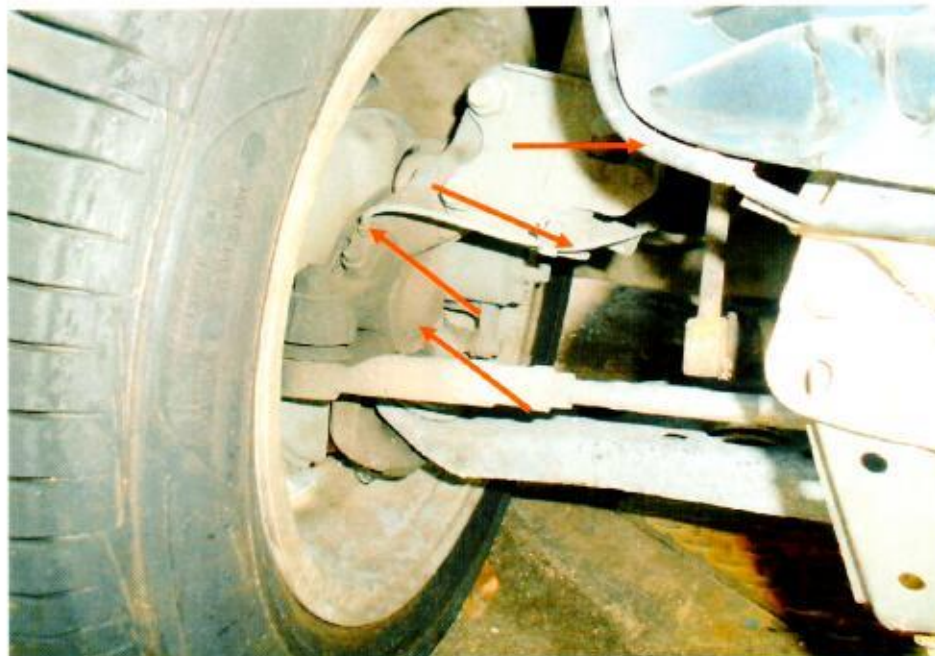
**Photo 21** shows the braking components at the front left wheel of the Motor Car. We did not observe any leakage of brake fluid at the time of our inspection of the Motor Car.

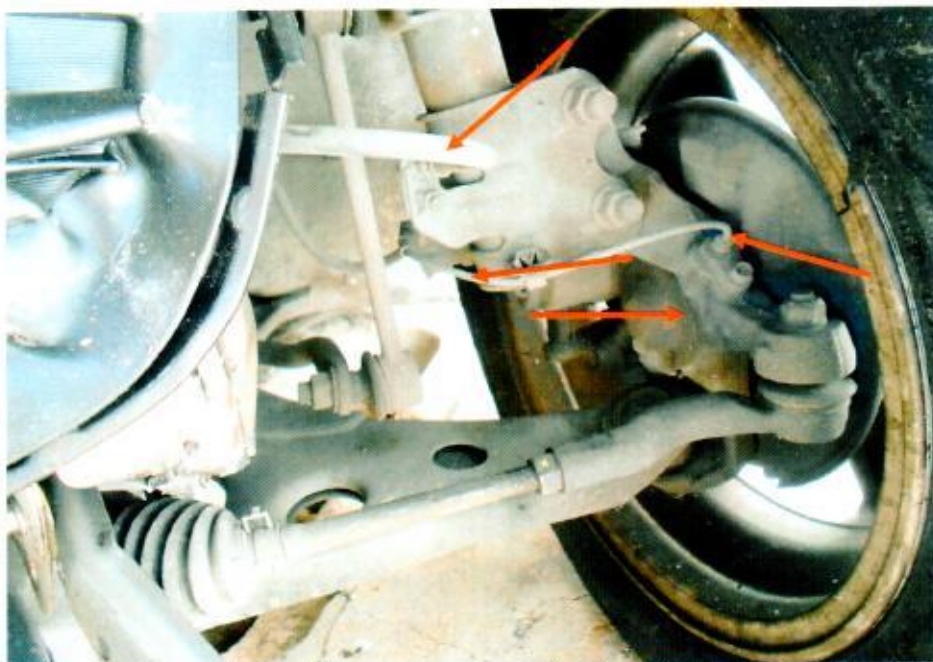
**Photo 22** shows the braking components at the front right wheel of the Motor Car. We did not observe any leakage of brake fluid at the time of our inspection of the Motor Car.

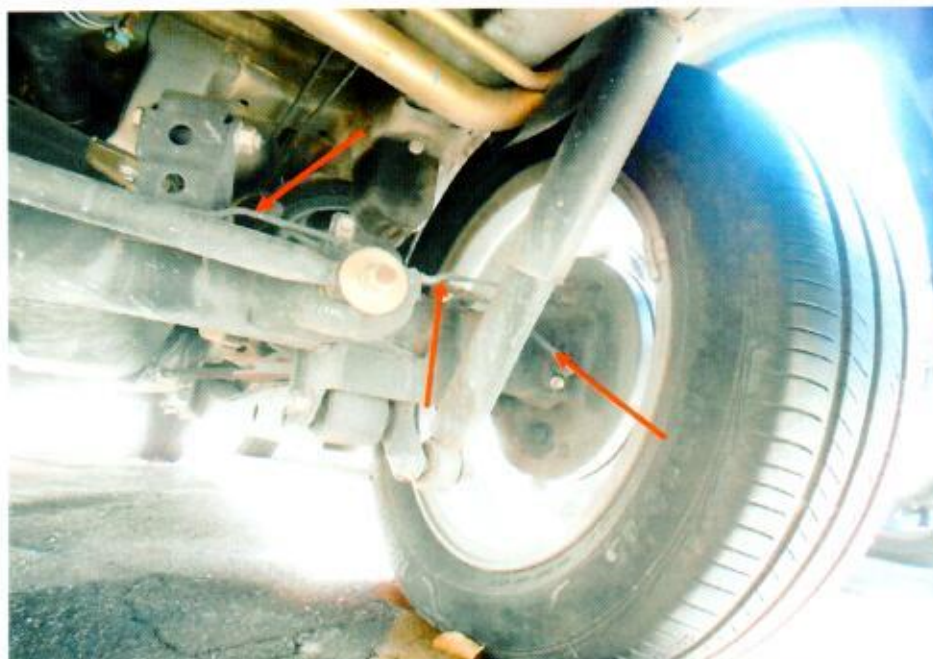
**Photo 23** shows the braking components at the rear right wheel of the Motor Car. We did not observe any leakage of brake fluid at the time of our inspection of the Motor Car.

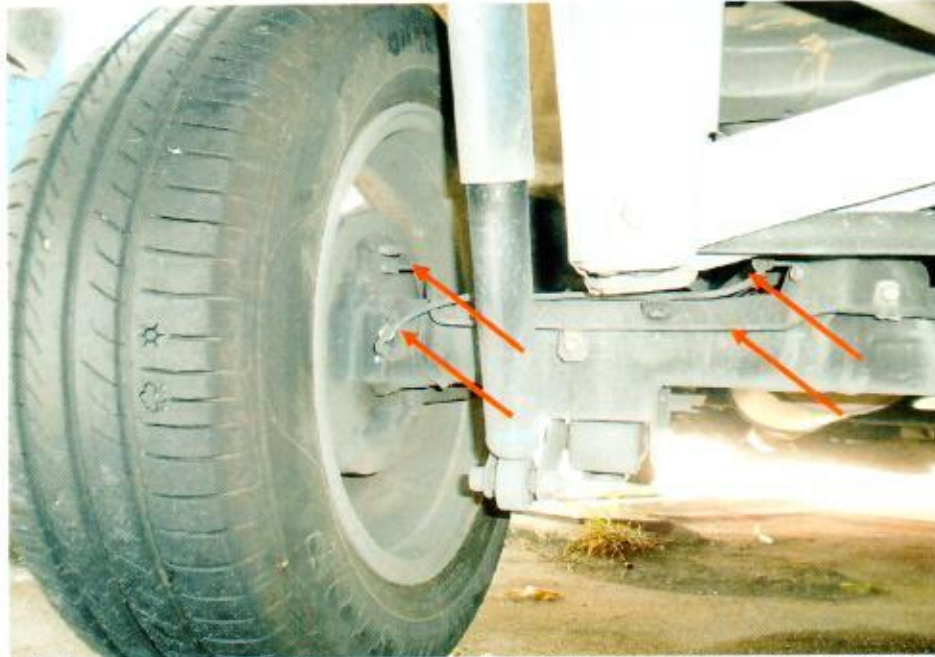
**Photo 24** shows the braking components at the rear left wheel of the Motor Car. We did not observe any leakage of brake fluid at the time of our inspection of the Motor Car.

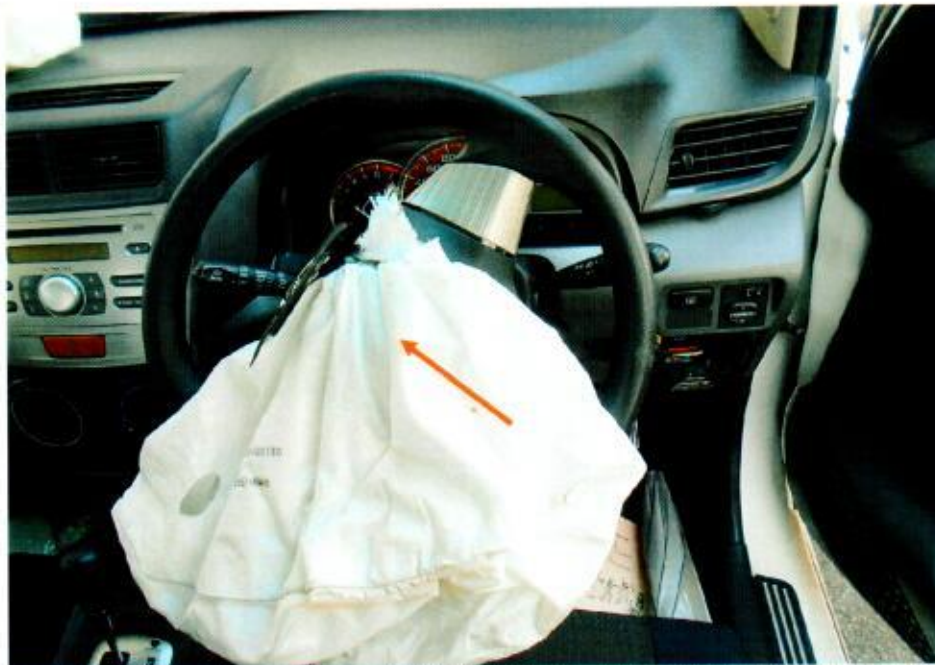
**Photo 25** shows the evidence of the deployed driver's airbag indicates that the impact sensors and control module of the Motor Car's SRS were all in serviceable condition at the material time of accident.

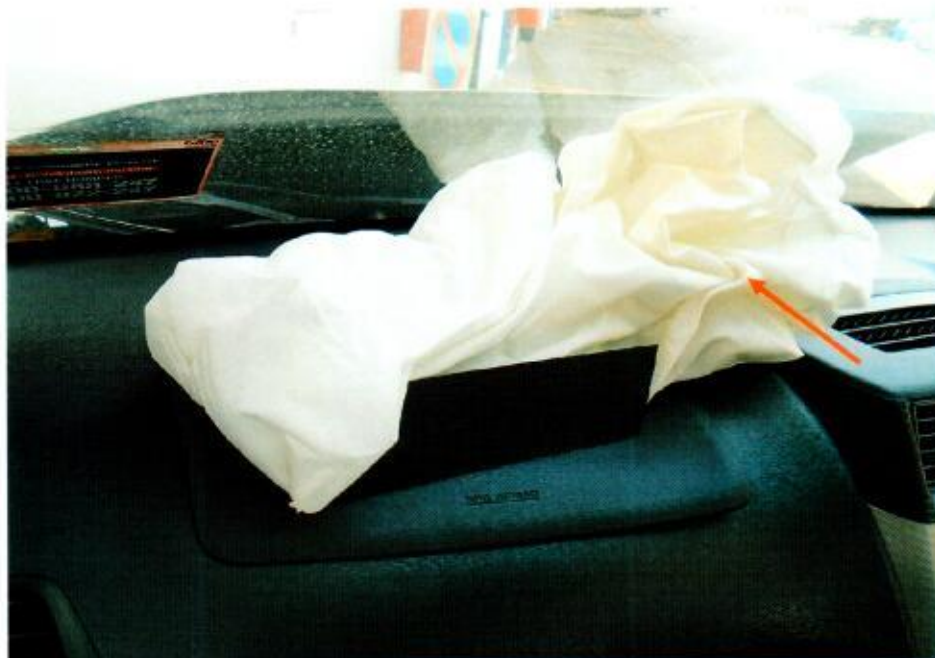
**Photo 26** shows the evidence of the deployed front passenger's airbag indicates that the impact sensors and control module of the Motor Car's SRS were all in serviceable condition at the material time of accident.
