Your Ref: TP/IP/09695/2018
Our Ref :CI/TPD18010470/Z

Fatal Accident Investigation Team

MECHANICAL INSPECTION REPORT OF MOTORCYCLE MCU 4806

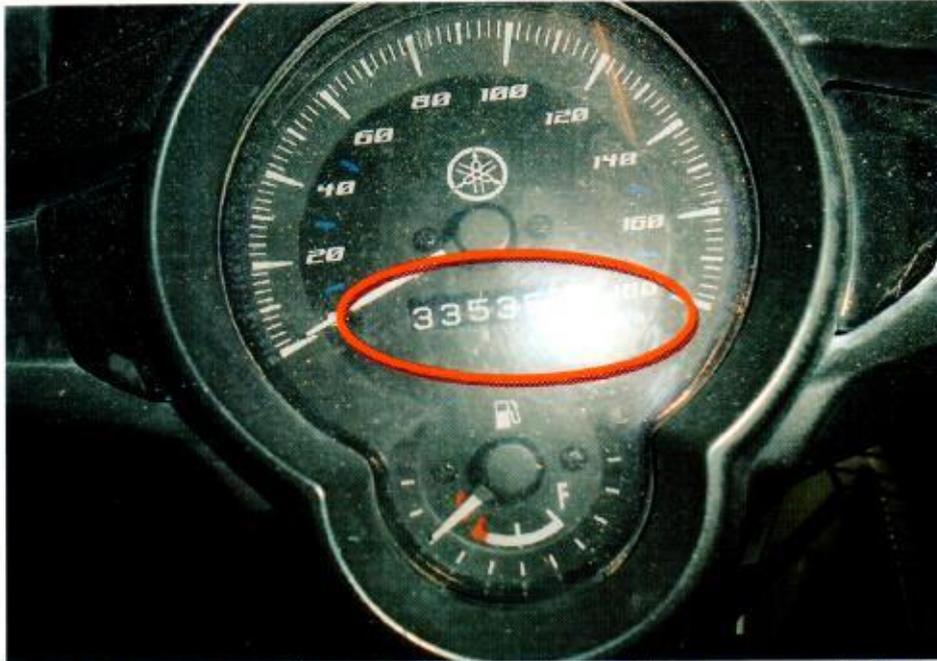
Photo 1 shows the mileage at the time of inspection was recorded to be 33532km.

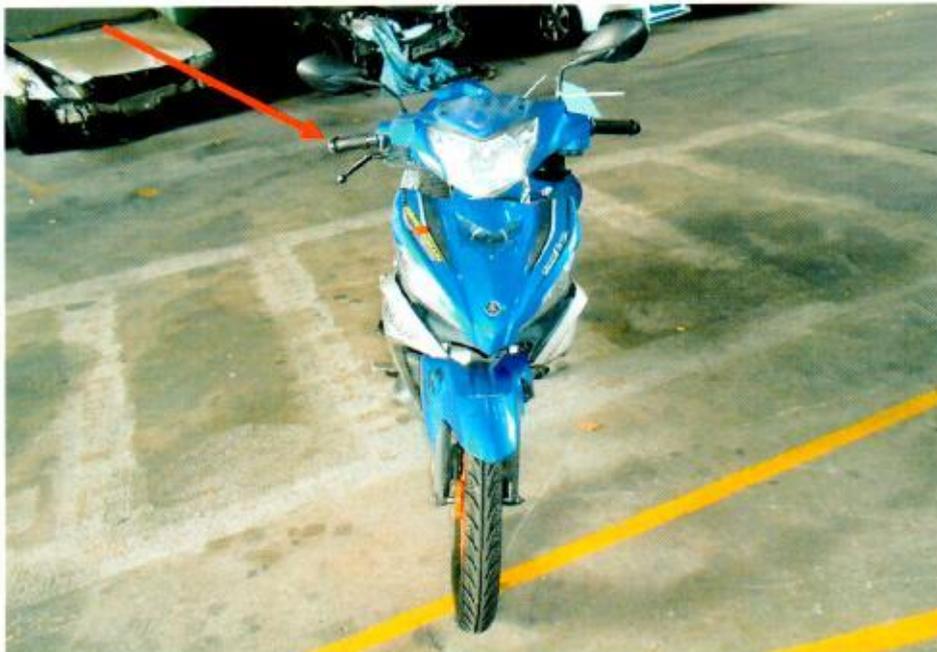
Photo 2 shows a general view of the front body of the Motorcycle at the time of our inspection. The Motorcycle was observed to be sustained with relatively minor impact due to the accident collision. Amongst the body parts damaged was its steering system (arrowed), which was observed to be misaligned.

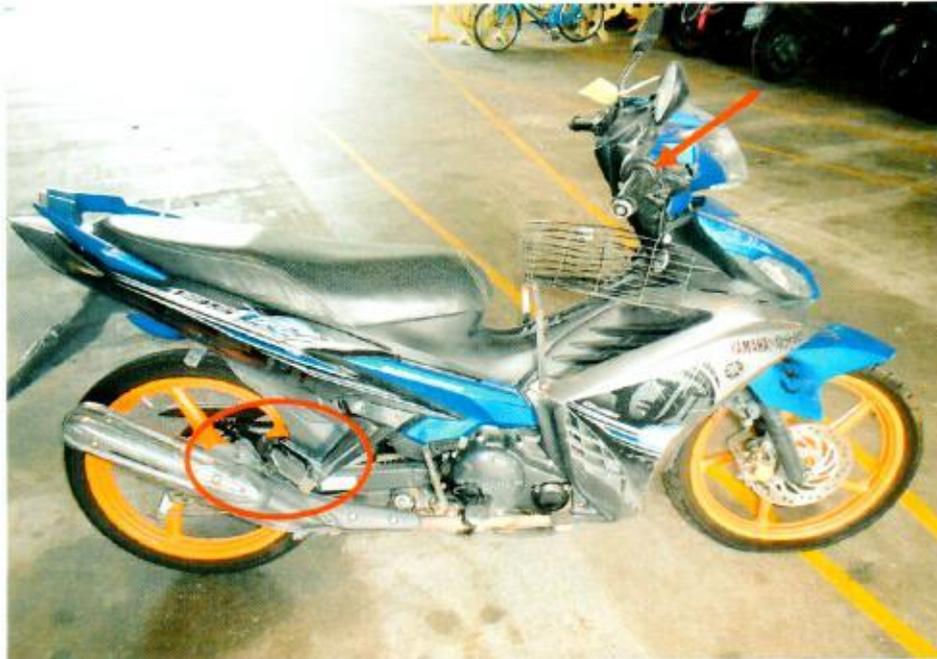
Photo 3 shows a general view of the front right body of the Motorcycle at the time of our inspection. The Motorcycle was observed to be sustained with relatively minor impact due to the accident collision. Amongst the body parts damaged was its steering system (arrowed), which was observed to be misaligned.

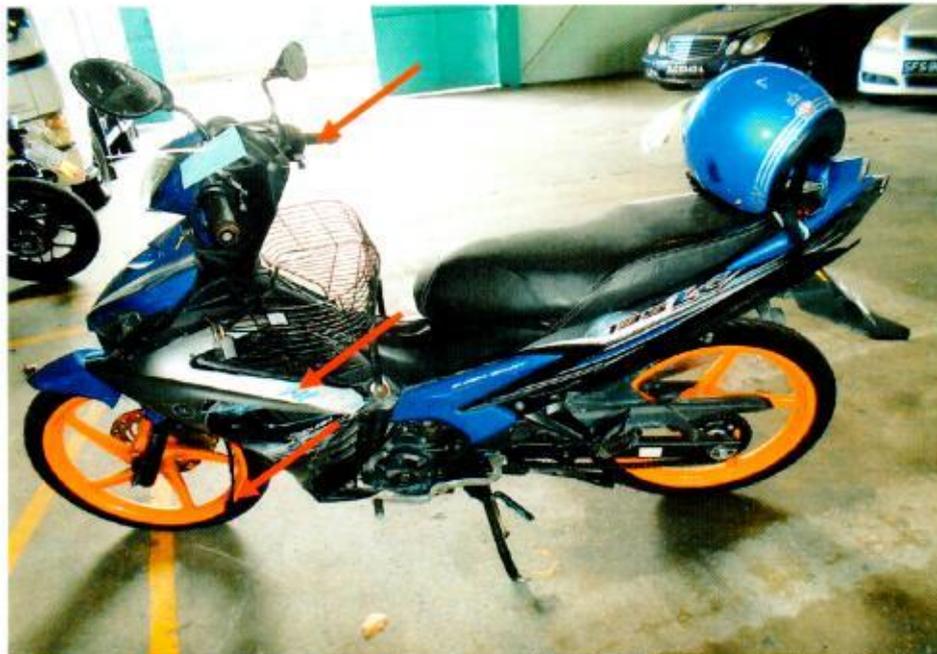
Photo 4 shows a general view of the front left body of the Motorcycle at the time of our inspection. The Motorcycle was observed to be sustained with relatively minor impact due to the accident collision. Amongst the body parts damaged was its steering system, which was observed to be misaligned.

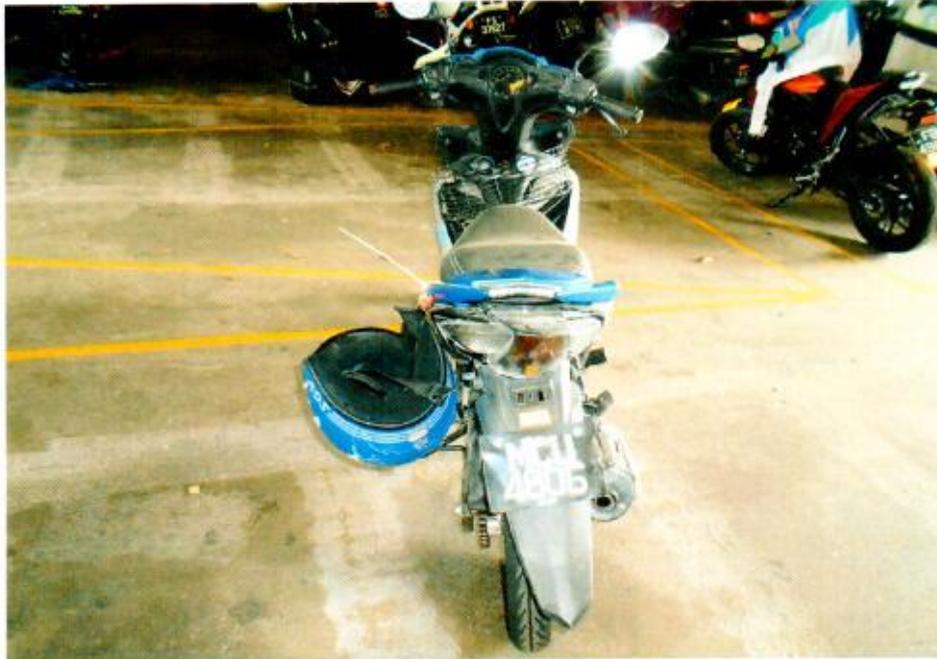
Photo 5 shows a general view of the rear body of the Motorcycle at the time of our inspection. The Motorcycle was observed to have sustained minor damages likely due to the accident.

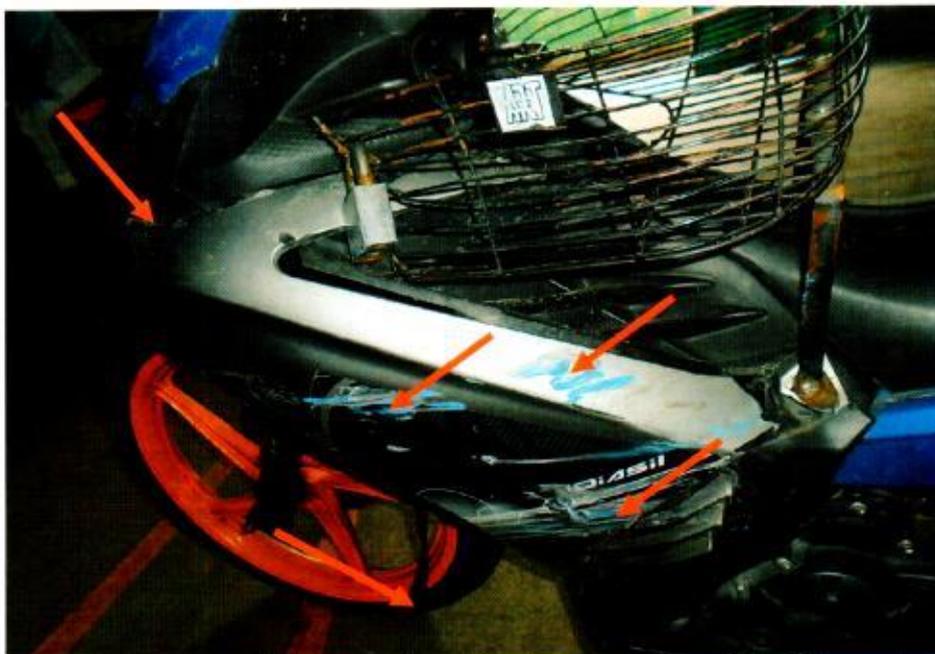
Photo 6 shows a semi close-up view of the damage portion of the Motorcycle at the time of our inspection. The Motorcycle was observed to be sustained with relatively minor damages due to the accident collision.

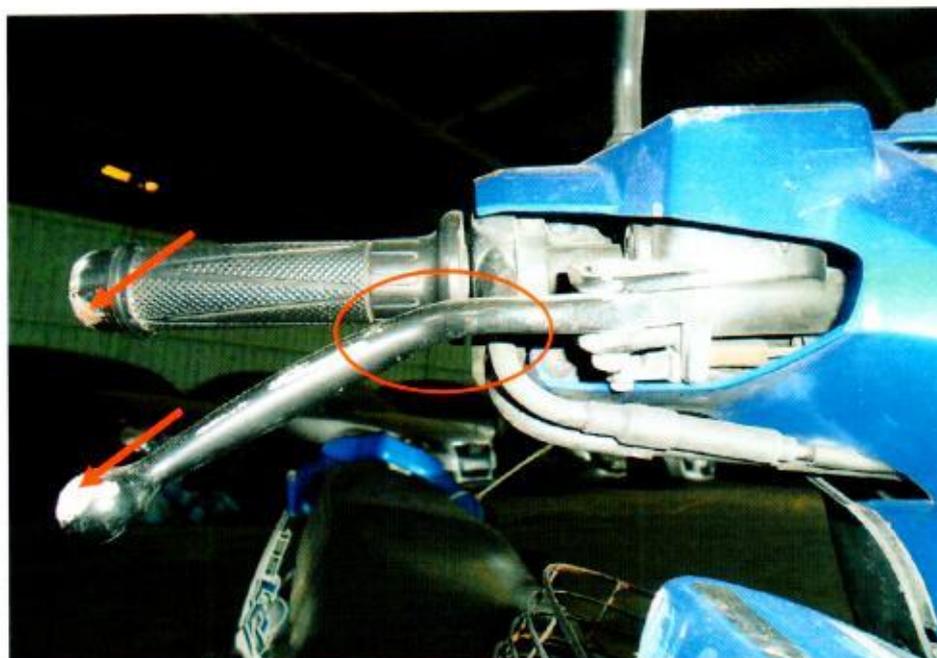
Photo 7 shows a close-up view of the damage portion of the Motorcycle at the time of our inspection. The hand throttle & front brake lever was observed to be sustained with relatively minor damage due to the accident collision.

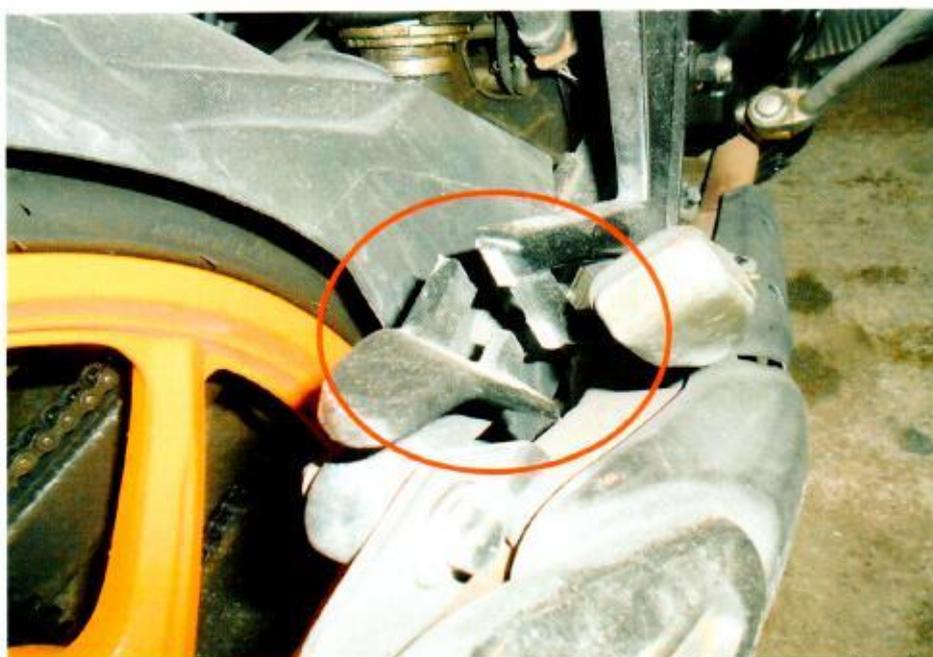
Photo 8 shows a close-up view of the damage portion of the Motorcycle at the time of our inspection. The passenger foot pedal bracket was observed to be broken likely due to the accident's collision.

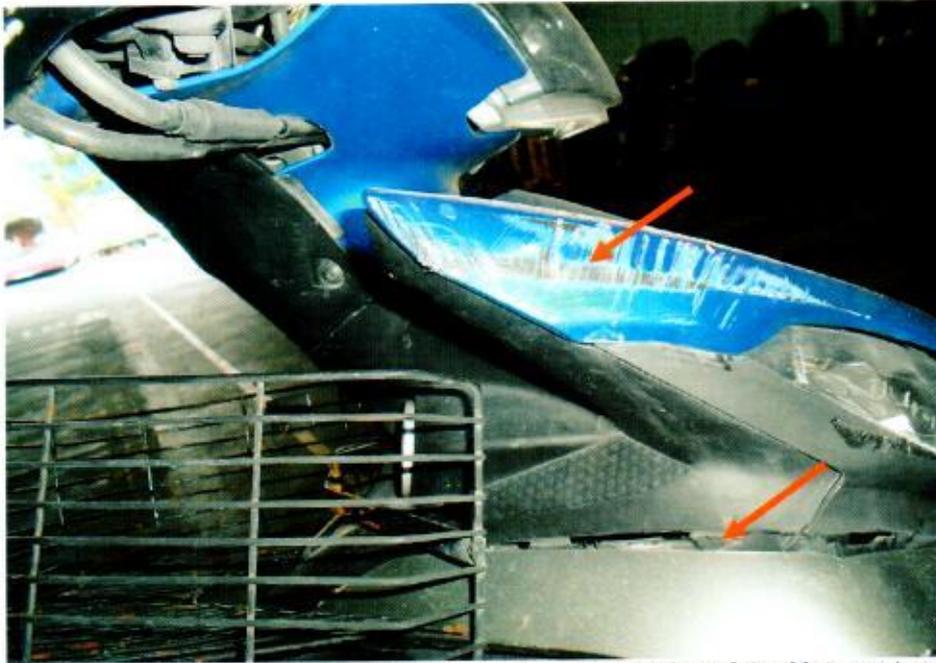
Photo 9 shows a semi close-up view of the damage portion of the Motorcycle at the time of our inspection. The Motorcycle was observed to be sustained with relatively minor damages due to the accident collision.

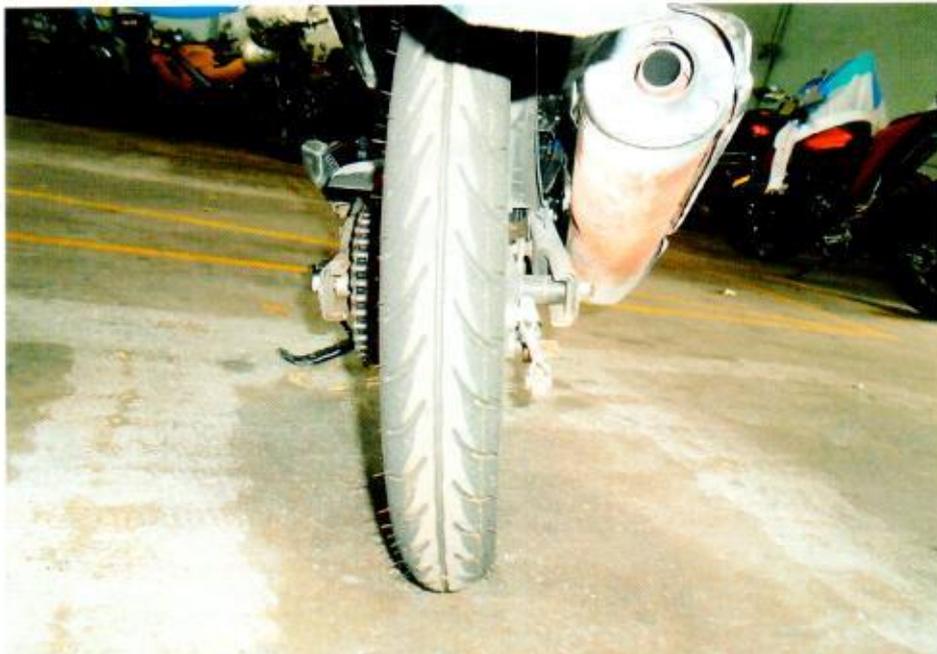
Photo 10 shows the rear tyre of the Motorcycle at the time of our inspection. The rear tyre was observed to be in serviceable condition with remaining tread depth of approximately 3mm. The tyre was also observed to be sufficiently inflated for vehicular operation. There was no significant damage observed on the rear wheel rim & tyre.

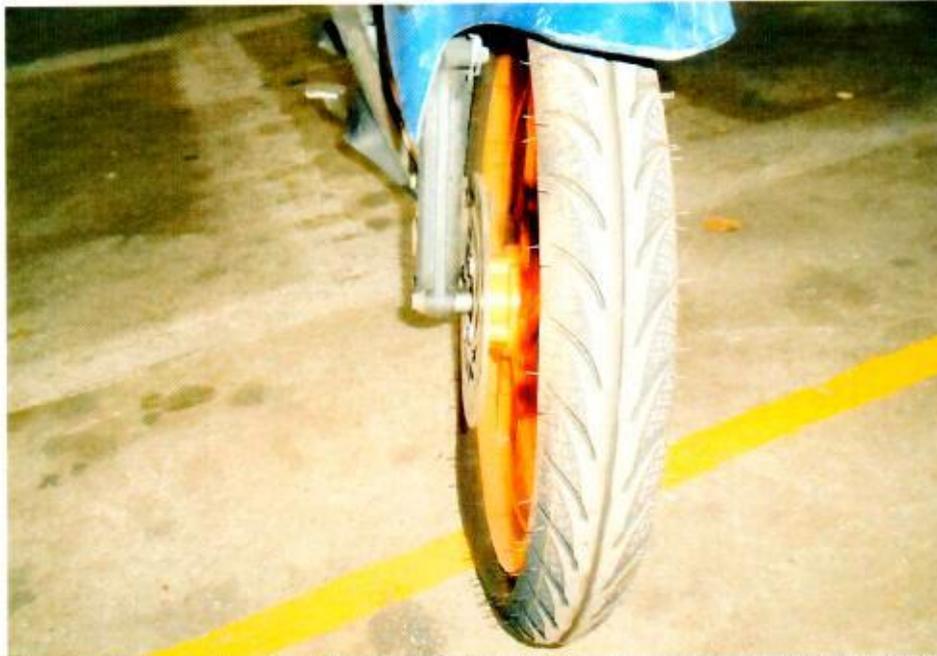
Photo 11 shows the front tyre of the Motorcycle. The pattern of the tread was clearly visible. There was no tear, burst mark(s) and/or punctured hole(s) on the sidewalls as well as across the tread of the front tyre. Except for it was observed to be deflated likely due to the accident's collision impact.

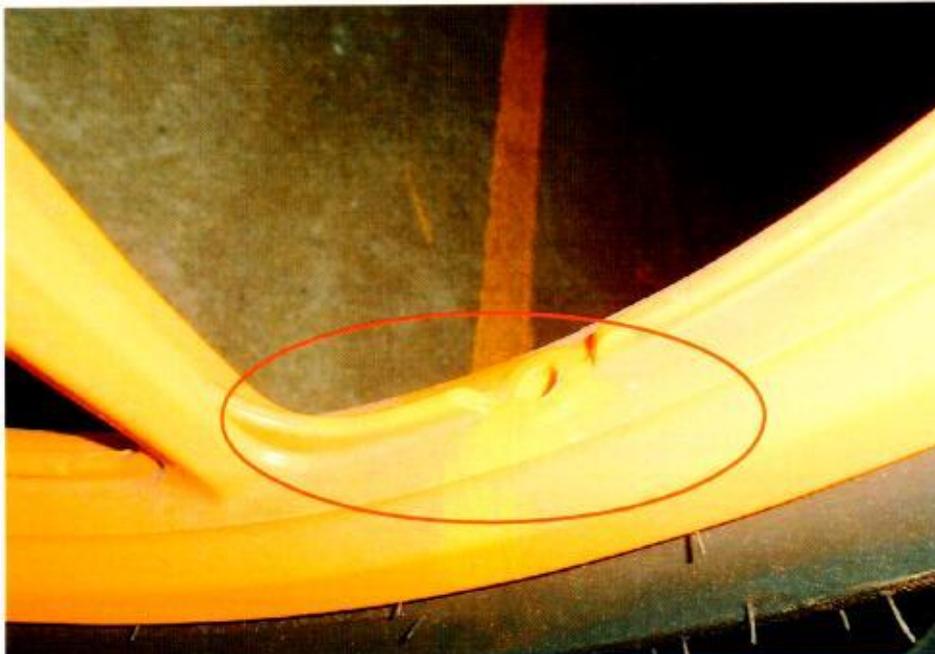
Photo 12 Further observation on the front tyre that was deflated due to missing tyre plug from the front rim likely caused by the accident collision impact.

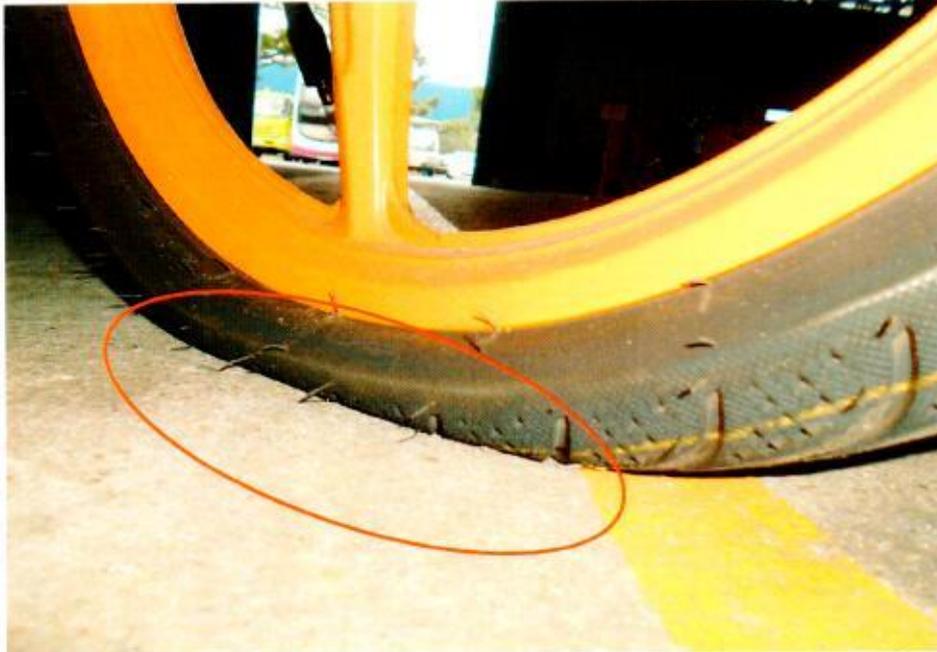
Photo 13 Further observation on the front tyre that was deflated at time of our inspection.

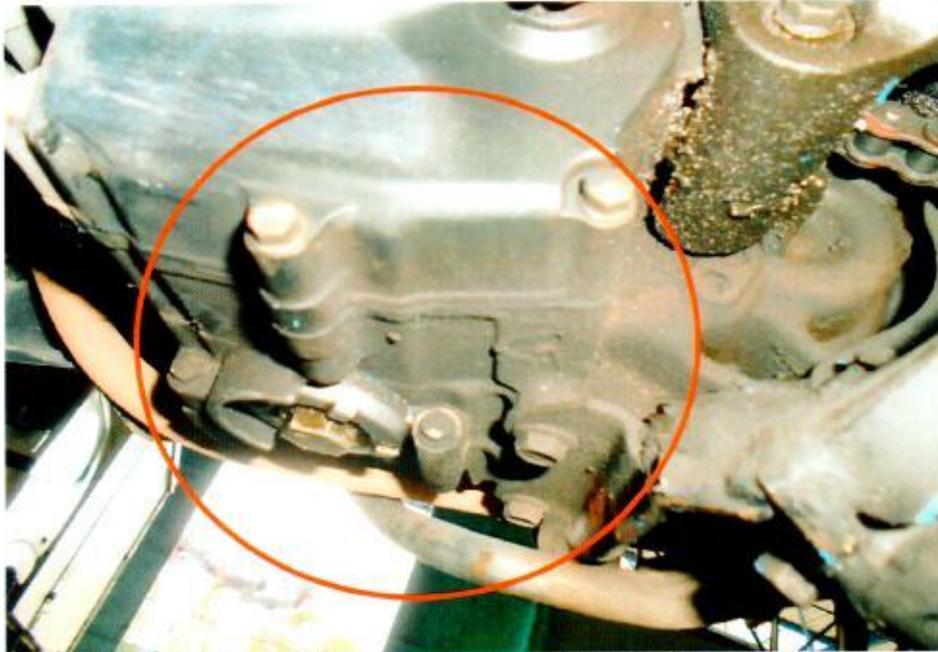
Photo 14 shows no sign(s) or indication(s) of fluid leakage stain around the engine undercarriage area of the Motorcycle.

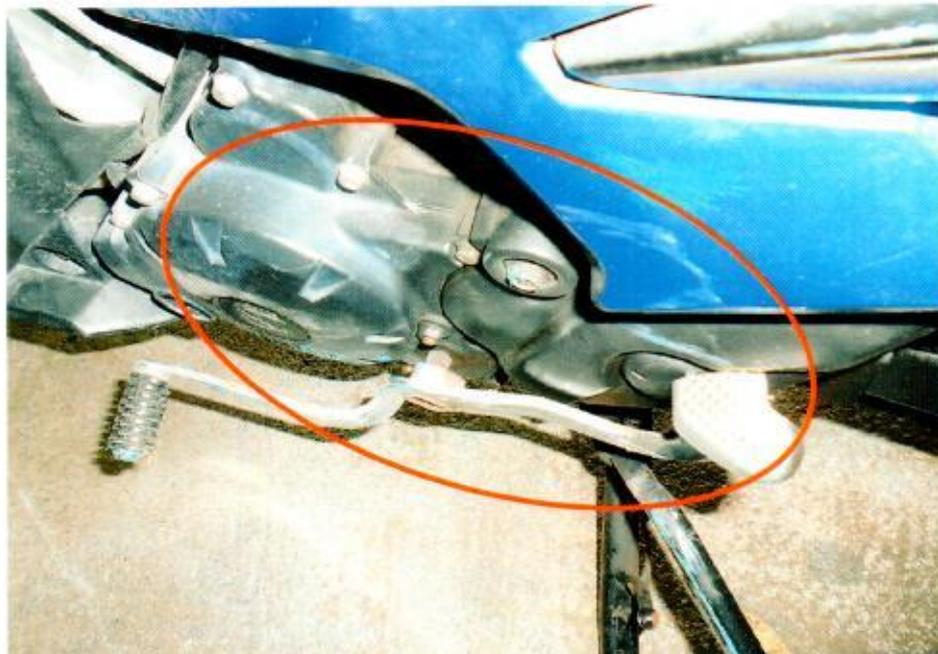
Photo 15 shows no sign(s) or indication(s) of fluid leakage stain around the engine undercarriage area of the Motorcycle.

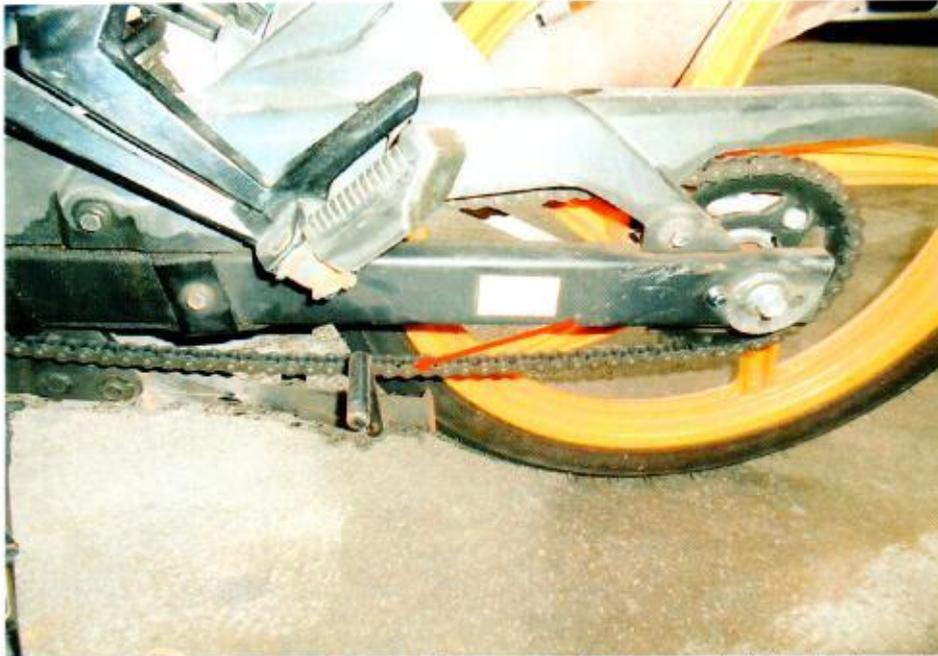
Photo 16 shows the general view of the gear train (arrowed) of the Motorcycle, which was observed to be intact with no misalignment. It was also adequately lubricated for operating purposes.

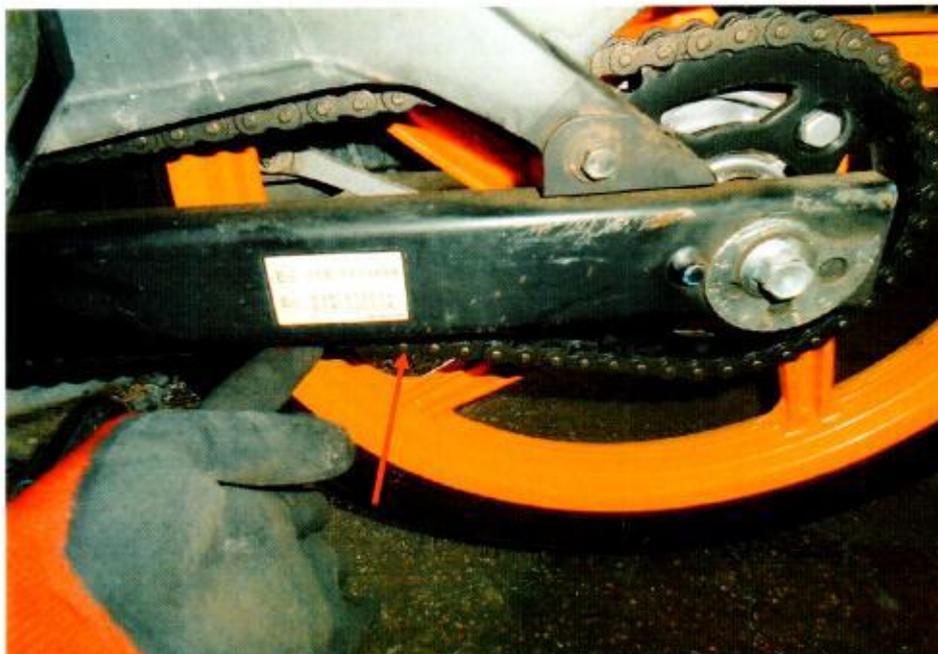
Photo 17 shows the general view of the gear train (arrowed) of the Motorcycle, which was observed to be intact with no misalignment. It was also adequately lubricated for operating purposes. Free play tension was also observed & found adequately acceptable.

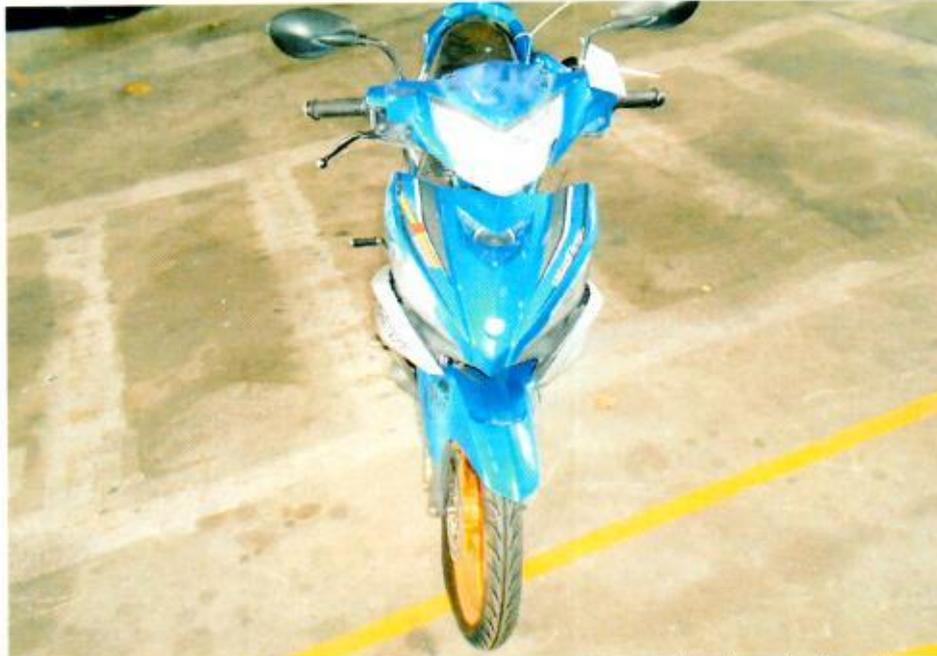
11. For this case, we were not able to conduct any test(s) on the steering system of the Motorcycle due to the damage on its steering system. It was found to be misaligned as a result of the accident. The front tyre was in deflated condition, hence causing the whole steering system to be in a state of immobility.

Photo 18 shows the front tyre & handle bar was observed to be misaligned as a result of the accident. Hence, we are not able to conduct any tests on the steering system of the Motorcycle.

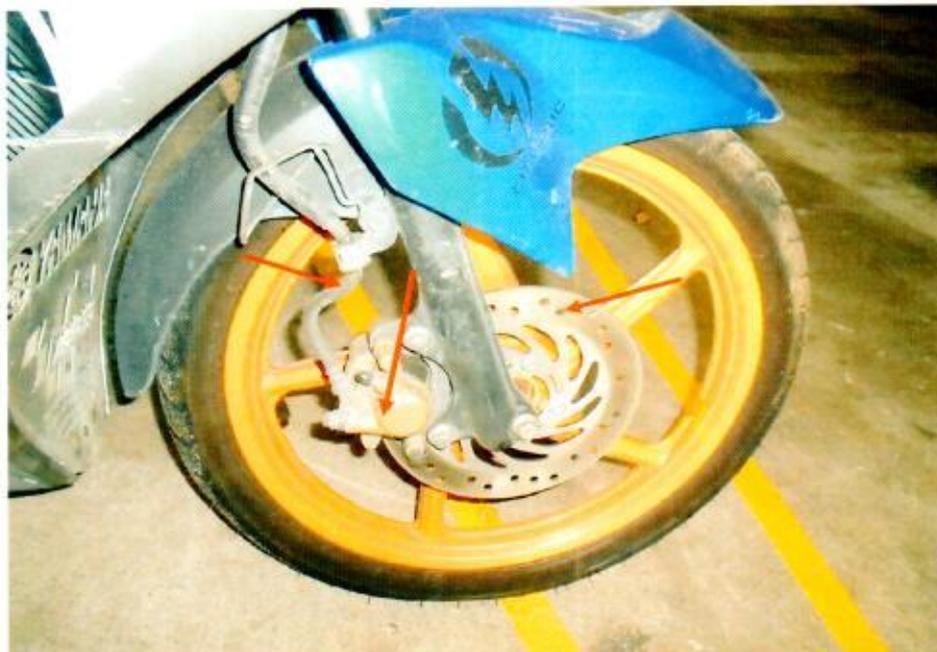
Photo 19 shows the front brake calliper, front brake disc and front brake hose of the Motorcycle (arrowed), which are all part of the components in the front brake system of the Motorcycle. Our visual checks of these various components had revealed all to be intact with no visible damage. No leakage of brake fluid was also observed.

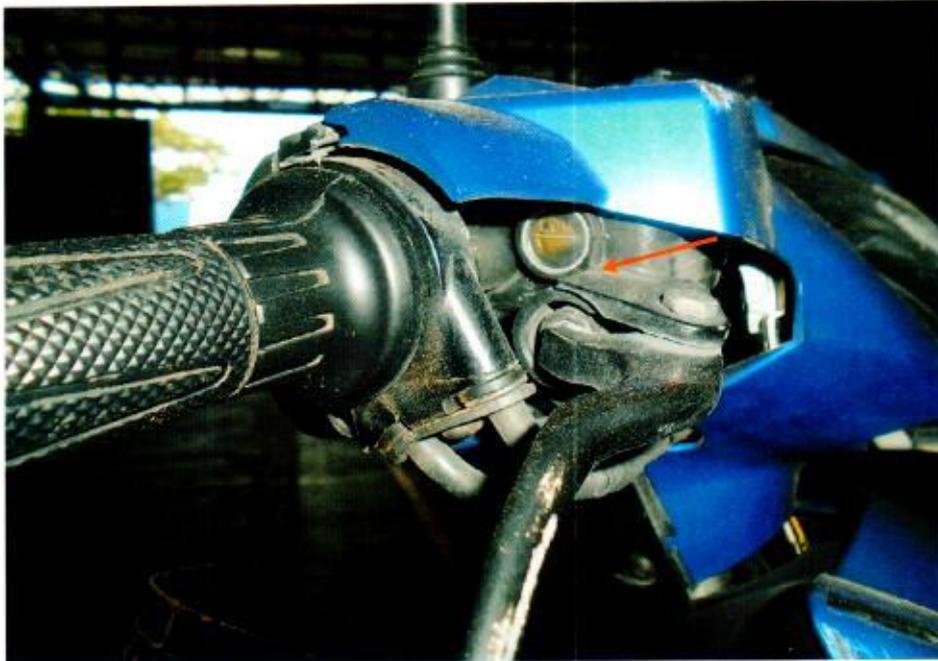
Photo 20 shows the front brake fluid reservoir. Our visual checks had revealed it was intact & sufficient level with no visible damage. No leakage of brake fluid was also observed.

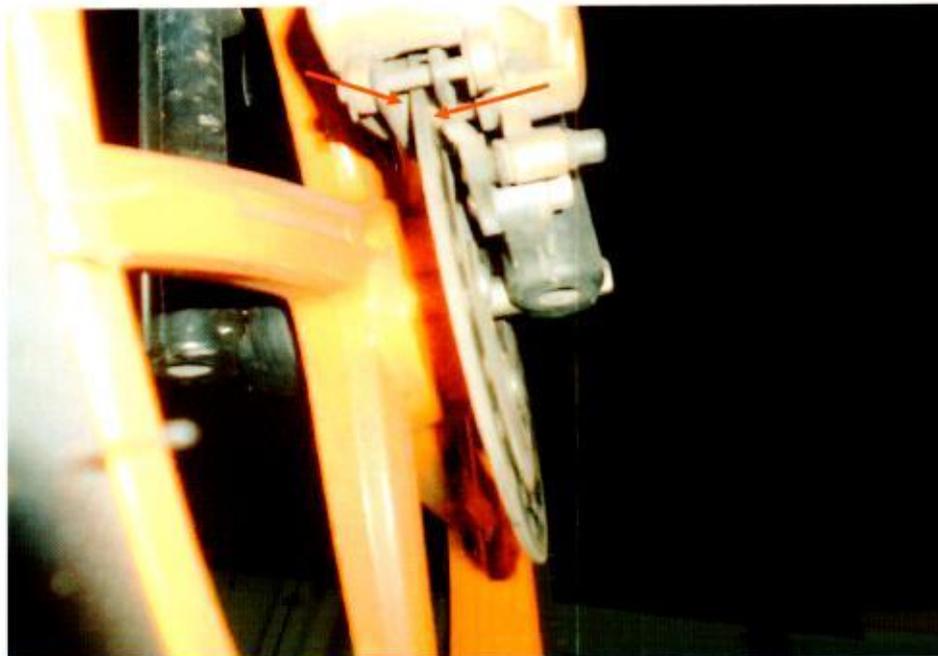
Photo 21 shows the front brake calliper, front brake disc and front brake hose of the Motorcycle, which are all part of the components in the front brake system of the Motorcycle. Our visual checks on the brake frictional pad and found to be still in serviceable condition.

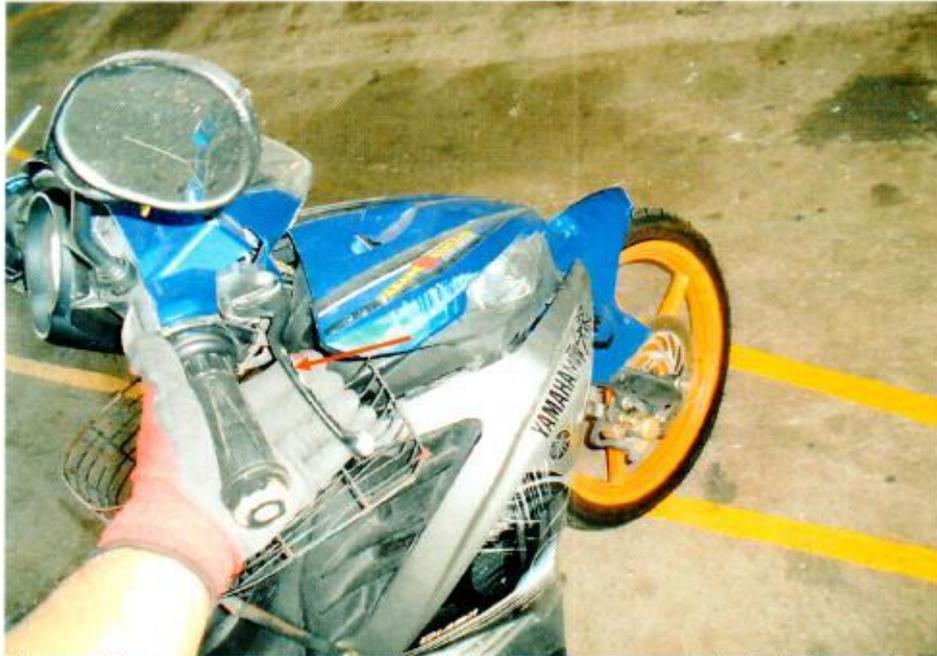
Photo 22 shows the front brake static test was conducted at time of our inspection.

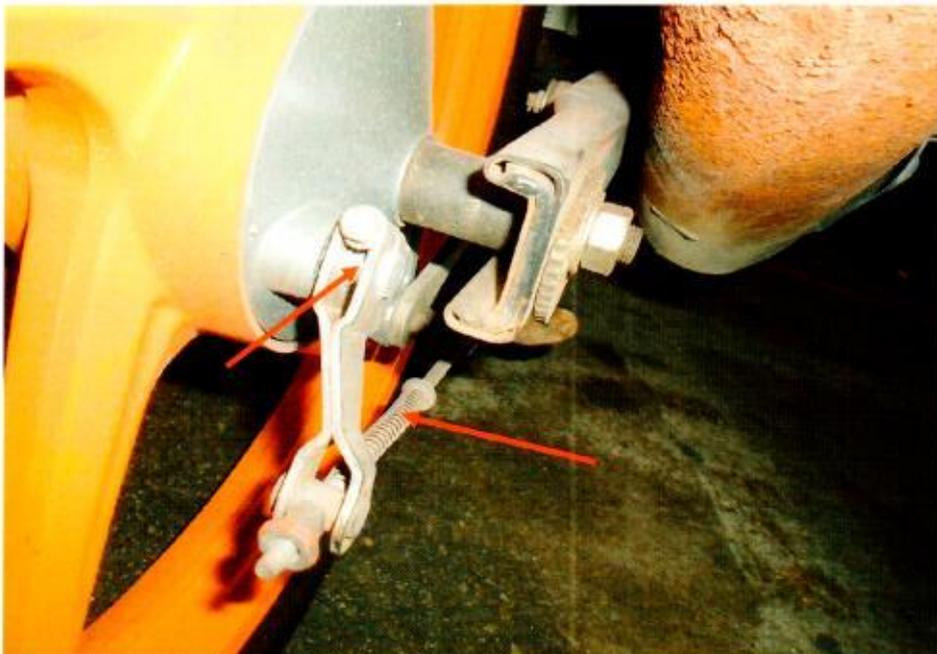
Photo 23 shows the rear wheel of the Motorcycle. The type of brake system for the rear wheel was of mechanical type, controlled by the brake foot pedal of the Motorcycle. Our checks of the cable (arrowed), spring and drum, which are all part of the components in the rear brake system of the Motorcycle reveal all to be intact and without damage.
