Your Ref: TP/IP/09695/2018
Our Ref : CI/TPD18010472/Z

Fatal Accident Investigation Team
Traffic Police Department
Singapore Police Force
10 Ubi Avenue 3
Singapore 408865

MECHANICAL INSPECTION REPORT OF MOTOR LORRY YP 2037B

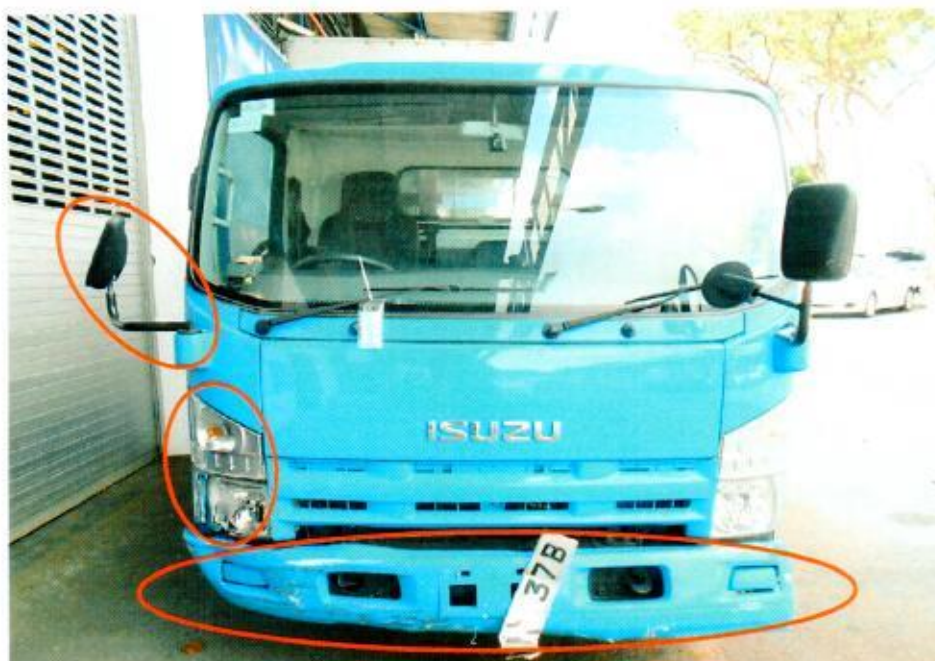
Photo 1 shows a general view of the front portion of the Motor Lorry at the time of our inspection. The Motor Lorry was observed to have sustained minor damage at its front lower bumper; its right headlamp; its right hand side mirror and number plate were amongst the body parts that were damaged as a result of the accident.

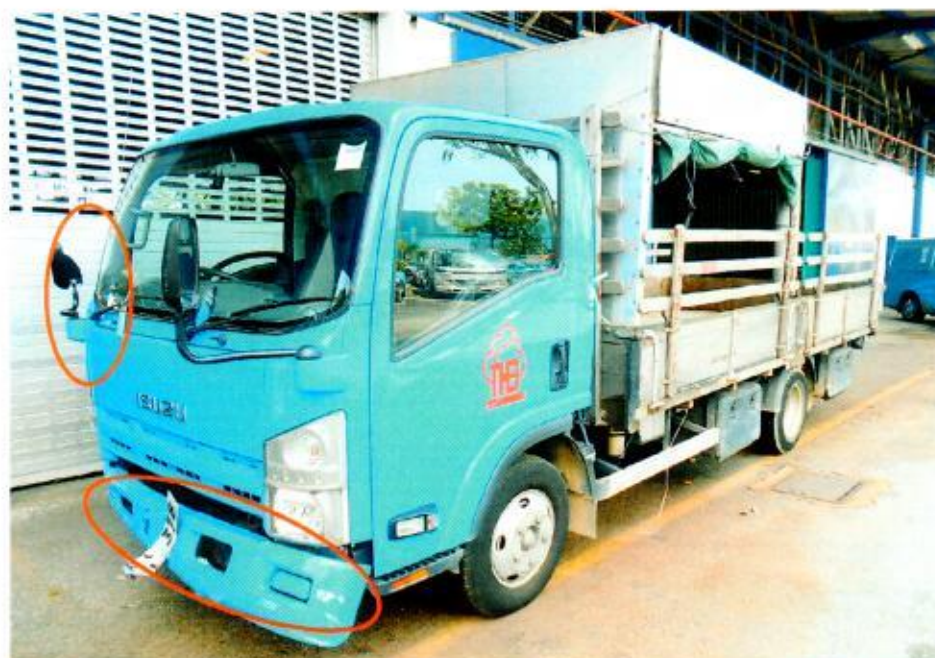
Photo 2 shows a general view of the front left of the Motor Lorry at the time of our inspection. The Motor Lorry was observed to have sustained minor damage at its front lower bumper; its right headlamp; its right hand side mirror and number plate were amongst the body parts that were damaged as a result of the accident.

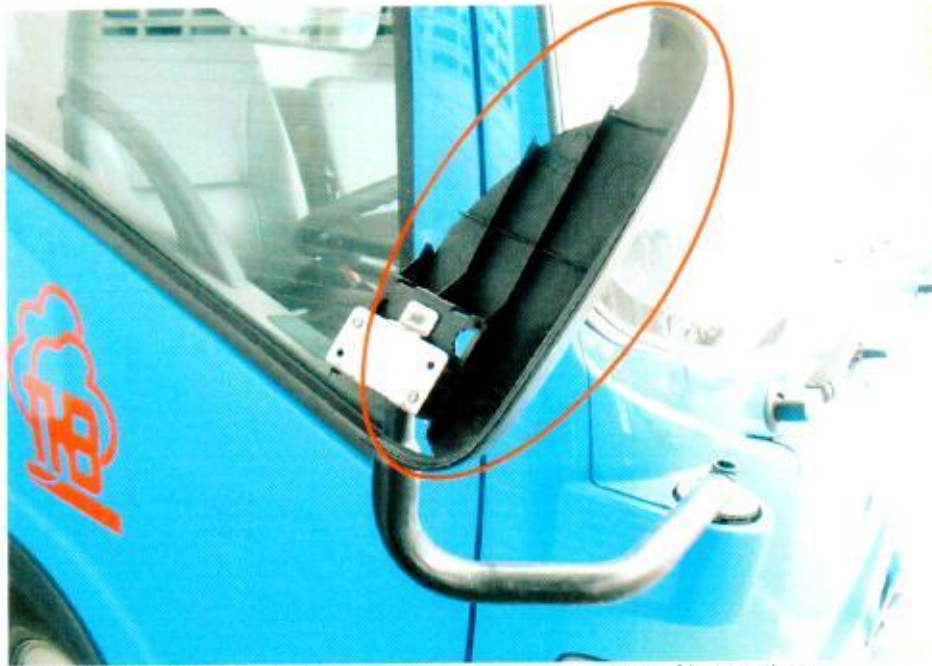
Photo 3 shows a damaged front right side mirror at time of inspection.

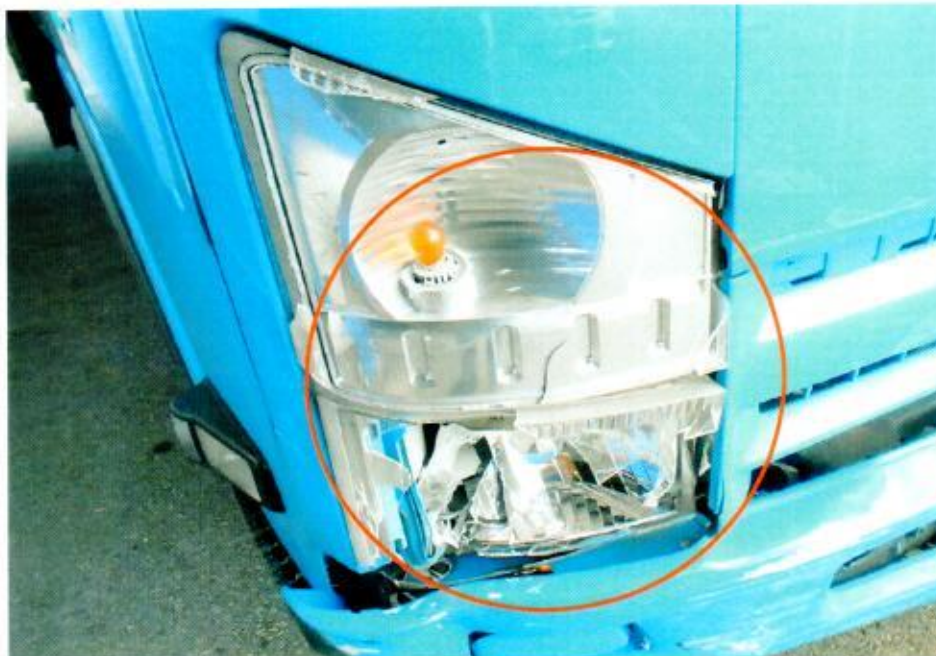
Photo 4 shows the right headlamp of the Motor Lorry. It was observed to have sustained damages as a result of the accidents.

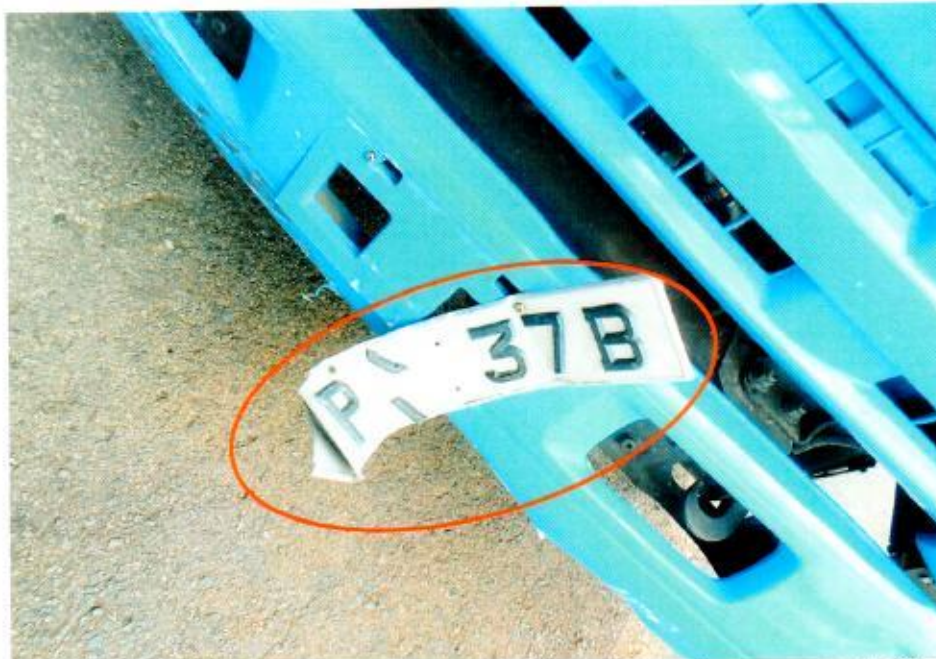
Photo 5 shows the damage sustained on the front number plate as a result of the accident.

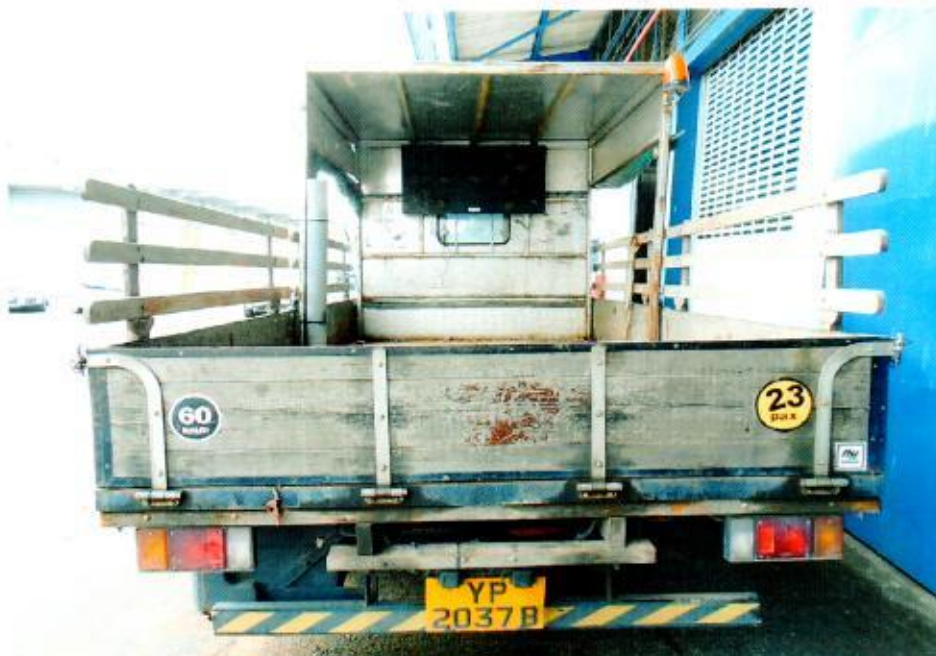
Photo 6 shows a general view of the Motor Lorry's rear body at the time of our inspection. There was no damage found to the rear portion of the Motor Lorry.

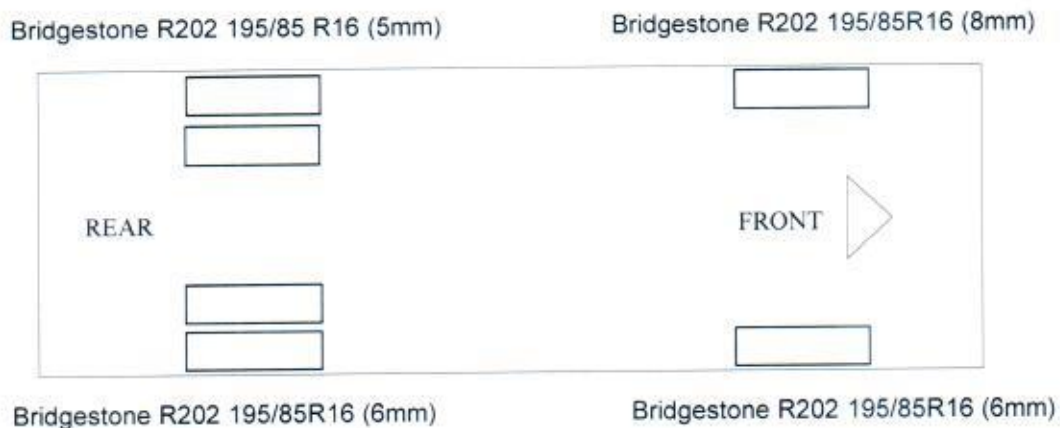
7. The 2 front tyres and 4 rear tyres of the Motor Lorry were observed to be in serviceable condition and sufficiently inflated for vehicular operation. We did not find any tear, cut or burst mark(s) on the outer and the inner sidewalls as well as across the tread of the 6 tyres. The tyre brand, tyre size and remaining tread depth of the 6 tyres of the Motor Lorry were recorded as follows:-

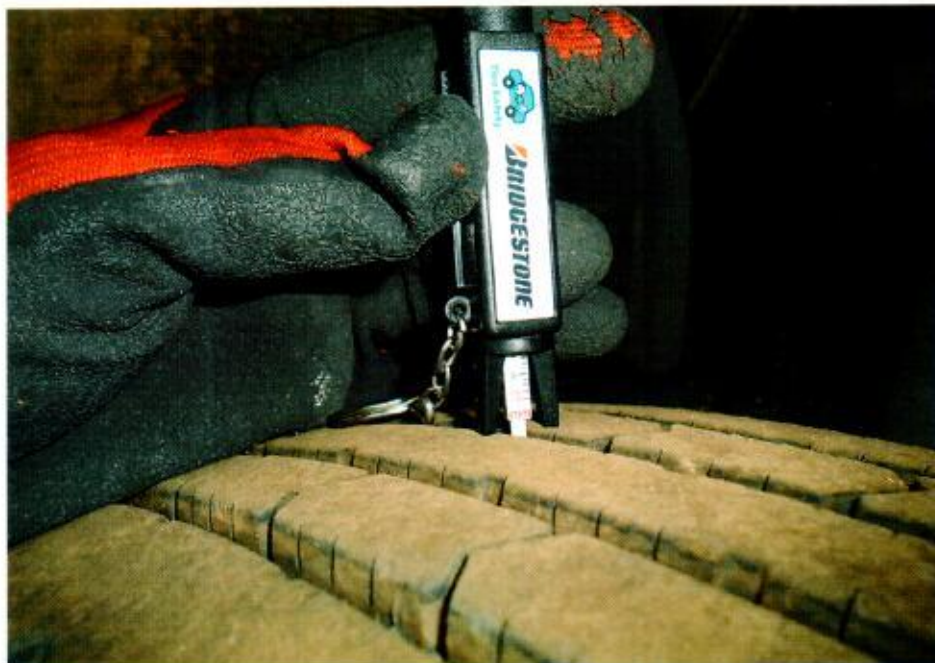
Photo 7 shows the remaining tread depth of the front left tyre of the Motor Lorry, which was observed to be in serviceable condition with remaining tread depth of approximately 8mm.

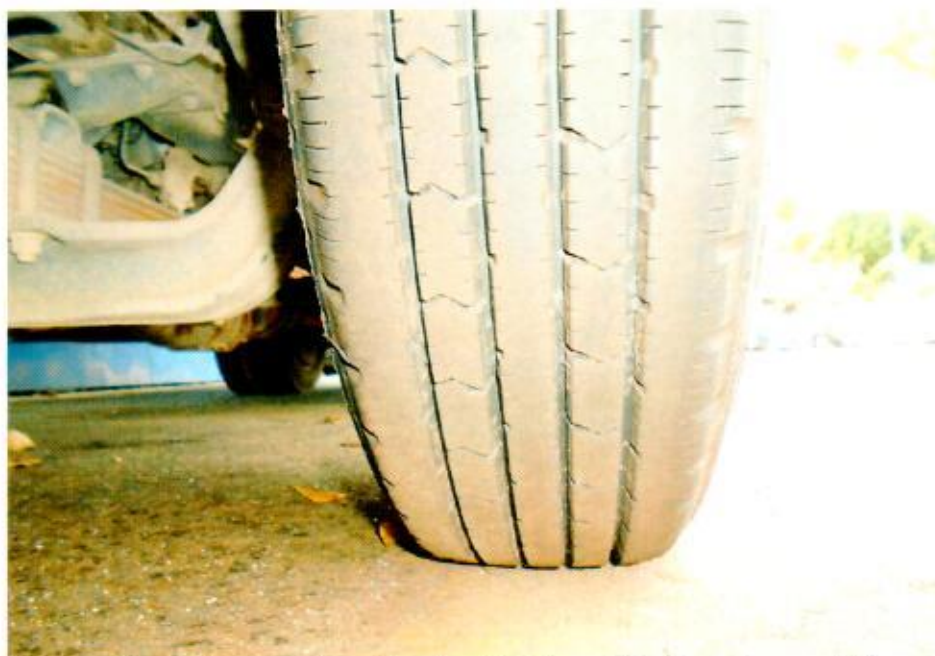
Photo 8 shows the condition of the front left tyre of the Motor Lorry, which was observed to be in serviceable condition with remaining tread depth of approximately 8mm. The tyre, which was wrapped around standard alloy wheel rim, was also observed to be sufficiently inflated for vehicular operation.

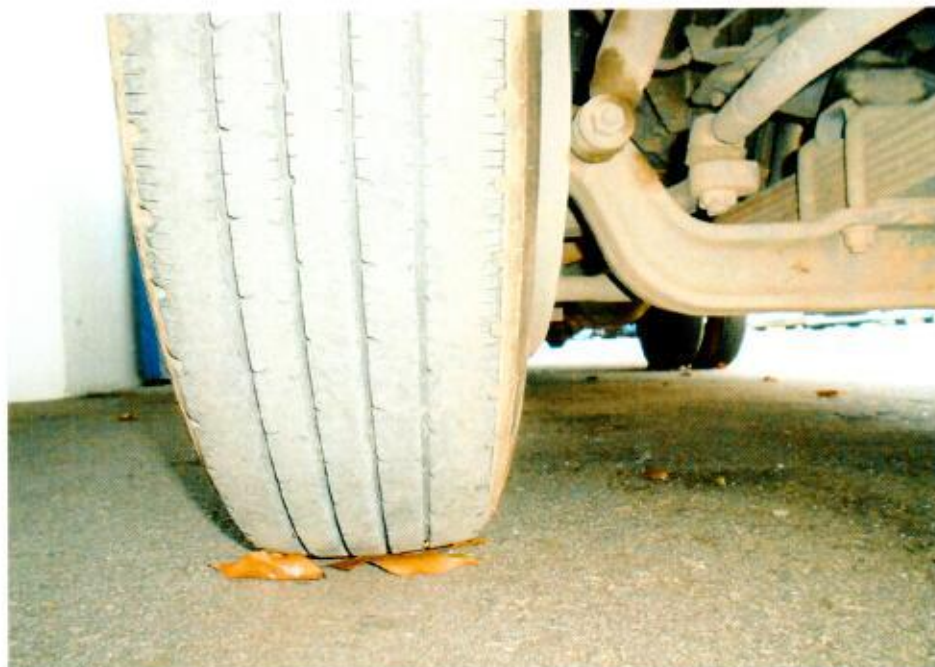
Photo 9 shows the condition of the front right tyre of the Motor Lorry, which was observed to be in serviceable condition with remaining tread depth of approximately 6mm. The tyre, which was wrapped around standard alloy wheel rim, was also observed to be sufficiently inflated for vehicular operation.

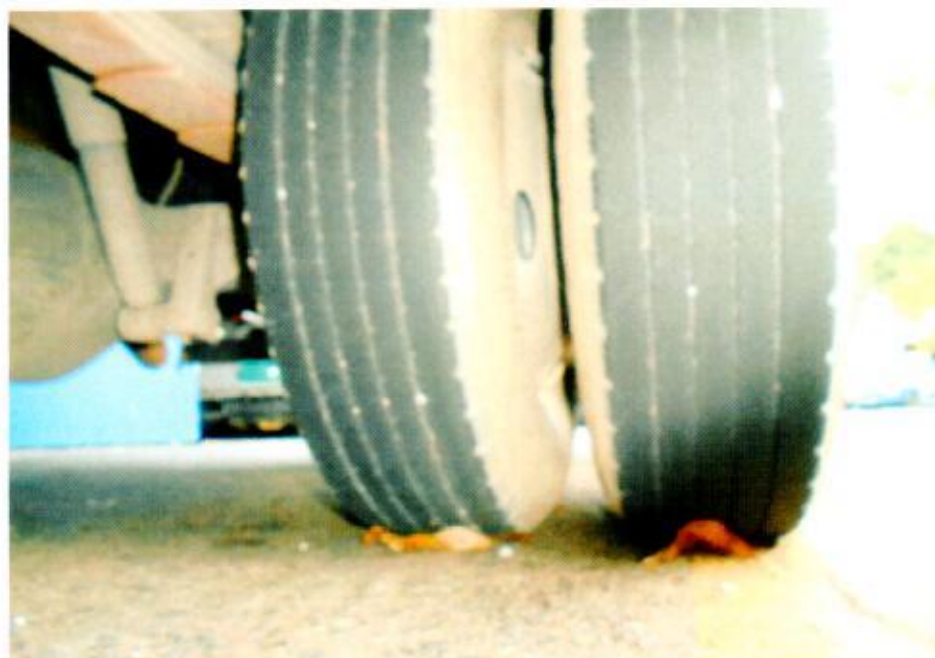
Photo 10 shows the condition of the rear left tyres of the Motor Lorry, which was observed to be in serviceable condition with remaining tread depth of approximately 5mm. The tyres, which were wrapped around standard alloy wheel rim, were also observed to be sufficiently inflated for vehicular operation.

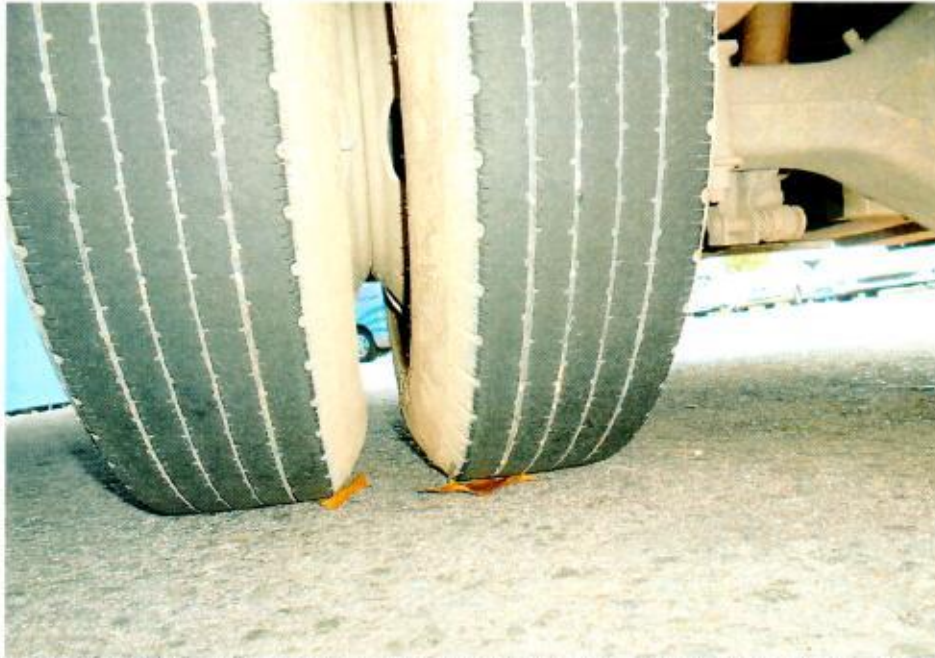
Photo 11 shows the condition of the rear right tyres of the Motor Lorry, which were observed to be in serviceable condition with remaining, tread depth of approximately 7mm.

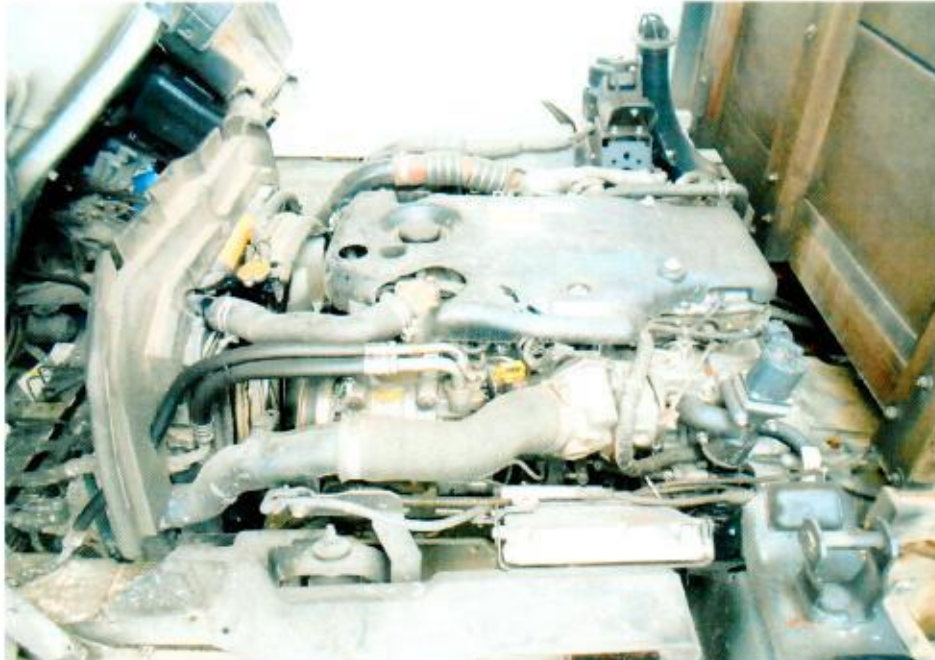
Photo 12 shows a general view of the Motor Lorry's engine compartment, which was accessed by lifting the front cabin of the Motor Lorry. The various parts and components inside the engine compartment were unaffected by the accident. There was also no sign(s) or indication(s) of fresh fluid leakage and/or fluid stain within the engine.

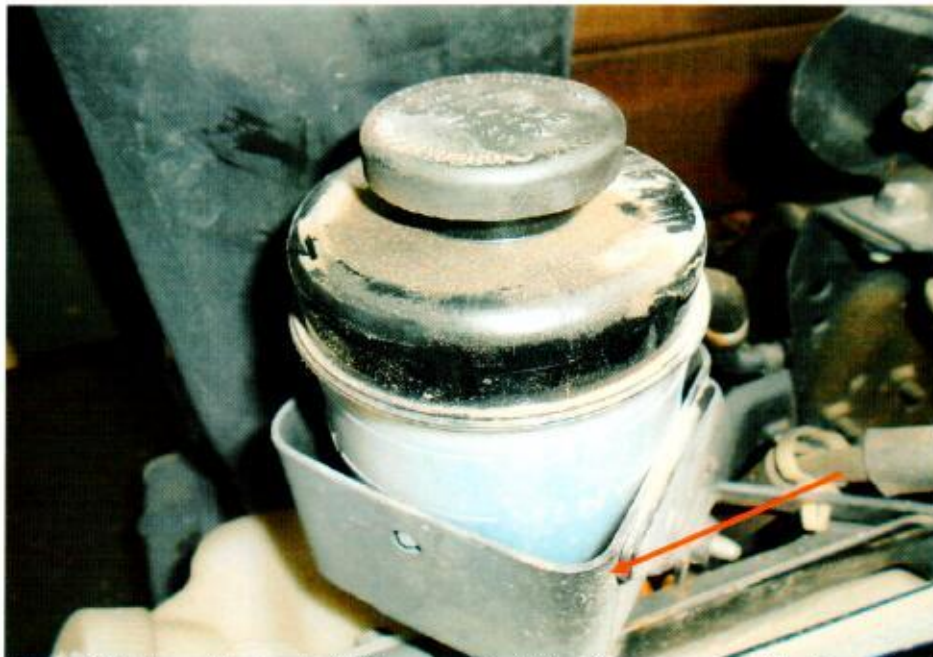
Photo 13 shows the brake fluid reservoir of the Motor Lorry at the time of our inspection. The brake fluid was observed to be of sufficient level and without any visible contamination (arrowed).

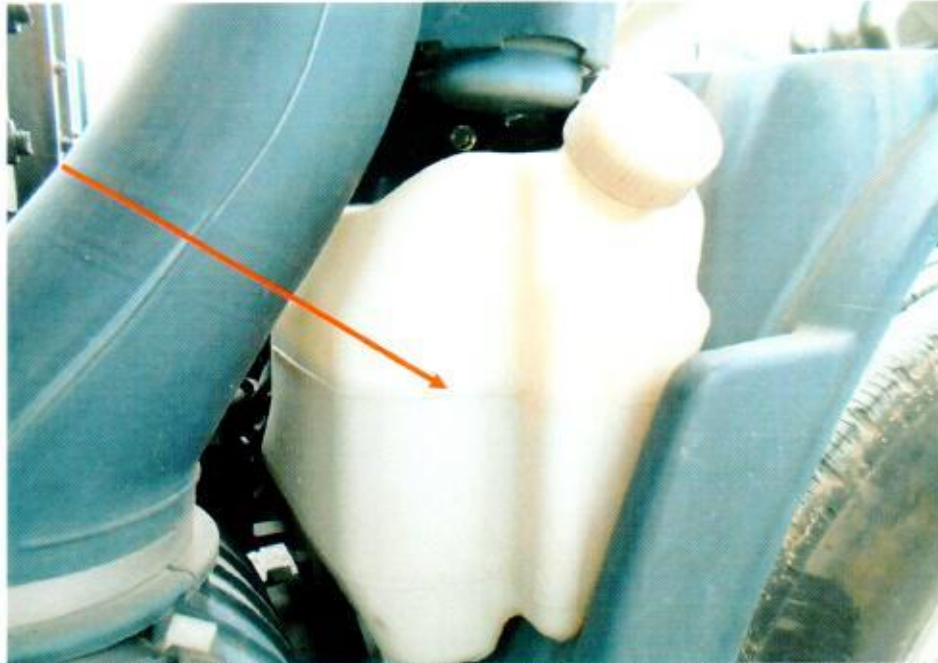
Photo 14 shows the engine coolant reservoir of the Motor Lorry at the time of our inspection. The engine coolant was observed to be of sufficient level and without any visible contamination (arrowed).

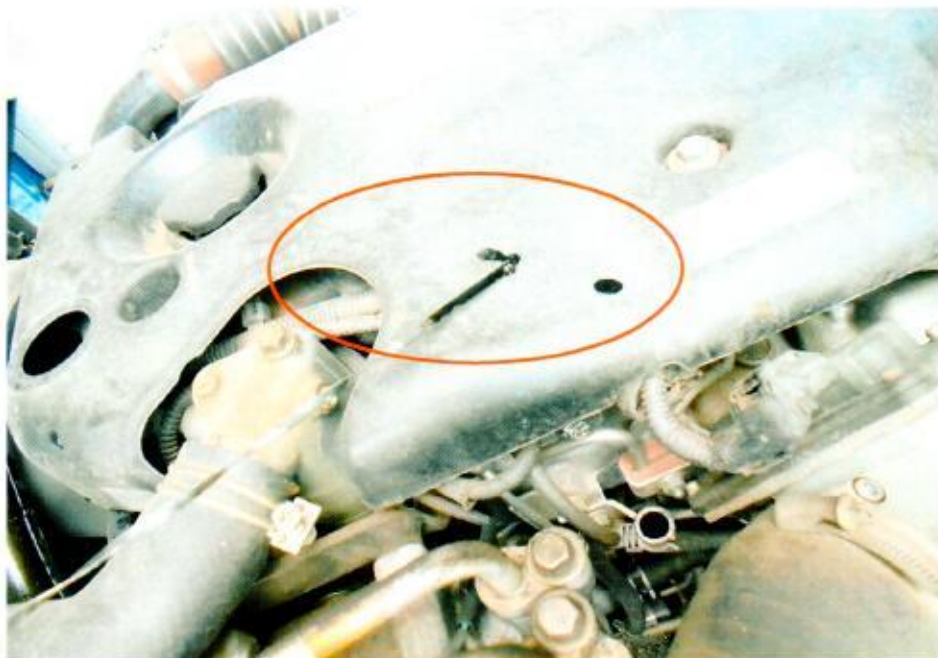
Photo 15 shows the engine dip stick of the Motor Lorry at the time of our inspection. The engine oil was observed to be of sufficient level and without any visible contamination (circled).

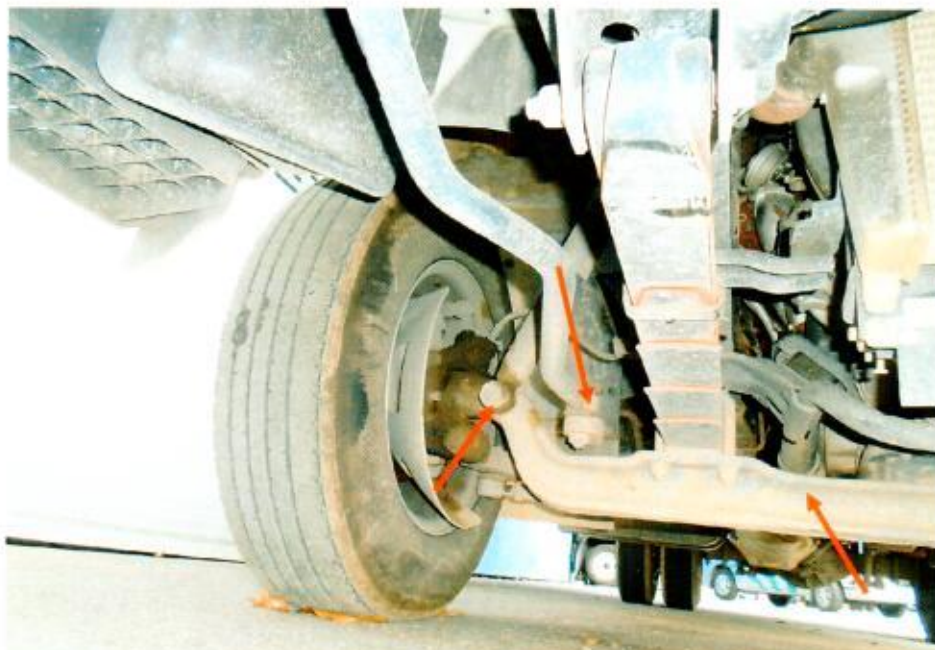
Photo 16 shows the various undercarriage components at the front left wheel of the Motor Lorry, in particular the steering tie rod end (arrowed). The various undercarriage components of the Motor Lorry were all found to be intact without any visible damage. There was also no sign of fluid stain(s) observed on the various undercarriage components.

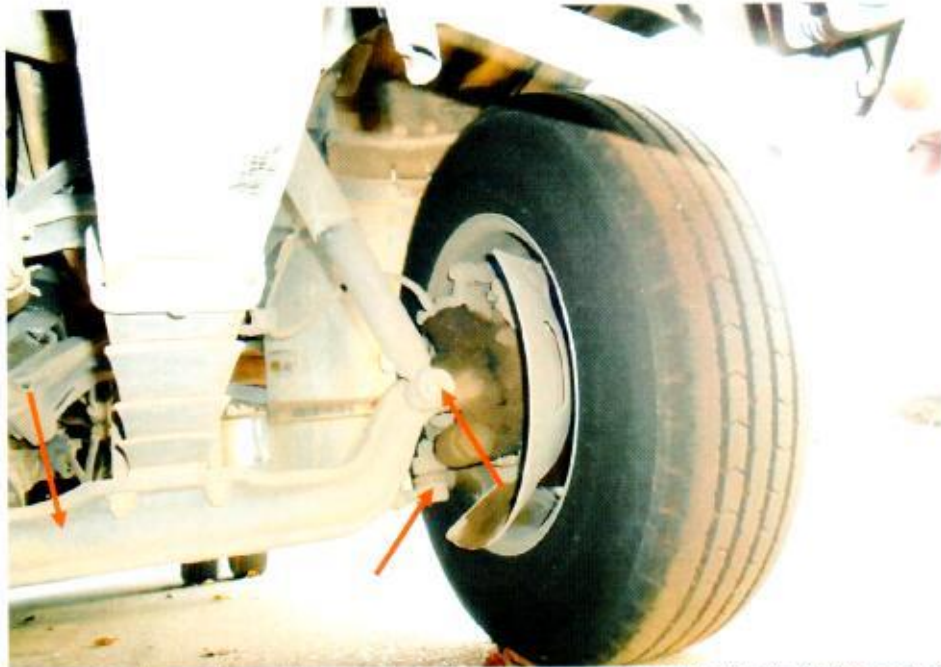
Photo 17 shows the various undercarriage components at the front right wheel of the Motor Lorry, in particular the steering tie rod end (arrowed). The various undercarriage components of the Motor Lorry were all found to be intact without any visible damage. There was also no sign of fluid stain(s) observed on the various undercarriage components.

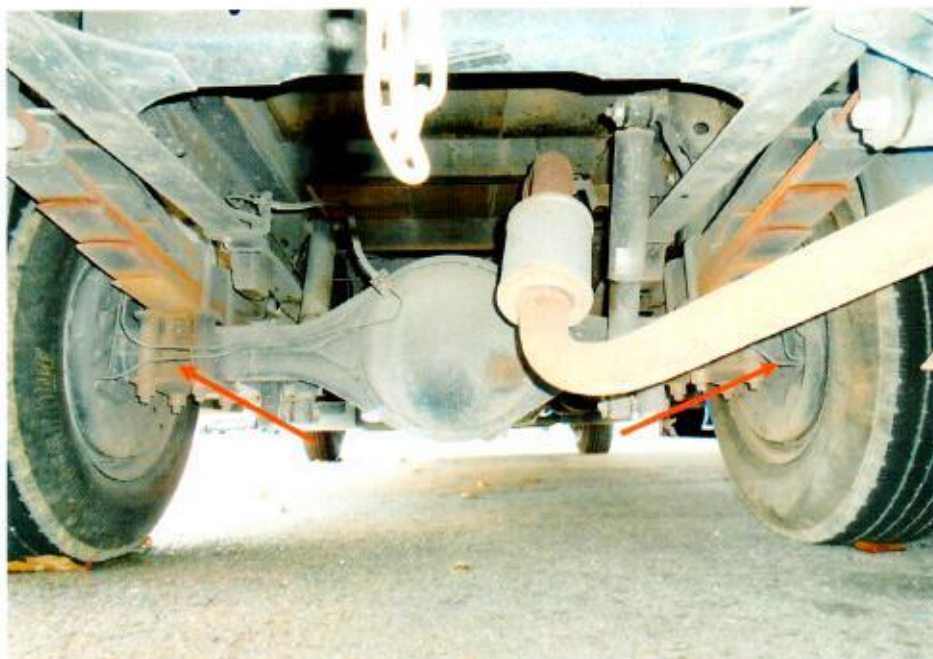
14. Static brake tests conducted on the Motor Lorry revealed no abnormality. The brake booster had responded well to the various tests conducted. There was also no abnormal movement of the brake pedal when it was depressed. In general, the static brake tests had suggested that there was no internal leakage of pressure/vacuum in the braking system of the Motor Lorry. The braking system of the Motor Lorry was likely to be in serviceable condition at the material time. This was also taking into consideration that the brake fluid was of sufficient level, and also that there was no sign(s) of brake fluid leakage along the brake hoses and brake pipes.

Photo 18 shows the various undercarriage components at the rear wheels of the Motor Lorry. There was no sign(s) of brake fluid leakage along the brake hoses and brake pipes.

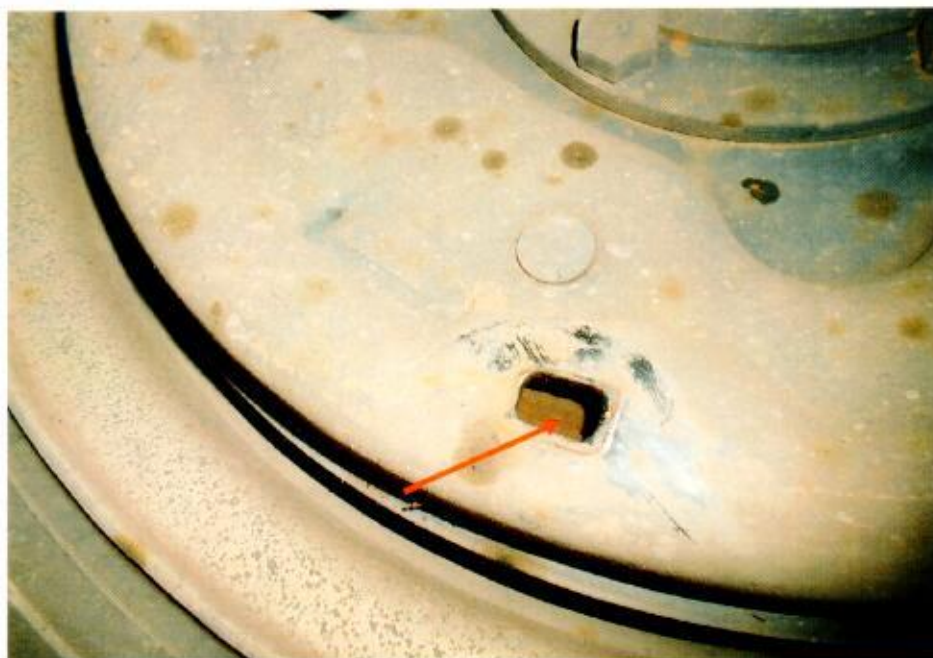
15. Checks on the brake shoes (brake pads) at the rear wheels of the Motor Lorry revealed that the brake shoes (brake pads) were in serviceable condition with sufficient frictional material for operational purposes. In general, our visual inspection of the mechanical components of the Motor Lorry's braking system appear to suggest that its braking system was in serviceable condition at the material time of accident. See photo 18 & 19 below.

Photo 19 shows the brake shoes (brake pads) at the rear wheels of the Motor Lorry revealed that the brake shoes (brake pads) were in serviceable condition with sufficient frictional material for operational purposes.
