Your Ref: TP/IP/12087/2018
Our Ref : CI/TPD18010484/Z

04th April 2018

Fatal Accident Investigation Team
Traffic Police Department
Singapore Police Force
10 Ubi Avenue 3
Singapore 408865

MECHANICAL INSPECTION REPORT OF MOTOR CAR SJL 4167U

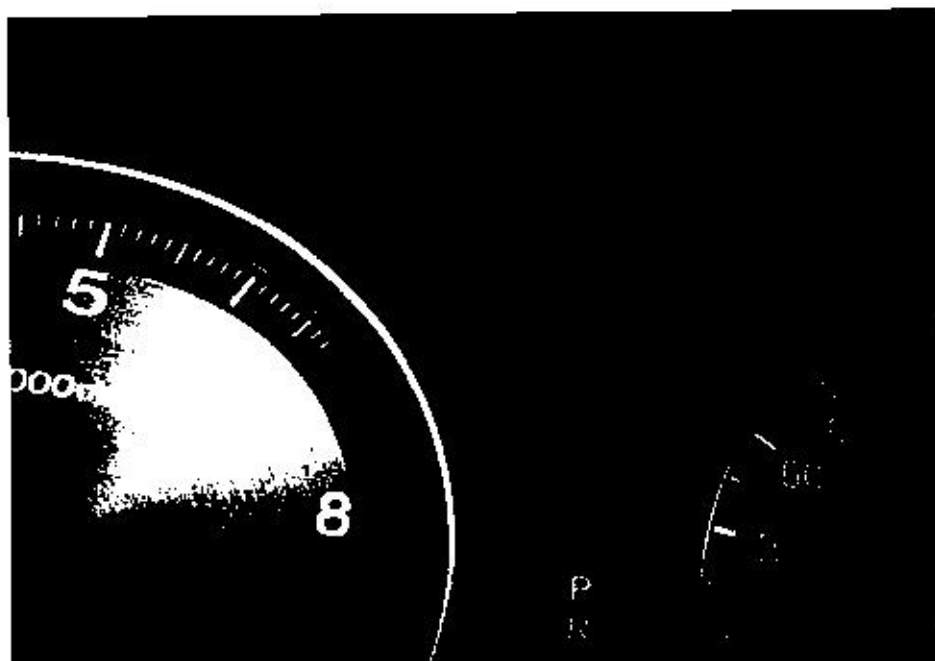
Photo 1 shows the mileage of the Motor Car at the time of our inspection was recorded at 465906km.

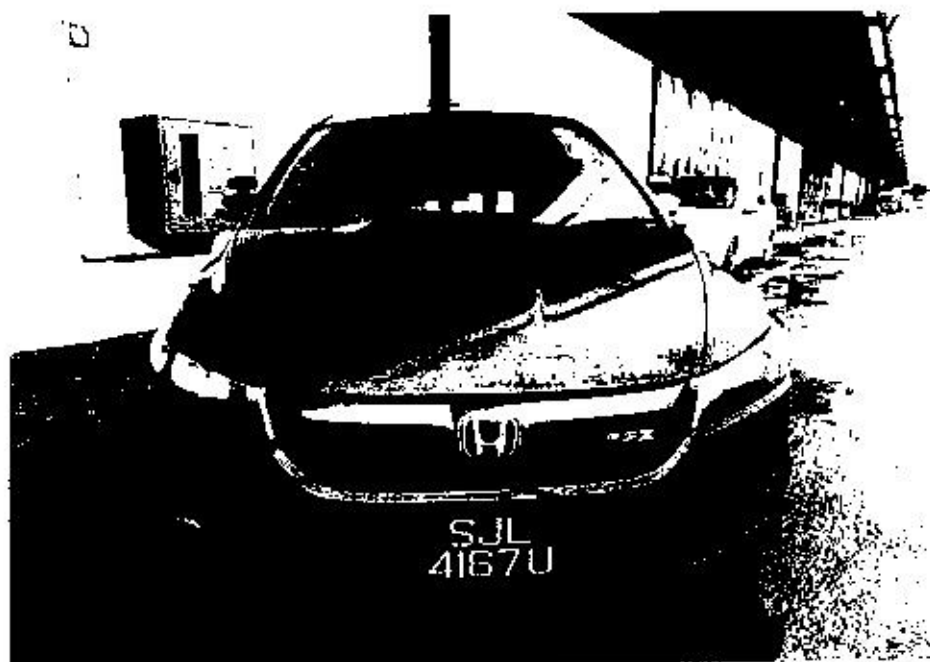
Photo 2 shows a general view of the front body of the Motor Car at the time of our inspection. The Motor Car was observed to have sustained a relatively minor impact damages that was confined to its frontal portion. Its front number plate was observed to be cracked & its lower right hand front bumper was chipped likely due to the accident's collision impact.

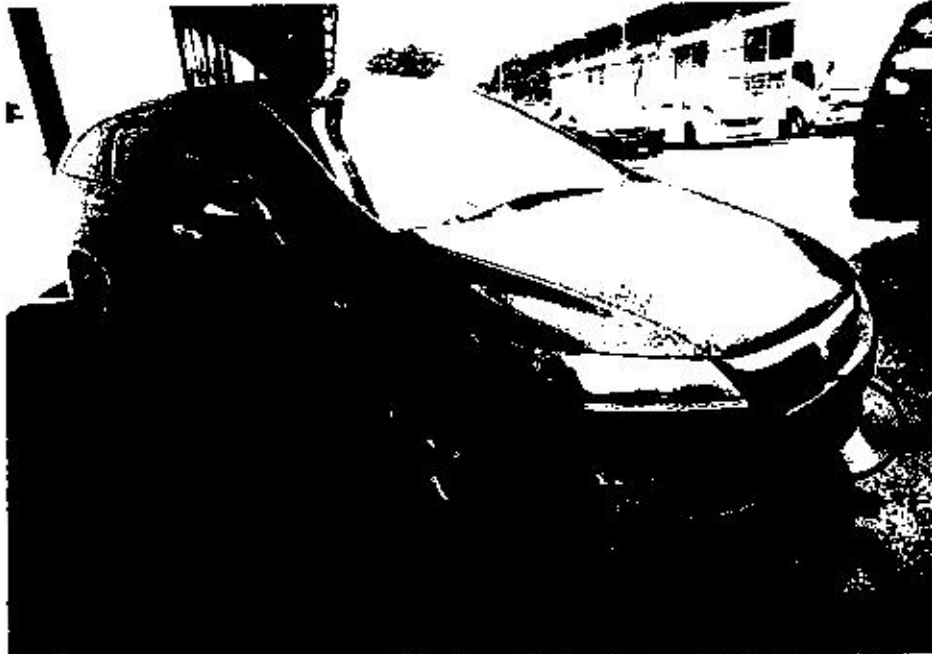
Photo 3 shows a general view of the front right body of the Motor Car at the time of our inspection. The Motor Car was observed to have sustained a relatively minor impact damages that was confined to its frontal portion.

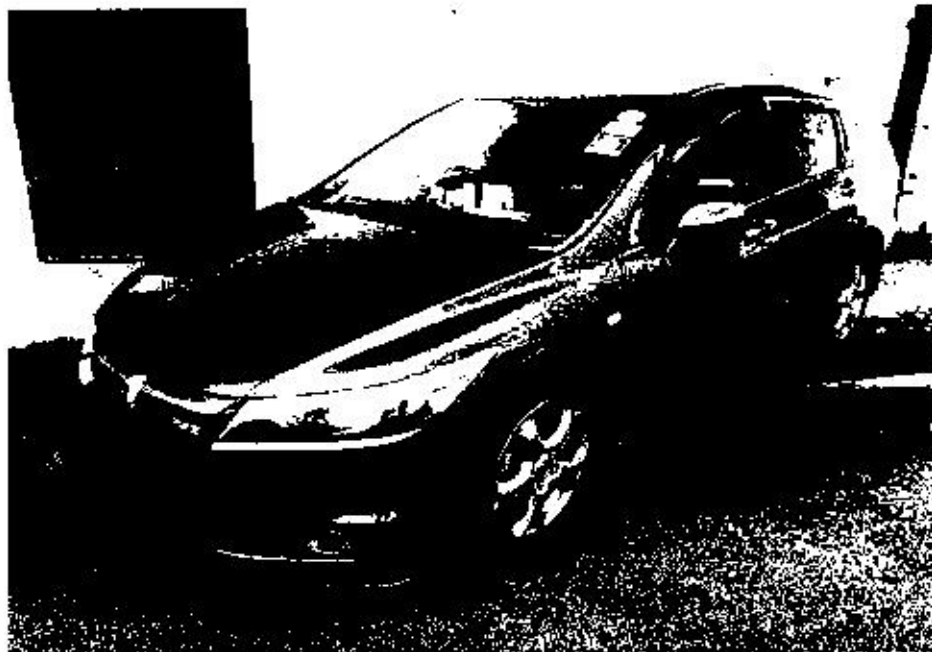
Photo 4 shows a general view of the front left body of the Motor Car at the time of our inspection. The Motor Car was observed to have sustained a relatively minor impact damages that was confined to its frontal portion.

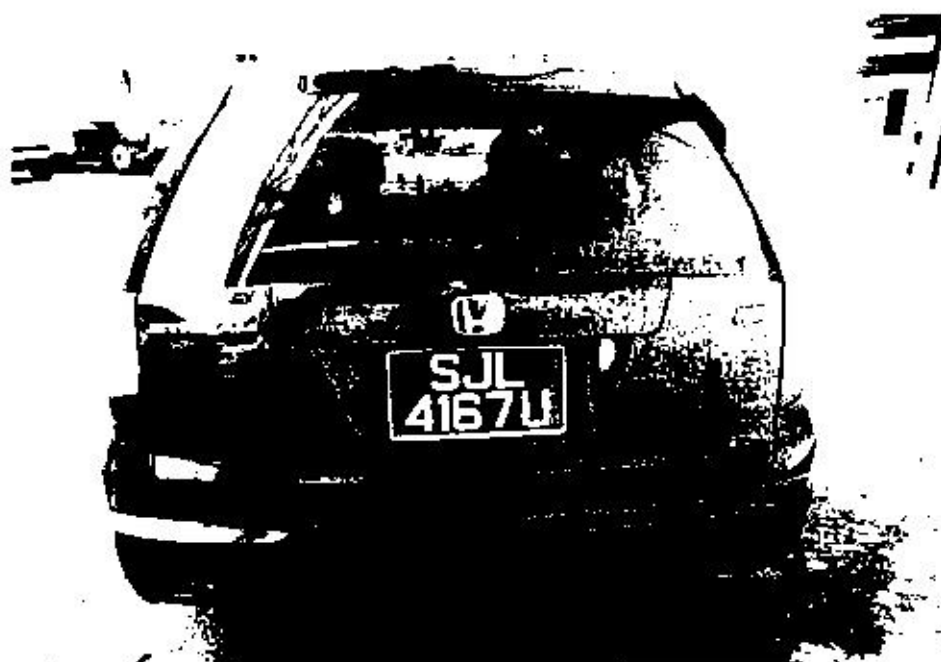
Photo 5 shows a general view of the rear body of the Motor Car at the time of our inspection. The Motor Car was observed to be in good general condition.

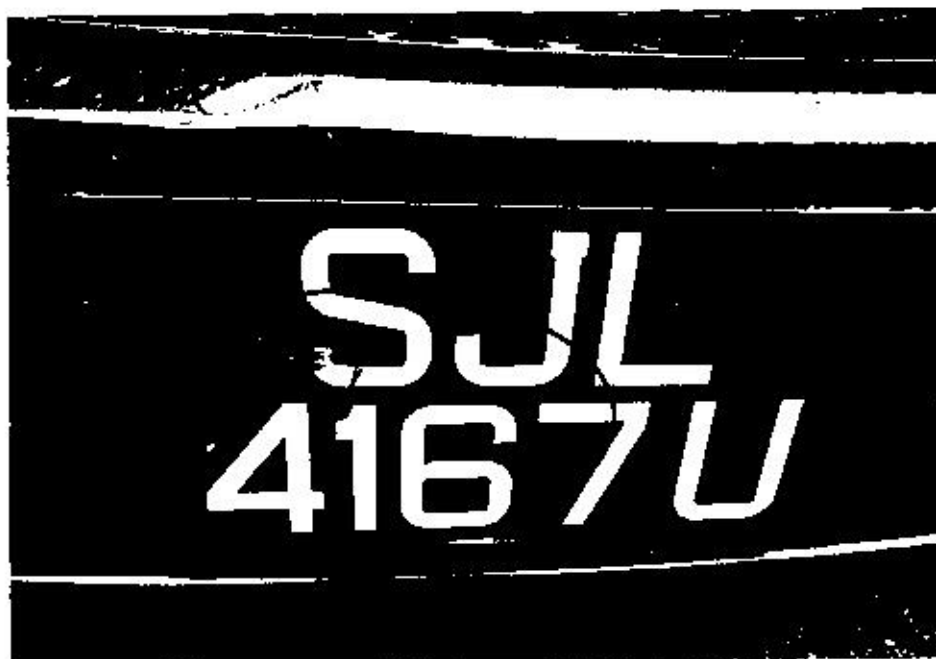
Photo 6 shows a close up view of the front number plate of the Motor Car at the time of our inspection. The Motor Car had sustained relatively minor damages at the front lower bumper & a cracked number plate of the Motor Car.

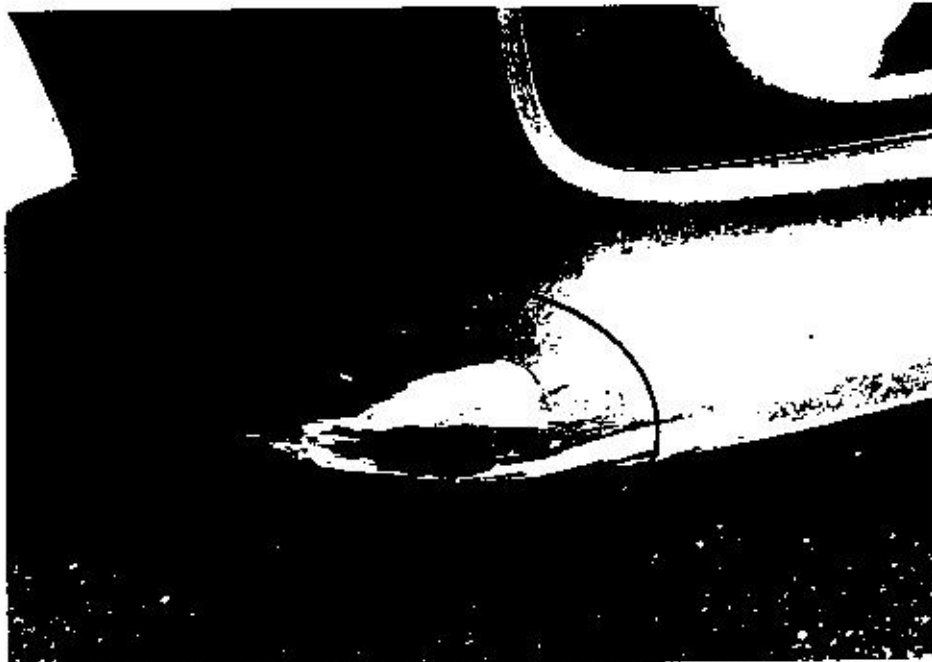
Photo 7 shows a close up view of the front lower bumper of the Motor Car at the time of our inspection. The Motor Car had sustained relatively minor damages at the front lower bumper of the Motor Car.

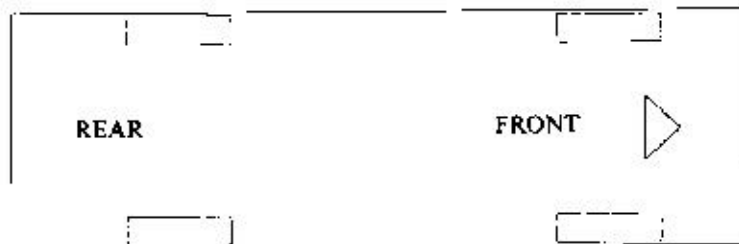
7. The condition of the Motor Car's 4 tyres was observed to be in serviceable condition, we did not find any tear, cut or burst mark(s) on the outer and the inner sidewalls as well as across the tread of the 4 tyres. The 4 tyres were also observed to be sufficiently inflated for vehicular operation. The remaining tread depth of the 4 tyres was approximately between 4 & 5mm. The tyre brand, tyre size and remaining tread depth of the 4 tyres were recorded as follows:-

Yokohama BluEarth-A
205/55R17 (5mm)

Falken ZIEX ZE914
215/50R17 (4mm)

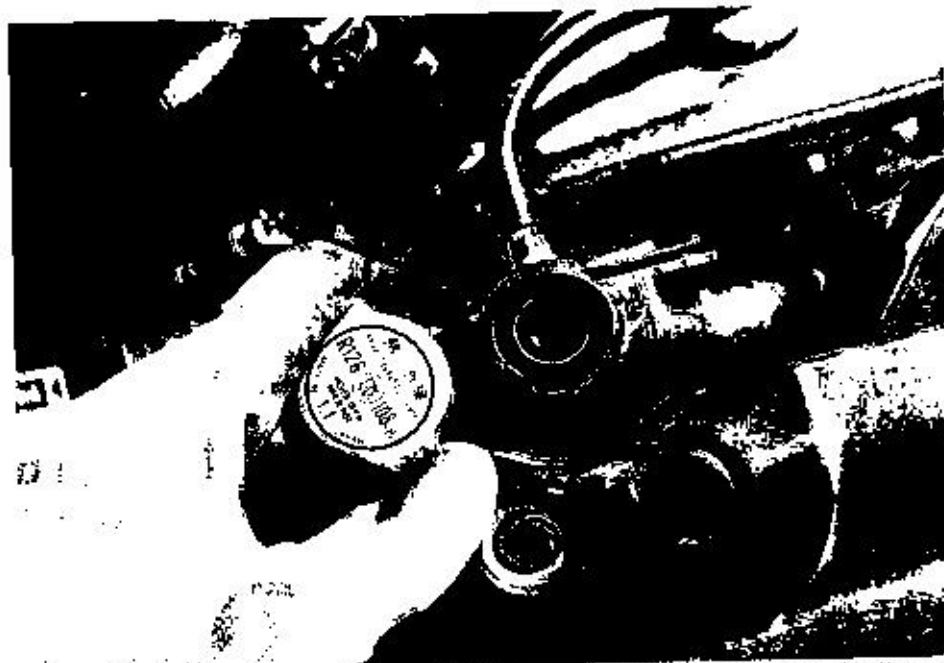
Photo 14 shows the engine coolant fluid reservoir of the Motor Car at the time of our inspection. The engine coolant fluid was observed to be of sufficient level and without any visible contamination.

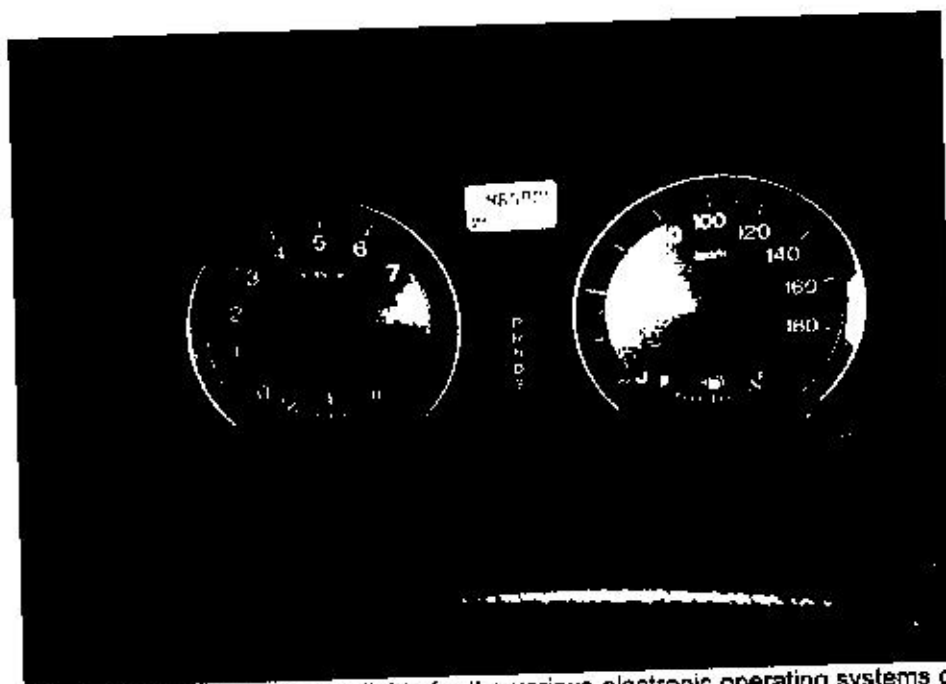
Photo 21 shows the warning lights for the various electronic operating systems of the Motor Car appearing on its instrument panel during the self-test when the engine is cranked, in particular the ABS light and SRS light.

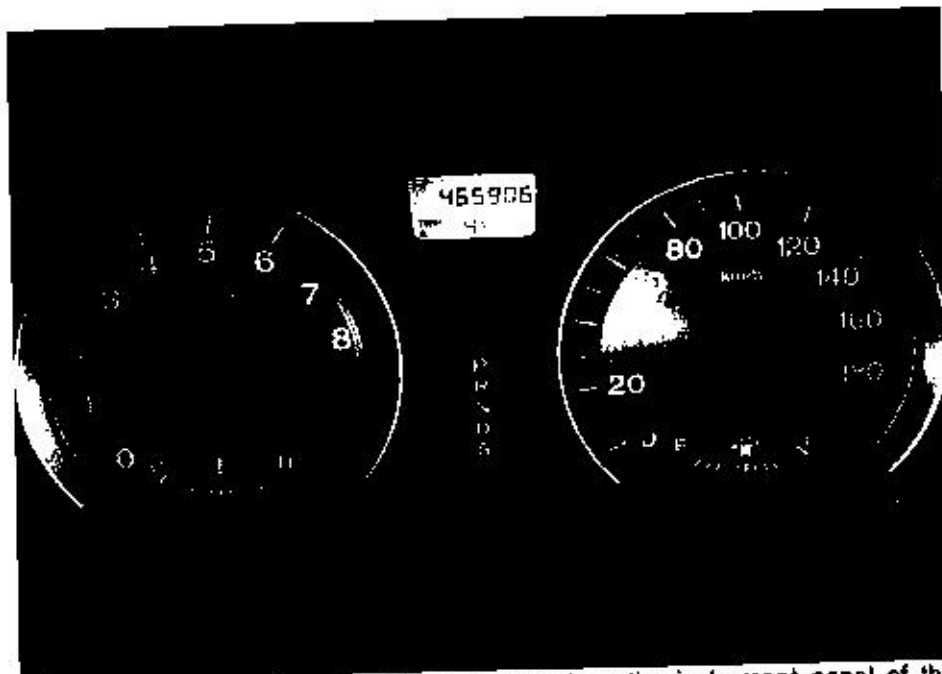
Photo 22 shows no warning lights illuminated on the instrument panel of the Motor Car after the engine was cranked. This would suggest that there was no abnormality to the various electronic operating systems of the Motor Car, like the ABS and SRS.

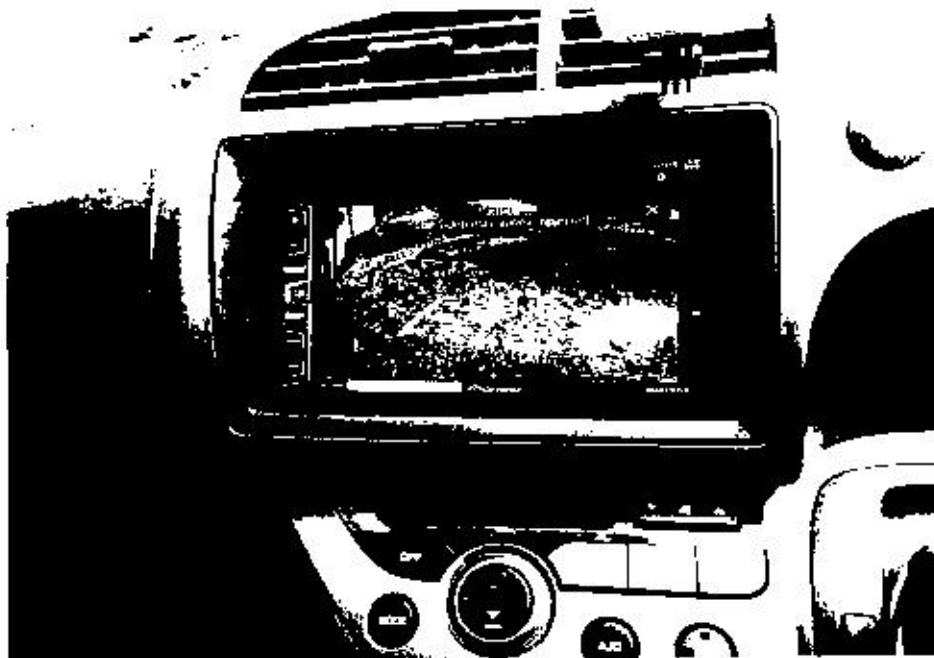
Photo 24 shows we conducted an operational test on the Motor Car. Reverse mode were engaged at time of our test. There was no abnormality observed at time of testing.

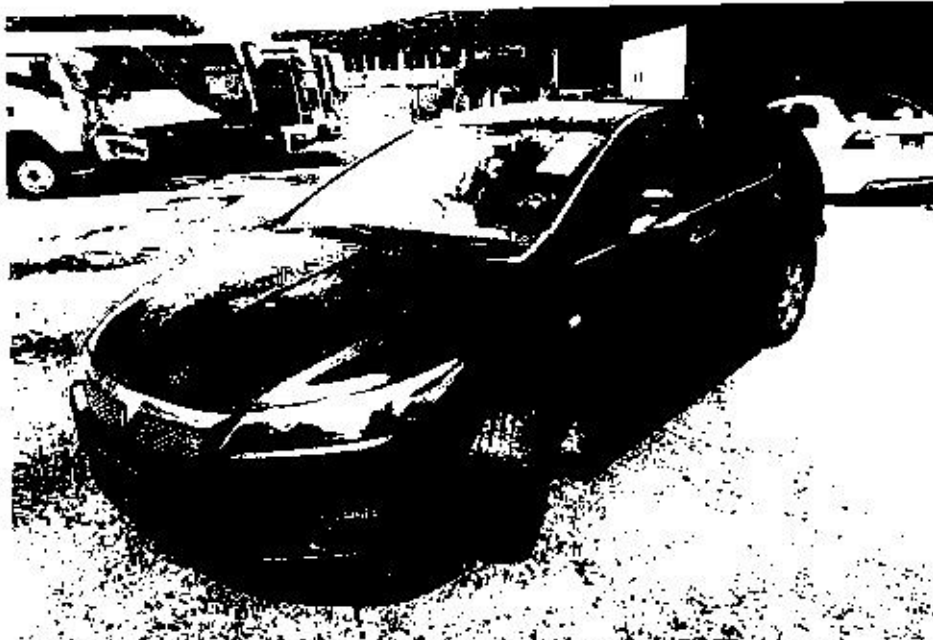
Photo 25 shows we conducted an operational test on the Motor Car. Drive mode, Reverse mode & Neutral mode were engaged at time of our test. Brake pedal was also engaged to a complete stop. There was no abnormality observed at time of testing.
