Your Ref: TP/IP/12353/2018
Our Ref :CI/TPD18010487/Z

Fatal Accident Investigation Team

MECHANICAL INSPECTION REPORT OF MOTORCYCLE FX 9957H

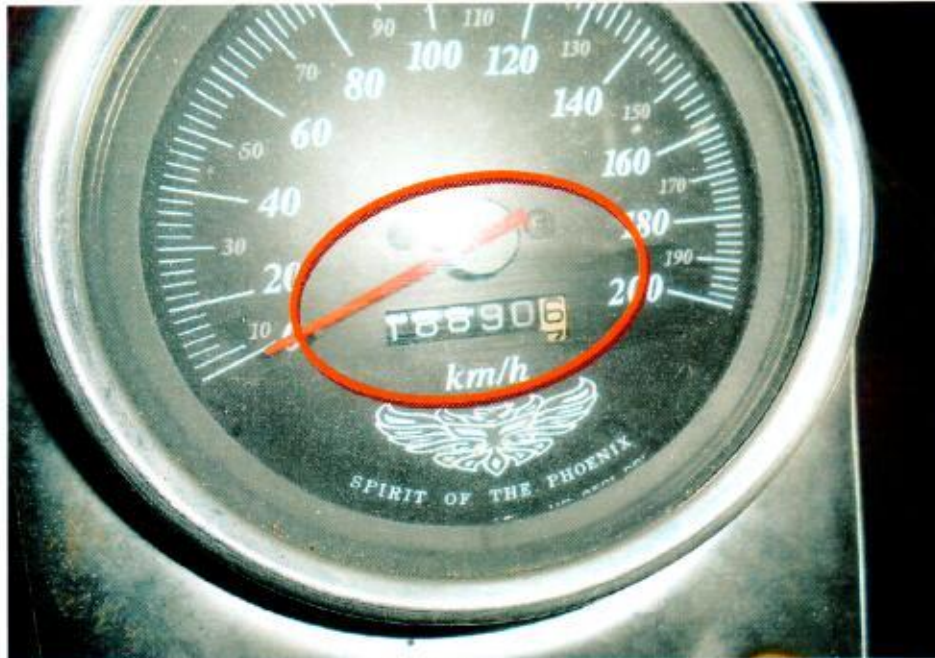
4. The mileage of the Motorcycle recorded at time of inspection was 188906km.
5. The Motorcycle was observed to have sustained minor damages at the frontal portion & along its right side. The body parts that were found to have been damaged include its dislocated handle, missing right hand brake lever, broken left wing mirror & dented right brake pedal amongst others as a result of the accident.
6. This is likely due to the consistency of the accident's case facts that the Motorcyclist was seen applying brake at the very last minute and subsequently fell & collided into the rear of stationery Motor Car. See photo 1 to 6.

Photo 1 shows the speedo-meter of the Motorcycle where the mileage recorded at 188906km.

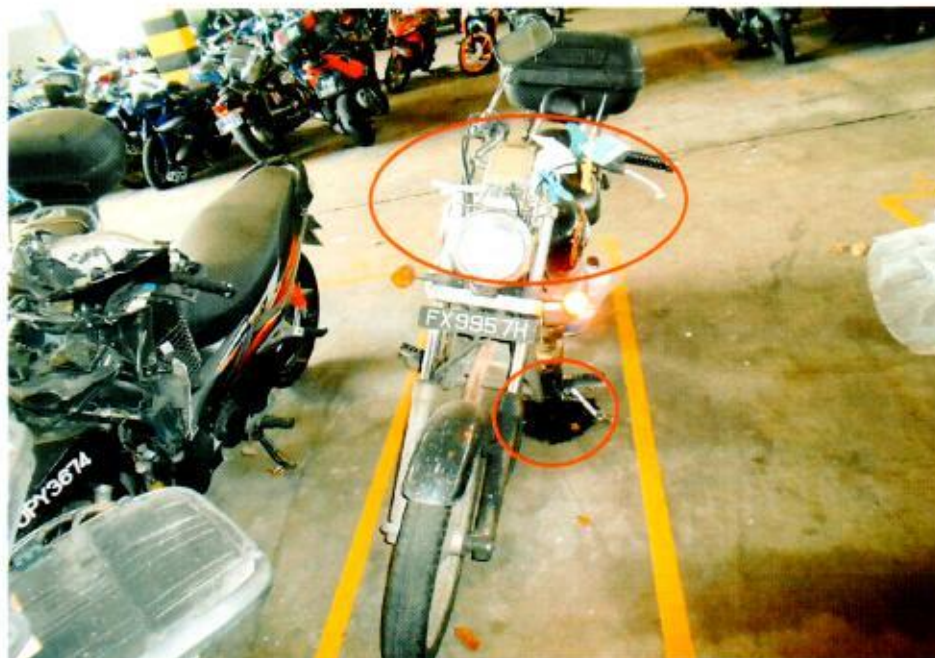
Photo 2 shows a general view of the front portion of the Motorcycle at the time of our inspection. The Motorcycle was observed to be sustained with damages due to the accident collision. (Circled)

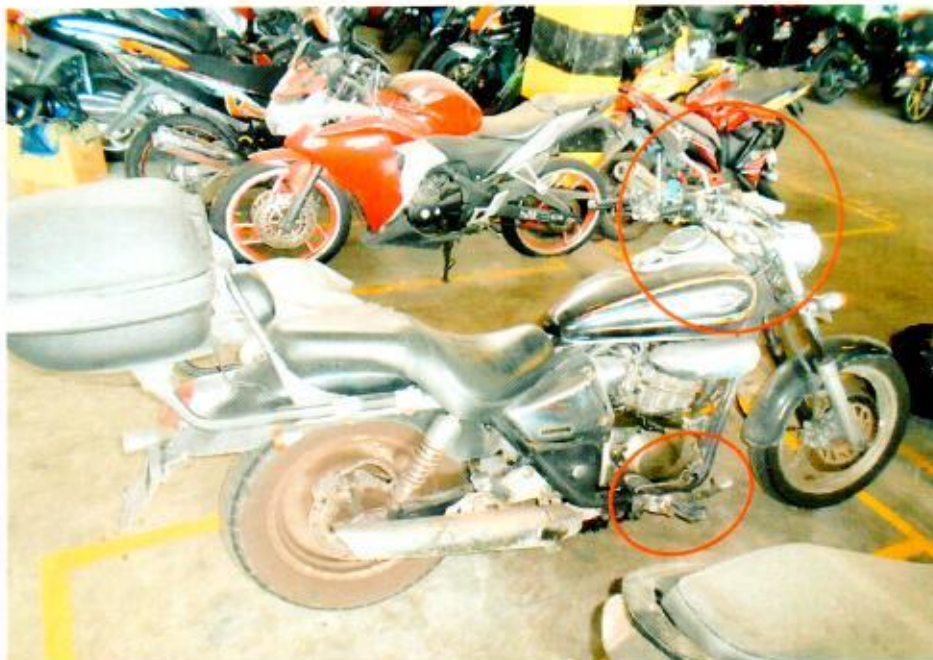
Photo 3 shows a general view of the right body of the Motorcycle at the time of our inspection. The Motorcycle was observed to have sustained minor damages at the frontal, rear portion & along its right side. (Circled)

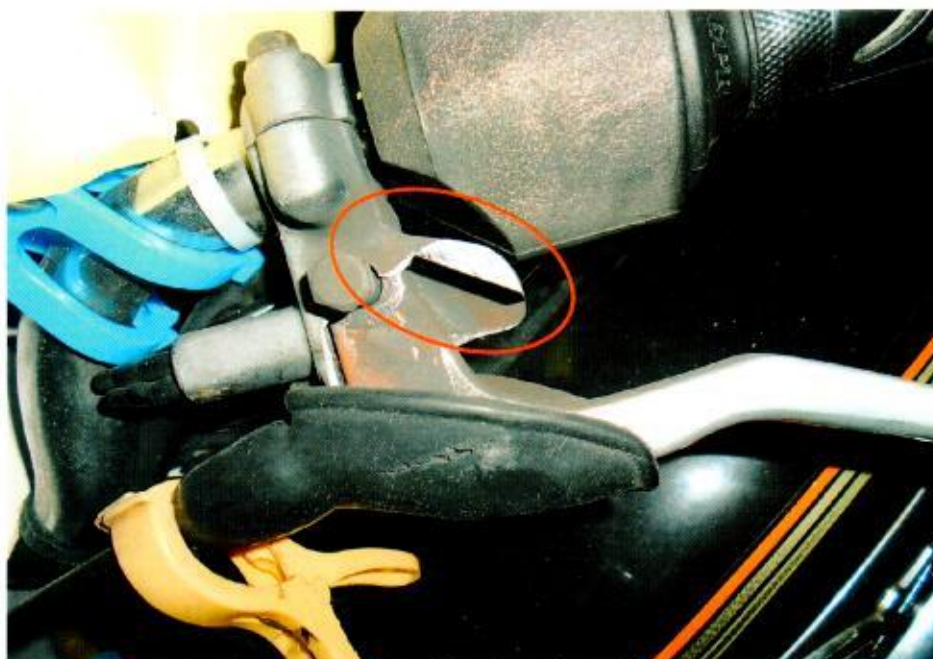
Photo 4 shows a closer view of the left wing mirror of the Motorcycle at the time of our inspection that was observed to be damaged due to the accident collision. (Circled)

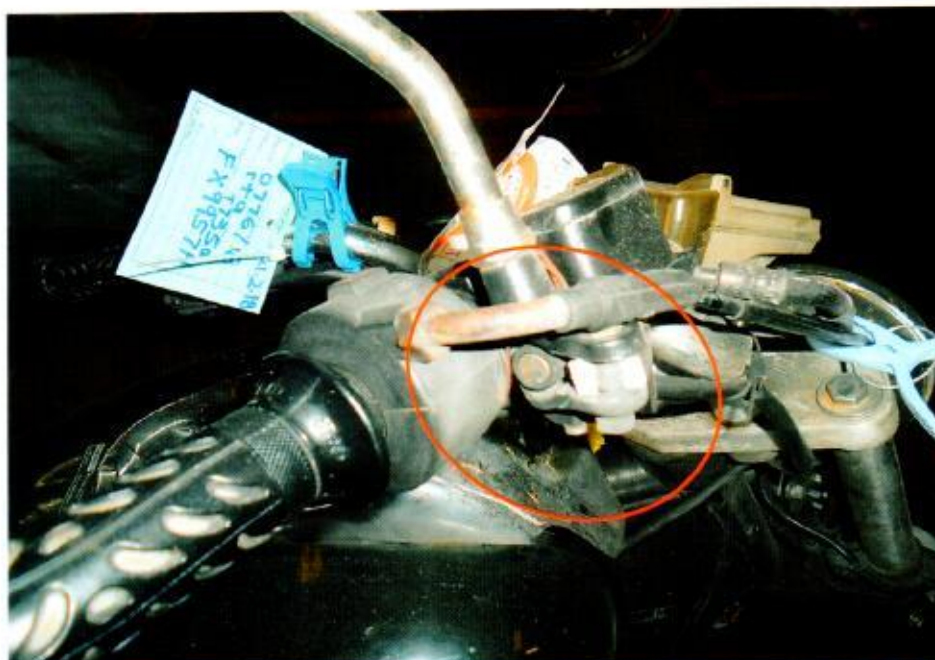
Photo 5 shows the right hand brake lever that was observed to be broken due to the accident.(Circled)

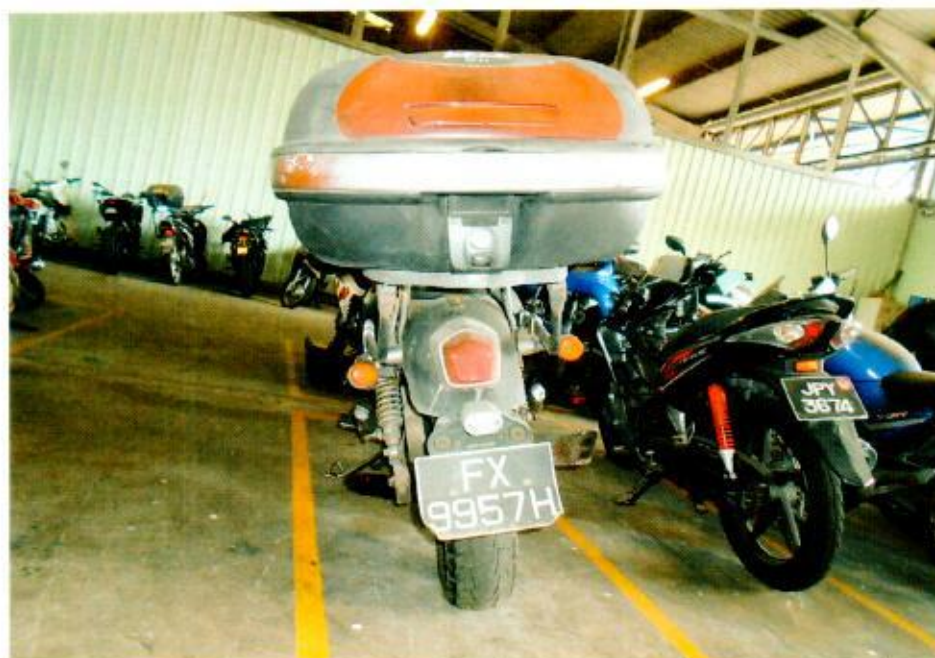
Photo 6 shows a rear view of the Motorcycle at the time of our inspection. It was observed to be in good condition not affected by the accident.

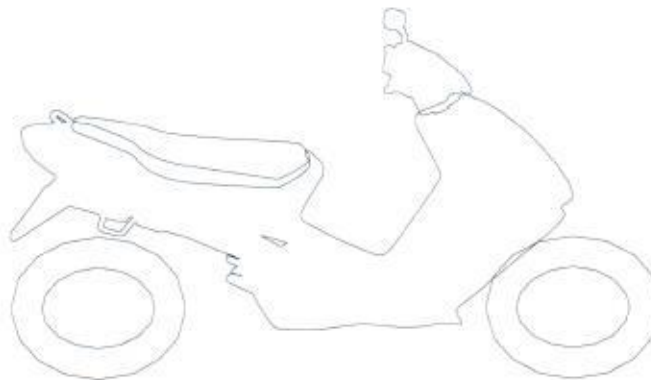
7. The condition of the Motorcycle's 2 tyres was observed to be in serviceable condition. The tread pattern of the 2 tyres was clearly visible. We did not observe any tear, burst mark(s) and/or punctured hole(s) on the sidewalls as well as across the tread of the 2 tyres. The 2 tyres were both observed to be sufficiently inflated for vehicular operation. The tyre brand, tyre size and remaining tread depth of the 2 tyres were recorded as follows:-

Pirelli City Demon 130/90 - 15 (4mm)

Pirelli City Demon 3.00 - 17 (3mm)

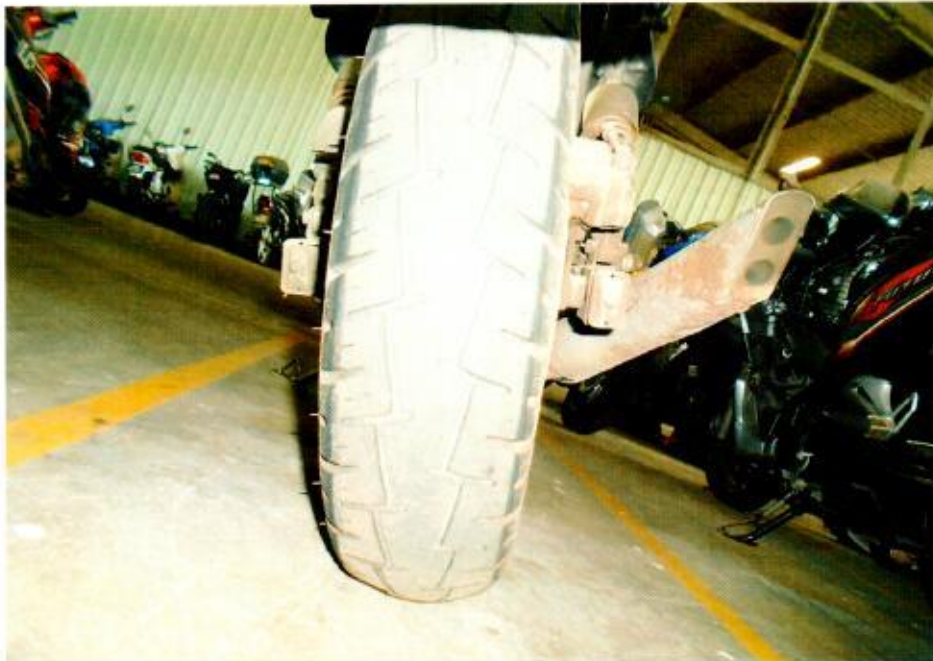
8. The rear tyre was wrapped around alloy wheel rims that were found to be without any significant damage. See photo 7 & 8 below.

Photo 7 shows the rear tyre of the Motorcycle. The rear tyre was observed to be in serviceable condition with remaining tread depth of approximately 4mm. The tyre was also observed to be sufficiently inflated for vehicular operation.

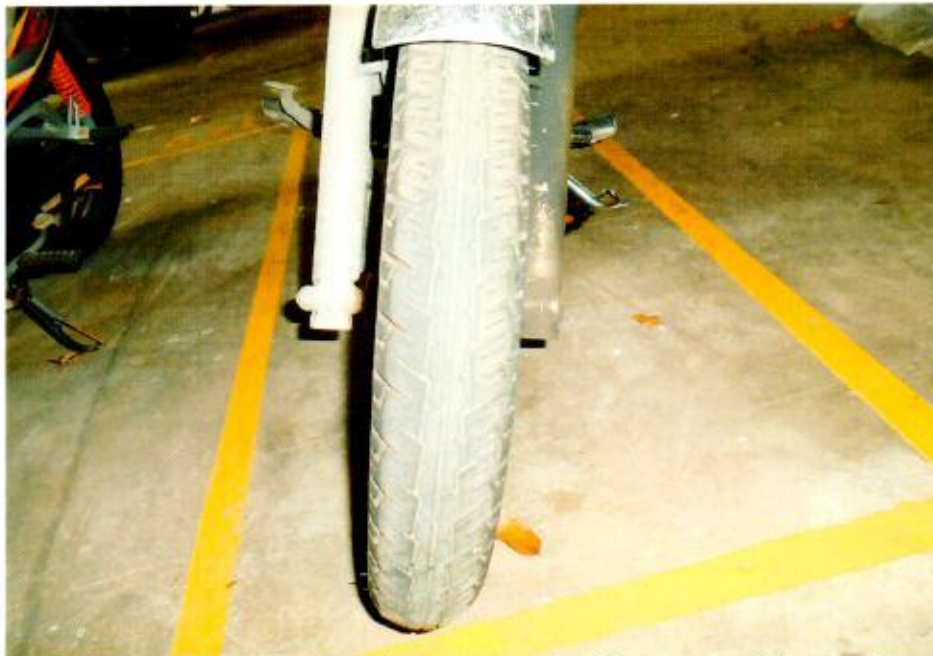
Photo 8 shows the front tyre of the Motorcycle. The pattern of the tread was clearly visible. There was no tear, burst mark(s) and/or punctured hole(s) on the sidewalls as well as across the tread of the front tyre.

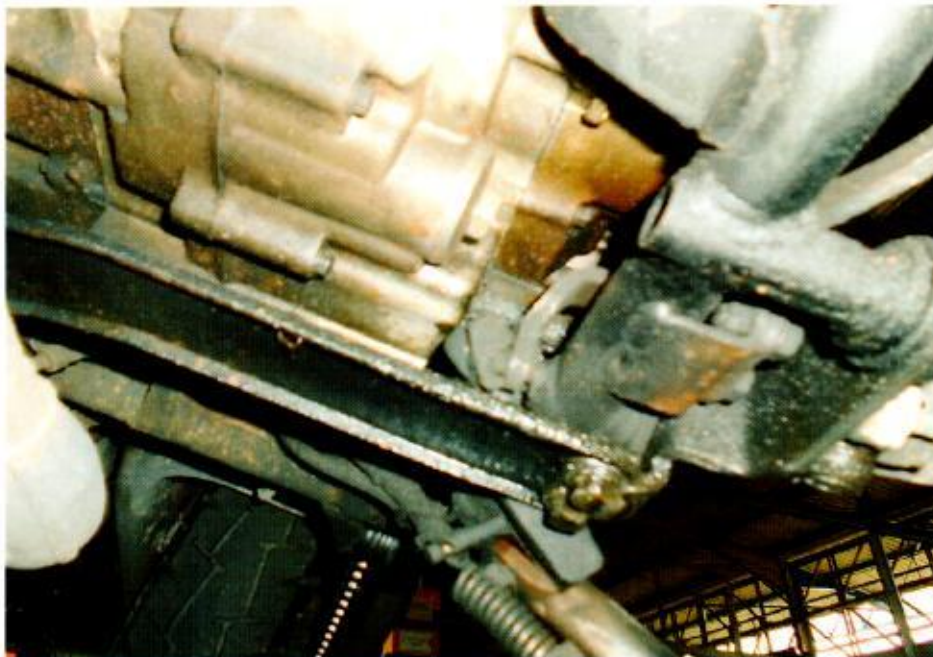
9. Upon examination of the Motorcycle's engine area, we had observed that the various engine related parts and components were intact with no visible damage. However, there was sign(s) or indication(s) of fluid leak observed around the engine area of the Motorcycle. A dark fluid stain was seen on the underside of the Motorcycle engine & also around the topside of the engine. The leakage was likely due to the accident's collision impact.
10. The gear chain of the motorcycle was found to be intact without any misalignment. It was also adequately lubricated for operating purposes. Free play tension test was also conducted & found adequately acceptable. See photo 9 – 13 below.

Photo 9 shows sign(s) or indication(s) of fluid leak observed around the underside engine area of the Motorcycle.

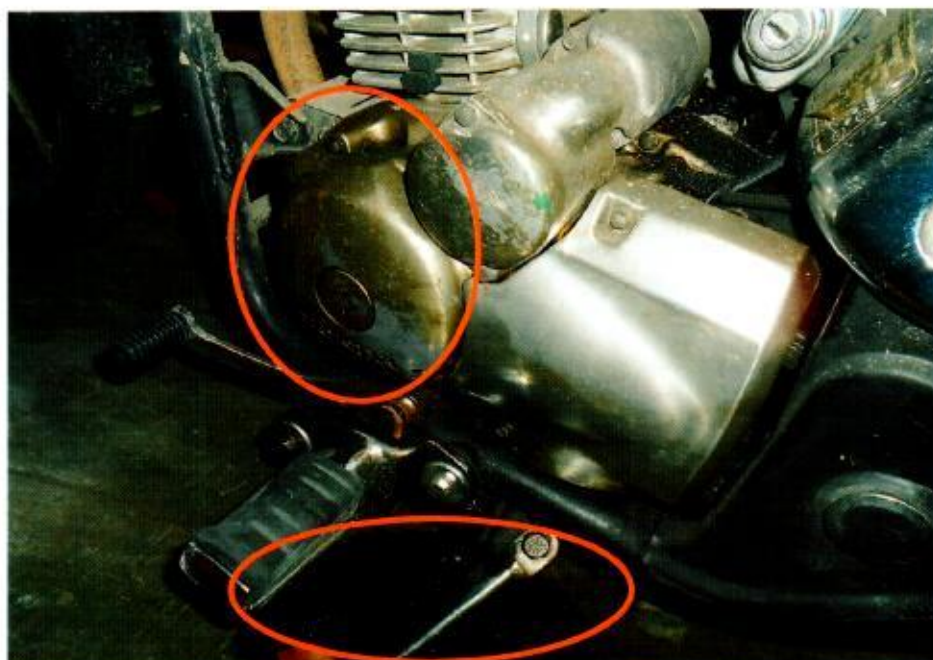
Photo 10 shows the engine fluid was sufficient, no sign(s) or indication(s) of fluid leakage stain observed around the underside of the engine area of the Motorcycle.

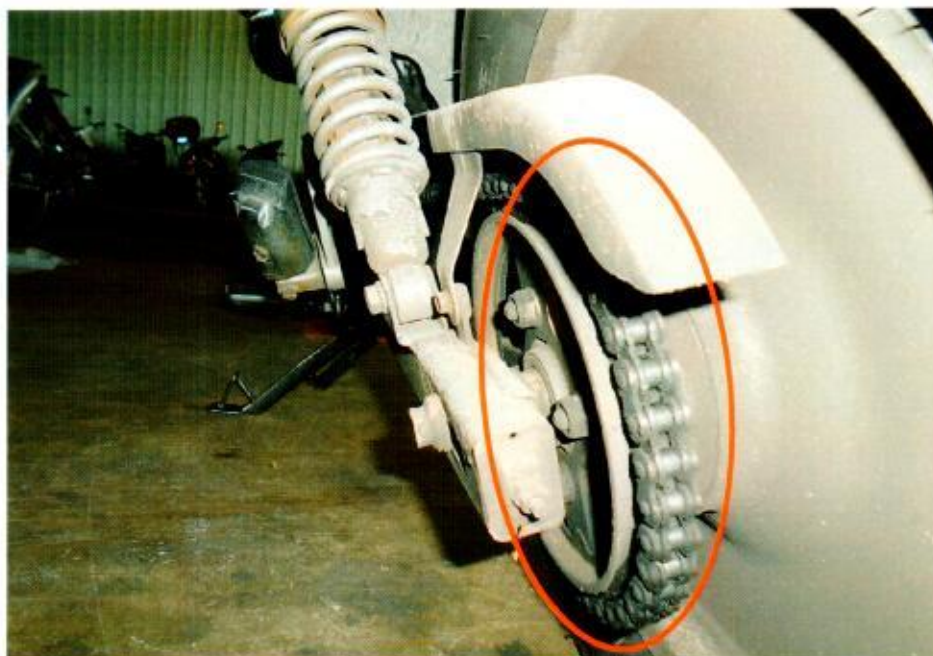
Photo 11 shows the gear chain of the motorcycle was found to be intact without any misalignment. It was also adequately lubricated for operating purposes.

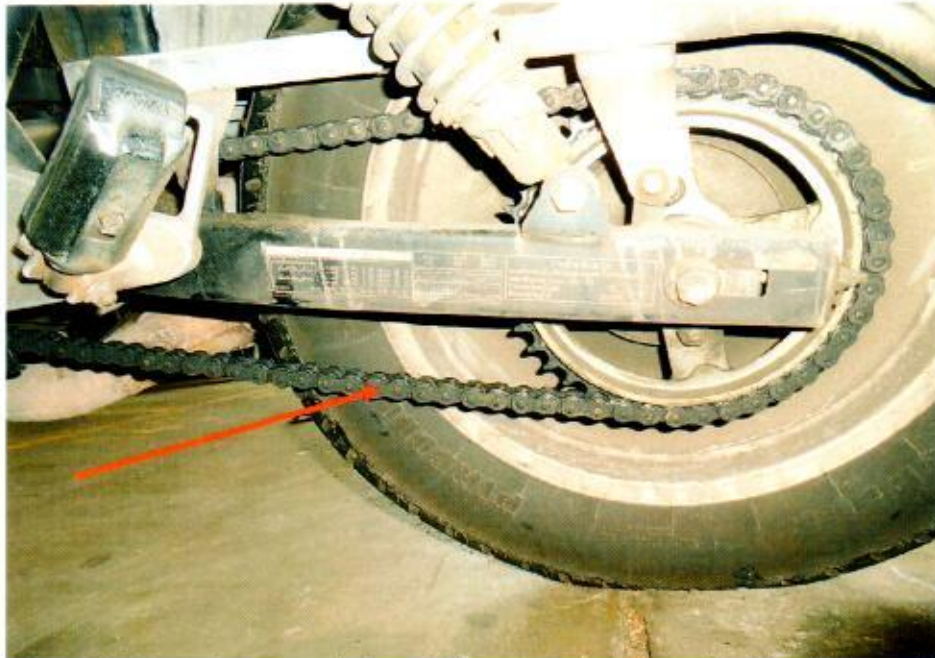
Photo 12 shows the general view of the gear train (arrowed) of the Motorcycle, which was observed to be intact with no misalignment. It was also adequately lubricated for operating purposes.

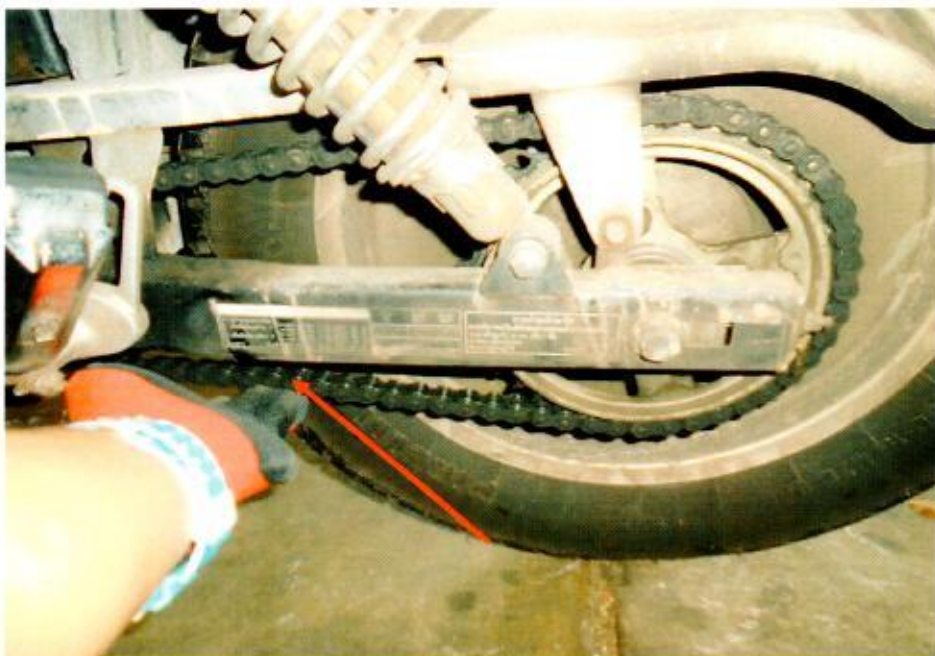
Photo 13 shows the general view of the gear train (arrowed) of the Motorcycle, which was observed to be intact with no misalignment. It was also adequately lubricated for operating purposes. Free play tension was also observed & found adequately acceptable.

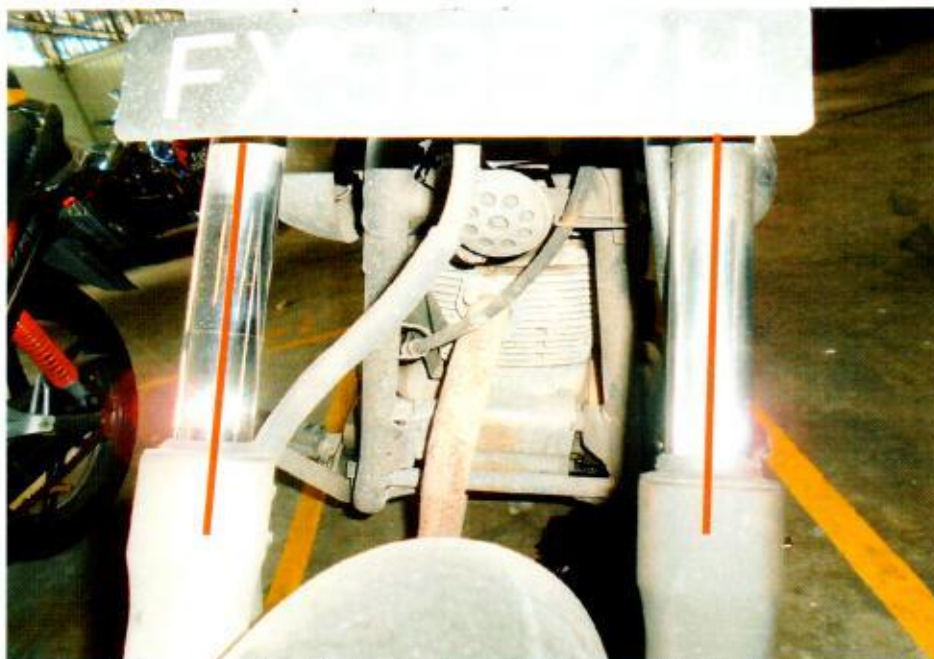
Photo 14 shows the front fork was observed to be unaffected by the accident's impact. It was observed to be in still in serviceable condition.

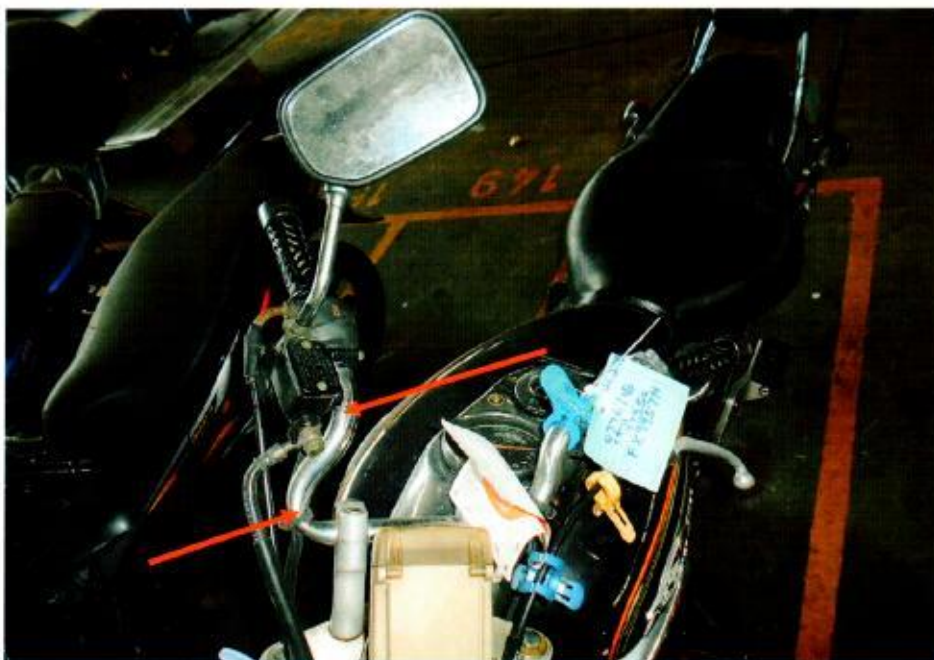
11. Our checks on the various steering components of the Motorcycle had revealed that its steering system was in not serviceable condition. Its handle bar was found to be severely bent likely due to the accident's impact collision.

Photo 15 shows the steering system was observed to be damaged likely due to the accident's impact.

15. Basing on our physical inspection of the Motorcycle, it appears that the steering system was not in serviceable condition. Its handle bar was found to be severely bent inwards likely due to the accident's impact collision.
16. The front braking systems of the Motorcycle could not be tested due to a broken hand brake lever as a result of the accident. However, further observation reveal that the front brake components such as brake cables, brake calliper brake pad amongst others were in serviceable condition. As for the rear brake, it was observed to be in serviceable condition as per our static brake test.
17. We did not find any evidence(s) to suggest that there was possible mechanical failure to the Motorcycle that may have caused and/or contributed to the accident.

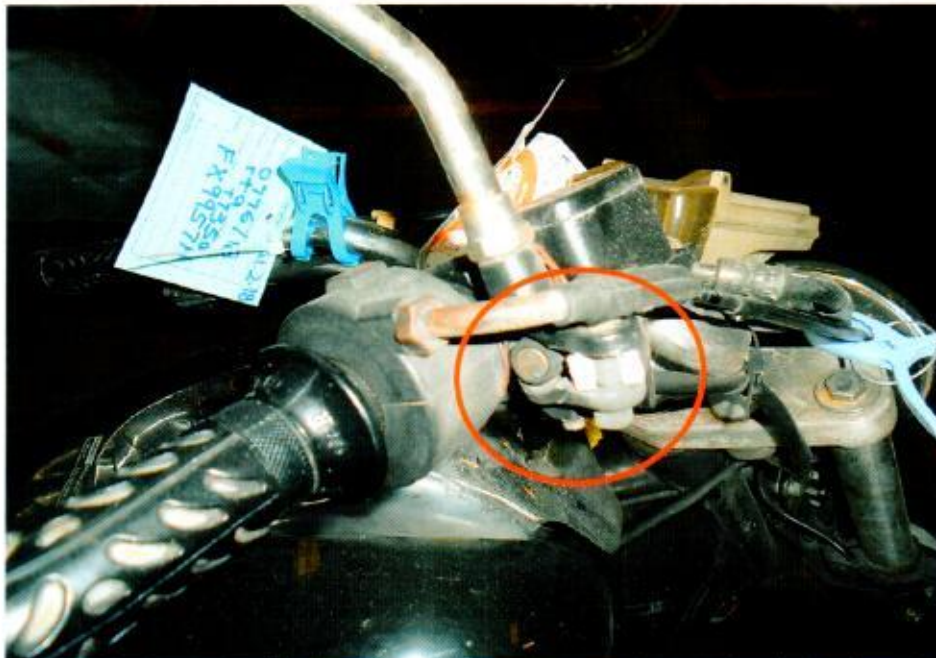
13. Static brake tests conducted only on the Motorcycle rear brake had appeared to indicate that it was in serviceable condition. As for the front brake, it's hand brake lever was found to have been broken due to the accident's impact collision. However, the Motorcycle's braking system like the brake discs, brake callipers, brake pad, brake foot pedal and brake hoses revealed all to be intact and without damage. There was some resistance felt (spongy like feel) upon stepping on the rear brake pedal. This would indicate that there was no leakage of pressure/vacuum in the rear brake system. Our checks on the brake fluid had also indicated that the brake fluid was of sufficient level for operational purposes, and without contamination.

Photo 16 shows the right hand brake lever that was observed to be broken due to the accident.

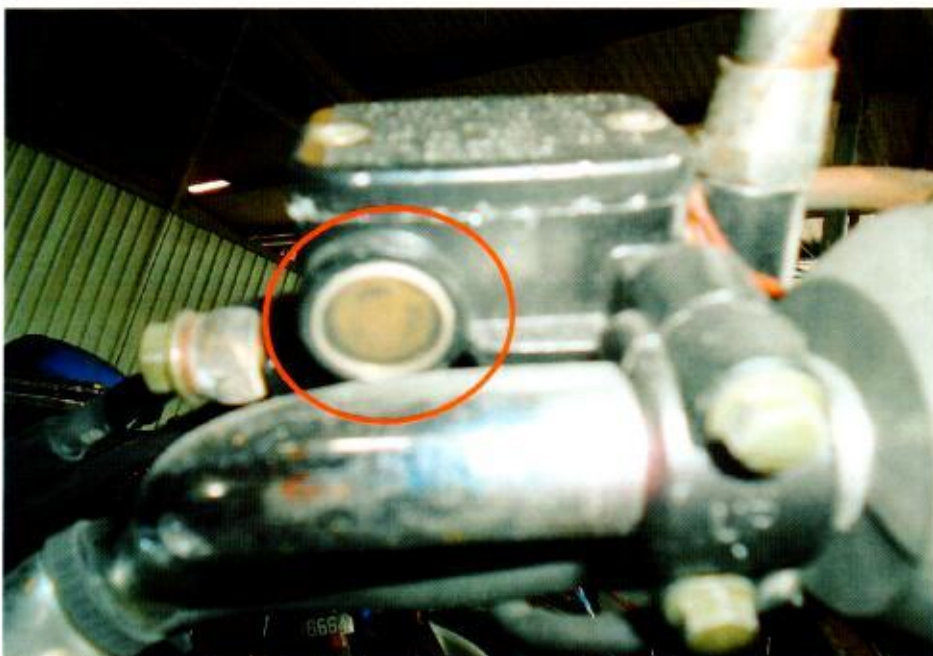
Photo 17 shows the brake fluid reservoir for front brake observed to be sufficient at time of our inspection.

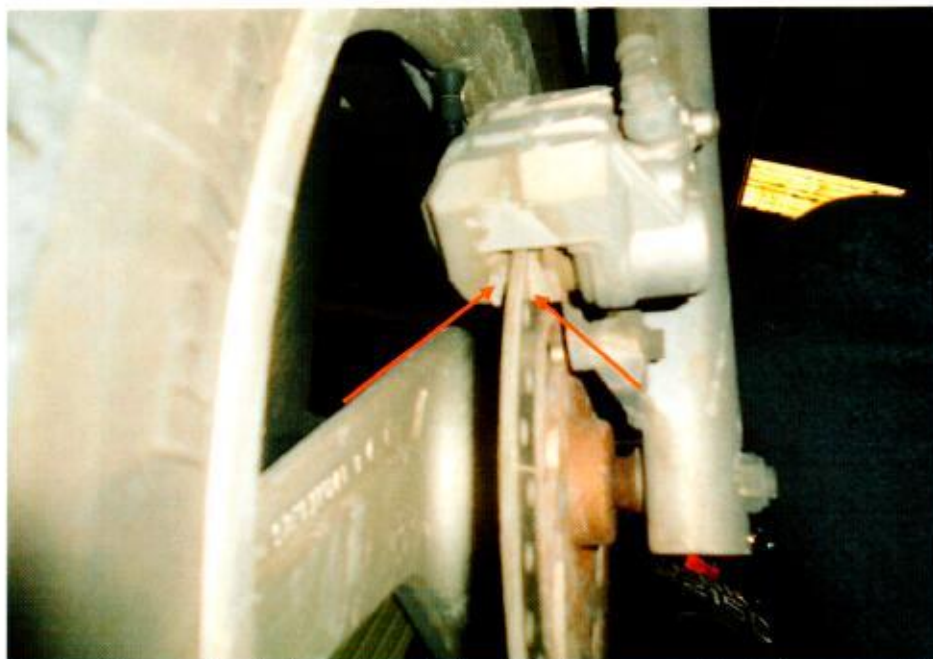
Photo 18 shows the brake pad for the front brake, observed to be in serviceable condition at time of our inspection. The frictional material found to be sufficient for operational purposes.

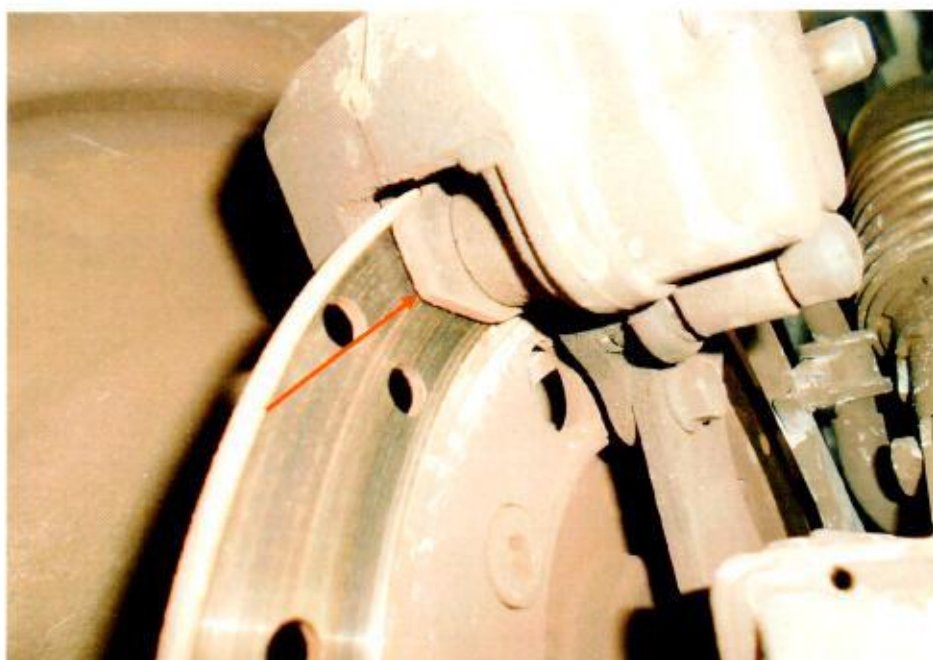
Photo 19 shows the brake pad for the rear brake observed to be in serviceable condition at time of our inspection. The frictional material found to be sufficient for operational purposes.

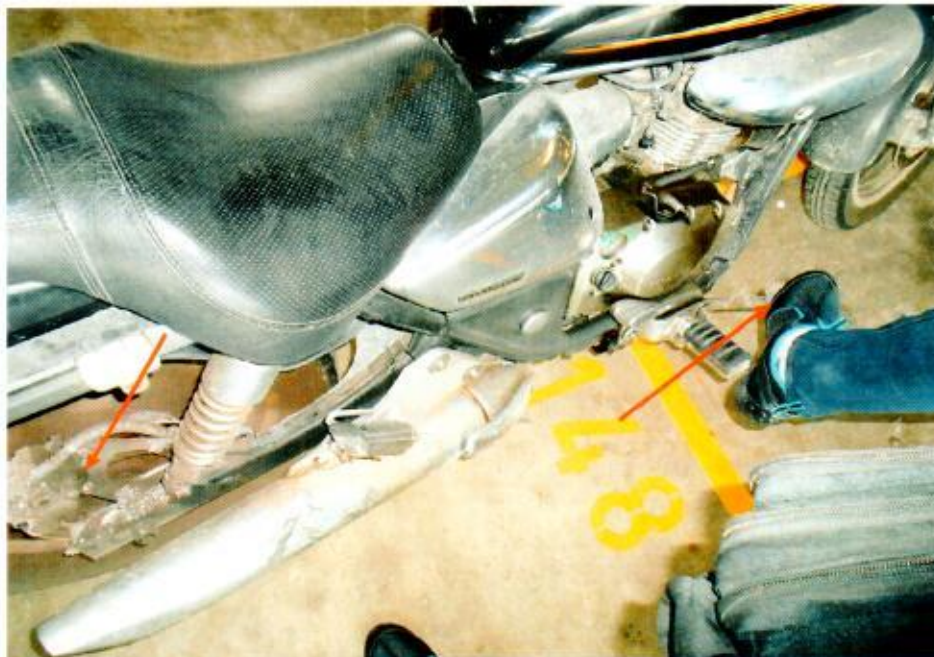
Photo 20 shows testing of the braking of the rear brake in progress. There was some resistance felt (spongy like feel) upon stepping on the brake pedal.
