Your Ref: TP/IP/21411/2018  
Our Ref : CI/TPD18010489/Z

25<sup>th</sup> April 2018

### **MECHANICAL INSPECTION REPORT OF MOTOR CAR SKV 6736A**

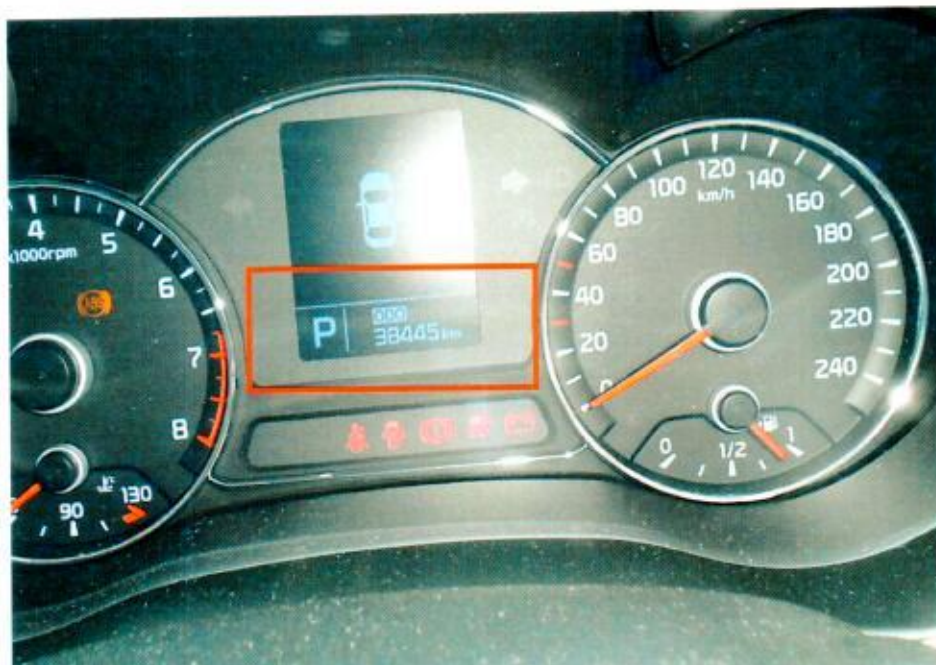
**Photo 1** shows the mileage of the Motor Car at the time of our inspection was recorded at 38445km.

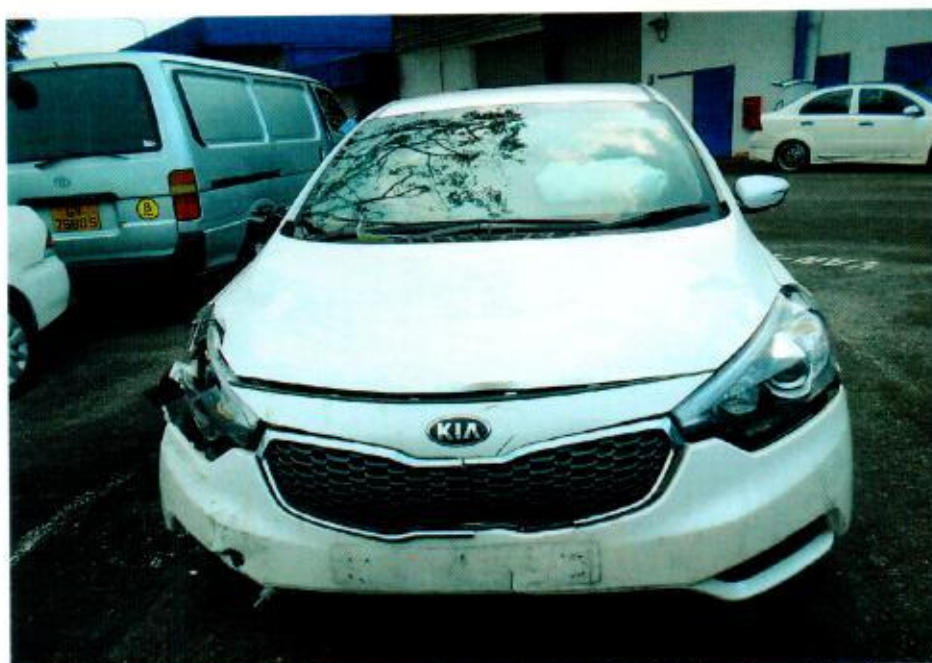
**Photo 2** shows a general view of the front body of the Motor Car at the time of our inspection. The Motor Car was observed to have sustained damages at the frontal, front left & front right portion.

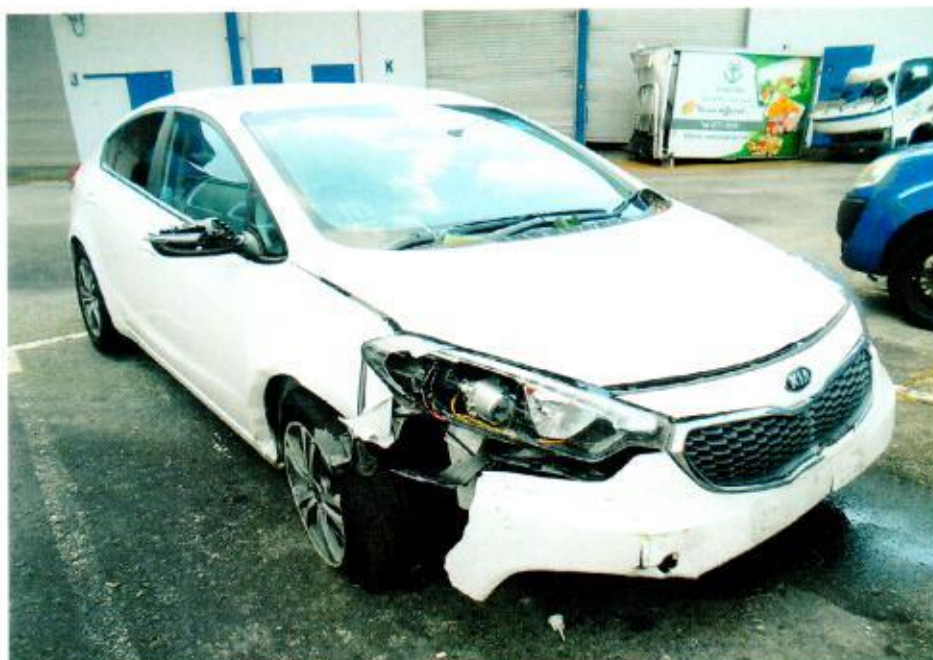
**Photo 3** shows a general view of the front right body of the Motor Car at the time of our inspection. The Motor Car was observed to have sustained damages at the frontal, front left & front right portion.

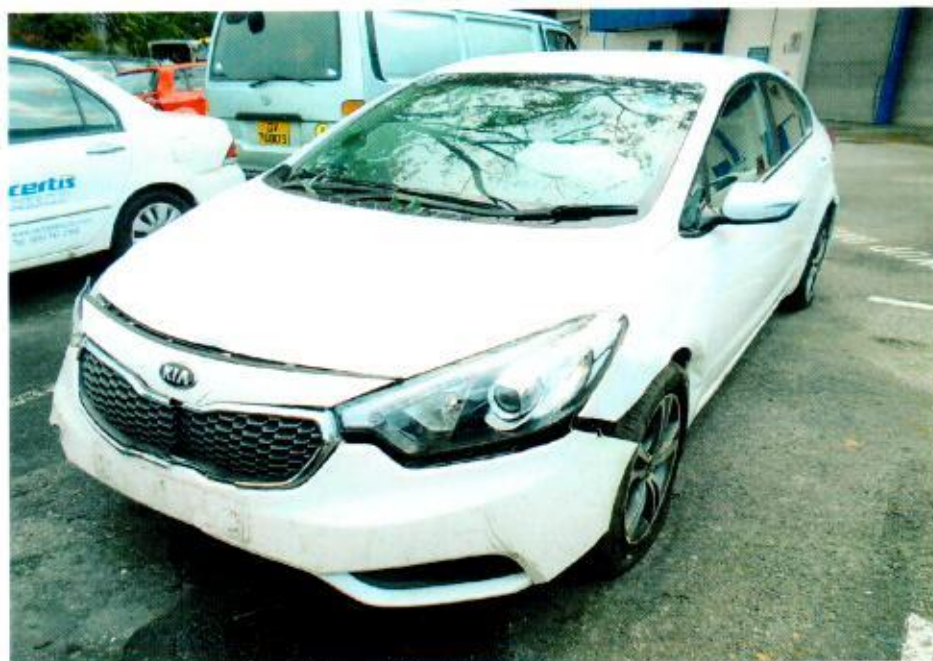
**Photo 4** shows a general view of the front left body of the Motor Car at the time of our inspection. The Motor Car was observed to have sustained damages at the left frontal portion.

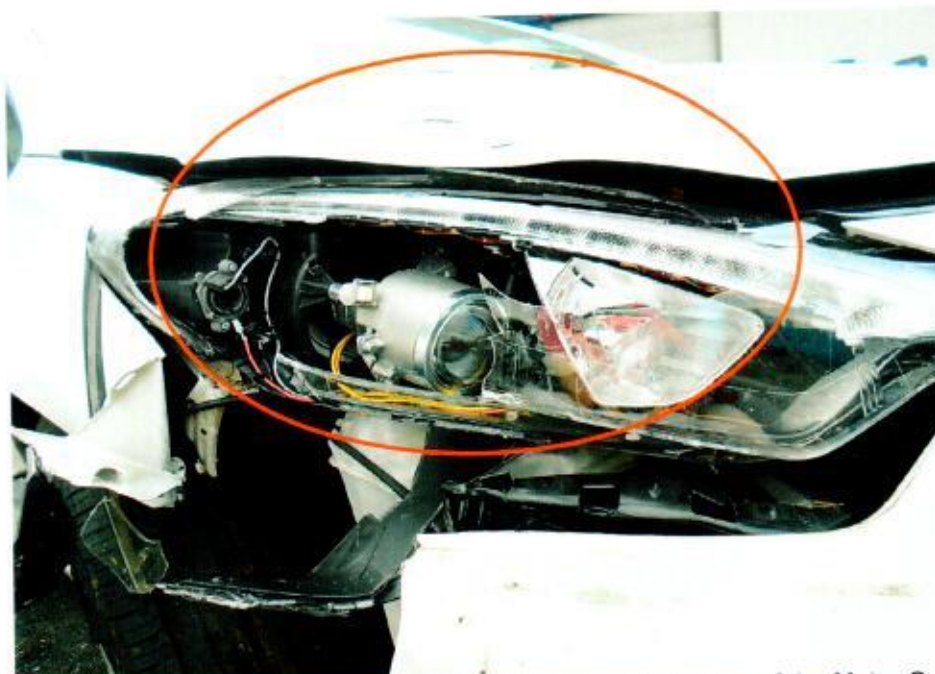
**Photo 5** shows a close up view of the front right side headlamp of the Motor Car at the time of our inspection. It had sustained damages likely due to the accident.

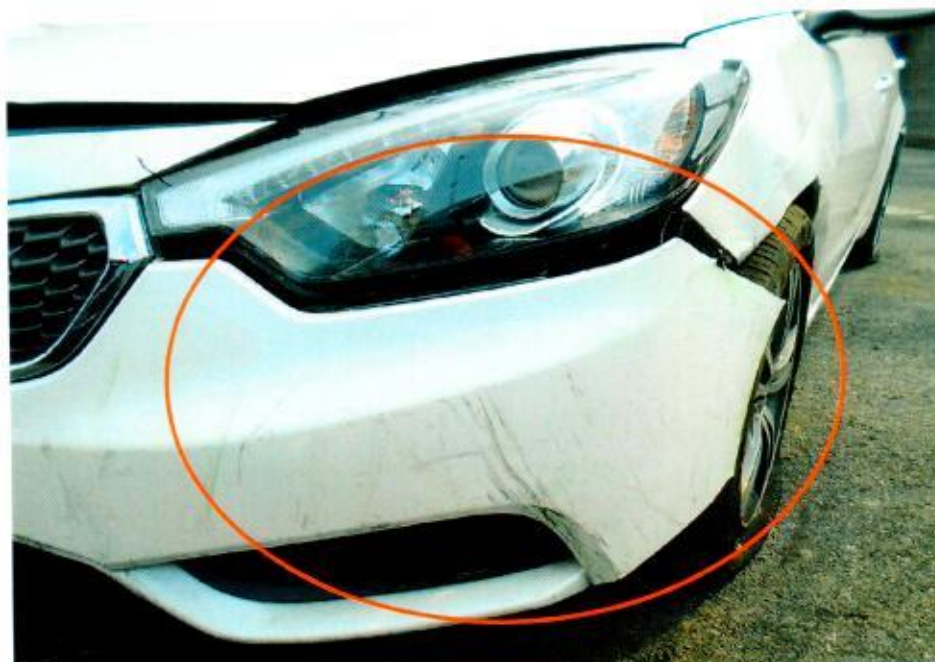
**Photo 6** shows a close up view of the front left lower bumper of the Motor Car at the time of our inspection. It had sustained damages likely due to the accident.

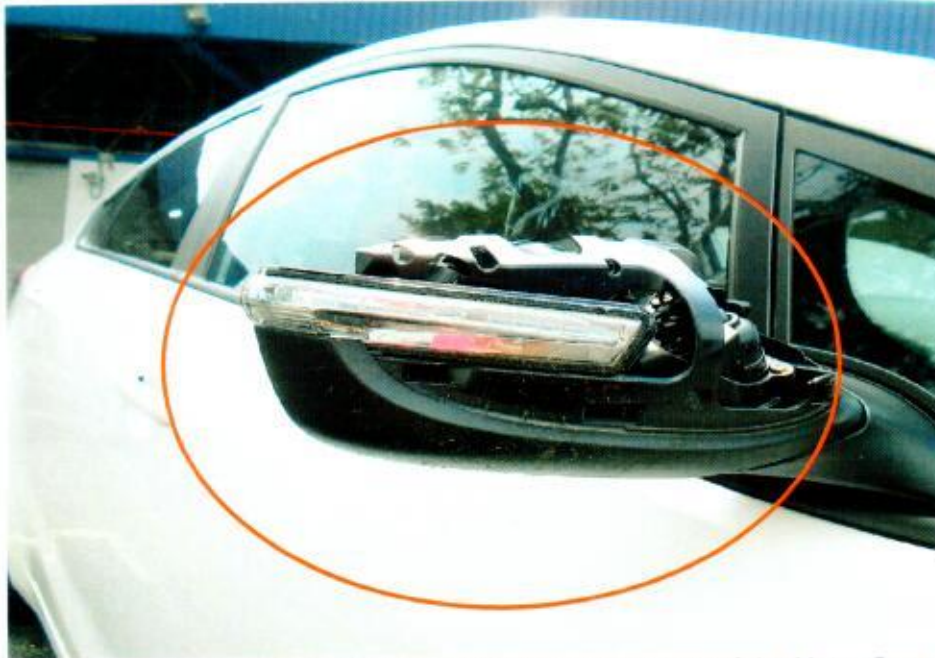
**Photo 7** shows a close up view of the front right side mirror of the Motor Car at the time of our inspection. It had sustained damages likely due to the accident.

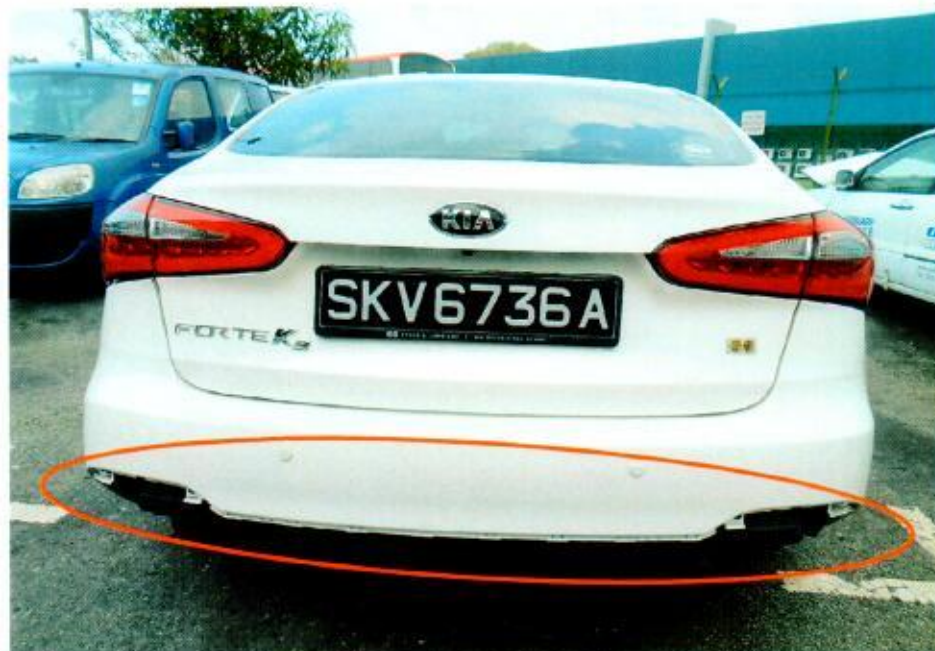
**Photo 8** shows a general view of the rear body of the Motor Car at the time of our inspection. It had sustained damages likely due to the accident.

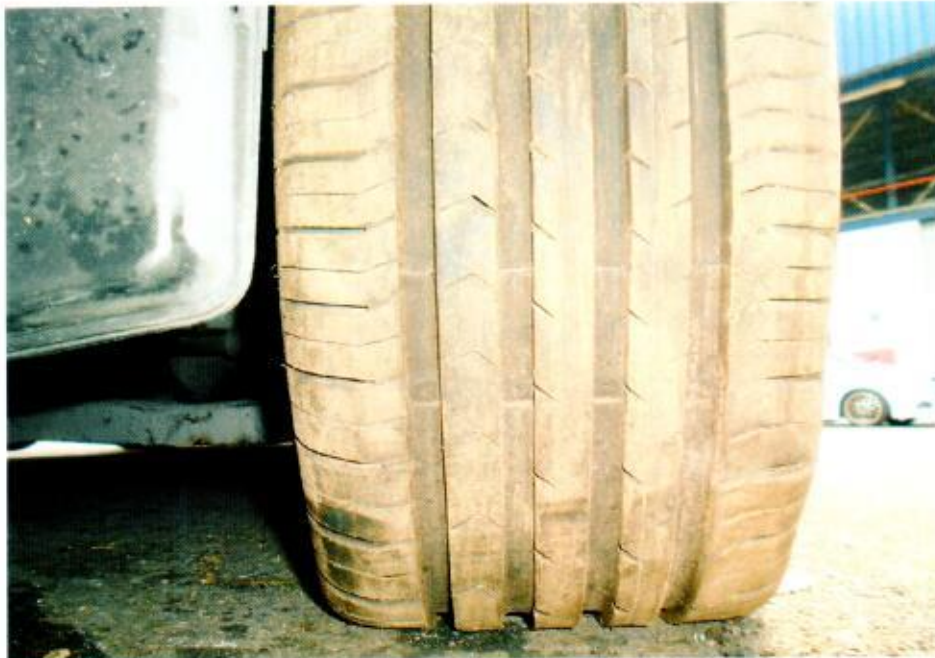
**Photo 9** shows the condition of the front left tyre of the Motor Car, with remaining tread depth of approximately 7mm. However, it was observed to be deflated due to the accident's impact.

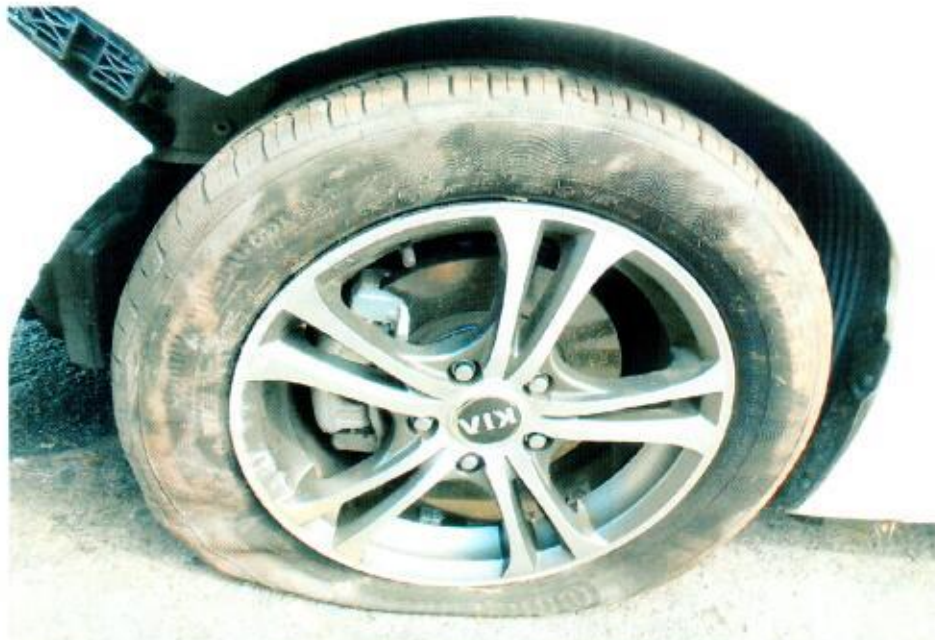
**Photo 10** shows the condition of the front left tyre of the Motor Car, which was observed to be deflated due to the accident. Its alloy wheel rim also found to have sustained with scratches.

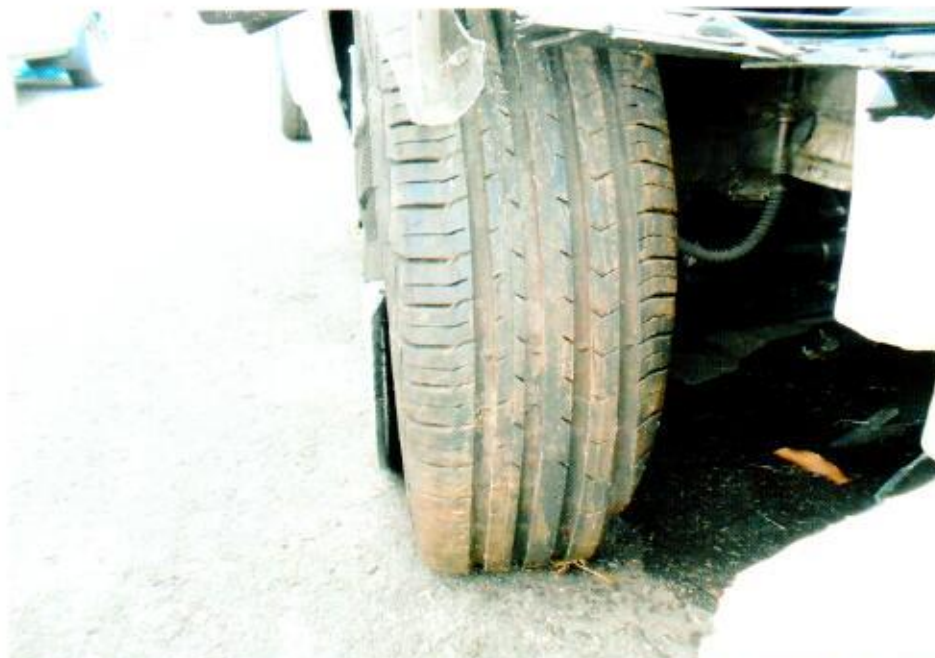
**Photo 11** shows the condition of the front right tyre of the Motor Car, with remaining tread depth of approximately 7mm. However, it was observed to be deflated due to the accident's impact.

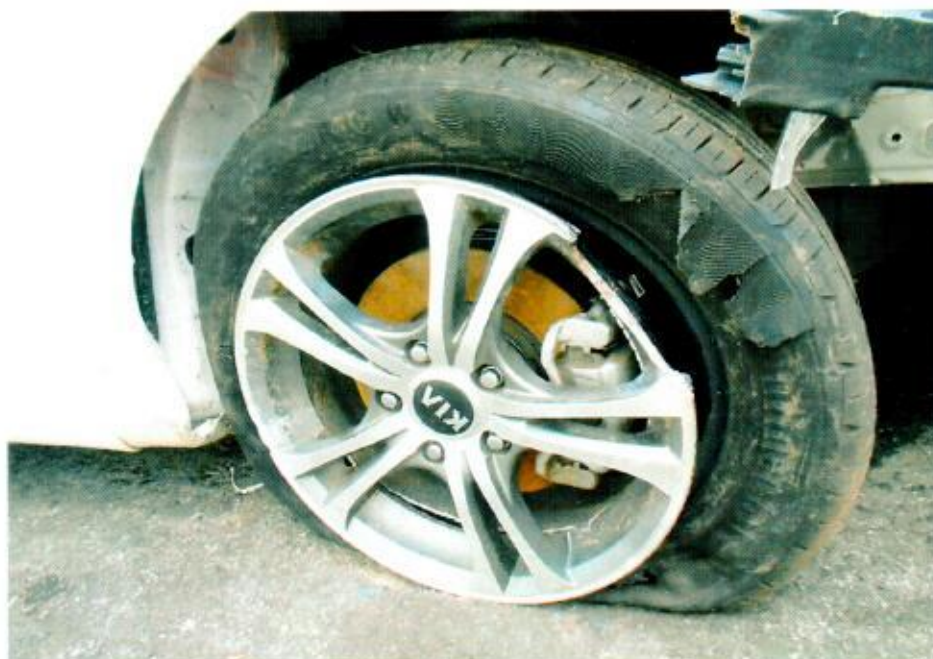
**Photo 12** shows the condition of the front right tyre of the Motor Car, with remaining tread depth of approximately 7mm. Further observation found that the sidewall was torn & deflated. The alloy wheel rim found to be damaged as a result of the accident.

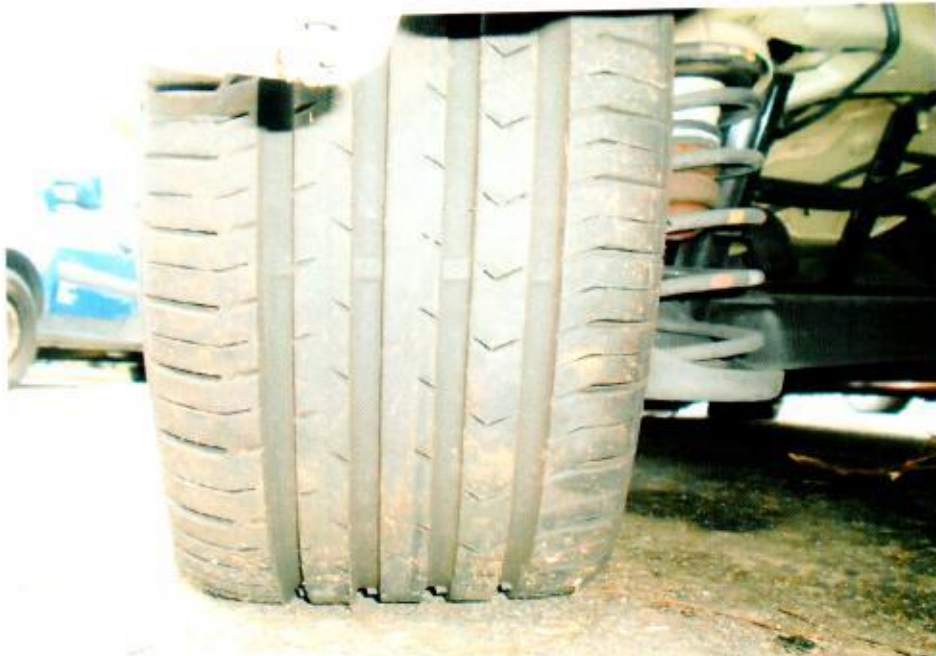
**Photo 13** shows the condition of the rear left tyre of the Motor Car, with remaining tread depth of approximately 7mm. However, it was observed to be deflated due to the accident's impact.

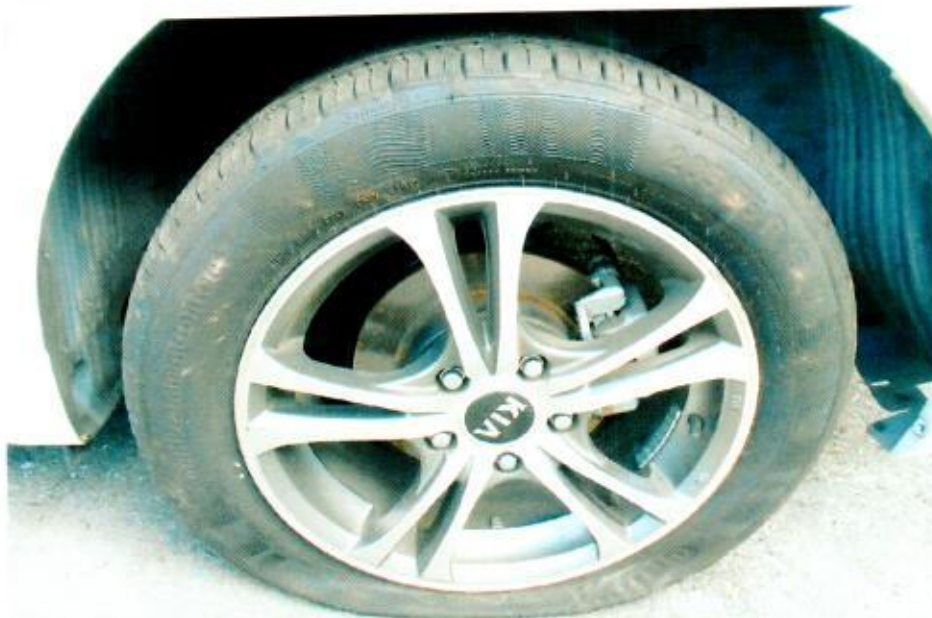
**Photo 14** shows the condition of the rear left tyre of the Motor Car, which was observed to be deflated due to the accident. Its alloy wheel rim also found to have sustained with scratches.

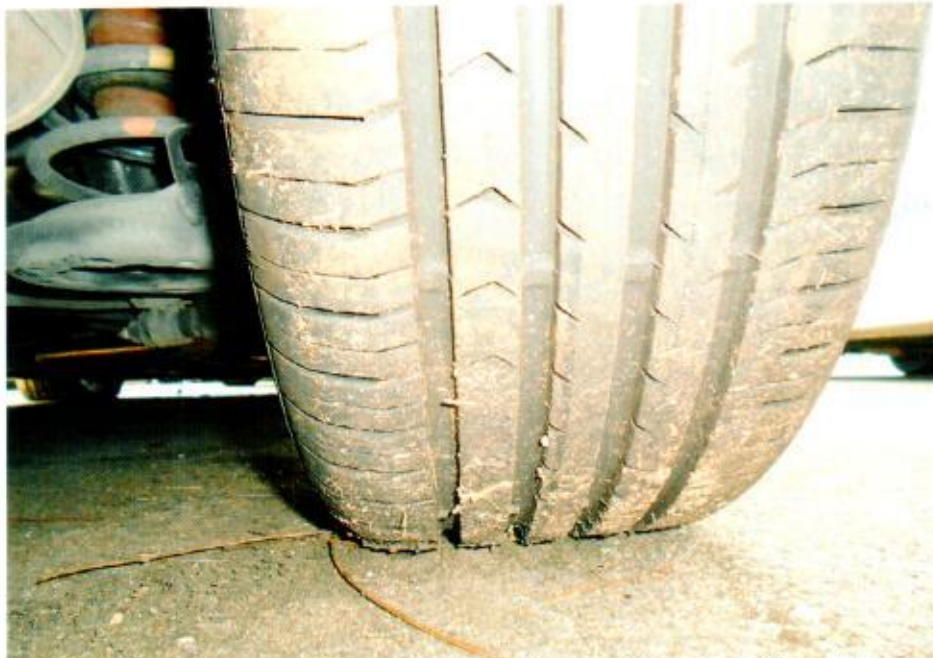
**Photo 15** shows the condition of the rear right tyre of the Motor Car, which was observed to be in serviceable condition with remaining tread depth of approximately 8mm. The tyre was also observed to be sufficiently inflated for vehicular operation.

21. As for the rear right tyre, it was observed to be in serviceable condition. We did not find any tear, cut or burst mark(s) on the outer and the inner sidewalls as well as across the tread of the tyre. It was also observed to be sufficiently inflated for vehicular operation. The remaining tread depth of the rear right tyre was approximately 8mm.

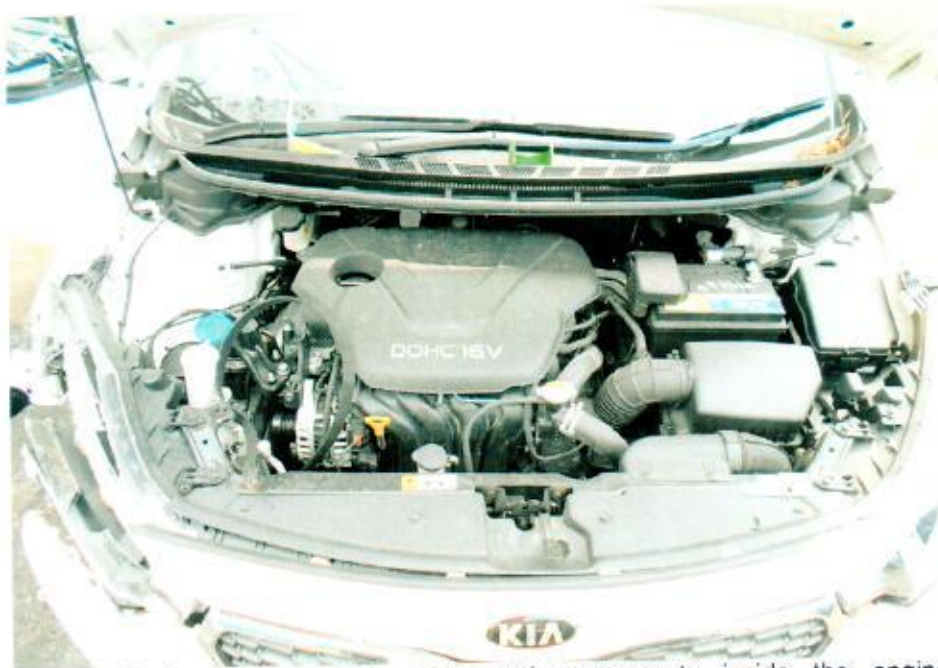
**Photo 16** shows the visible parts and components inside the engine compartment to be intact and unaffected by the accident.

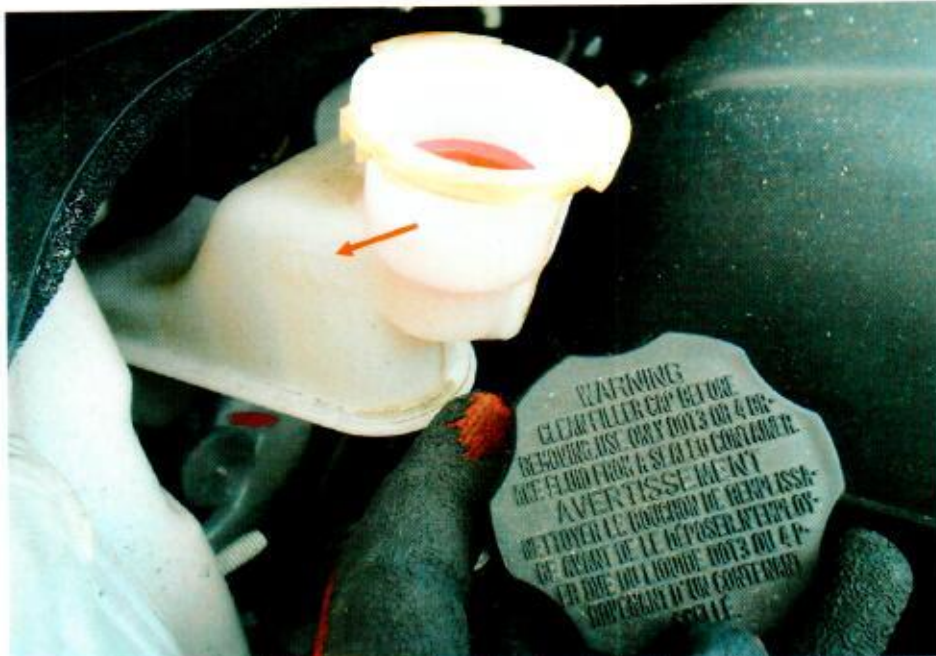
Photo 17 shows the fluid component such as brake fluid was visible and found to be of sufficient level for operating purposes. Visually, there was also no contamination found to this fluid.

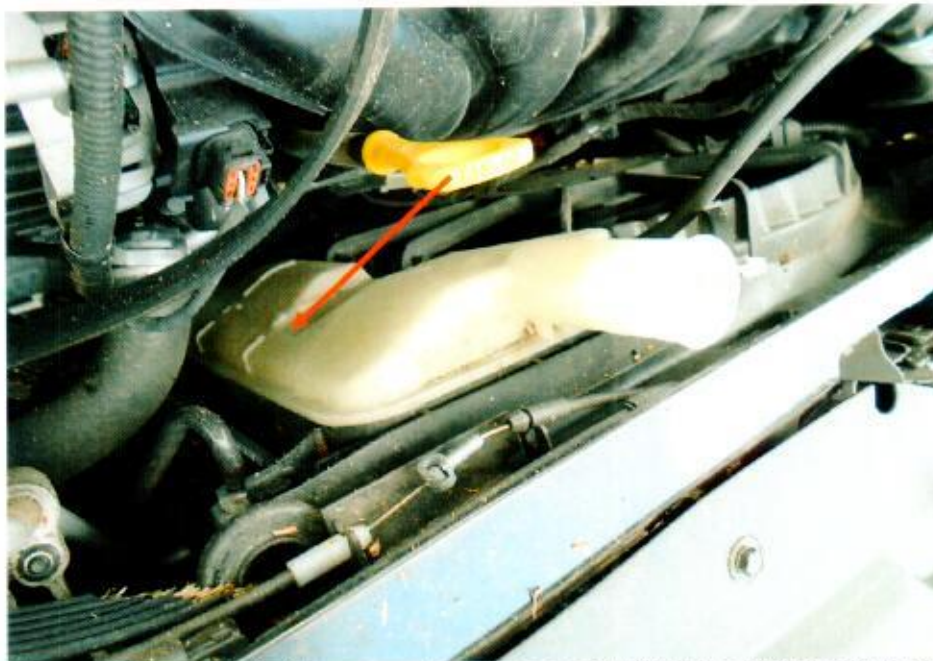
Photo 18 shows the fluid component such as coolant fluid was visible and found to be of sufficient level for operating purposes. Visually, there was also no contamination found to this fluid.

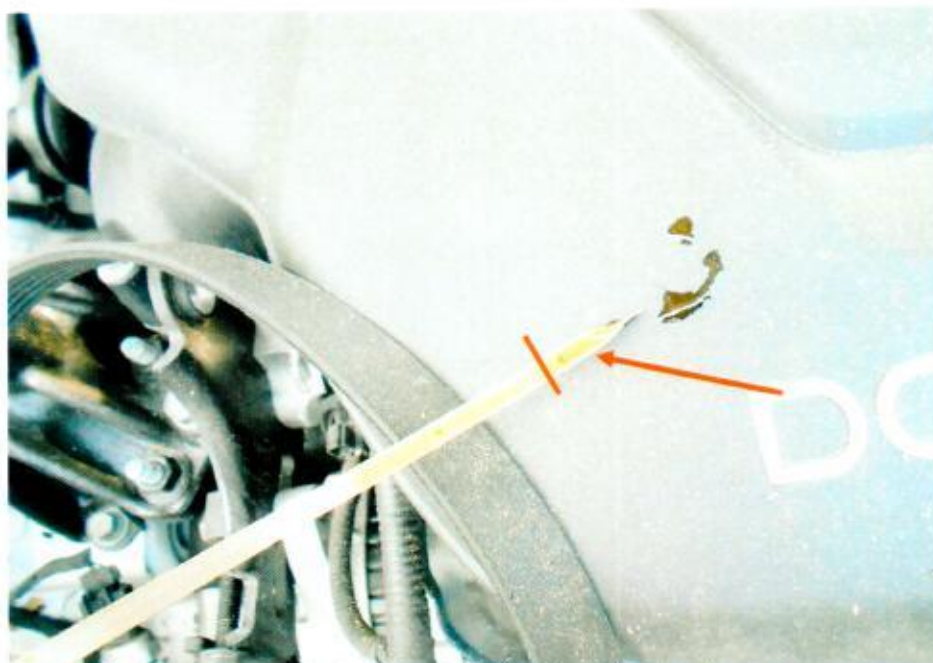
10. Upon thorough examination of the engine compartment, the engine undercarriage was however observed to be covered with fluid, suggesting leakage of fluid. There was no accumulation of dust and/or dirt particles on the engine housing where the fluid stains had formed. This would indicate that the fluid leakage was a fresh leak and likely to be a result of the accident. Despite leakage traces found on the engine undercarriage, there were also traces of fluids on the ground right above the engine pan. Our further observation on the engine fluid, we found that it was at slightly above the minimum level mark on the dip stick. This indicates that there's a decrease to the engine fluid likely due to the leakage.

**Photo 19** shows the engine fluid. Although, visually there was also no contamination found to this fluid. However, due to leakage observed on the underside of the engine, the engine fluid was found to be around the lower level of the acceptable mark on the dip stick.

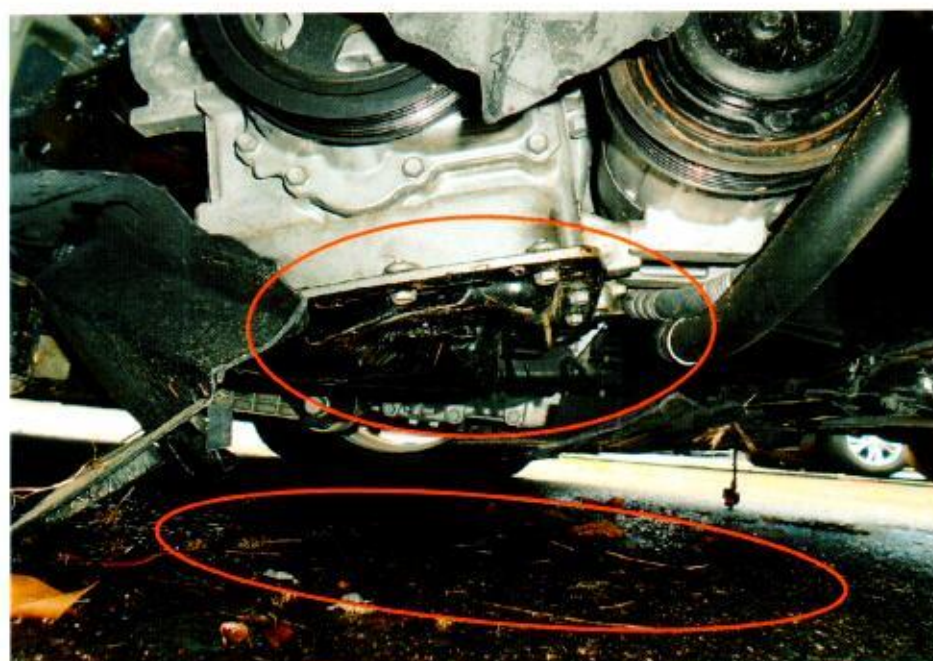
**Photo 20** shows the underside of the Motor Car also reveals there's fluid stain on the ground right underneath the engine pan. This indicates that there's fluid leakage exist likely due to the damages sustained as a result of the accident's impact.

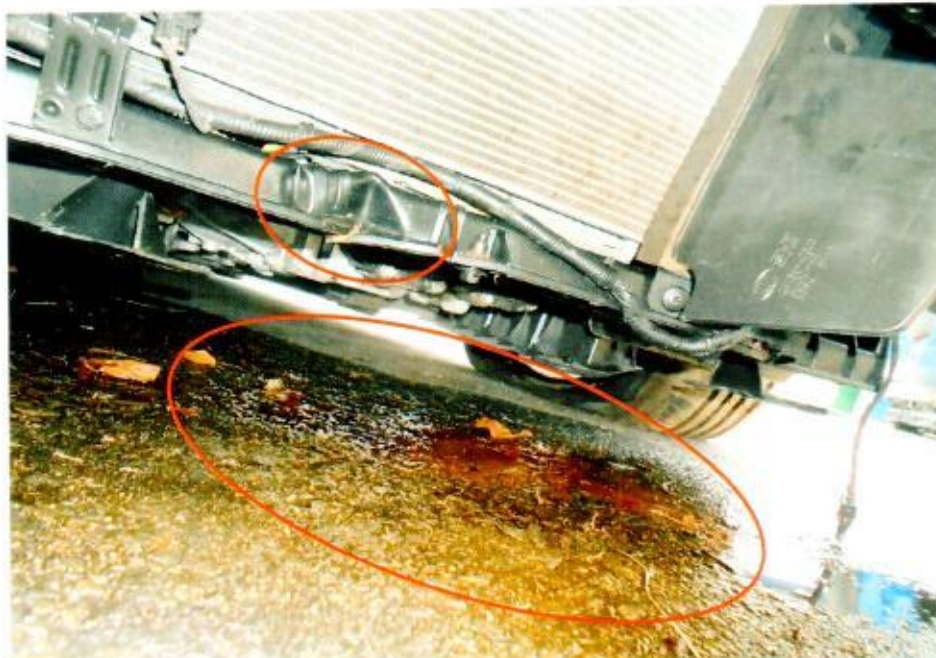
**Photo 21** shows our subsequent checks on the underside of the Motor Car also reveals there's fluid stain on the ground right underneath the engine pan. This indicates that there's fluid leakage exist likely due to the accident's impact.

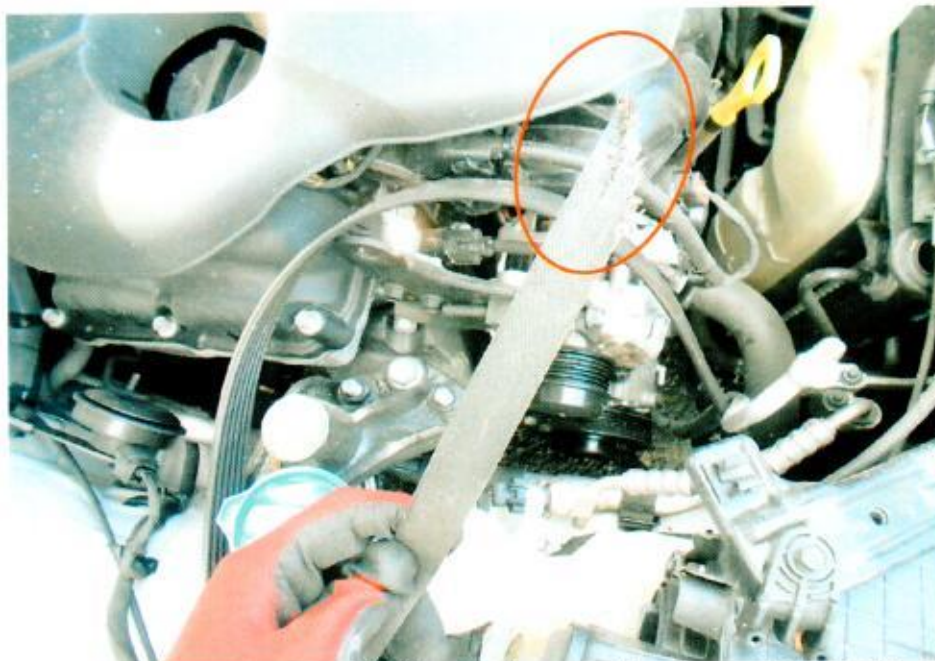
**Photo 22** showed damaged belting for the operational components such as alternator, air-conditioning compressor amongst others for the normal operation.

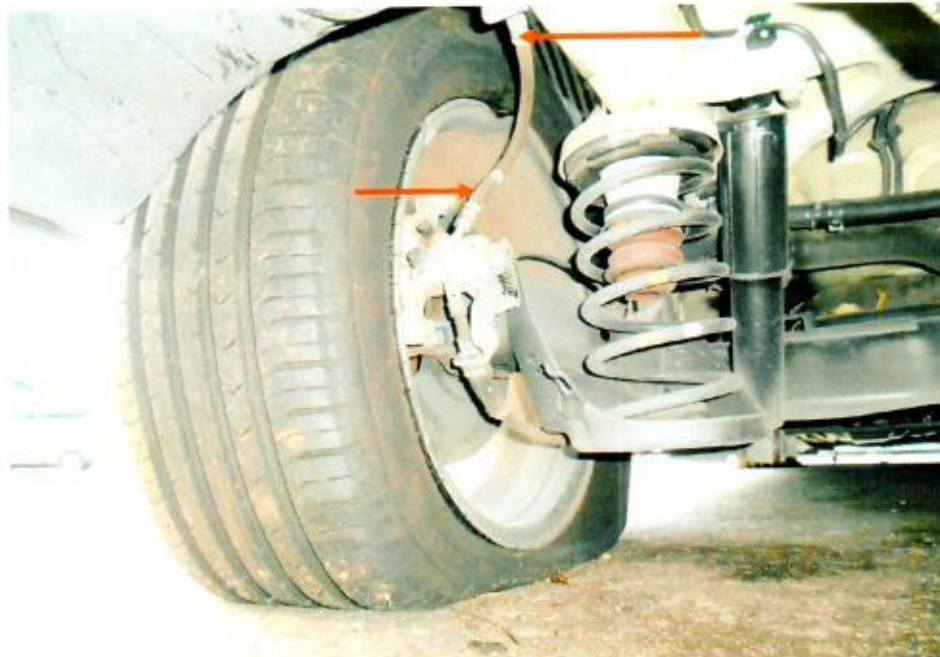
**Photo 23** shows the brake hose (arrowed) at the rear left wheel of the Motor Car. Our visual inspection of the various mechanical components of the Motor Car's braking system revealed all to be intact and without visible damage, indicating that the braking system was likely to be in serviceable condition at the material time of accident.

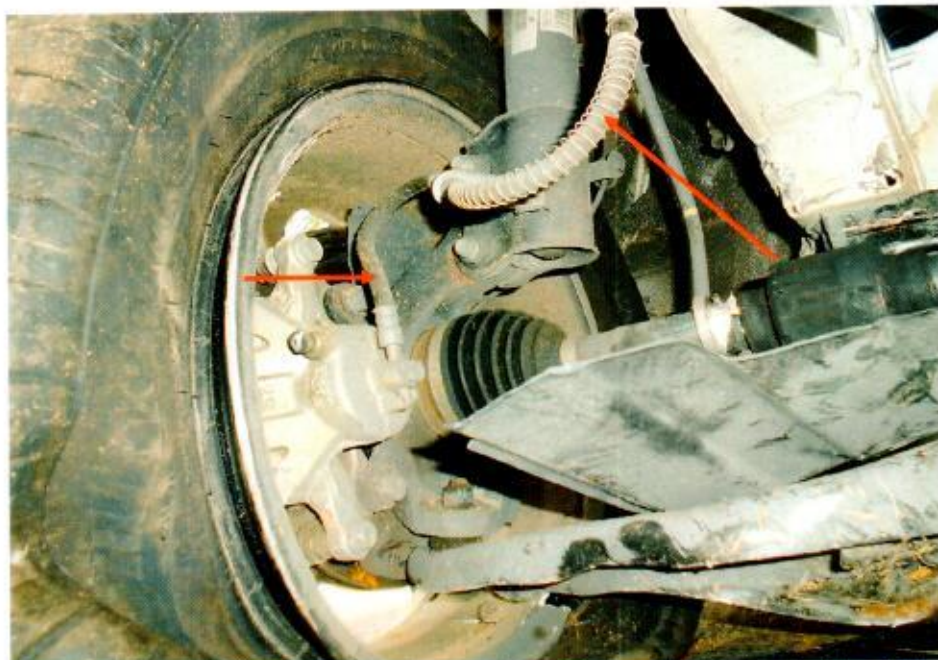
**Photo 24** shows the brake hose (arrowed) at the front right wheel of the Motor Car. Our visual inspection of the various mechanical components of the Motor Car's braking system, including its brake calliper, revealed all to be intact and without visible damage, indicating that the braking system was likely to be in serviceable condition at the material time of accident.

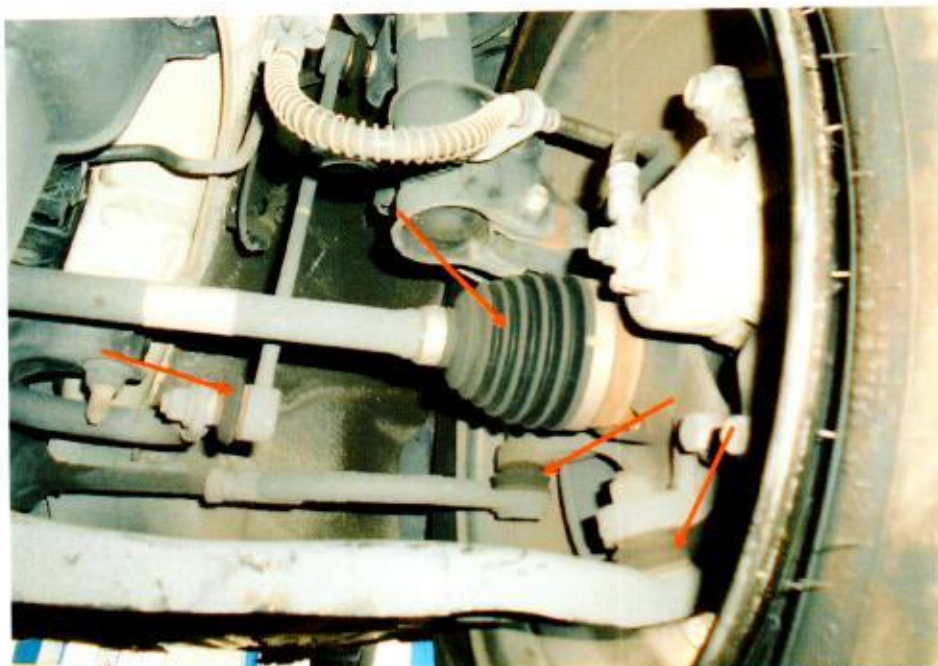
**Photo 25** shows the various undercarriage components at the front left wheel of the Motor Car, in particular the steering tie rod (arrowed). The various steering components were all found to be intact, suggesting that the steering system of the Motor Car was likely to be in serviceable condition.

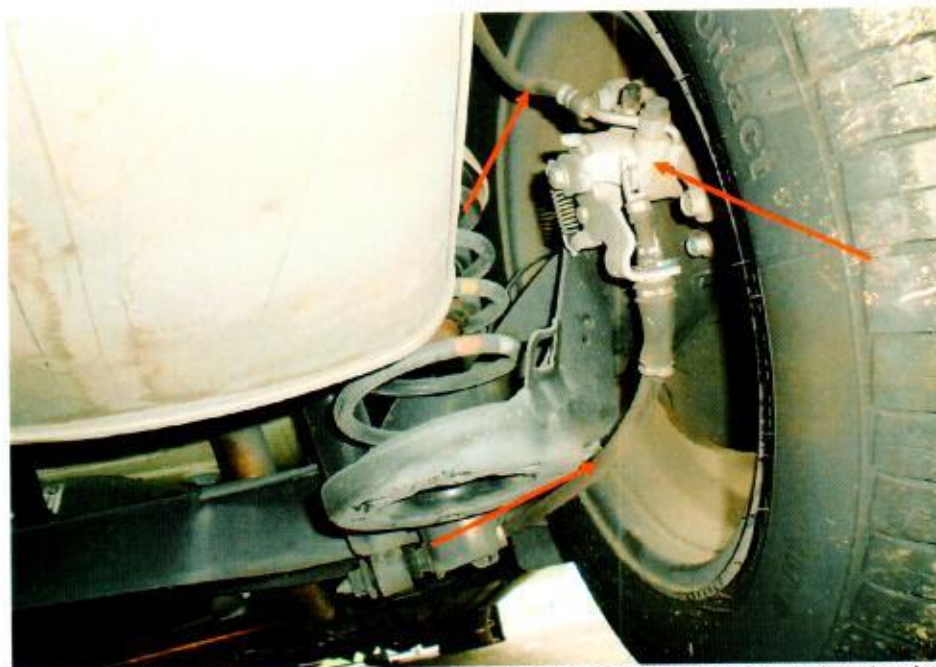
**Photo 26** shows the various undercarriage components at the rear right wheel of the Motor Car. We did not observe any leakage of brake fluid at the time of our inspection of the Motor Car. Our visual inspection of the various mechanical components of the Motor Car's braking system revealed all to be intact and without visible damage, indicating that the braking system was likely to be in serviceable condition at the material time of accident.

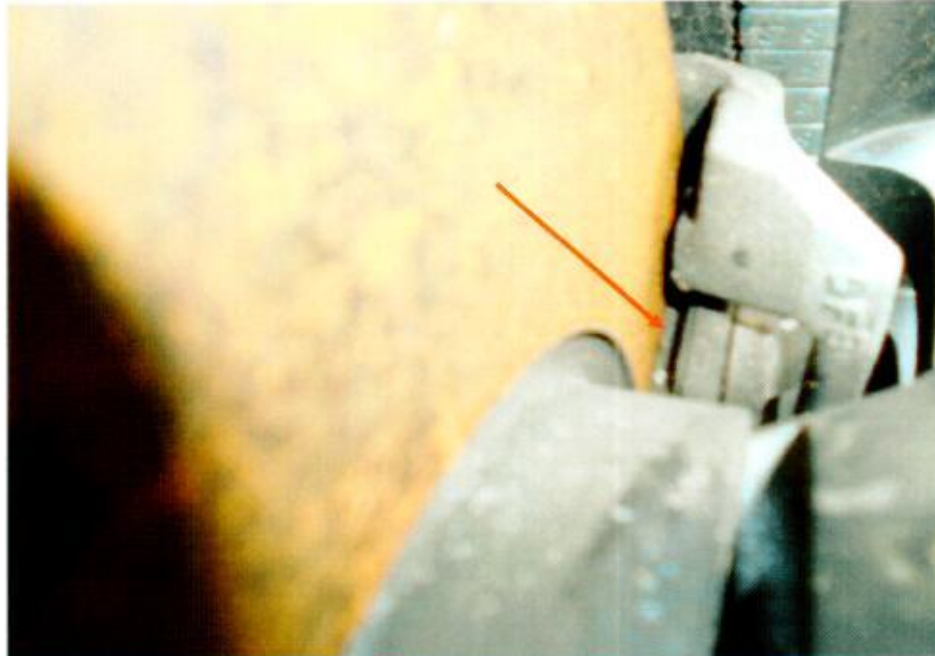
**Photo 27** shows the front right brake pad of the Motor Car. It was observed to be in serviceable condition looking at the thickness of the brake pad at time of our inspection.

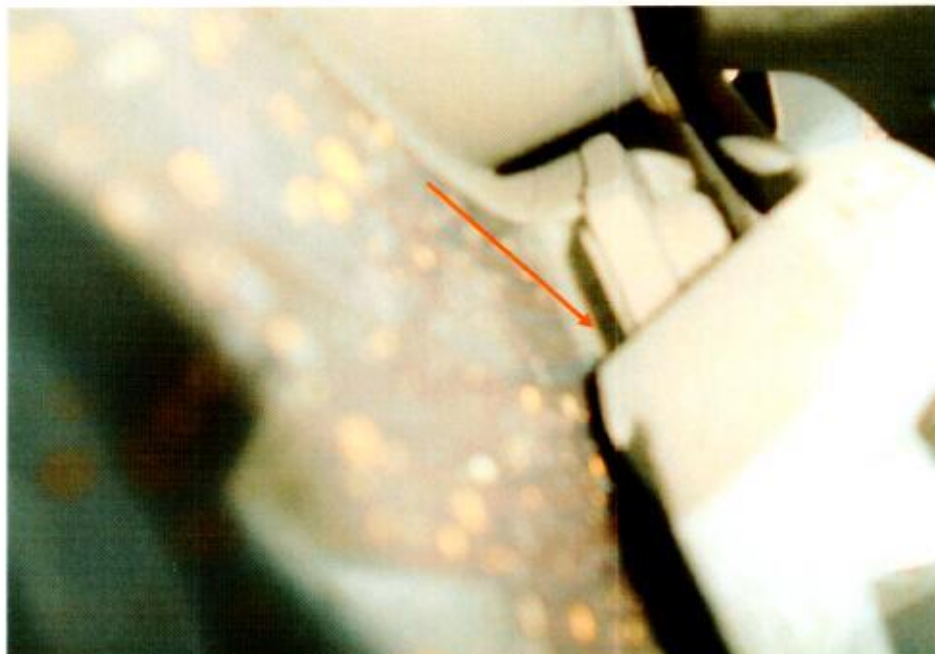
**Photo 28** shows the front left brake pad of the Motor Car. It was observed to be in serviceable condition looking at the thickness of the brake pad at time of our inspection.

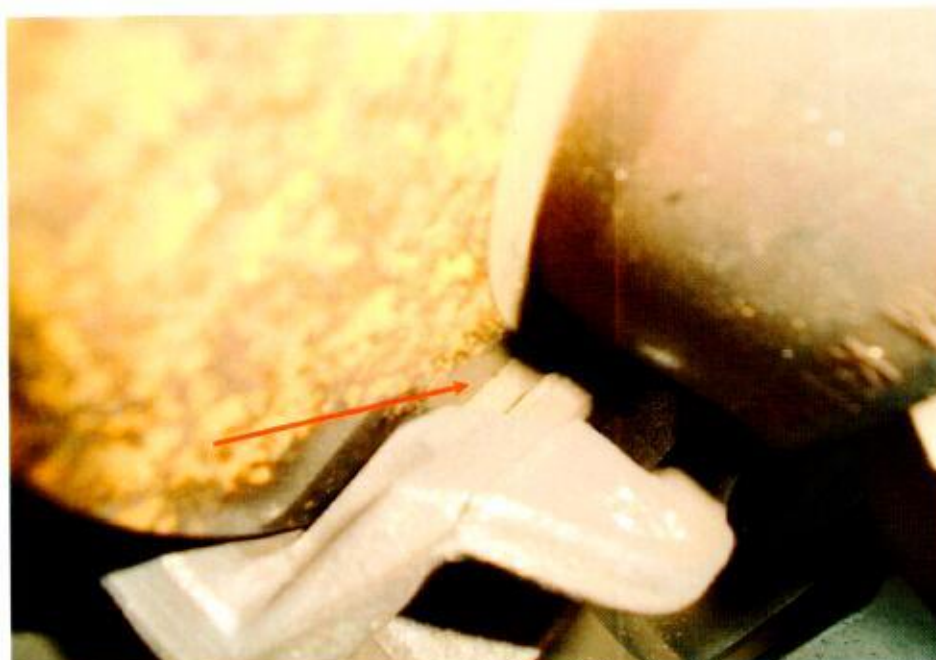
**Photo 30** shows the rear right brake pad of the Motor Car. It was observed to be in serviceable condition looking at the thickness of the brake pad at time of our inspection.

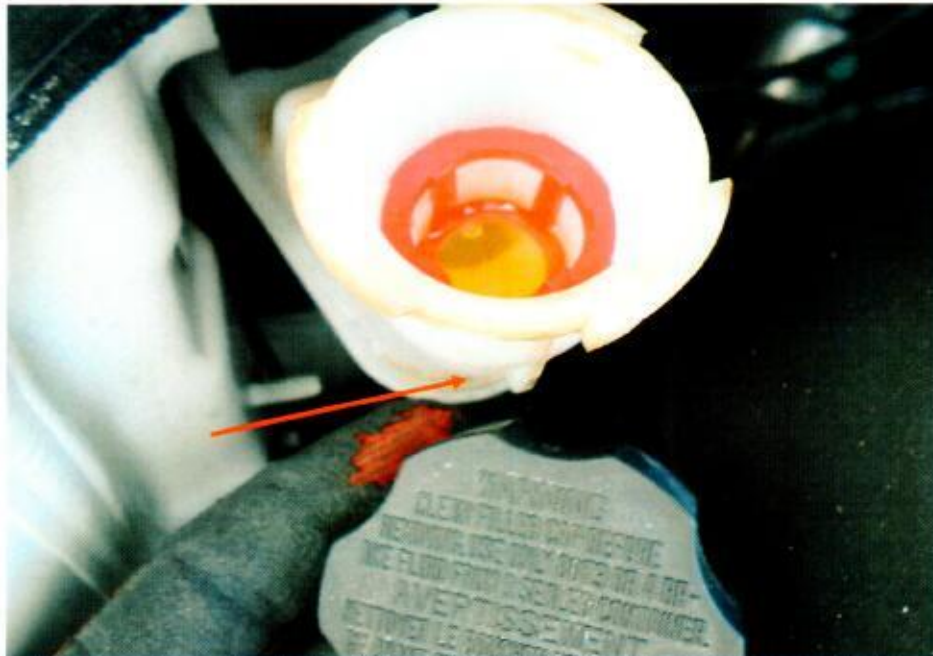
**Photo 31** shows the brake fluid of the Motor Car. It was observed to be of sufficient level for operation purposes at time of our inspection.

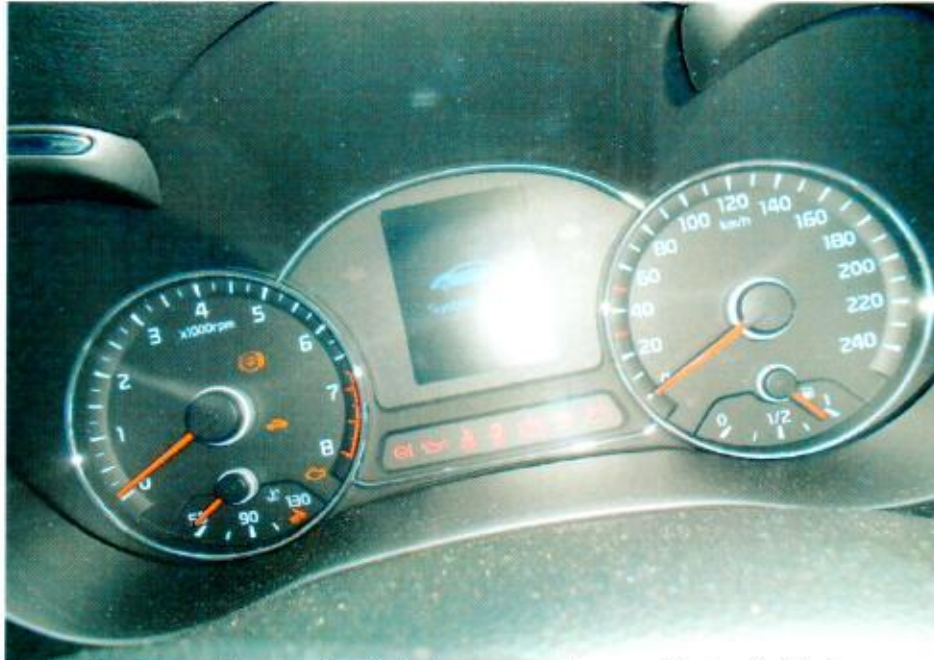
**Photo 32** shows the warning indicators were observed to be lighted up upon cranking of the engine. It was observed to be operating abnormally likely due to the accident's impact collision. This indicates that the Motor Car electronic systems sustained system malfunction as a result of the accident.

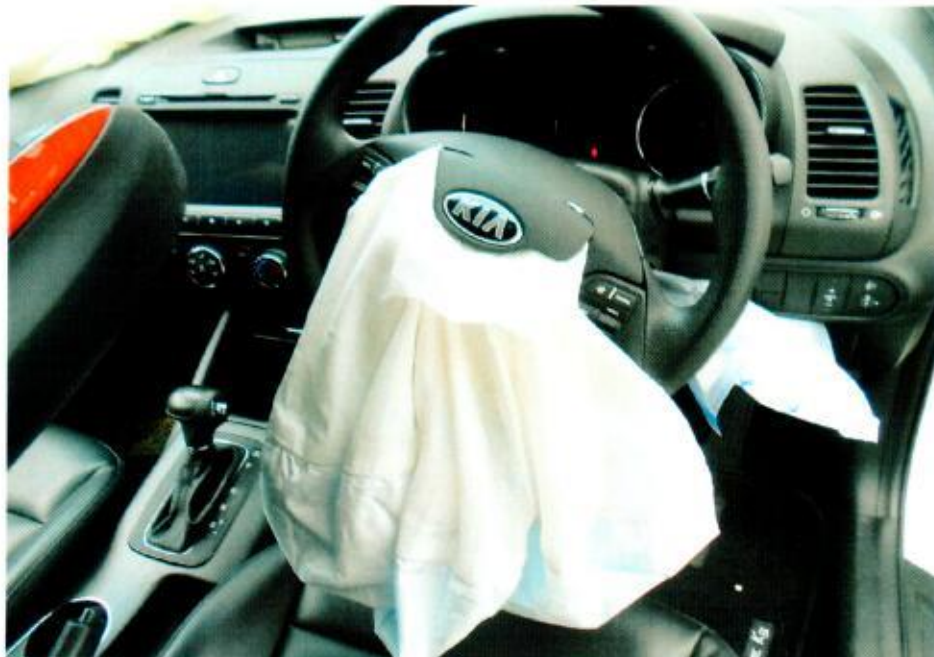
**Photo 33** shows the driver seat airbag was activated indicating that the airbag system was in serviceable condition prior to the accident.

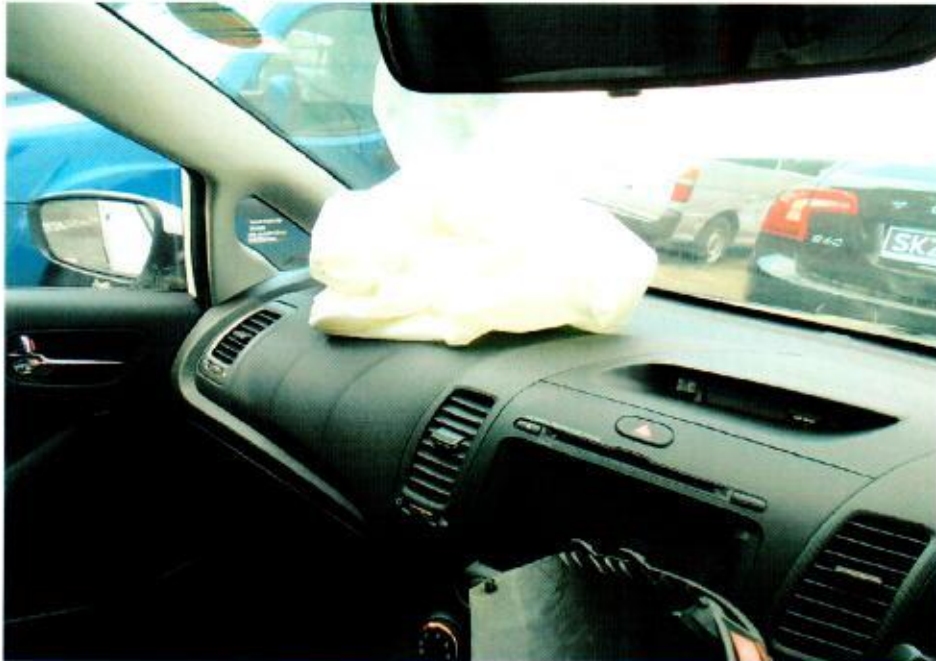
**Photo 34** shows the front passenger's seat airbag was activated indicating that the airbag system was in serviceable condition prior to the accident.
