Your Ref: TP/IP/13129/2018
Our Ref : CI/TPD18010491/Z

Fatal Accident Investigation Team

MECHANICAL INSPECTION REPORT OF MOTOR TAXI SHC 2188T

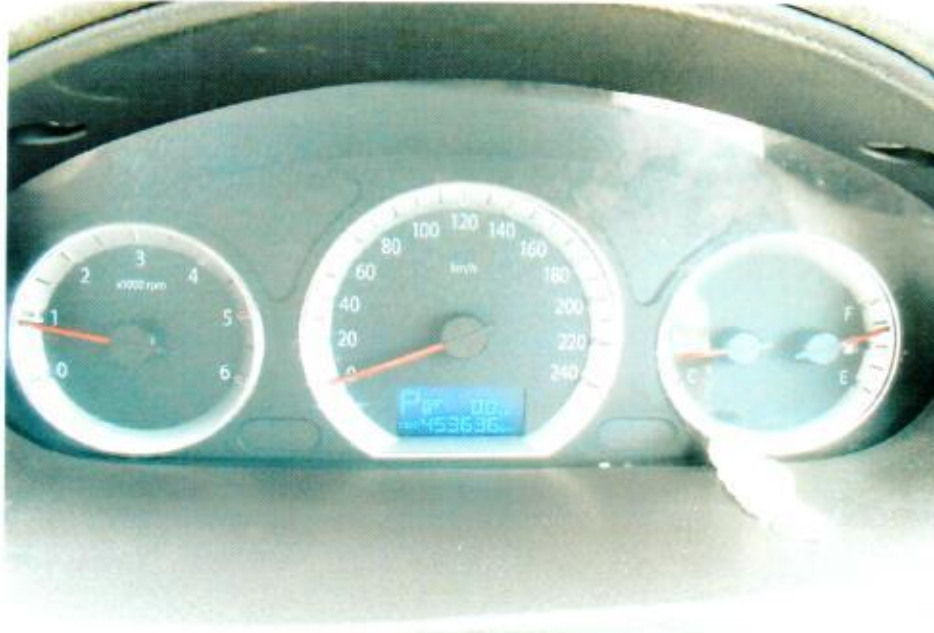
Photo 1 shows the mileage of the Motor Taxi was 453636 km.

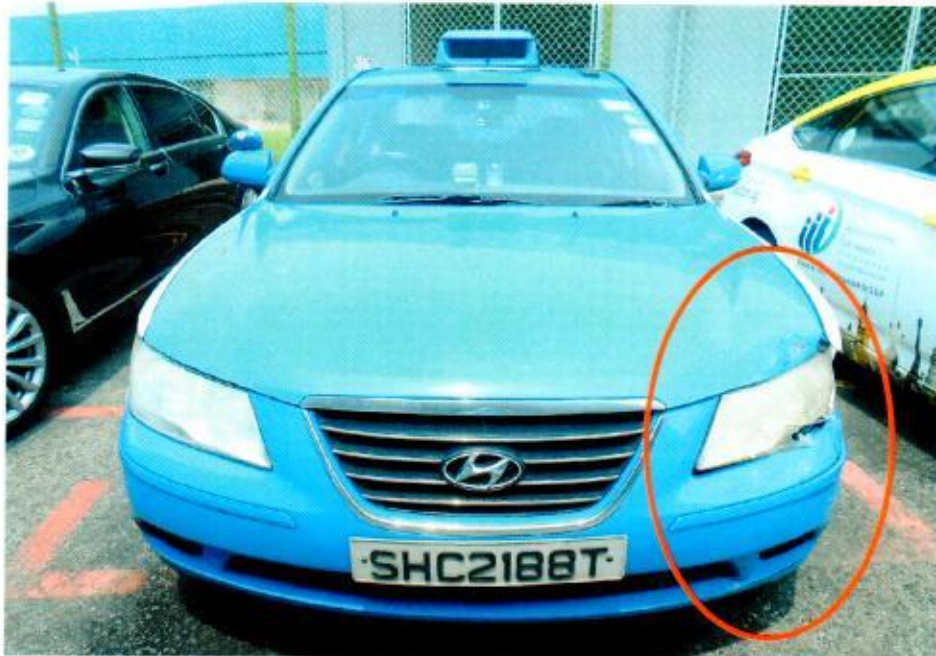
Photo 2 shows a general view of the front body of the Motor Taxi at the time of our inspection. The Motor Taxi was observed to be in good general condition except for minor damages at the front left portion.

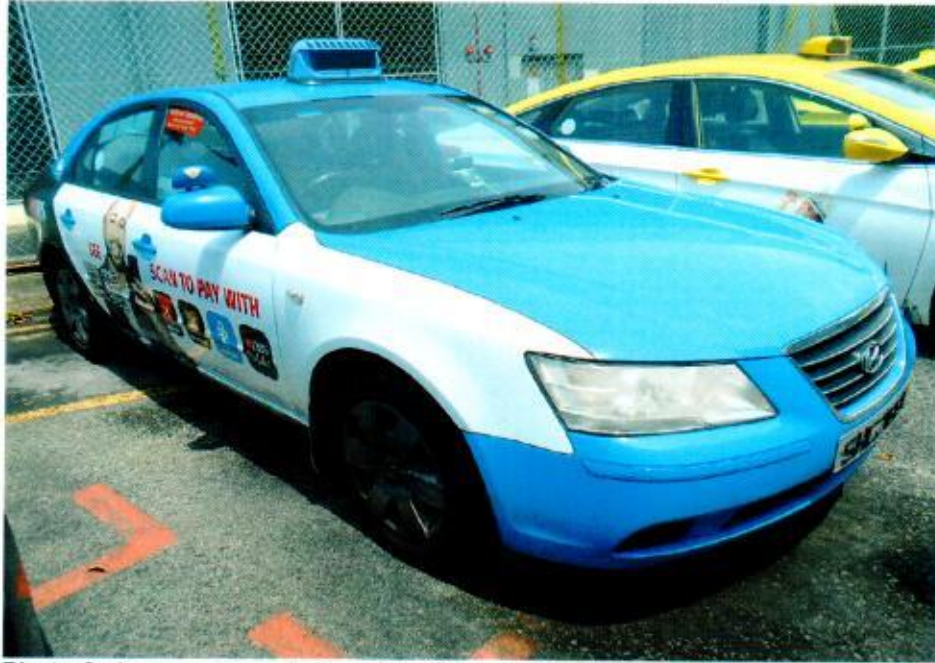
Photo 3 shows a general view of the front right body of the Motor Taxi at the time of our inspection. The Motor Taxi was observed to be in good general condition except for minor damages at the front left portion.

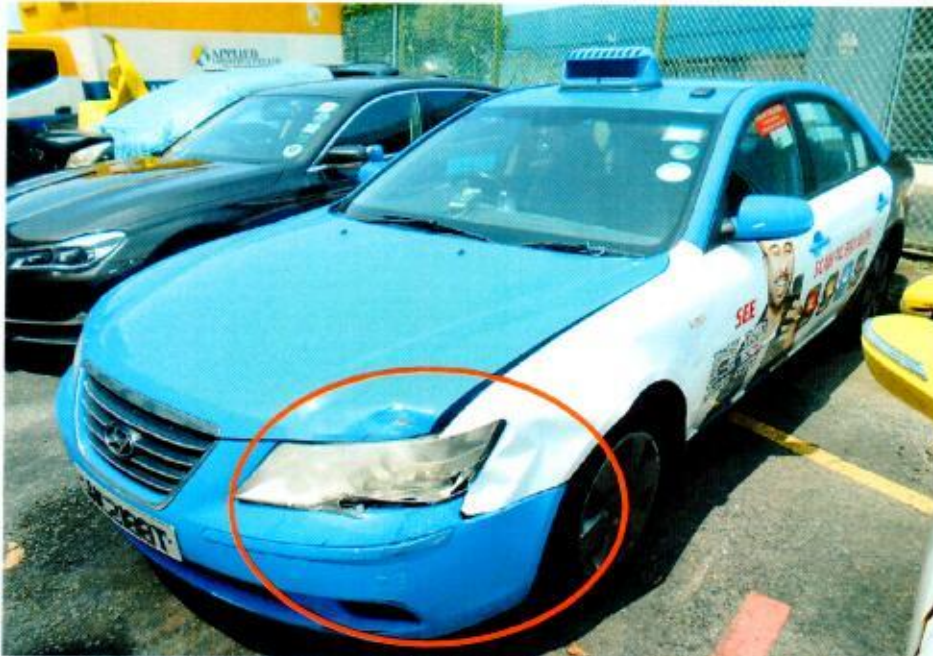
4. The mileage of the Motor taxi at the time of our inspection was 453636 km.
5. The Motor taxi had sustained a relatively minor impact damages that was confined to its front left portion. Its front left side fender was observed to have been corrugated; its front left hand lower bumper was observed to have scratches & dented; its front left headlamp was observed to have been broken; its front bonnet was noted to be deformed likely due to the accident's impact.
6. This was likely due the consistency of the accident's case facts that the Motor Taxi was driving along Commonwealth Avenue towards Commonwealth Avenue West when it collided into a pedestrian with wheelchair whom was crossing from his right to left on the left most lane of a 3 lane road. The front left portion of the Motor Taxi collided onto the pedestrian's with his wheelchair. See photo 1 to 6 below.

Photo 4 shows a general view of the front left body of the Motor Taxi at the time of our inspection. The Motor Taxi was observed to sustained minor damages at the front left portion.

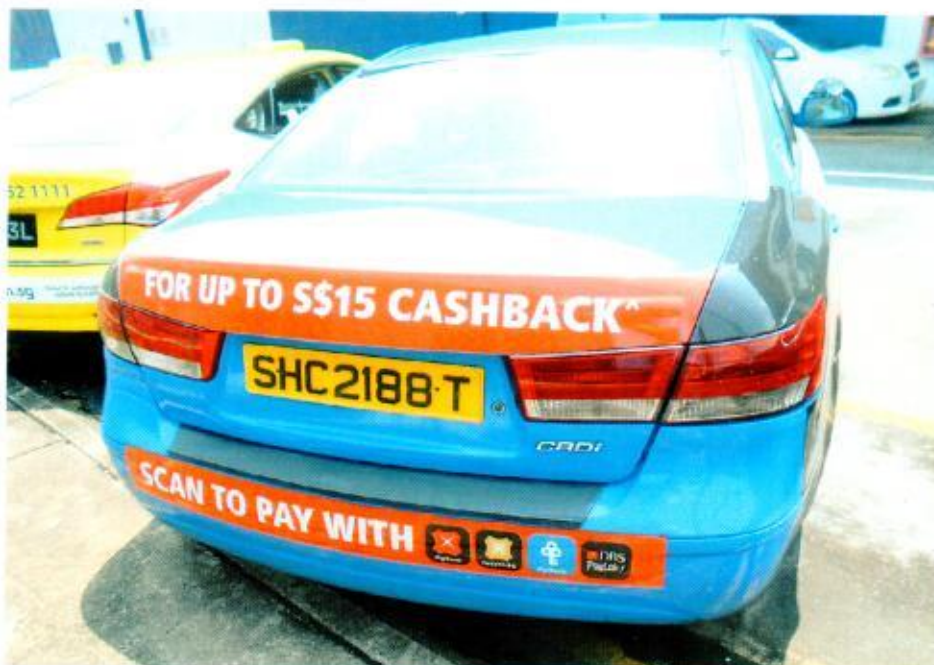
Photo 5 shows a general view of the rear body of the Motor Taxi at the time of our inspection. The Motor Taxi was observed to be in good general condition.

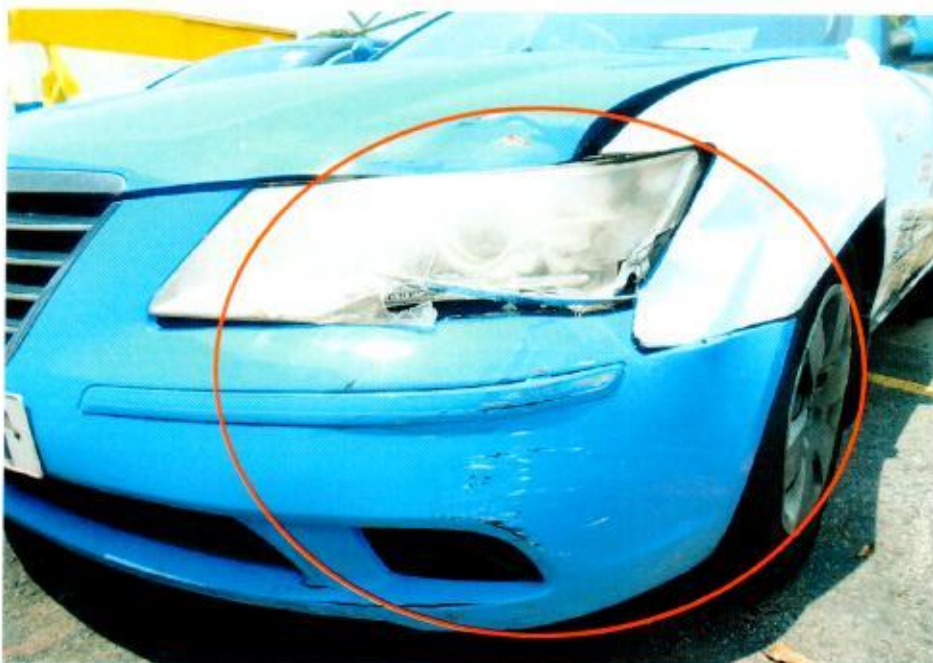
Photo 6 shows a close up view of the front number plate/base of the Motor Taxi at the time of our inspection. The Motor Taxi had sustained relatively minor impact at the front left of the Motor Car.

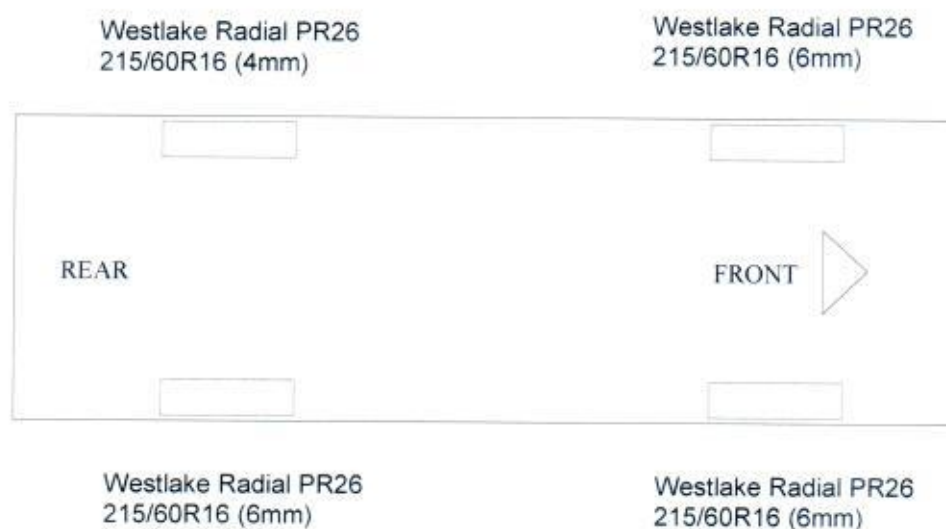
7. The condition of the Motor Taxi's 4 tyres was observed to be in serviceable condition. We did not find any tear, cut or burst mark(s) on the outer and the inner sidewalls as well as across the tread of the 4 tyres. The 4 tyres were also observed to be sufficiently inflated for vehicular operation. The tyre brand, tyre size and remaining tread depth of the 4 tyres were recorded as follows:-

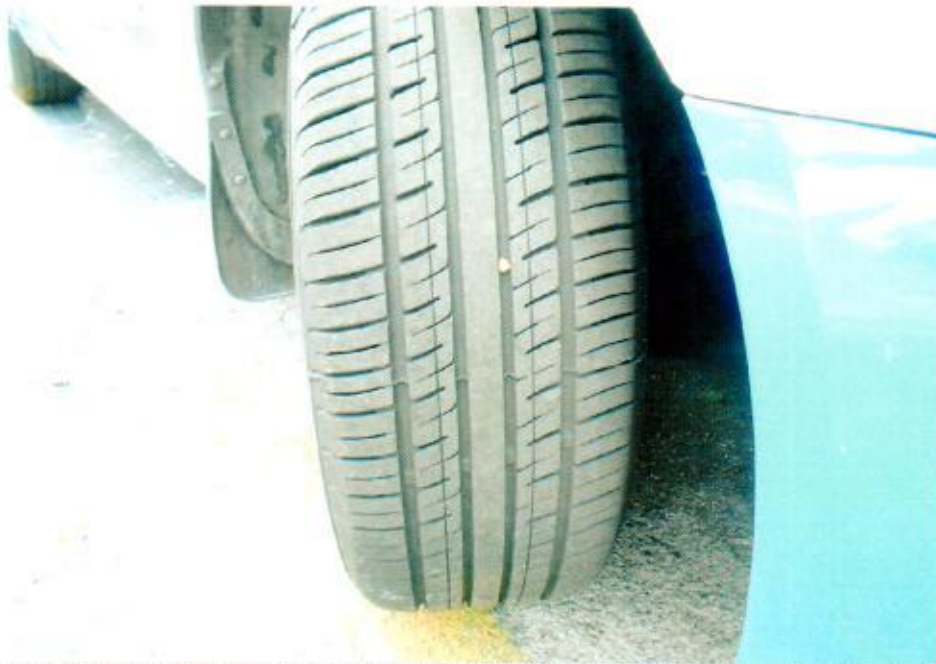
Photo 7 shows the condition of the front right tyre of the Motor Taxi, which was observed to be in serviceable condition with remaining tread depth of approximately 6mm. There was no tear, cut or burst mark(s) on the outer and the inner sidewalls.

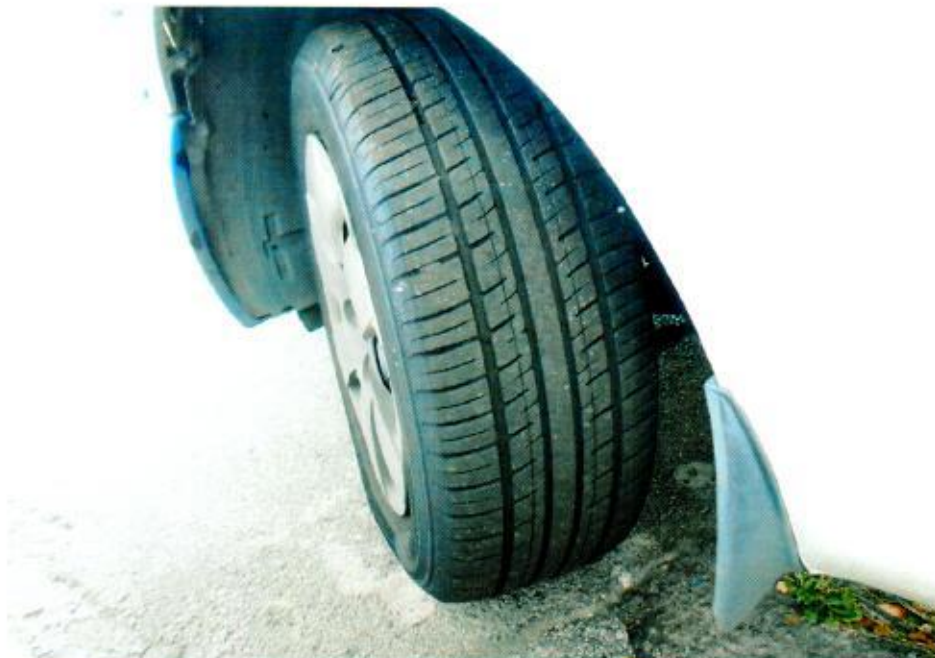
Photo 8 shows the condition of the front left tyre of the Motor Taxi, which was observed to be in serviceable condition with remaining tread depth of approximately 6mm. The tyre, which was wrapped around alloy wheel rim, was also observed to be sufficiently inflated for vehicular operation.

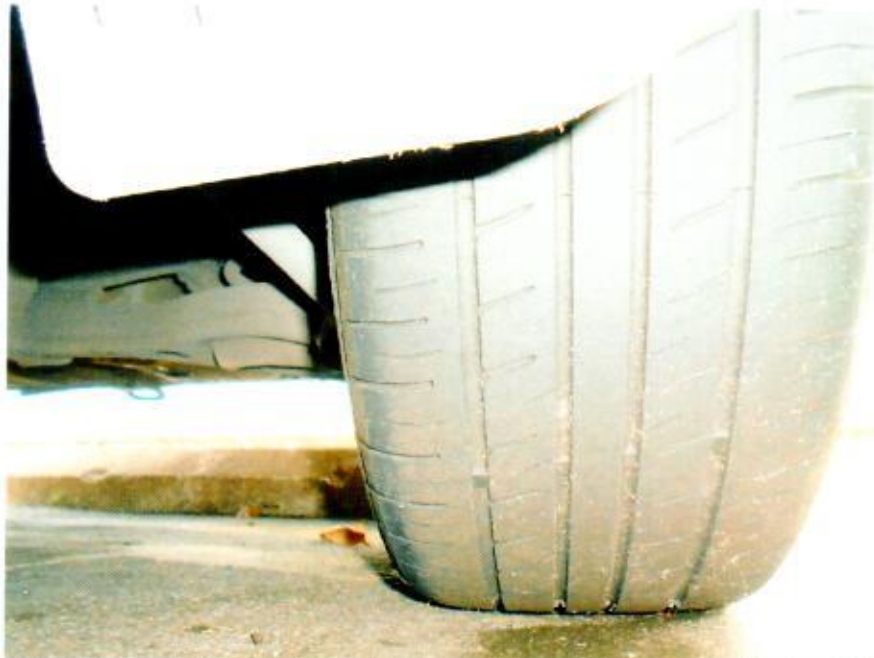
Photo 9 shows the condition of the rear left tyre of the Motor Taxi, which was observed to be in serviceable condition with remaining tread depth of approximately 4mm. The tyre, which was wrapped around alloy wheel rim, was also observed to be sufficiently inflated for vehicular operation.

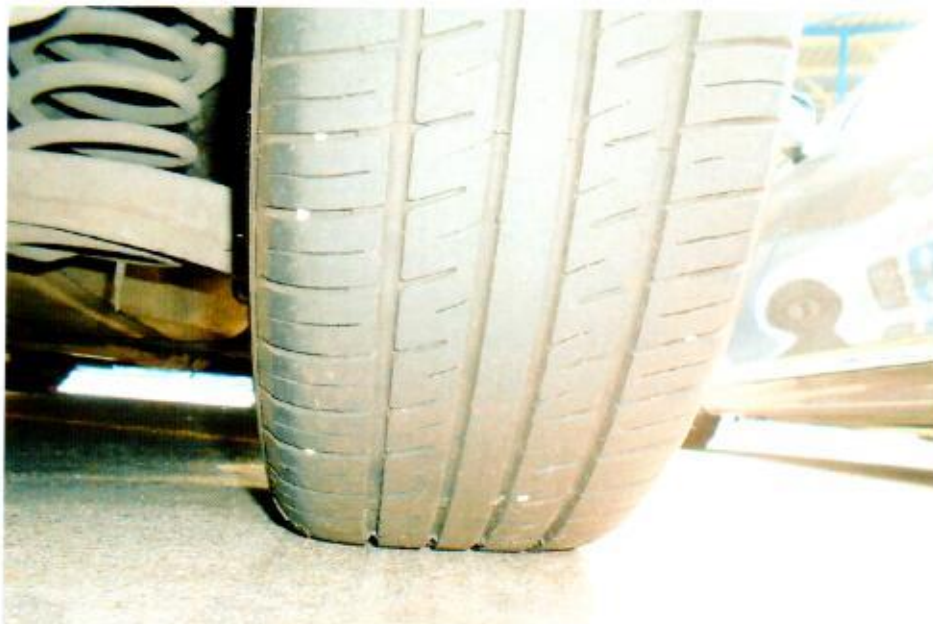
Photo 10 shows the condition of the rear right tyre of the Motor Taxi, which was observed to be in serviceable condition with remaining tread depth of approximately 6mm. There was also no tear, cut or burst mark(s) on the outer and the inner sidewalls as well as across the tread of the 4 tyres.

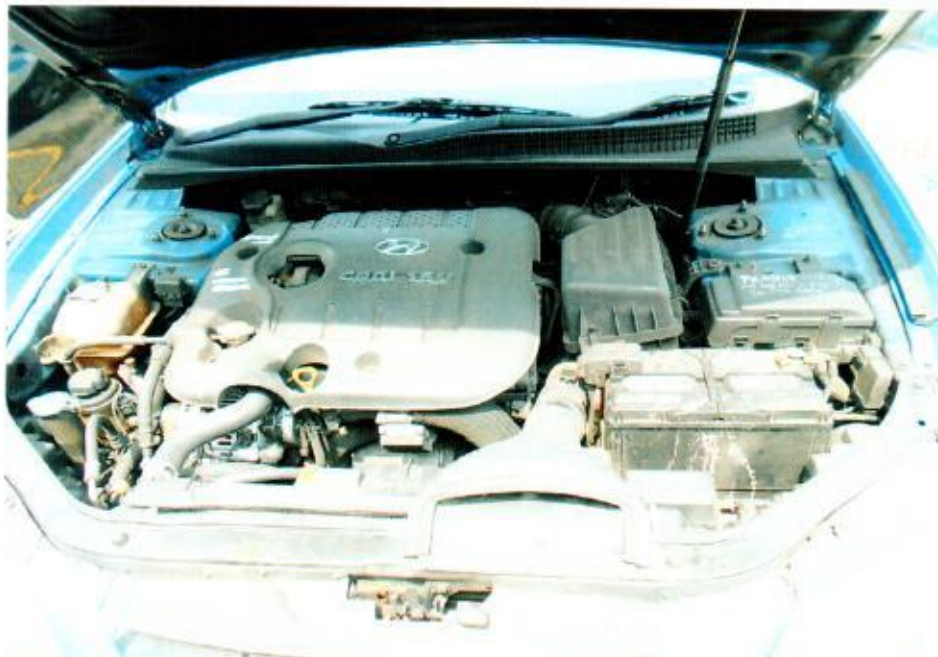
Photo 11 shows a general view of the Motor Car's engine compartment. The various parts and components inside the engine compartment were unaffected by the accident. There was also no sign(s) or indication(s) of fluid leakage and/or fluid stain within the engine compartment.

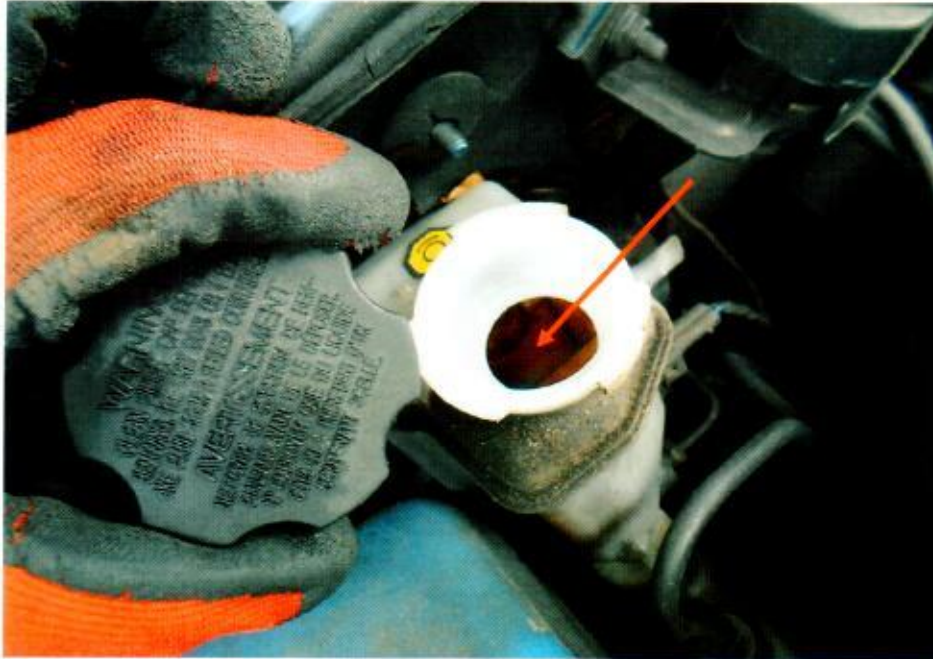
Photo 12 shows the brake fluid reservoir of the Motor Taxi at the time of our inspection. The brake fluid was observed to be of sufficient level (arrowed) and without any visible contamination.

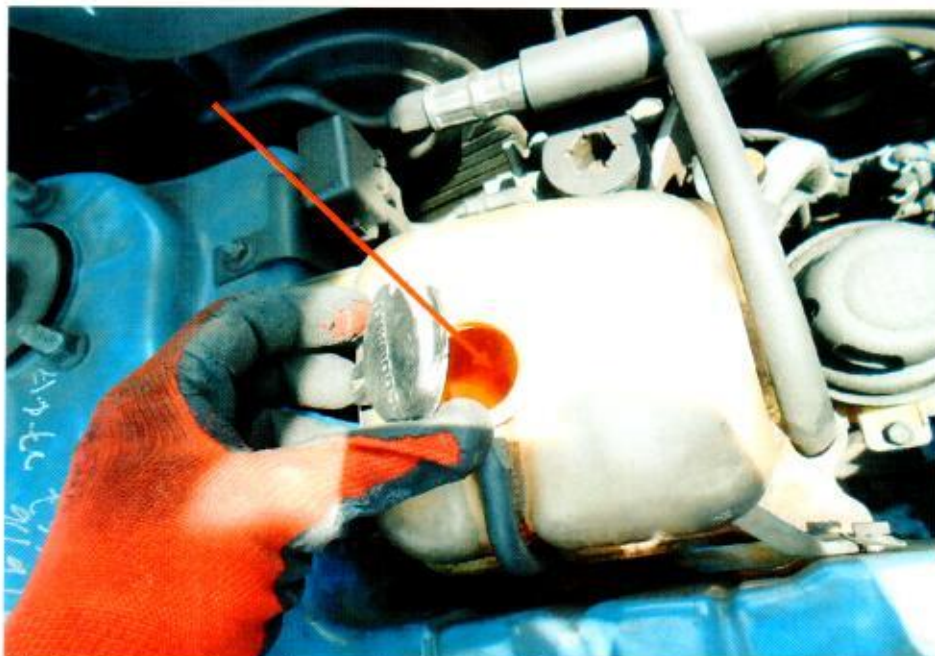
Photo 13 shows the engine coolant fluid reservoir of the Motor Taxi at the time of our inspection. The engine coolant fluid was observed to be of sufficient level and without any visible contamination.

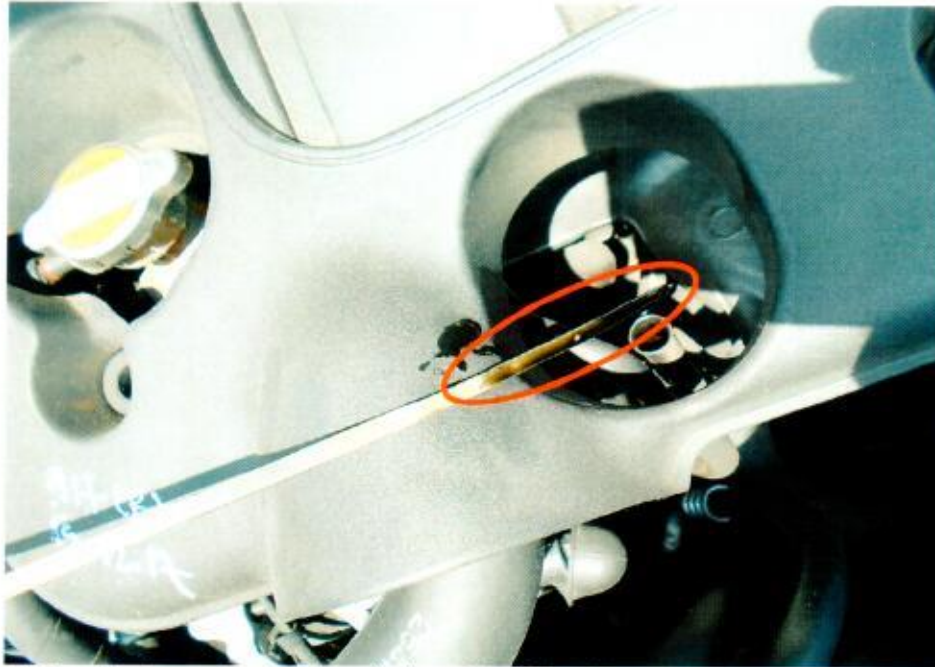
Photo 14 shows the engine oil dip stick of the Motor Taxi at the time of our inspection. The engine oil was observed to be of sufficient level and without any visible contamination.

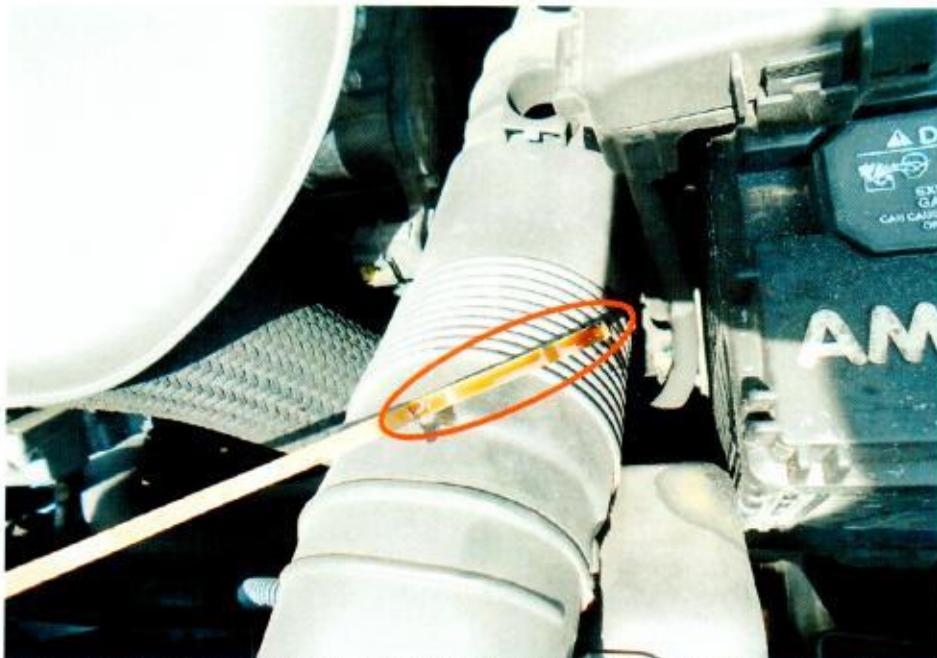
Photo 15 shows the transmission fluid dip stick of the Motor Taxi at the time of our inspection. The transmission fluid was observed to be of sufficient level and without any visible contamination.

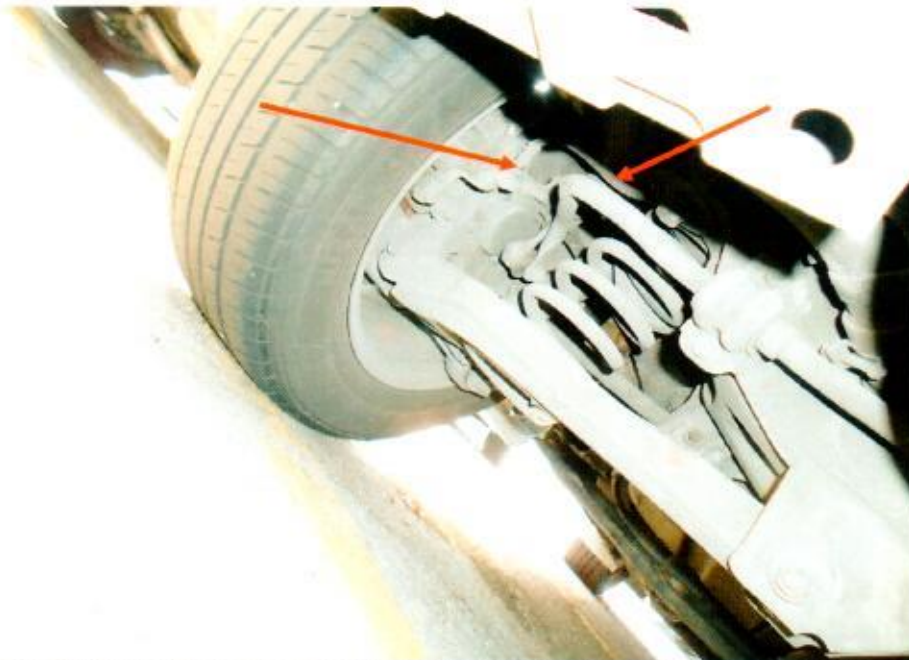
Photo 16 shows the brake hose (arrowed) at the rear left wheel of the Motor Taxi. We did not observe any leakage of brake fluid at the time of our inspection of the Motor Taxi. Our visual inspection of the various mechanical components of the Motor Taxi's braking system revealed all to be intact and without visible damage, indicating that the braking system was likely to be in serviceable condition at the material time of accident.

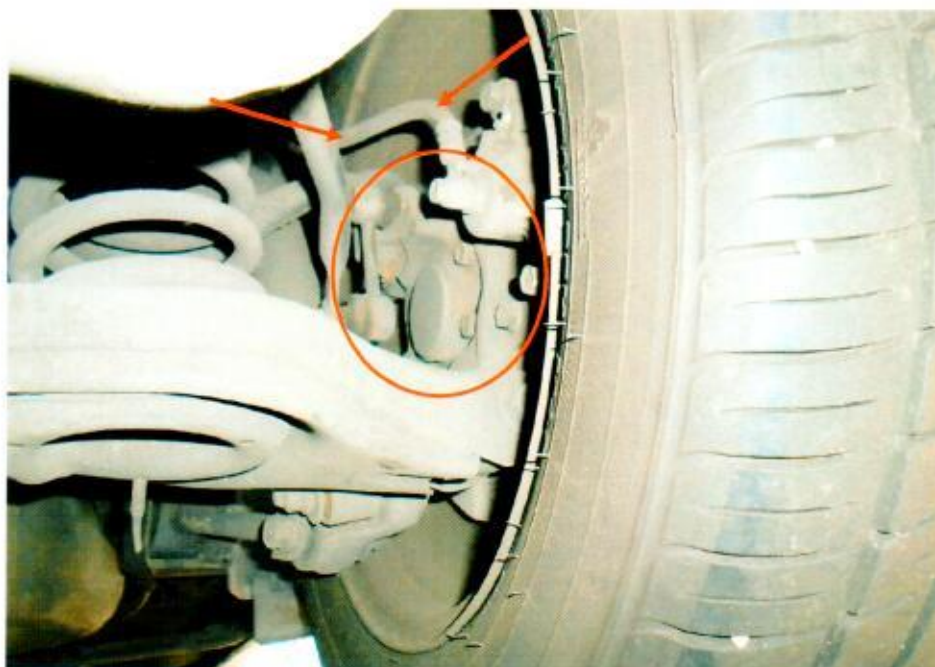
Photo 17 shows the brake hose (arrowed) at the rear right wheel of the Motor Taxi. We did not observe any leakage of brake fluid at the time of our inspection of the Motor Taxi. Our visual inspection of the various mechanical components of the Motor Taxi's braking system, including its brake calliper (circled), revealed all to be intact and without visible damage, indicating that the braking system was likely to be in serviceable condition at the material time of accident.

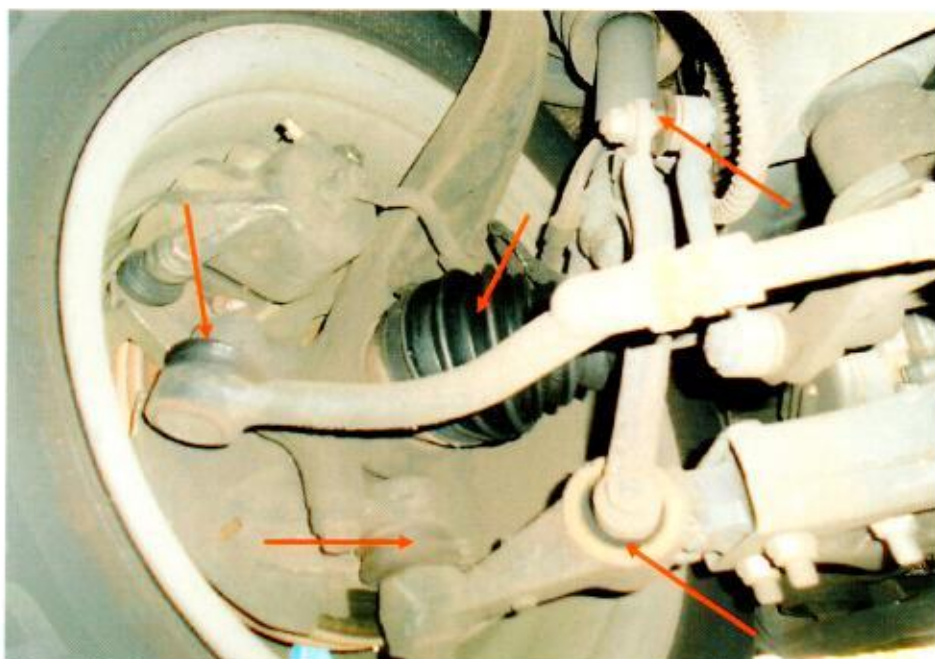
Photo 18 shows the various undercarriage components at the front right wheel of the Motor Taxi, in particular the steering tie rod (arrowed). The various steering components were all found to be intact, suggesting that the steering system of the Motor Taxi was likely to be in serviceable condition.

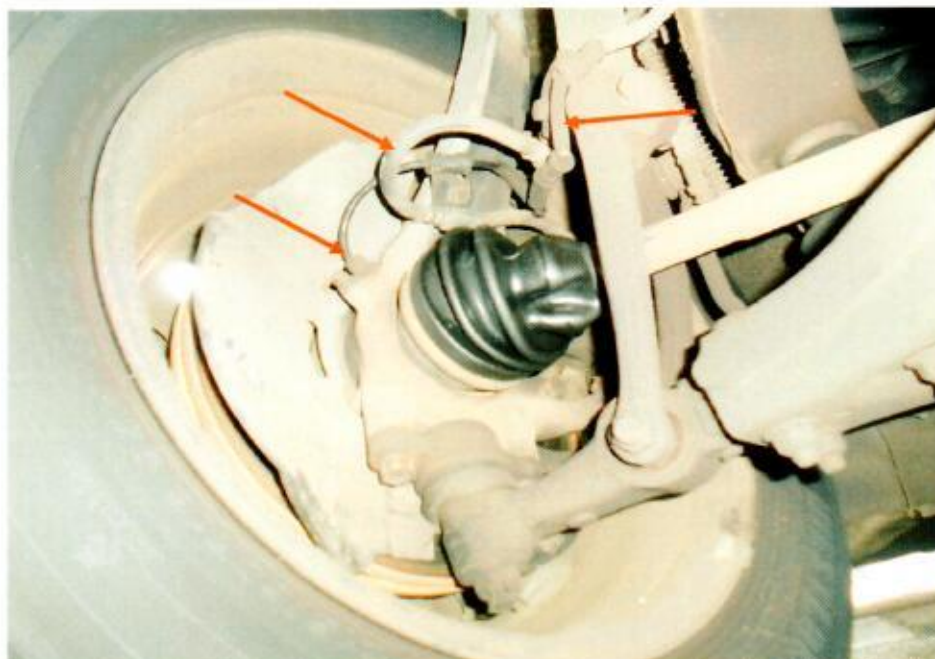
Photo 19 shows the various undercarriage components at the front left wheel of the Motor Taxi. We did not observe any leakage of brake fluid (arrowed) at the time of our inspection of the Motor Taxi. Our visual inspection of the various mechanical components of the Motor Taxi's braking system revealed all to be intact and without visible damage, indicating that the braking system was likely to be in serviceable condition at the material time of accident.

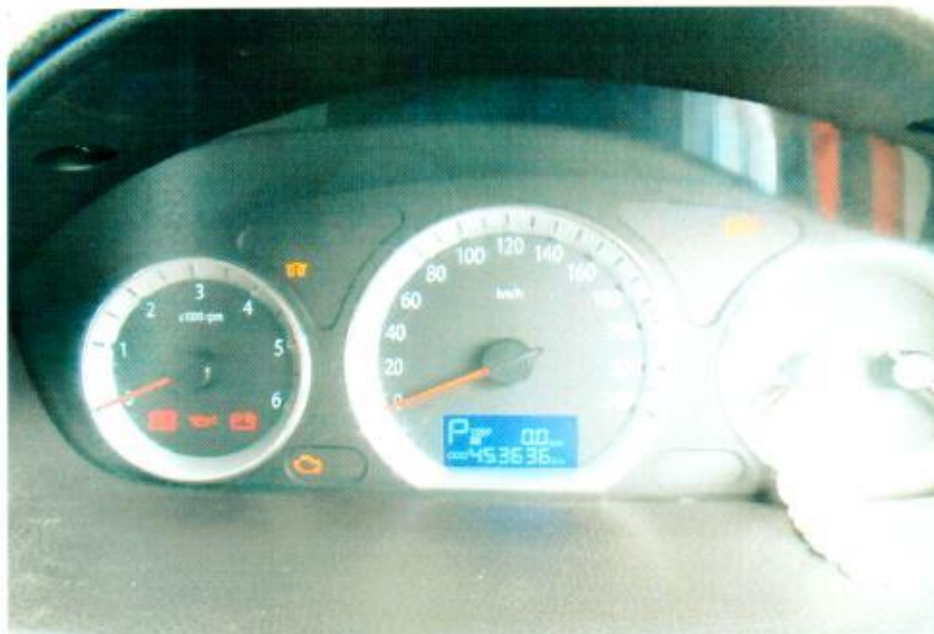
Photo 20 shows the warning lights for the various electronic operating systems of the Motor Taxi appearing on its instrument panel during the self-test when the engine is cranked, in particular the ABS light and SRS light.

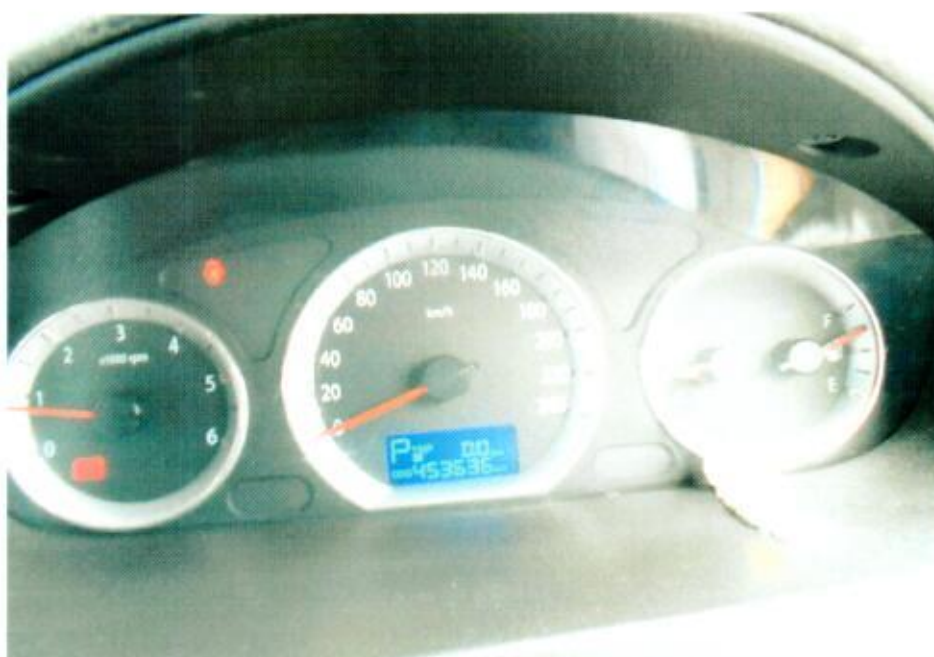
Photo 21 shows no warning lights illuminated on the instrument panel of the Motor Taxi after the engine was cranked. This would suggest that there was no abnormality to the various electronic operating systems of the Motor Taxi, like the ABS and SRS.

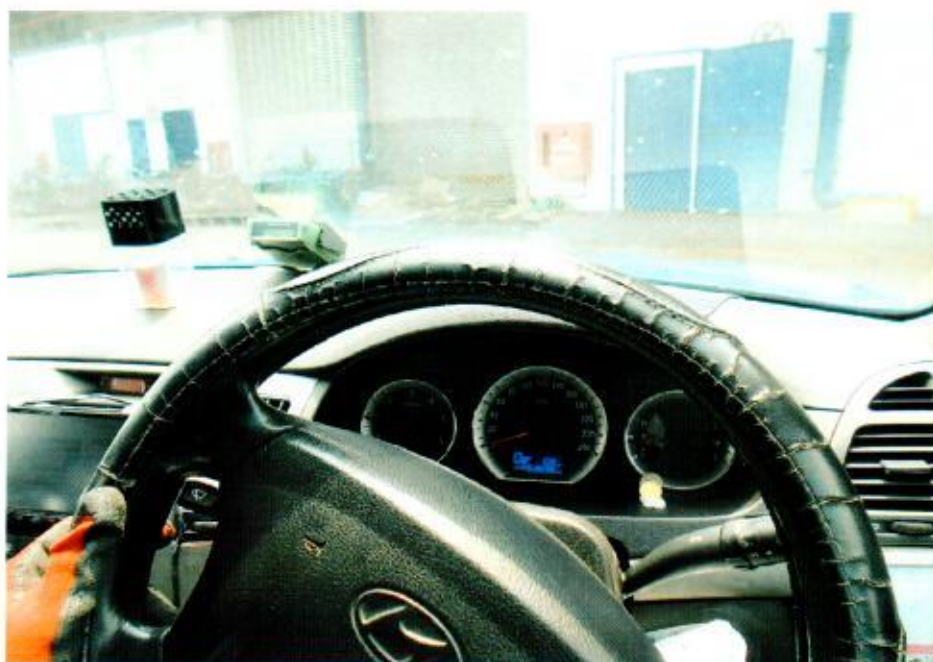
Photo 22 shows an operational test of the Motor Taxi. We were able to move the vehicle reverse, forward and backward normally.
