| Affiliated to Federation Internationale Des Experts En Automobile | | | | |
|---|---|---|---|---|
| FIRST CAPITAL INSURANCE LTD | | | Ref : CS/FCI18010503/R1vd3 | |
| Insured Veh. | SHA 1618L | Veh. Inspected | XE 1648P | |

**PRELIMINARY ADVICE OF VEHICLE NO. XE 1648P**

### ADJUSTMENT ON REPAIR COST FOR VEHICLE NO. XE 1648P

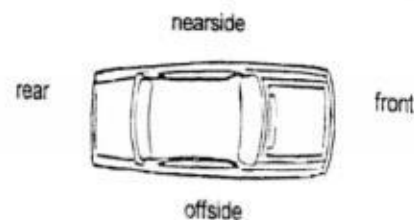
The vehicle sustained damages at the  
front n/s portion and front o/s portion

Comments/Present Status:  
Damages Consistent
